Vehicle Inspection Report

Date Inspected: 19/03/2025 15:29

GX68ZXD Reg: VIN: 6FPPXXMJ2PJM11751

Appraised By: Eastbourne Car Auctions

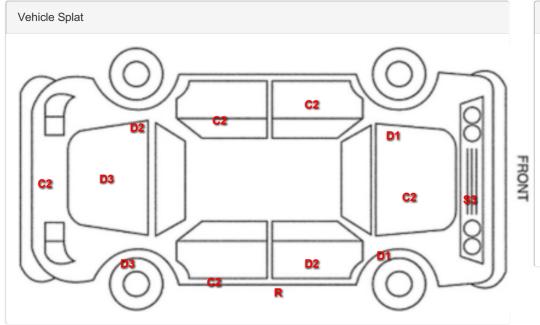
front bumper misaligned. eml, abs and traction control light on.esc service. hill descent and pre collision fault
