#### **Vehicle Inspection Report**

Date Inspected: 24/03/2025 12:41

GY69XHD Reg:

NISSAN Make Model X-TRAIL N-

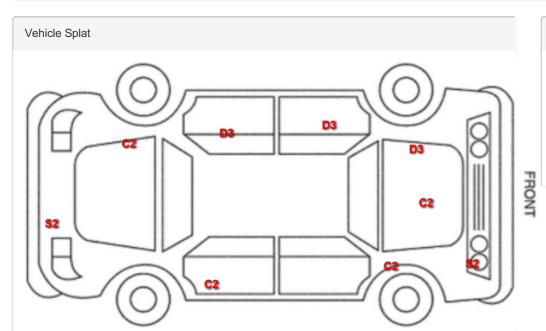
Component	Condition	Severity	Repair
Bumper Front	Scratched	Over 25mm Not Thru Paint	Machine Polish
Bumper Front	Scratched	25 to 100mm Thru Paint	Smart Repair
Bonnet	Chipped	1 To 5	Smart Repair
Wing osf	Chipped	1 To 5	Smart Repair
Door osf	Scratched	Over 25mm Not Thru Paint	Machine Polish
Door osr	Scratched	Over 25mm Not Thru Paint	Machine Polish
Door osr	Chipped	1 To 5	Smart Repair
Qtr Panel osr	Scratched	Over 25mm Not Thru Paint	Machine Polish
Bumper Rear	Scratched	25 to 100mm Thru Paint	Smart Repair
Bumper Rear	Scratched	Over 25mm Not Thru Paint	Machine Polish
Boot Lid	Scratched	Over 25mm Not Thru Paint	Machine Polish
Qtr Panel nsr	Scratched	Over 25mm Not Thru Paint	Machine Polish
Qtr Panel nsr	Chipped	1 To 5	Smart Repair
Door nsr	Dented	With Paint Damage	Repair and Refinish
Door nsf	Dented	With Paint Damage	Repair and Refinish
Wing nsf	Dented	Over 30mm	Repair and Refinish
