Vehicle Inspection Report

Reg: LG20VLM

VIN: 5YJ3F7EBXLF703352

NAMA Grading

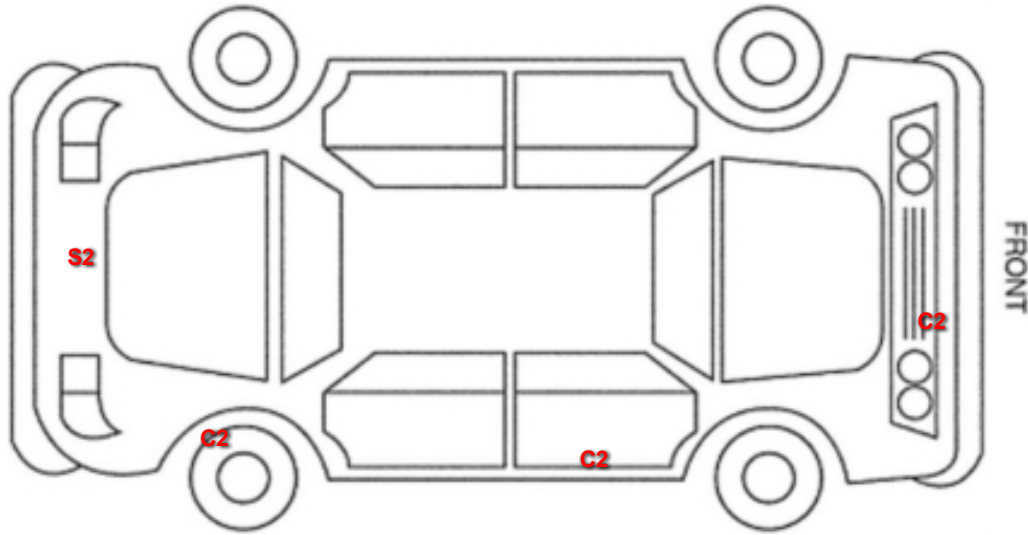
Vehicle Splat

Damage Assessment				
	Bonnet Scratched Over 25mm Not Thru Paint Machine Polish		Bumper Front Scratched Over 25mm Not Thru Paint Machine Polish	Bumper Front Chipped Multiple Chips Smart Repair
	Wing nsf Scratched Over 25mm Not Thru Paint Machine Polish		Door nsf Scratched Over 25mm Not Thru Paint Machine Polish	Door nsr Scratched Over 25mm Not Thru Paint Machine Polish
	Bumper Rear Scratched Over 25mm Not Thru Paint Machine Polish

Bumper Rear Scratched 25 to 100mm Thru Paint Smart Repair	Boot Lid Scratched Over 25mm Not Thru Paint Machine Polish

Qtr Panel osr Chipped 1 To 5 Smart Repair		Door osr Scratched Over 25mm Not Thru Paint Machine Polish

Door osf Chipped 1 To 5 Smart Repair
