Vehicle Inspection Report

Date Inspected: 27/03/2025 10:01

Reg: LD60XZM

Make MINI Model COOPER - 1598cc

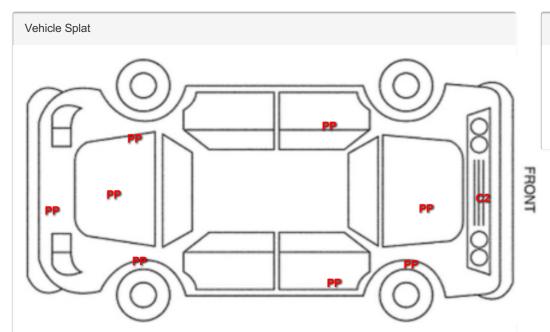
Damage Lines

Bumper Rear

Poor Previous Repair

Paint Flake

Boot Lid

Poor Paint

Qtr Panel osr

Door osf

Wing osf

Bonnet

Bumper Front

Scratched

Over 25mm Not Thru Paint

Chipped

Multiple

Qtr Panel nsr

Wing nsf

Door nsf

Screen Front

UpTo 10mm

Refinish

Machine Polish

Smart

Repair

Smart Repair
