Vehicle Inspection Report

GU16FUV Reg:

VIN: JN1TCNT32U0016467

Appraised By: Eastbourne Car Auctions

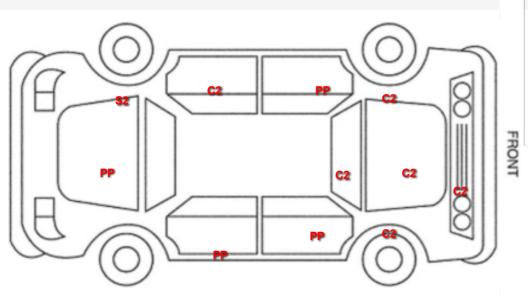
Vehicle Splat

Component	Condition
Bonnet	Chipped
Bumper Front	Scratched
Bumper Front	Chipped
Wing osf	Scratched
Wing osf	Chipped
Wing osf	Scratched
Door osf	Poor Previous Repair
Door osr	Poor Previous Repair
Qtr Panel osr	Scratched
Boot Lid	Poor Previous Repair
Bumper Rear	Scratched
Bumper Rear	Chipped
Qtr Panel nsr	Scratched
Door nsr	Chipped
Door nsf	Scratched
Door nsf	Poor Previous Repair
Wing nsf	Scratched
Wing nsf	Chipped
Roof	Scratched
Screen Front	Chipped

Multiple Chips Over 25mm Not Thru Paint **Multiple Chips** Over 25mm Not Thru Paint 1 To 5 Over 25mm Not Thru Paint Poor Paint Poor Paint Over 25mm Not Thru Paint Paint Flake Over 25mm Not Thru Paint Multiple Chips Over 25mm Thru Paint **Multiple Chips** Over 25mm Not Thru Paint Paint Flake Over 25mm Not Thru Paint 1 To 5 Over 25mm Not Thru Paint UpTo 10mm

nsf wheel arch trim insecure and wnginw noisy. gearbox/transfer box whine. parking sensor system fault

Refinish Machine Polish Smart Repair Machine Polish Smart Repair Machine Polish Refinish Refinish Machine Polish Refinish Machine Polish Smart Repair Refinish Refinish Machine Polish Refinish Machine Polish Smart Repair Machine Polish Smart Repair
