Vehicle Inspection Report

Date Inspected: 23/01/2025 15:45

Reg: EY17WTP

Make	VAUXHALL	Body Type	MPV	Doors	5
Model	ZAFIRA TOURER SRI CDTI EC - 1598cc	Fuel Type	Diesel	Colour	Grey
Mileage	114195 miles	Transmission	Manual	Year of MFR	2017
		Gears	6	Date First Reg	14/06/2017

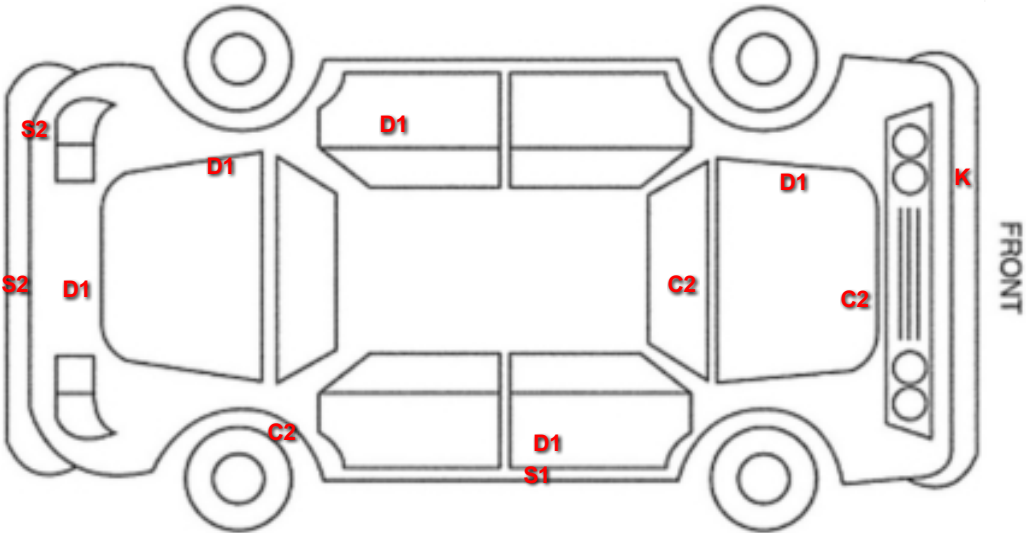
Vehicle Splat

Component	Condition	Severity	Repair
Door osf	Dented	2 Or Less UpTo 10mm	Smart Repair
Door osf	Scratched	UpTo 25mm Thru Paint	Smart Repair
Door osf	Chipped	Edge Chip	Smart Repair
Door osr	Scratched	Over 25mm Not Thru Paint	Machine Polish
Qtr Panel osr	Chipped	1 To 5	Smart Repair
Bumper Rear	Scratched	Over 100mm Thru Paint	Refinish
Tailgate	Dented	2 Or Less UpTo 10mm	Smart Repair
Qtr Panel nsr	Scratched	Over 25mm Not Thru Paint	Machine Polish
Qtr Panel nsr	Dented	2 Or Less UpTo 10mm	Smart Repair
Door nsf	Chipped	Edge Chip	Smart Repair
Door nsr	Dented	Between 10mm + 30mm	Smart Repair
Door nsr	Scratched	Over 25mm Not Thru Paint	Machine Polish
Door nsf	Scratched	Over 25mm Not Thru Paint	Machine Polish
Door nsf	Chipped	Edge Chip	Smart Repair
Door Mirror Assy nsf	Scratched (Painted)	UpTo 25mm Thru Paint	Smart Repair
Wing nsf	Scratched	Over 25mm Not Thru Paint	Machine Polish
Wing nsf	Dented	2 Or Less UpTo 10mm	Smart Repair

Bumper Front	Cracked	UpTo 25mm	Repair and Refinish
Bonnet	Chipped	1 To 5	Smart Repair
Screen Front	Chipped	UpTo 10mm	Smart Repair
B Post os	Dented	2 Or Less UpTo 10mm	Smart Repair
C Post os	Dented	Between 10mm + 30mm	Smart Repair
