VEHICLE INSPECTION REPORT

GU22VVA

Ford Kuga 2.5 PHEV ST-Line Edition 5dr CVT

nama
GRADE
3

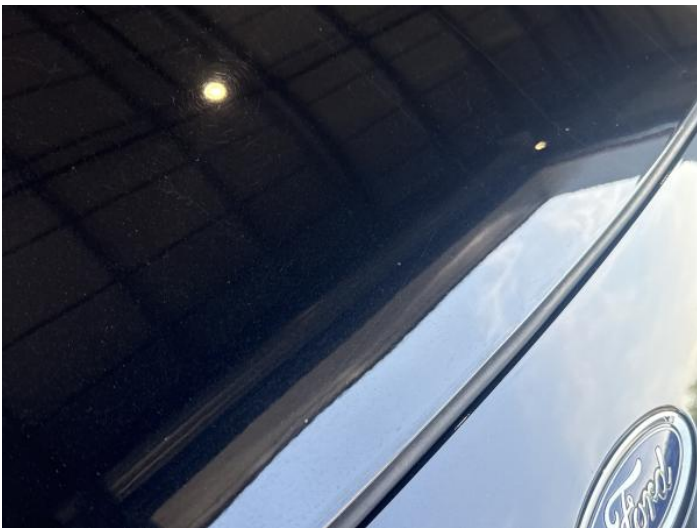
1: Bonnet
Chipped
1 To 5

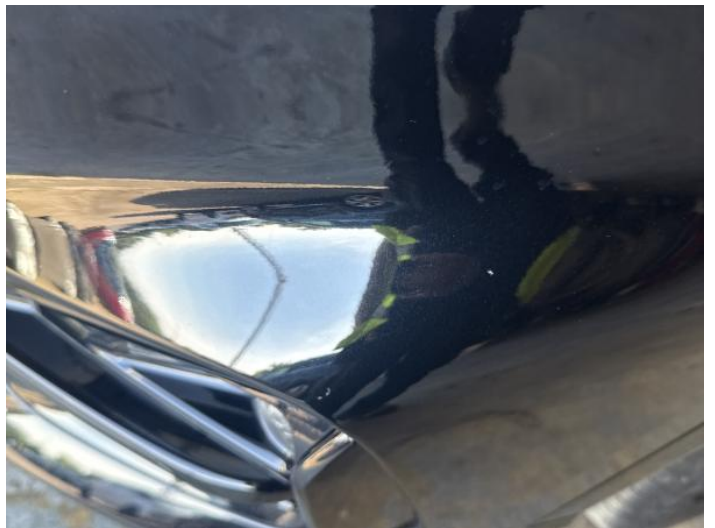
2: Bumper Front
Chipped
1 To 5

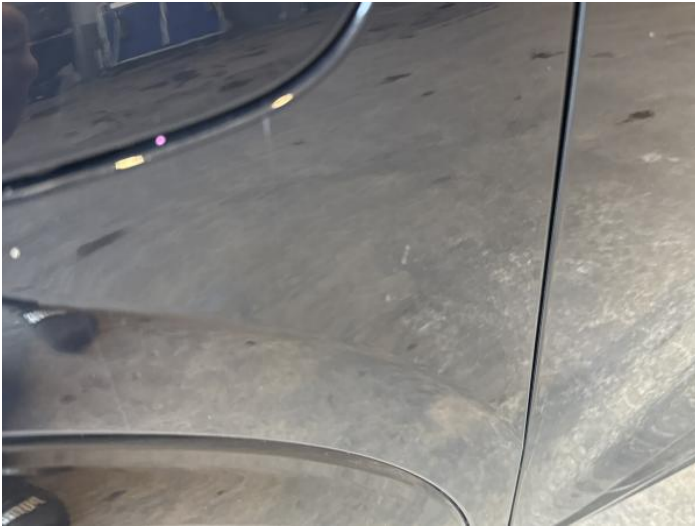
3: Wing nsf
Scratched
UpTo 25mm Thru Paint

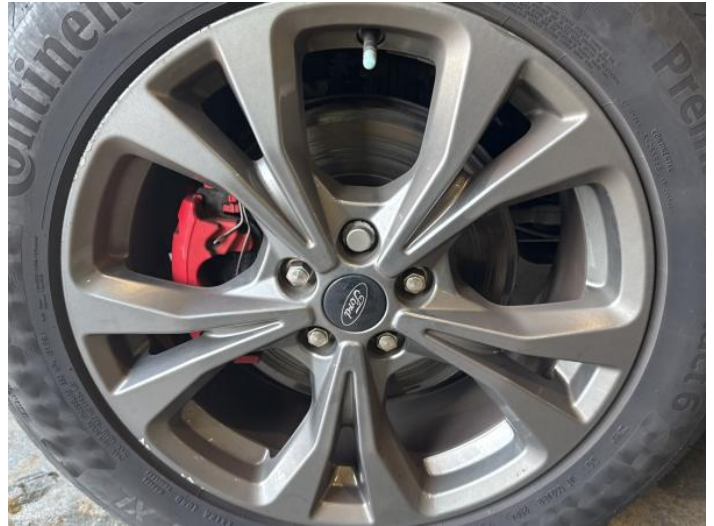
4: Wheel nsf
Scratched
Over 50mm

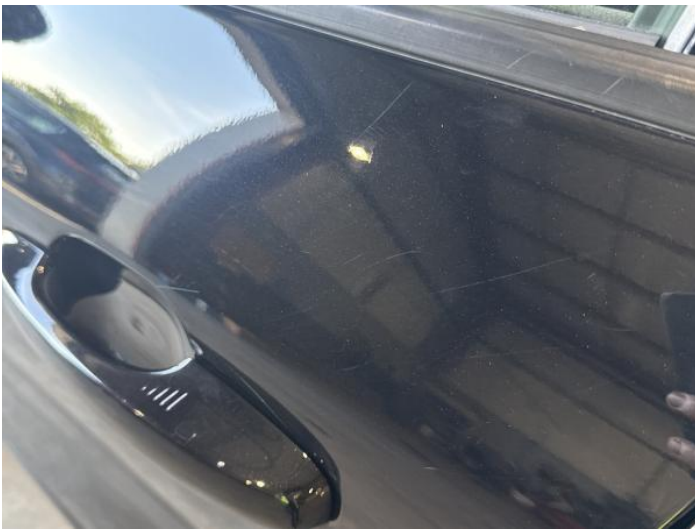
5: Door nsf
Scratched
UpTo 25mm Thru Paint

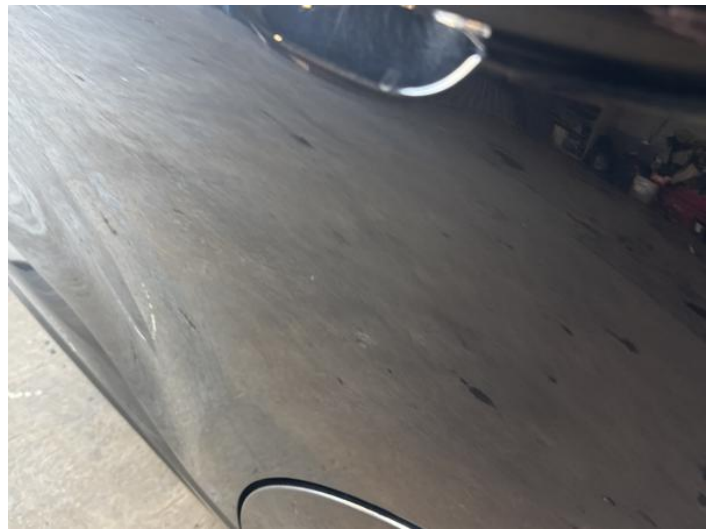
6: Door nsr
Chipped
1 To 5

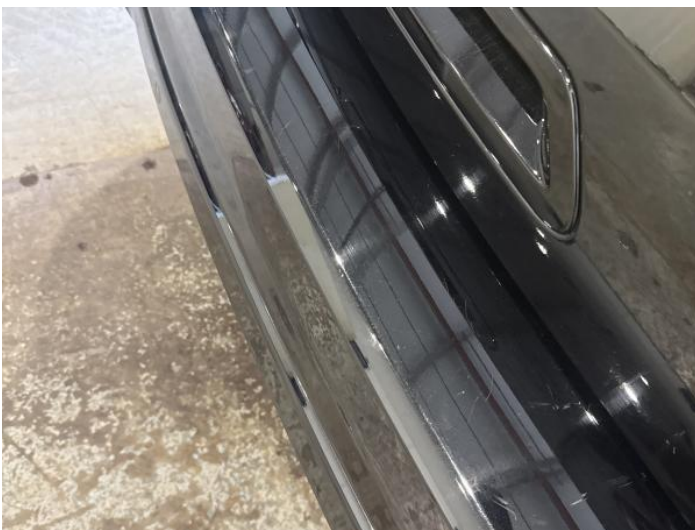
7: Bumper Rear
Scratched
25 to 100mm Thru Paint

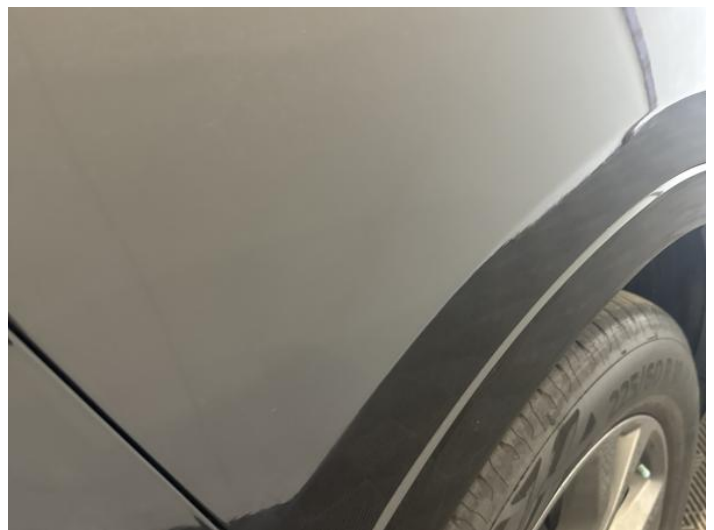
8: Qtr Panel osr
Scratched
Over 25mm Thru Paint

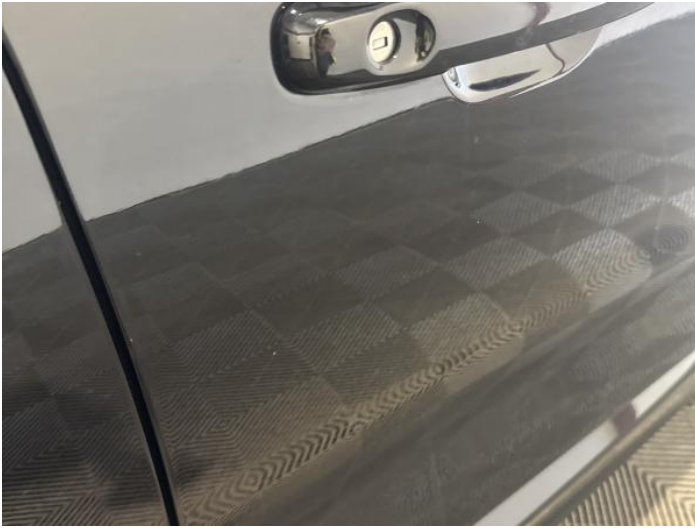
9: Door osf
Chipped
1 To 5

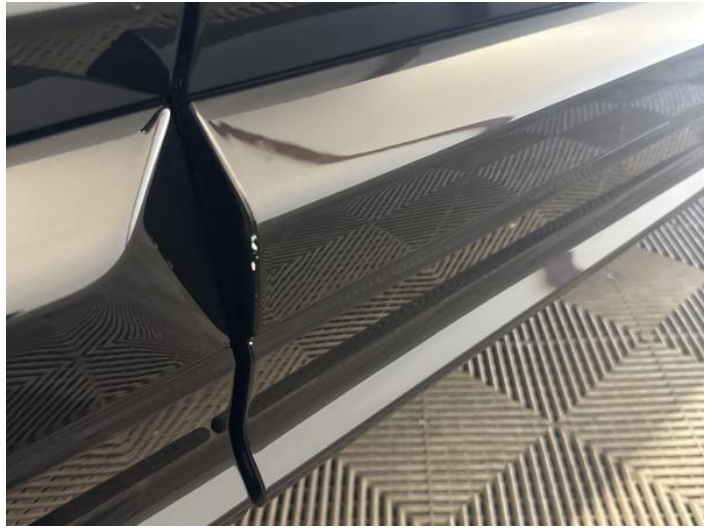
10: Door Moulding osf
Scratched (Painted)
UpTo 25mm Thru Paint

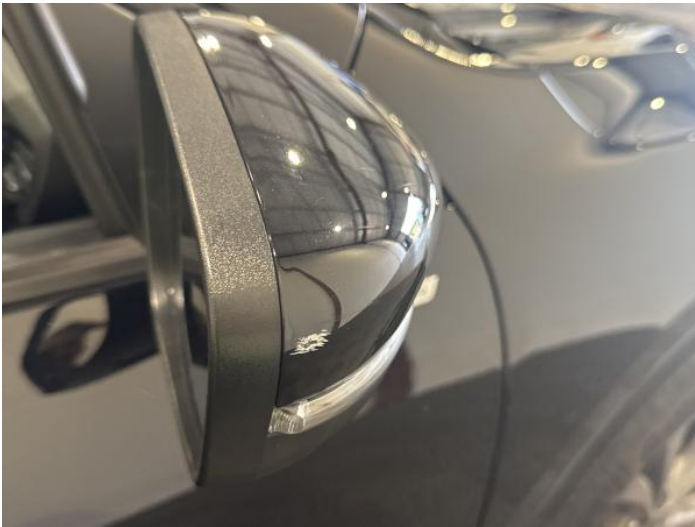
11: Door Mirror Assy osf
Scratched (Painted)
UpTo 25mm Thru Paint

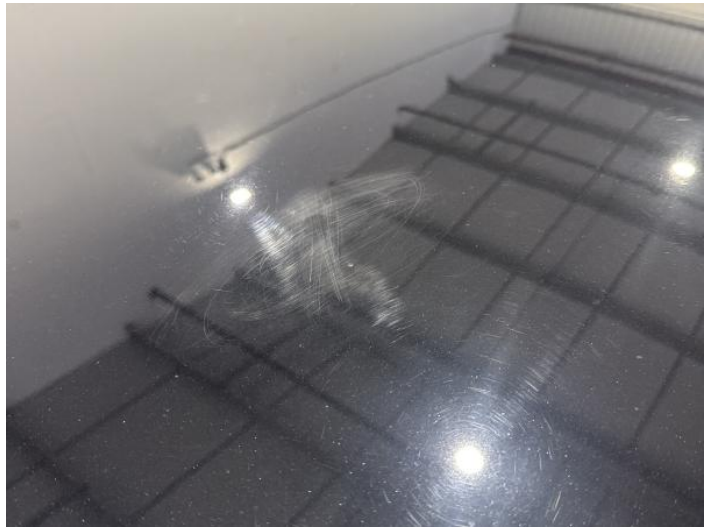
12: Roof
Scratched
Over 25mm Thru Paint
