VEHICLE INSPECTION REPORT

GV19KYU

Toyota Yaris 1.5 Hybrid Y20 5dr CVT [Bi-tone]

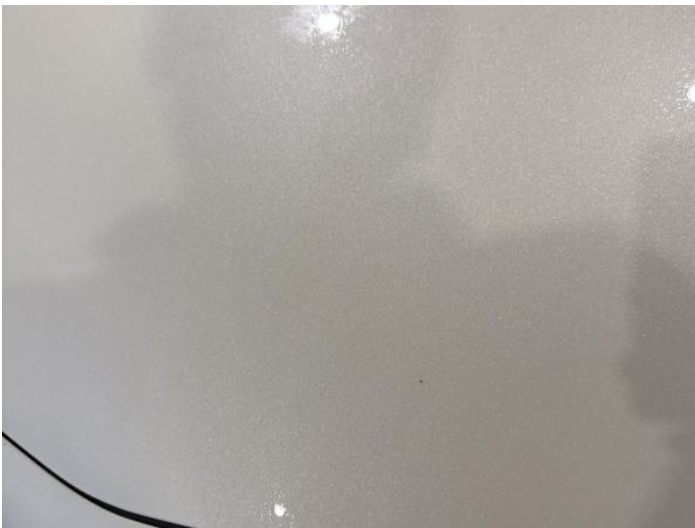
1: Bonnet
Chipped
1 To 5

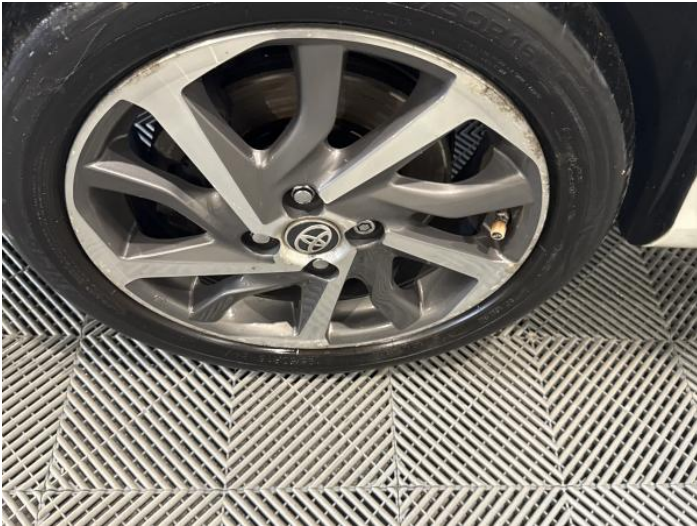
3: Wheel nsf
Scratched
Over 50mm

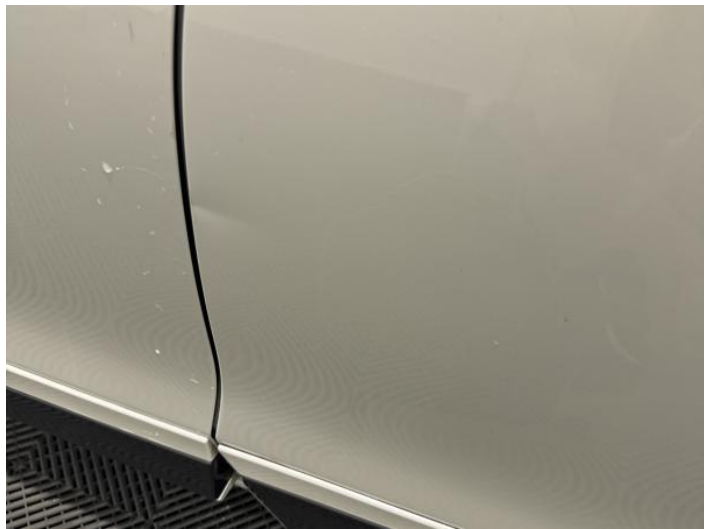
6: Door nsr
Dented
Over 30mm

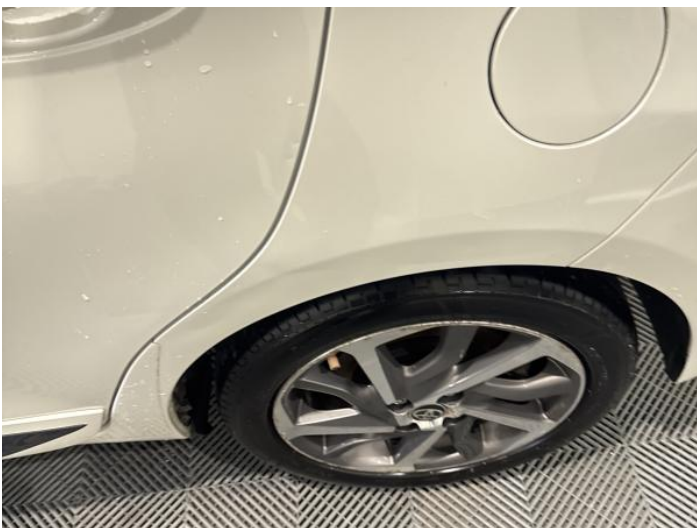
7: Qtr Panel nsr
Dented
Over 30mm

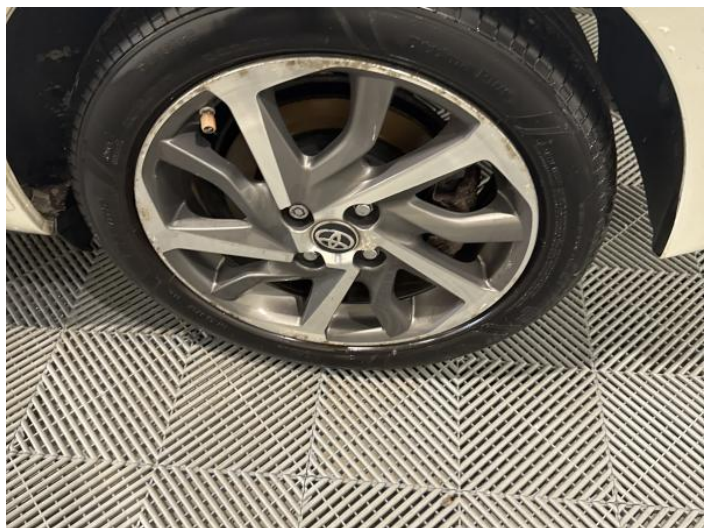
8: Wheel nsr
Scratched
Over 50mm

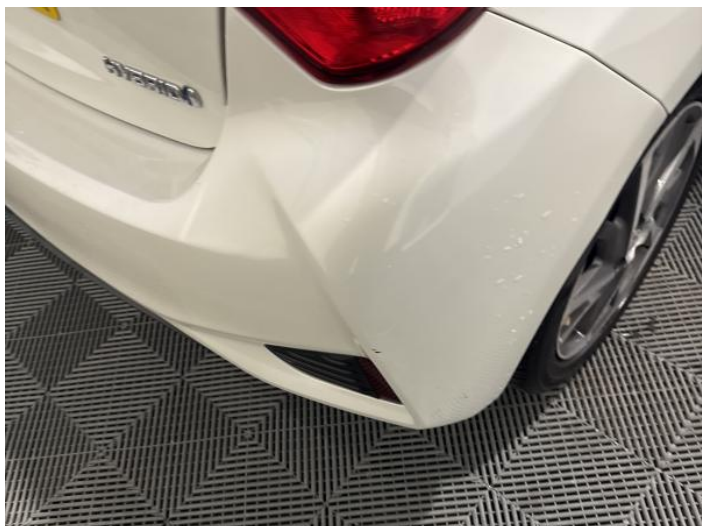
9: Bumper Rear
Scratched
Over 100mm Thru Paint

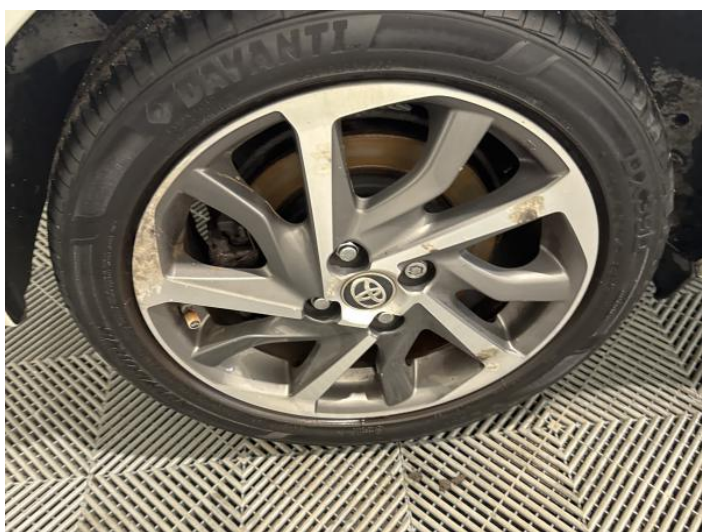
11: Wheel osr
Scratched
Over 50mm

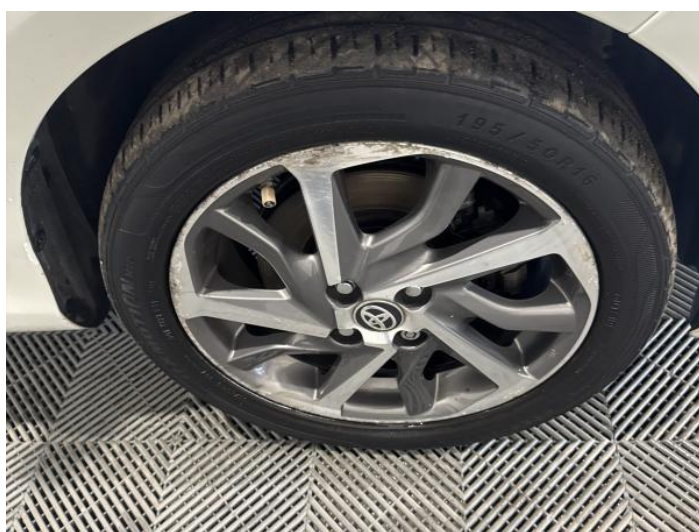
14: Wheel osf
Scratched
Over 50mm

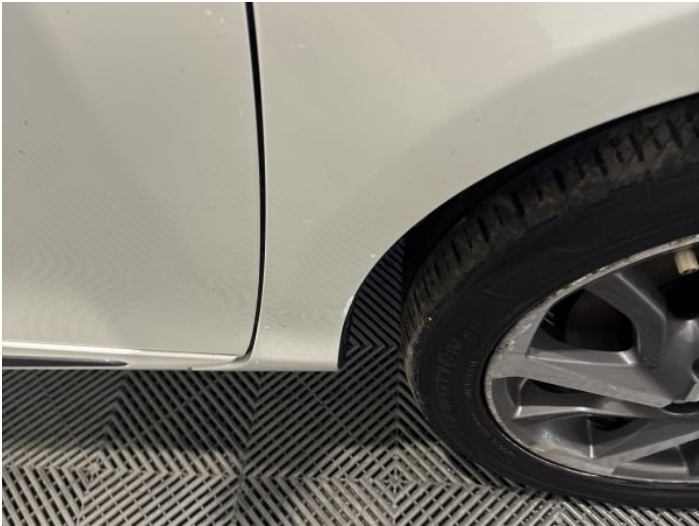
15: Wing osf
Dented
With Paint Damage
