# VEHICLE INSPECTION REPORT

**NL14WJU**

## Mini Clubman 1.6 Cooper S Bond Street 5dr

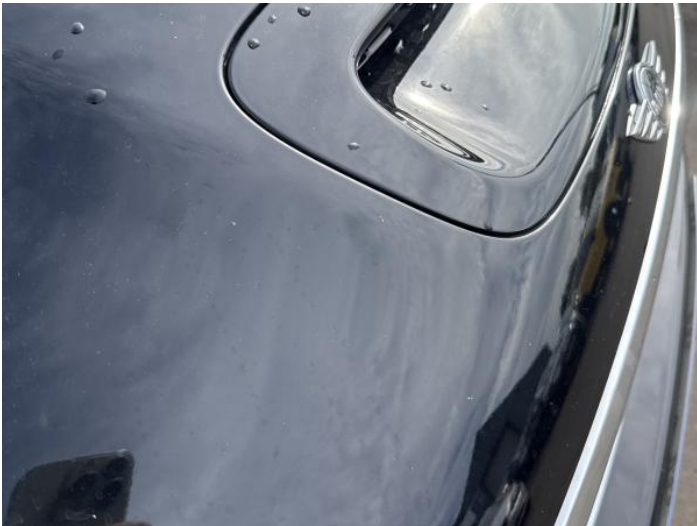
1: Bonnet  
Chipped  
Multiple Chips

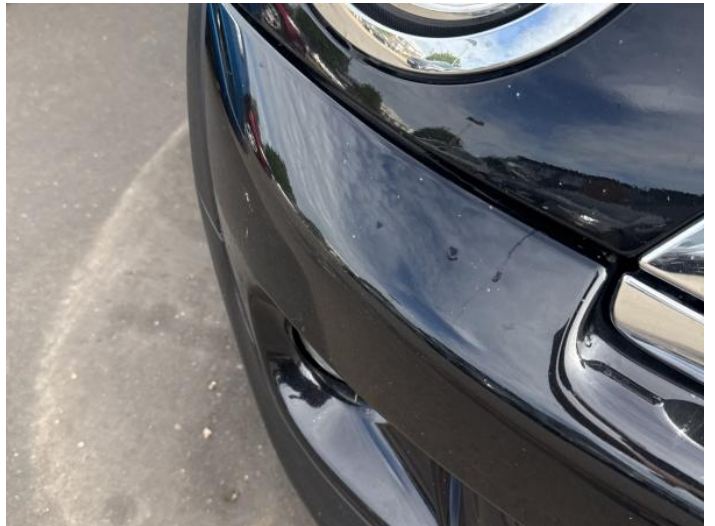
2: Bumper Front  
Scratched  
25 to 100mm Thru Paint

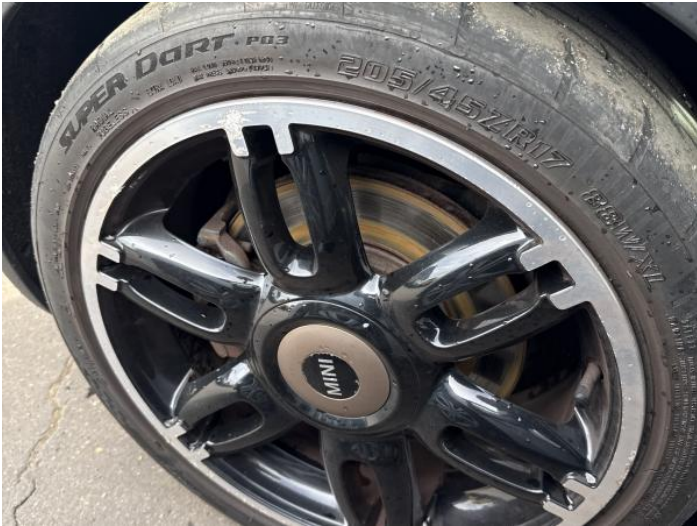
3: Wheel nsf  
Scratched  
Over 50mm

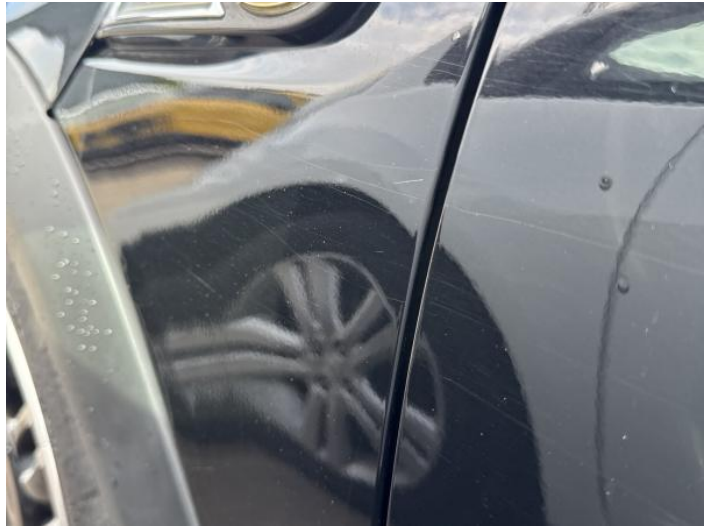
4: Wing nsf  
Scratched  
UpTo 25mm Thru Paint

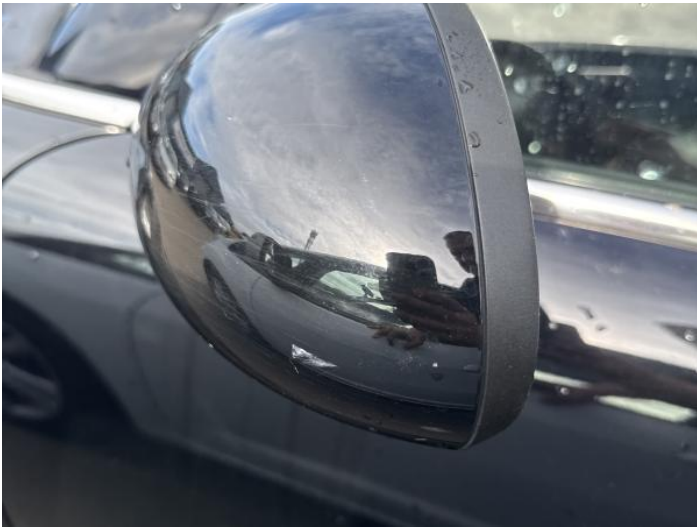
5: Door Mirror Assy nsf  
Scratched (Painted)  
UpTo 25mm Thru Paint

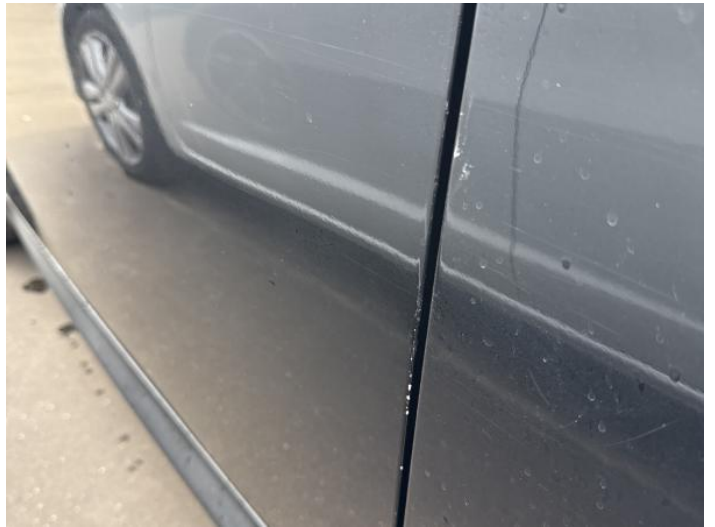
6: Door nsf  
Scratched  
Over 25mm Thru Paint

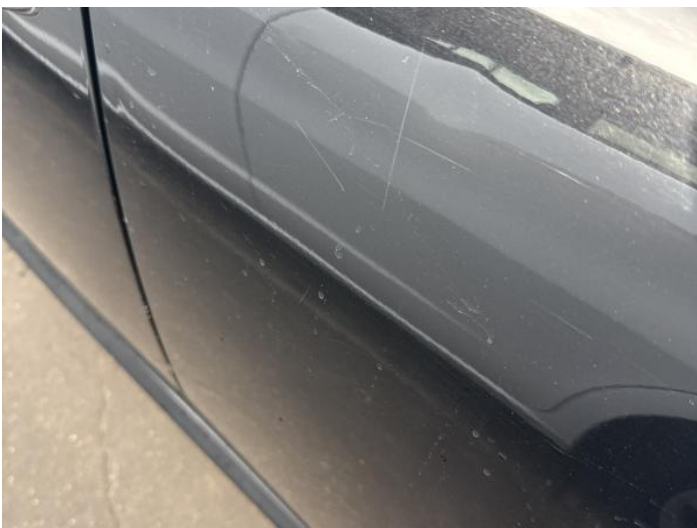
7: Qtr Panel nsr  
Dented  
With Paint Damage

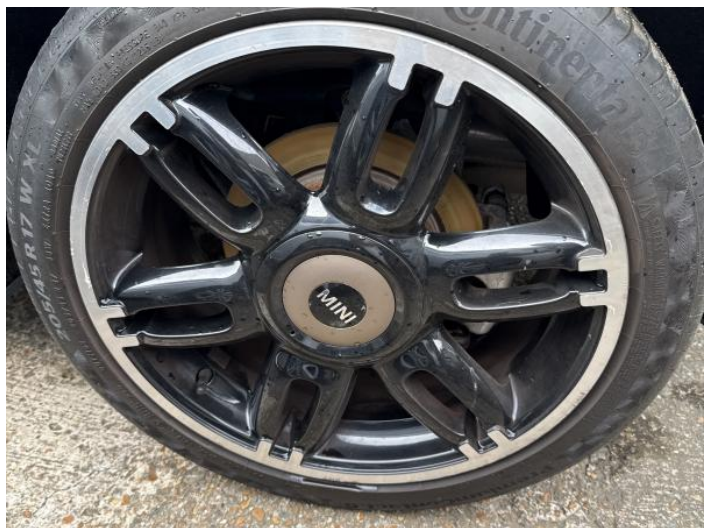
8: Wheel nsr  
Scratched  
Over 50mm

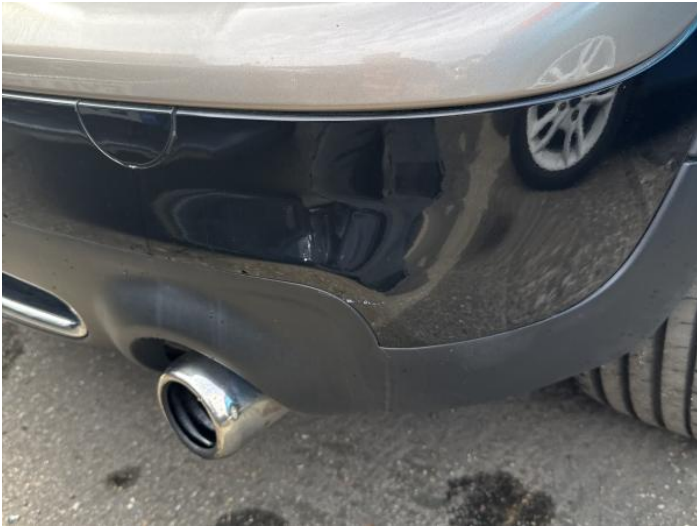
9: Bumper Rear  
Scratched  
25 to 100mm Thru Paint

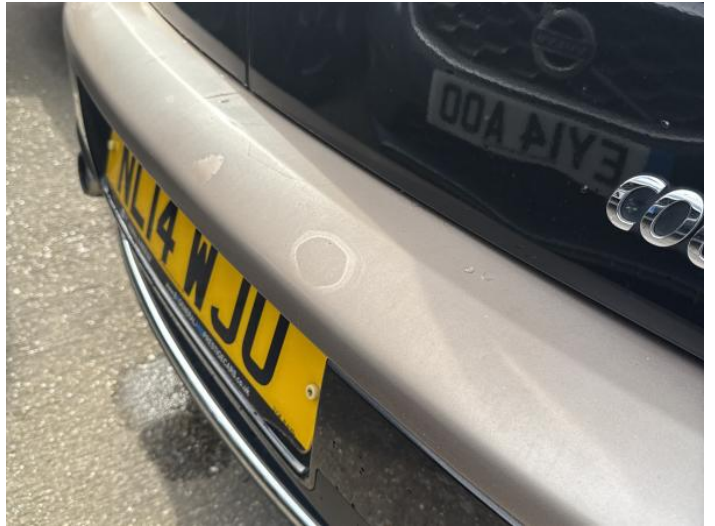
10: Bumper Rear Moulding  
Scratched (Painted)  
Over 25mm Thru Paint

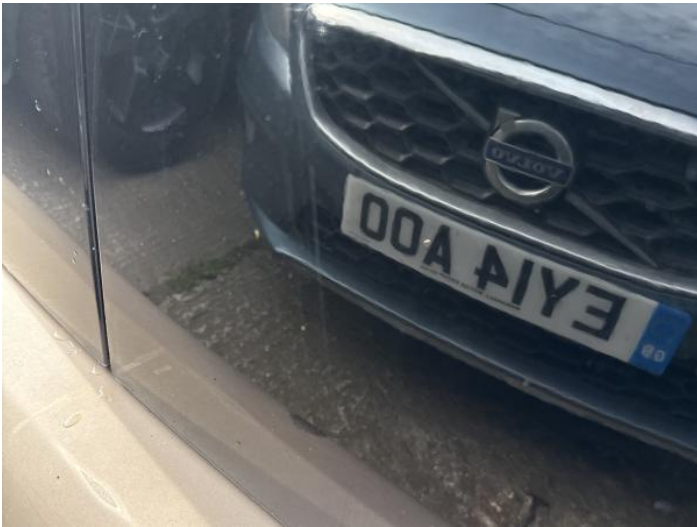
11: Tailgate  
Scratched  
Over 25mm Thru Paint

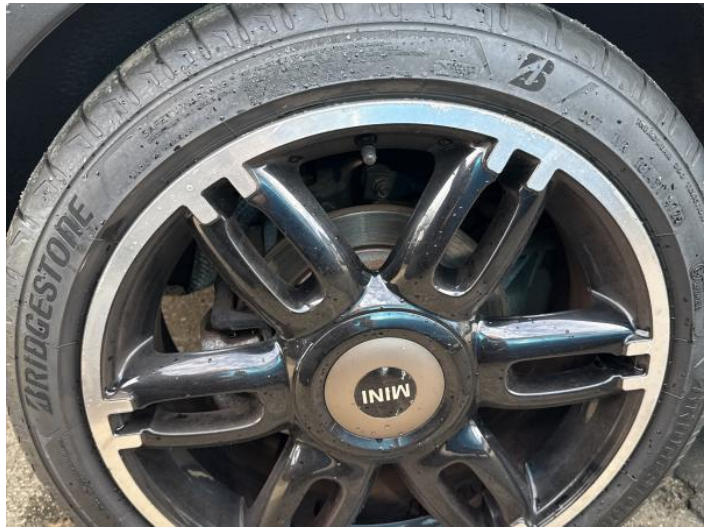
12: Wheel osr  
Scratched  
Over 50mm

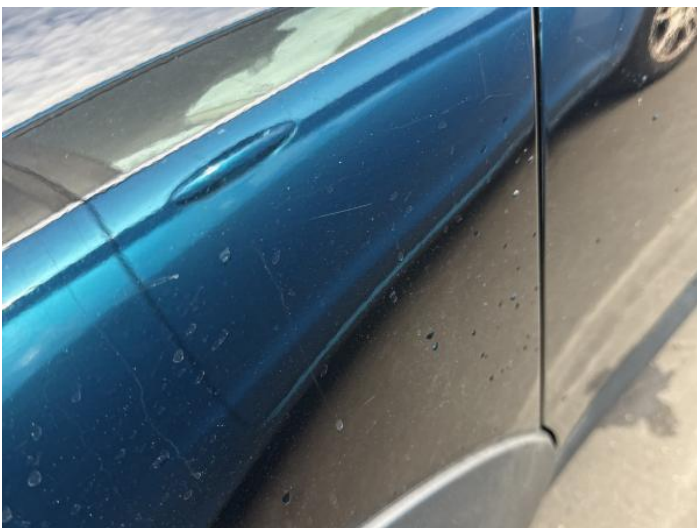
13: Qtr Panel osr  
Scratched  
Over 25mm Thru Paint

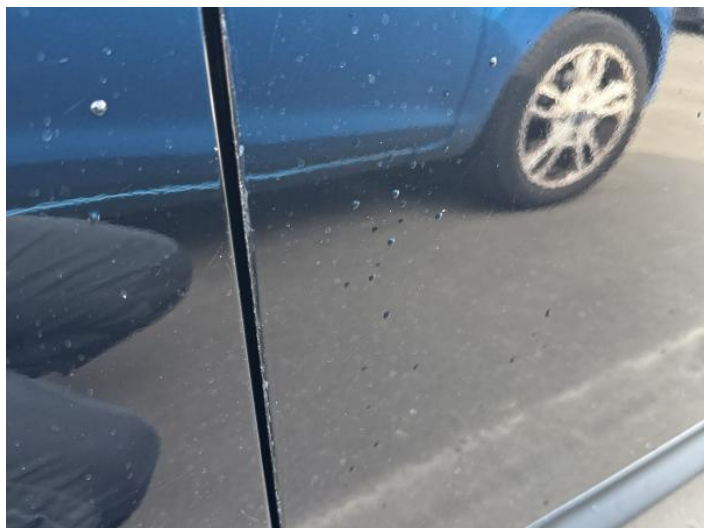
14: Door osf  
Chipped  
Edge Chip

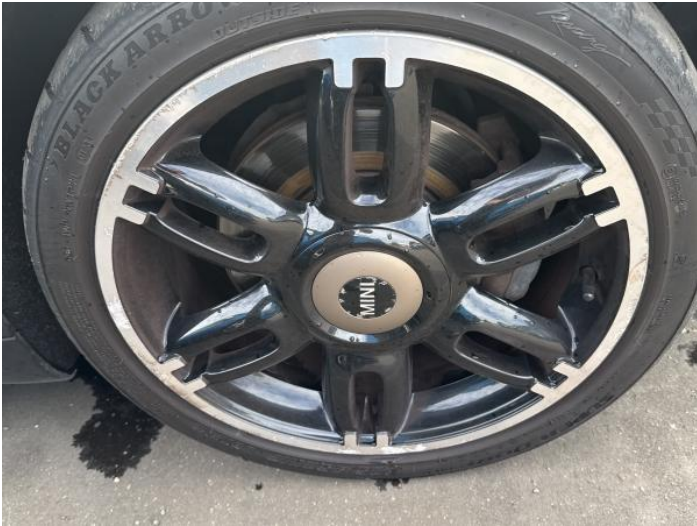
15: Wheel osf  
Scratched  
Over 50mm

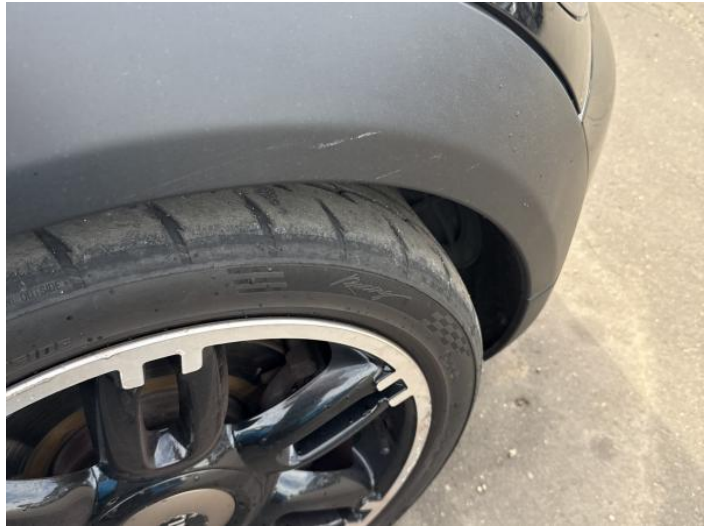
16: Wing Front Arch Extension os  
Scuffed (Unpainted)  
Over 100mm

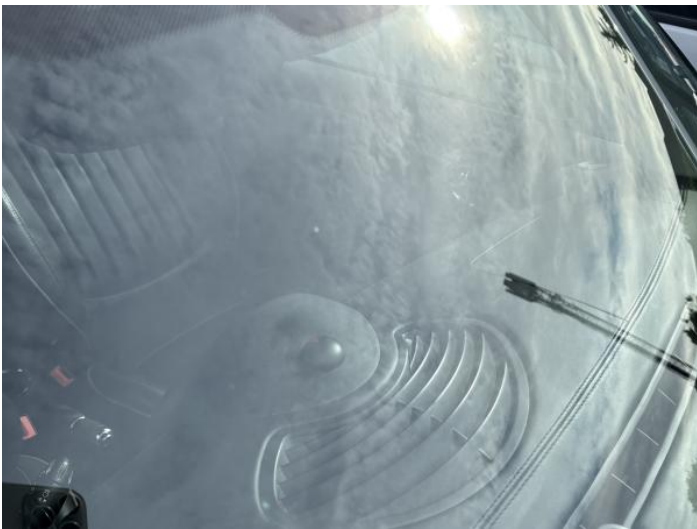
17: Screen Front  
Cracked  
Replace

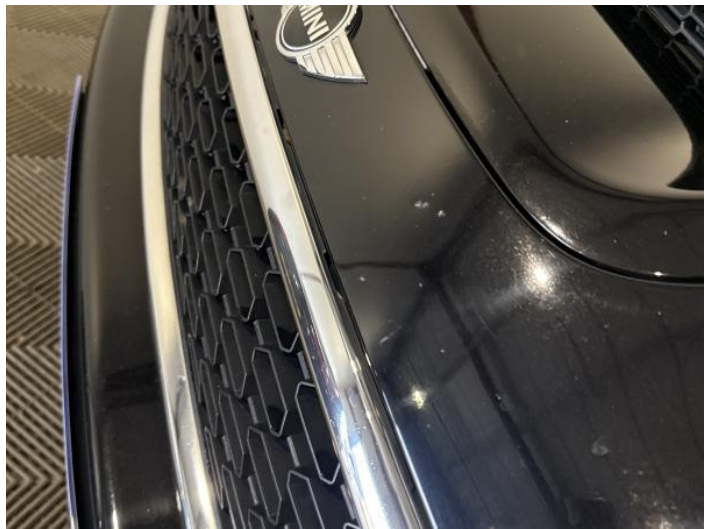
18: Bumper Front Grill  
Broken  
Replace
