# VEHICLE INSPECTION REPORT

**YT11TBZ**

## Land Rover Freelander 2.2 SD4 XS 5dr Auto

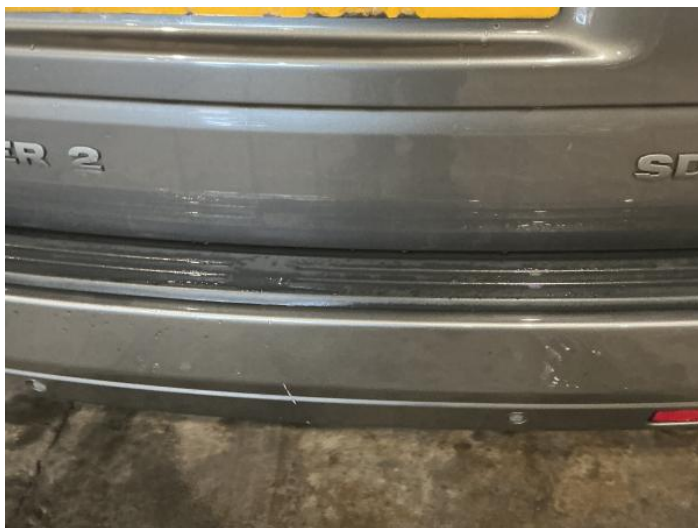
1: Bumper Rear  
Scratched  
Over 100mm Thru Paint

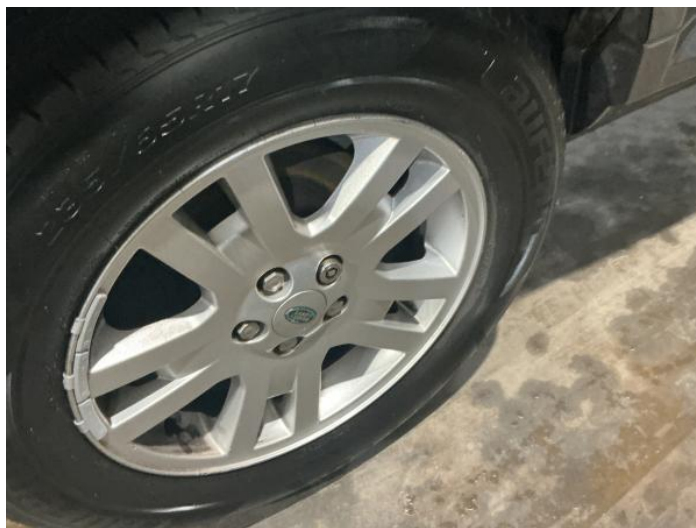
2: Wheel osr  
Scratched  
Over 50mm

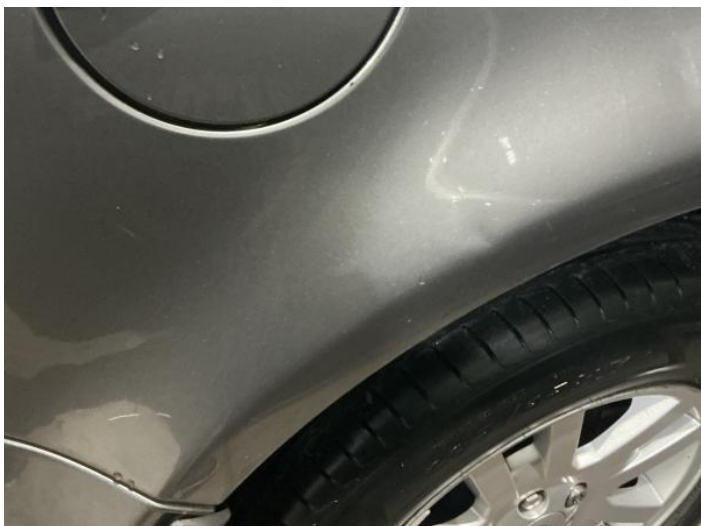
3: Qtr Panel osr  
Dented  
With Paint Damage

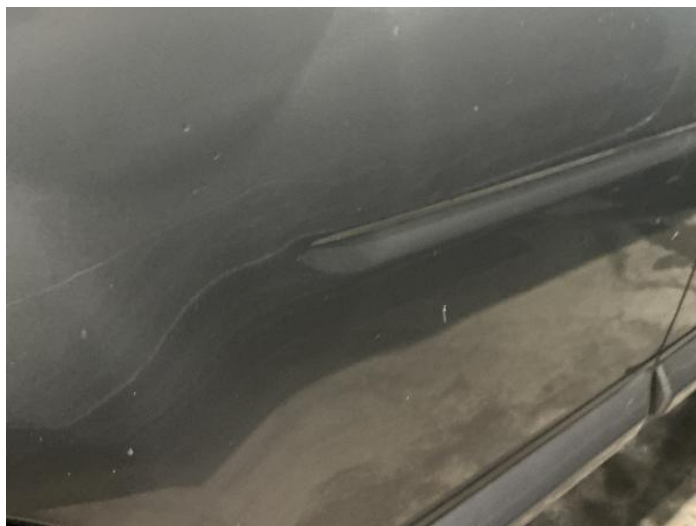
4: Door osr  
Chipped  
1 To 5

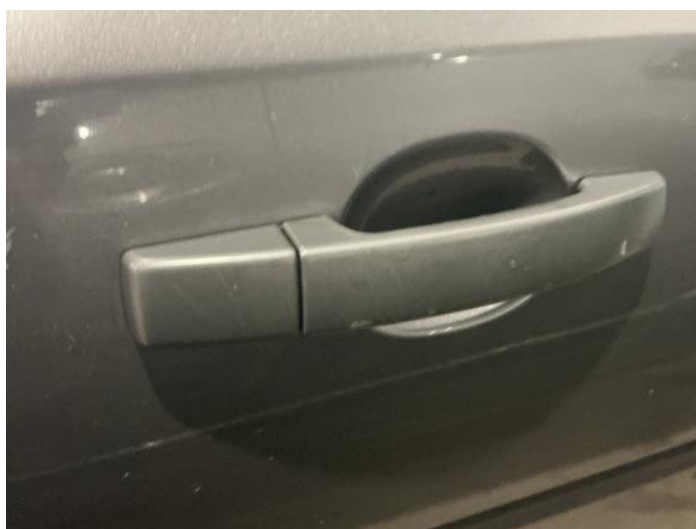
6: Door osf  
Chipped  
Multiple Chips

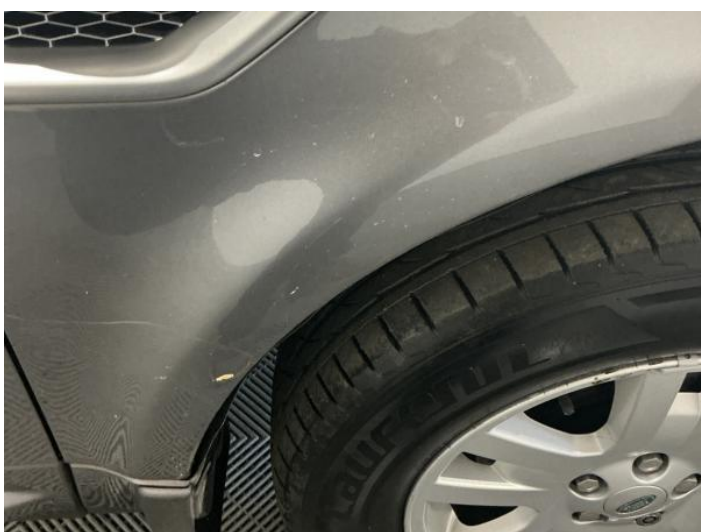
7: Wing osf  
Scratched  
Over 25mm Thru Paint

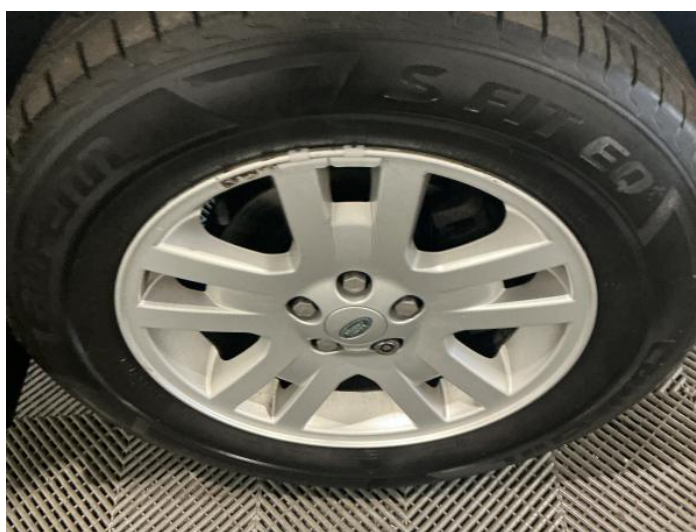
8: Wheel osf  
Scratched  
Over 50mm

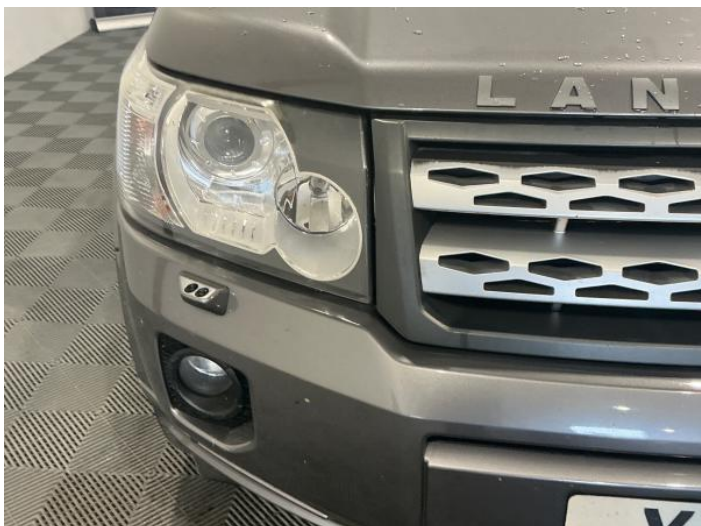
9: Bumper Front  
Chipped  
Multiple Chips

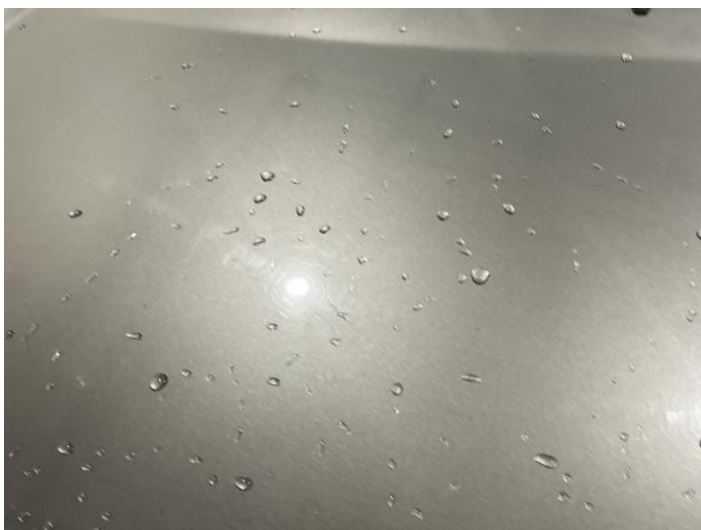
11: Bonnet  
Chipped  
1 To 5

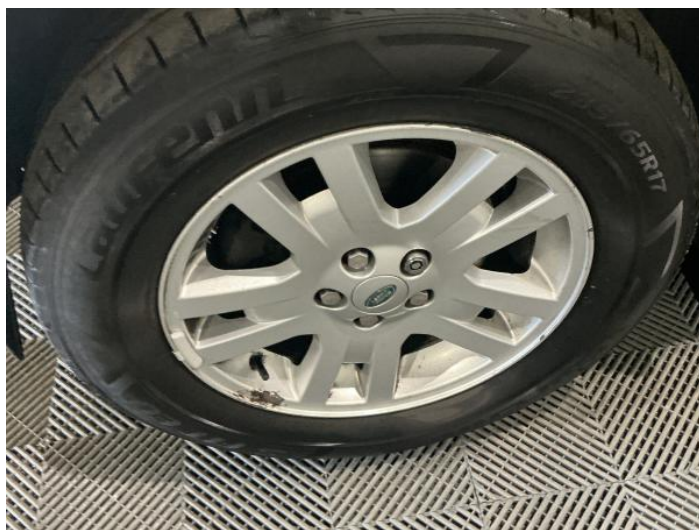
12: Wheel nsf  
Corroded  
Light

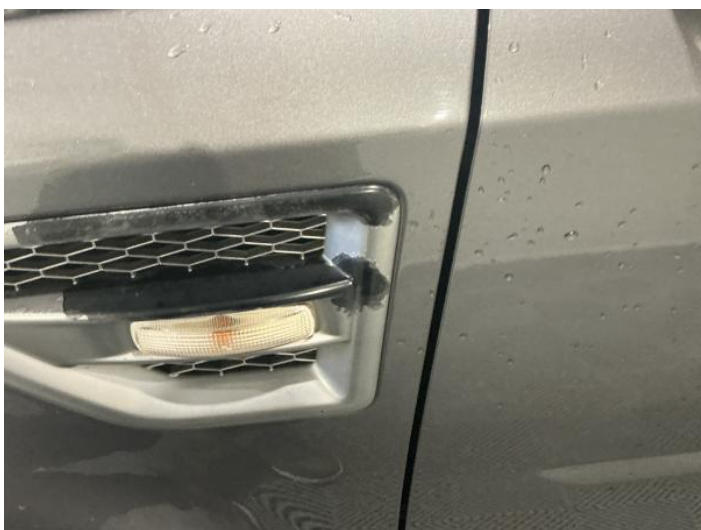
13: Other  
N/A  
N/A

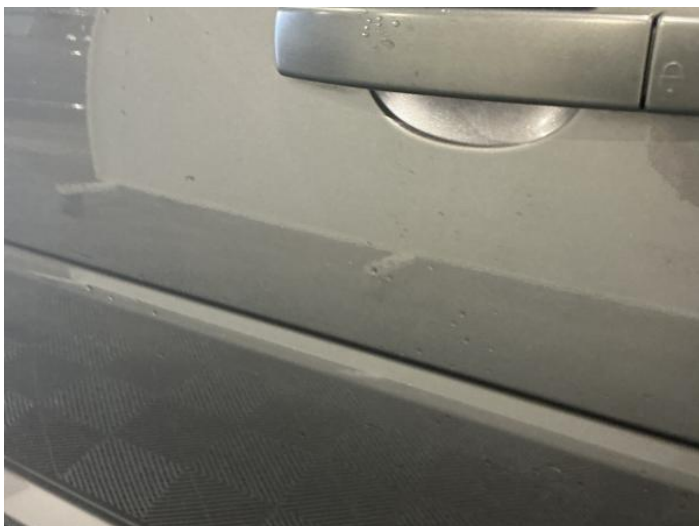
15: Door nsf  
Chipped  
1 To 5

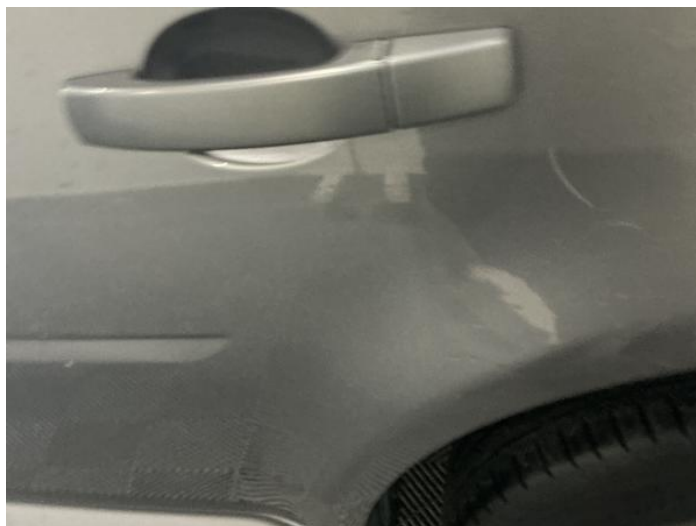
16: Door nsr  
Scratched  
Over 25mm Not Thru Paint

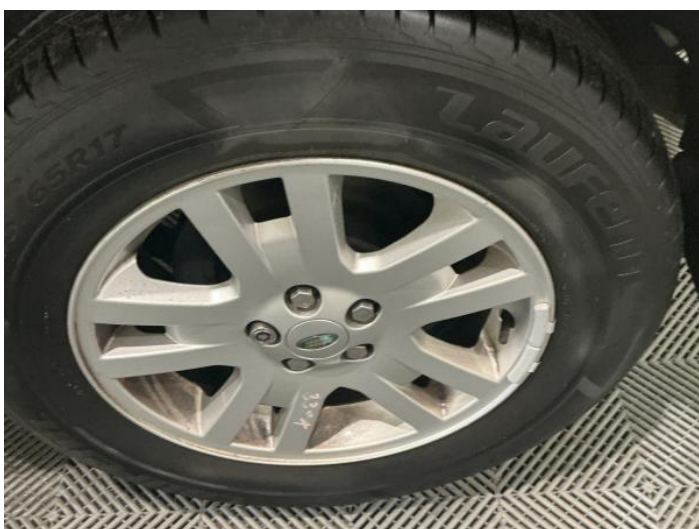
17: Wheel nsr  
Corroded  
Light
