VEHICLE INSPECTION REPORT

GF64UDY

Ford Fiesta 1.0 EcoBoost Titanium 5dr

nama
GRADE
4

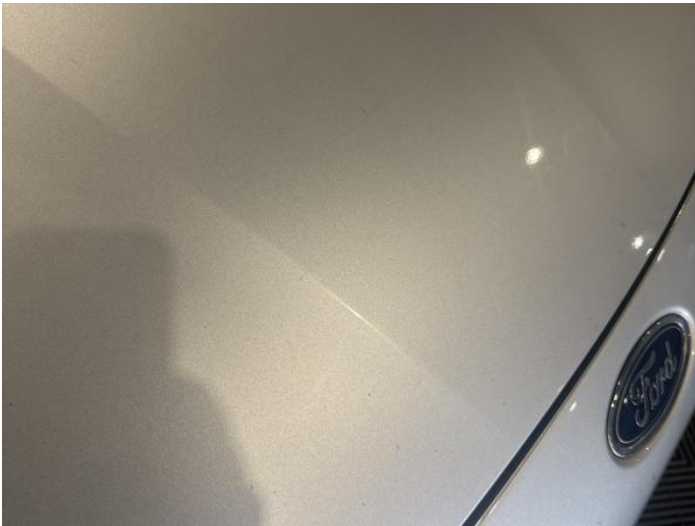
1: Bonnet
Chipped
Multiple Chips

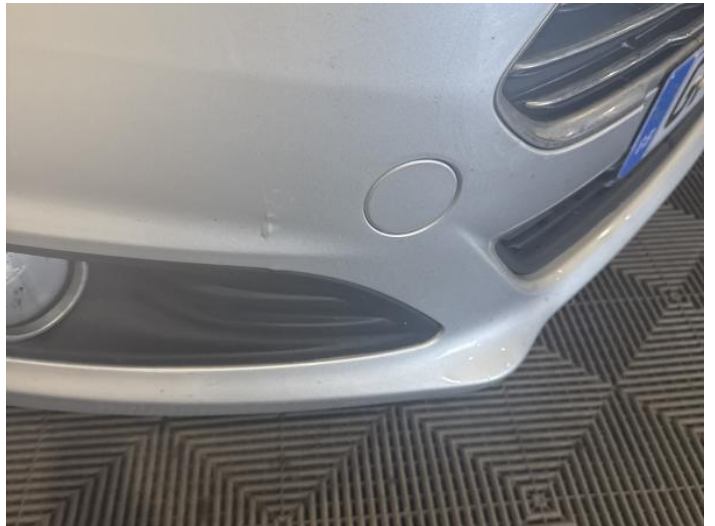
2: Bumper Front
Dented
With Paint Damage

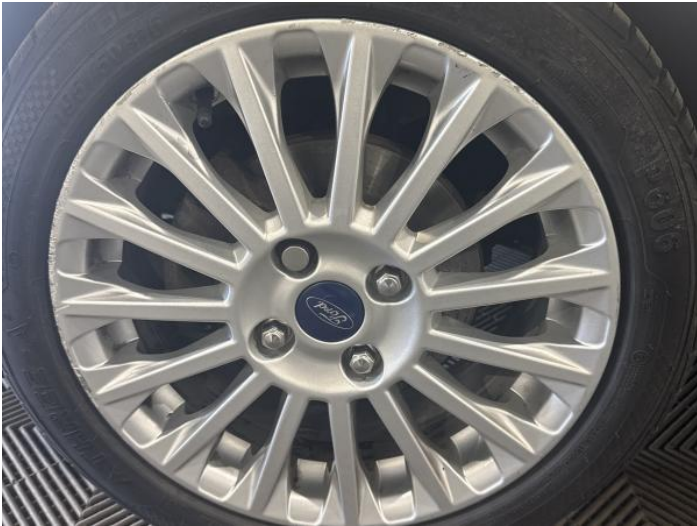
3: Wheel nsf
Scratched
Over 50mm

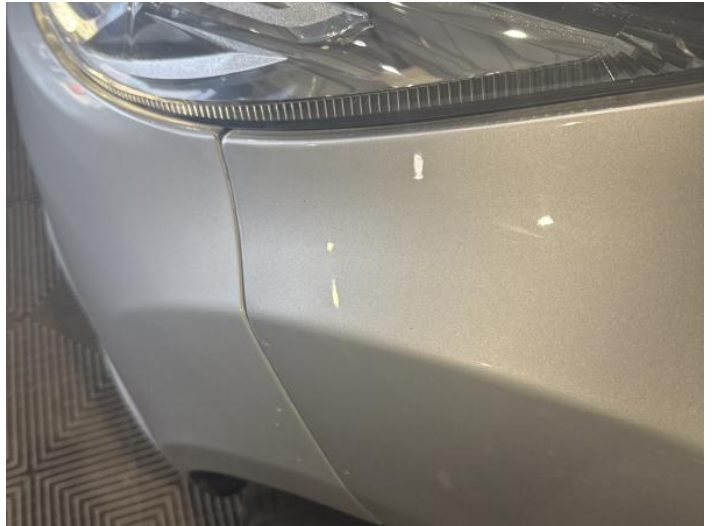
4: Wing nsf
Chipped
1 To 5

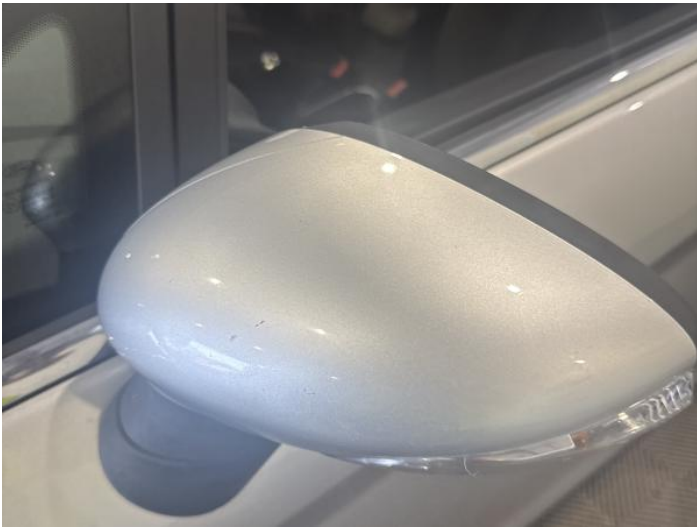
5: Door Mirror Assy nsf
Scratched (Painted)
UpTo 25mm Thru Paint

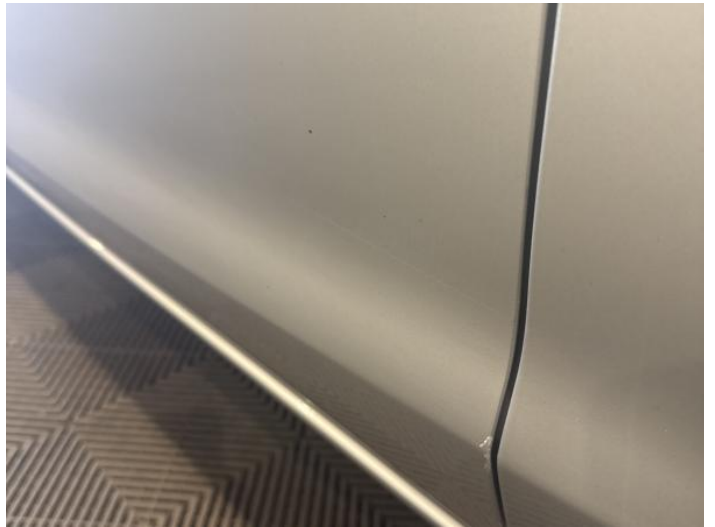
6: Door nsf
Scratched
Over 25mm Thru Paint

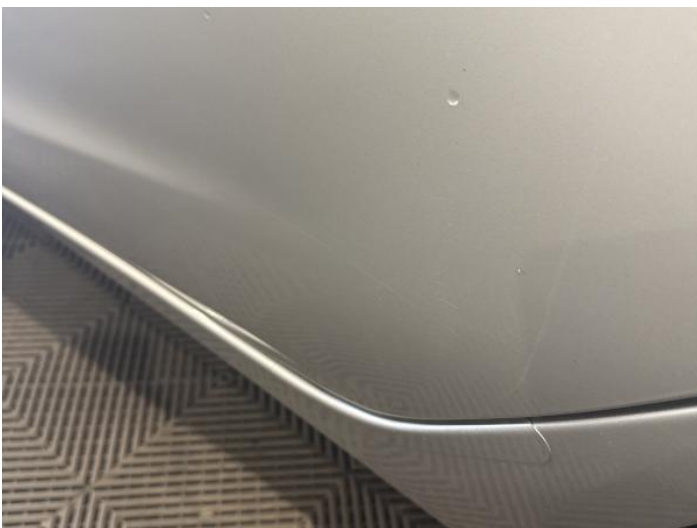
7: Door nsr
Scratched
Over 25mm Thru Paint

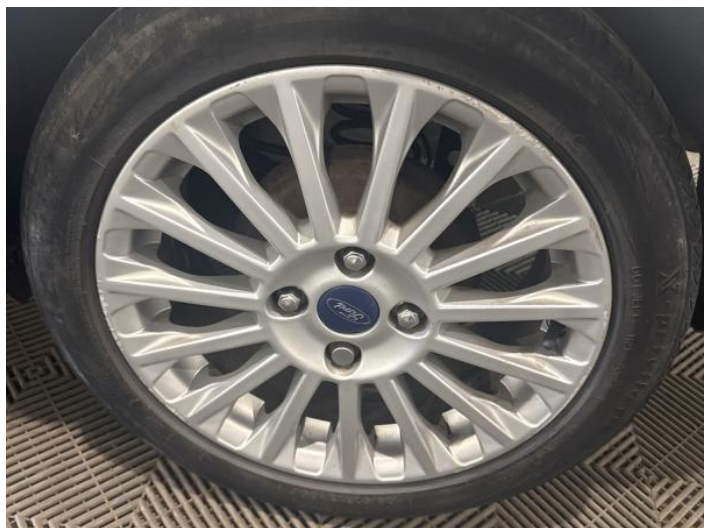
8: Wheel nsr
Scratched
Over 50mm

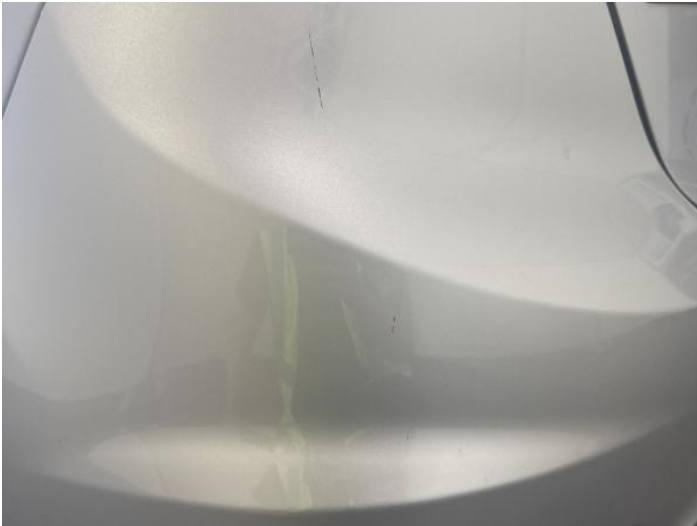
9: Bumper Rear
Scratched
25 to 100mm Thru Paint

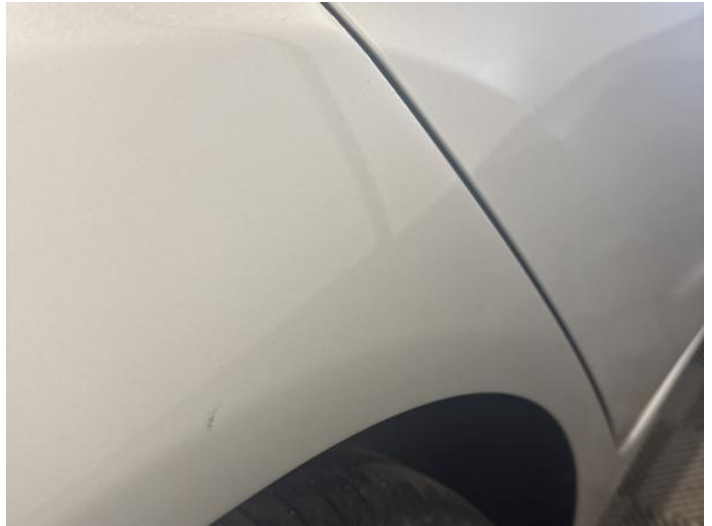
10: Qtr Panel osr
Dented
Between 10mm + 30mm

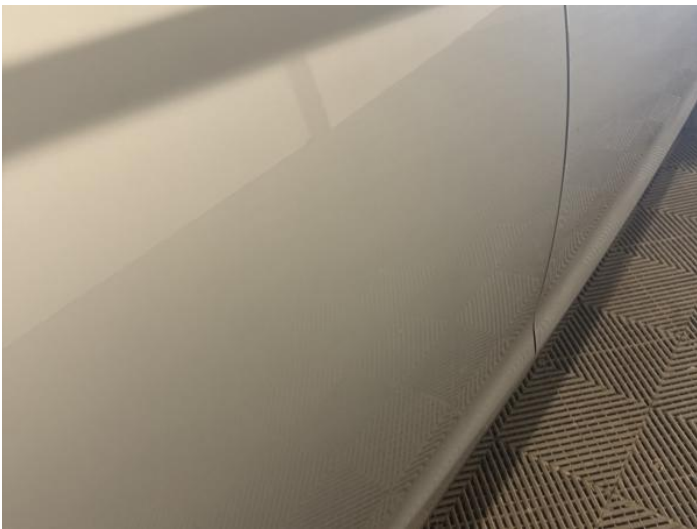
11: Door osr
Dented
Over 30mm

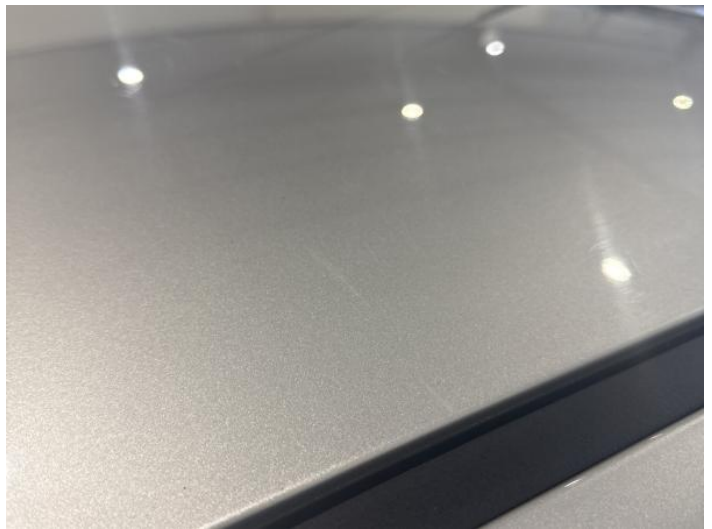
12: Roof
Scratched
UpTo 25mm Thru Paint

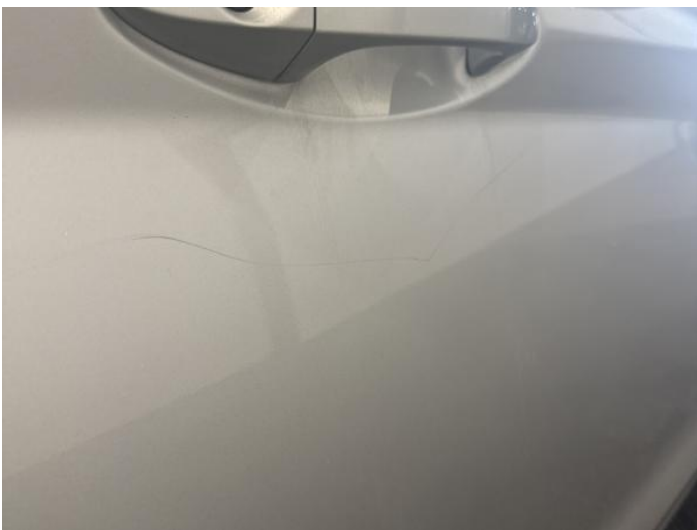
13: Door osf
Scratched
Over 25mm Thru Paint

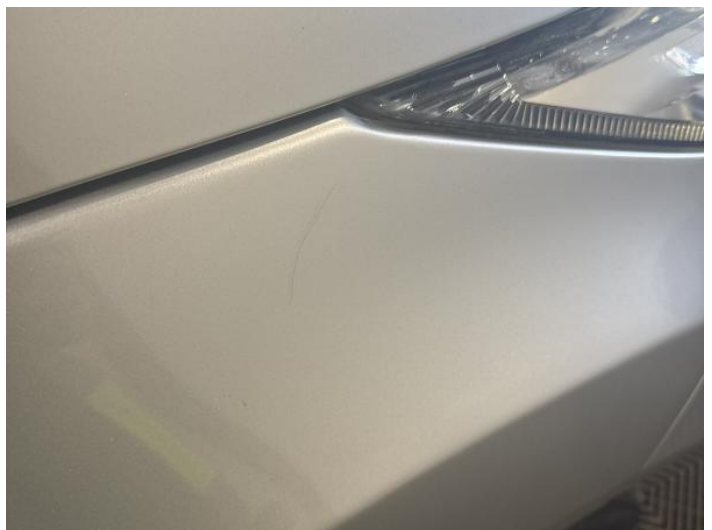
14: Wing osf
Scratched
Over 25mm Thru Paint

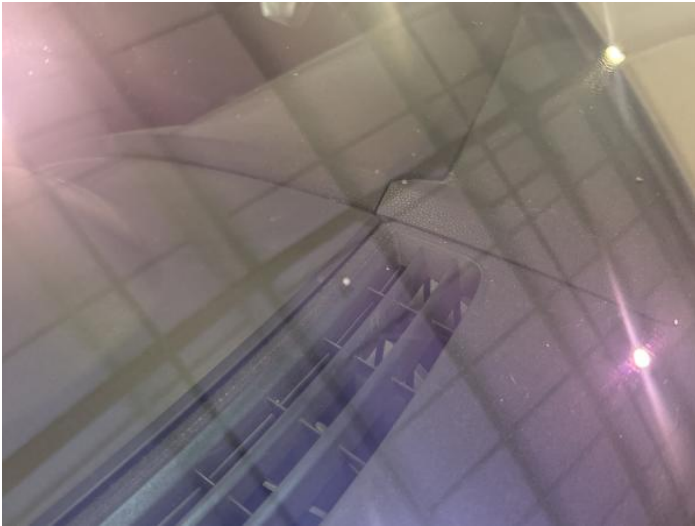
15: Screen Front
Cracked
Replace
