VEHICLE INSPECTION REPORT

MK66YBM

Honda HR-V 1.6 i-DTEC EX 5dr

nama
GRADE
4

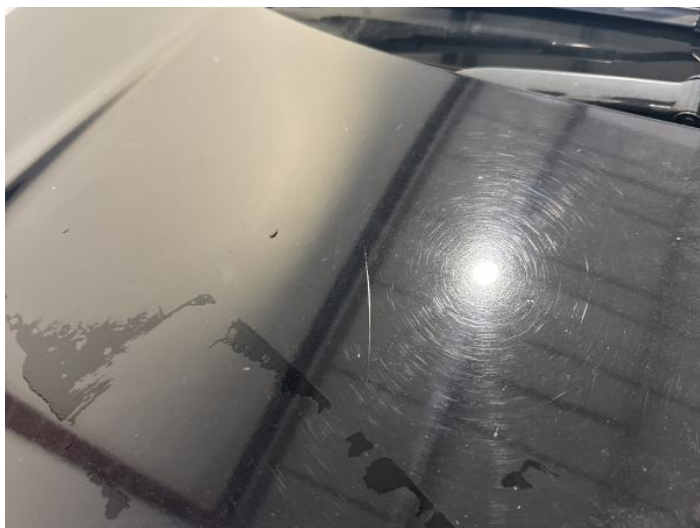
1: Bonnet
Scratched
Over 25mm Thru Paint

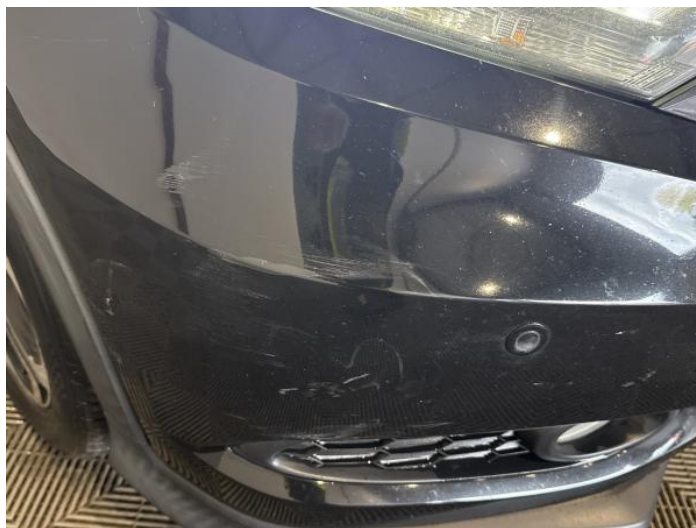
2: Bumper Front
Scratched
Over 100mm Thru Paint

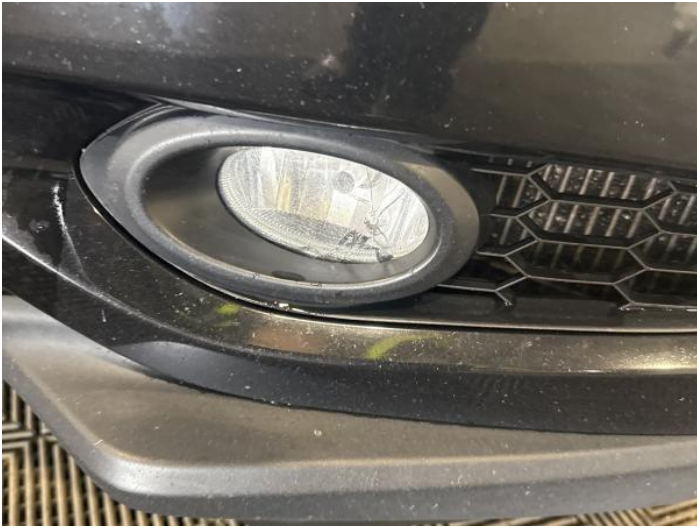
3: Fogdriving Lamp osf
Broken
Replace

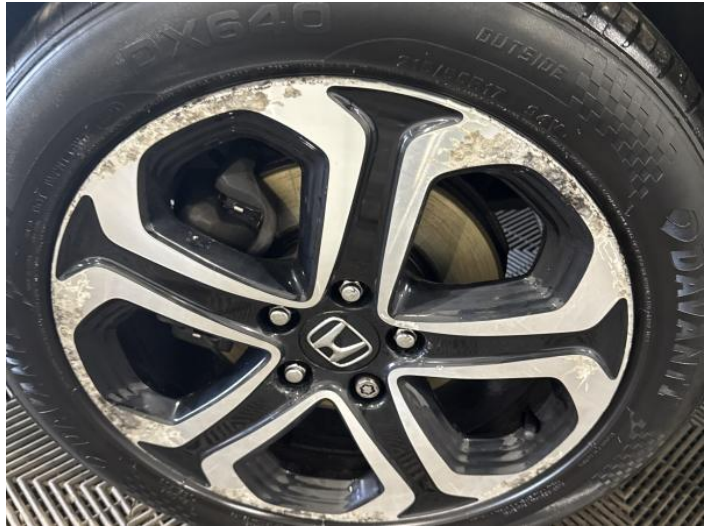
4: Wheel nsf
Scratched
Over 50mm

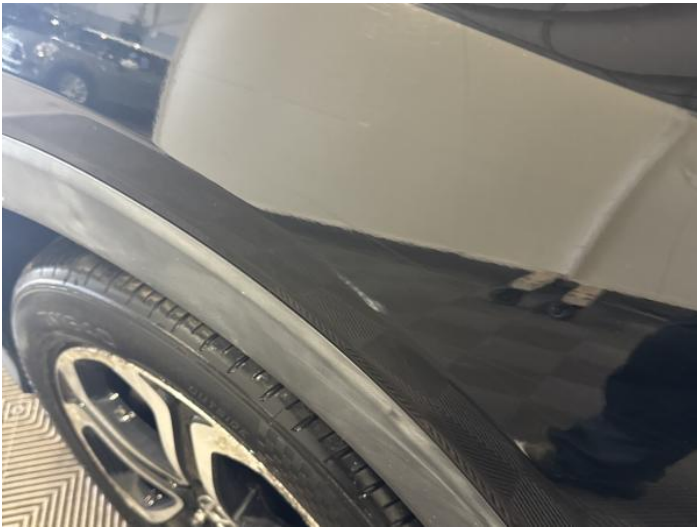
5: Wing nsf
Scratched
Over 25mm Thru Paint

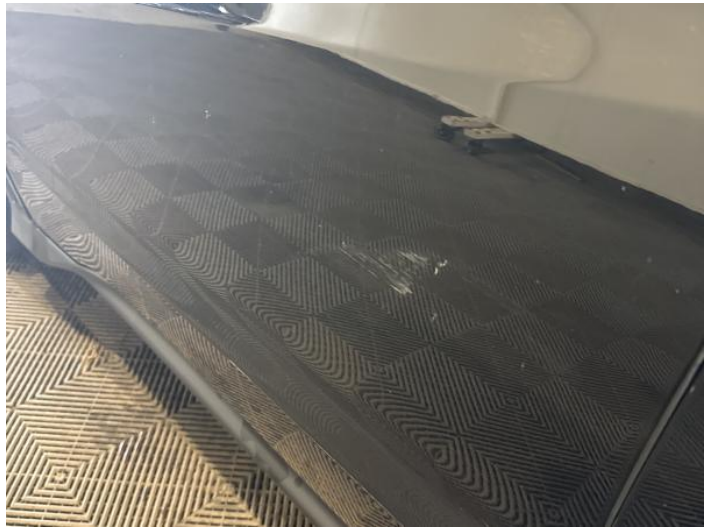
6: Door nsf
Scratched
Over 25mm Thru Paint

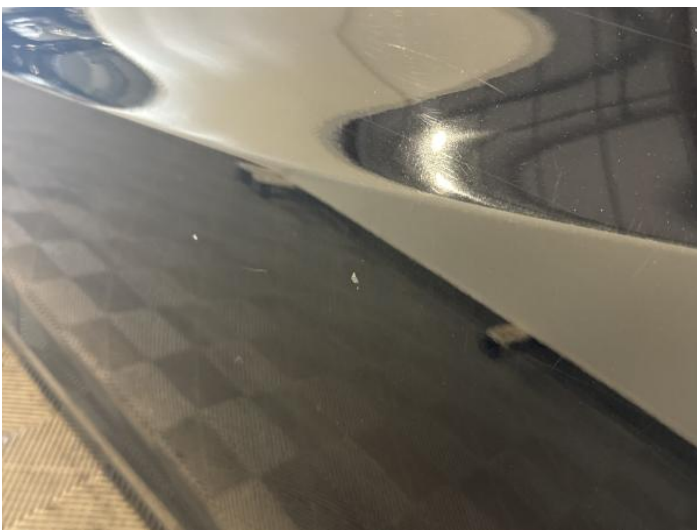
7: Door nsr
Dented
Between 10mm + 30mm

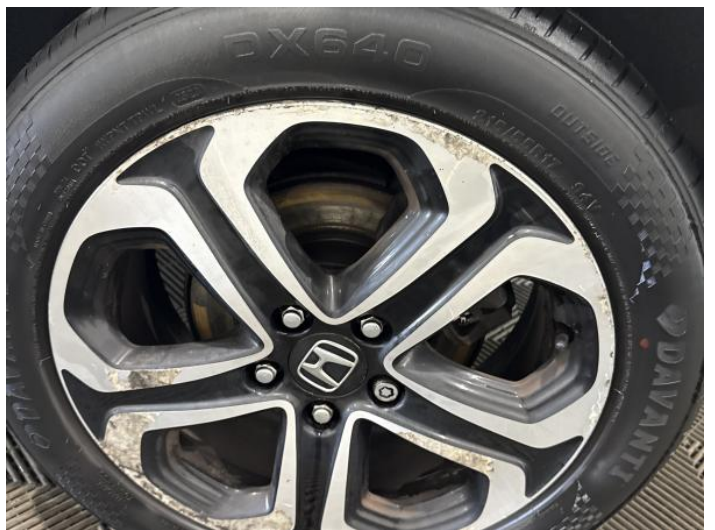
8: Wheel nsr
Scratched
Over 50mm

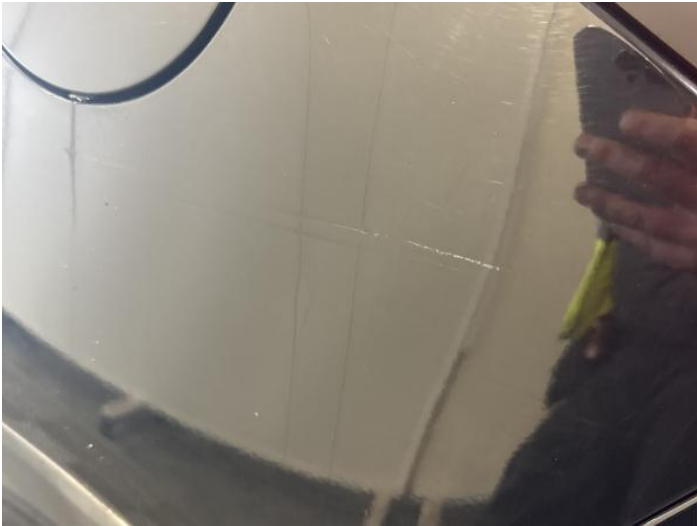
9: Qtr Panel nsr
Scratched
Over 25mm Thru Paint

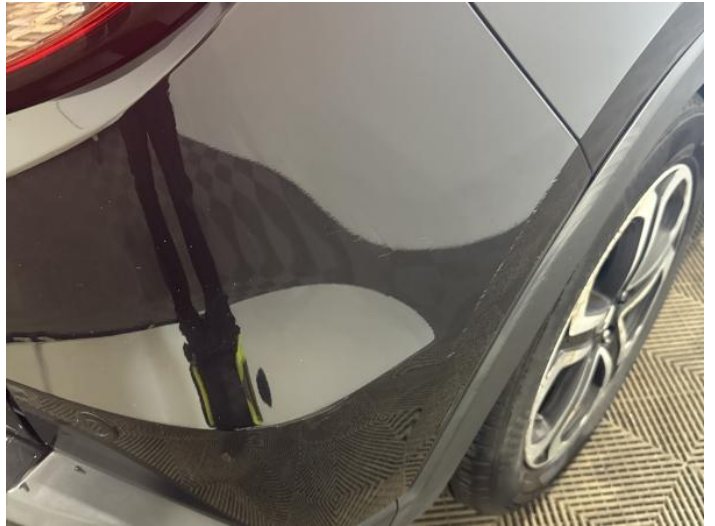
10: Bumper Rear
Scratched
25 to 100mm Thru Paint

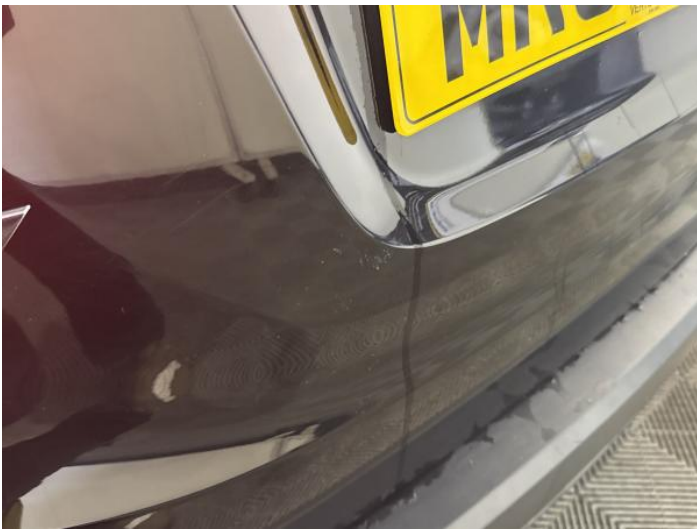
11: Tailgate
Chipped
1 To 5

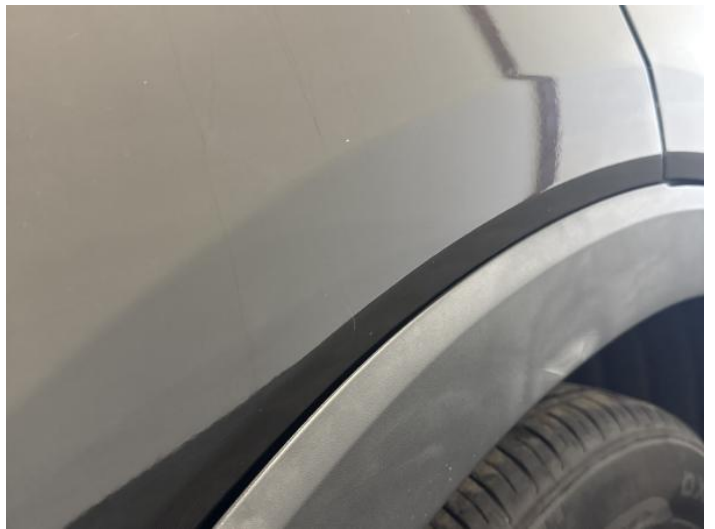
12: Qtr Panel osr
Scratched
UpTo 25mm Thru Paint

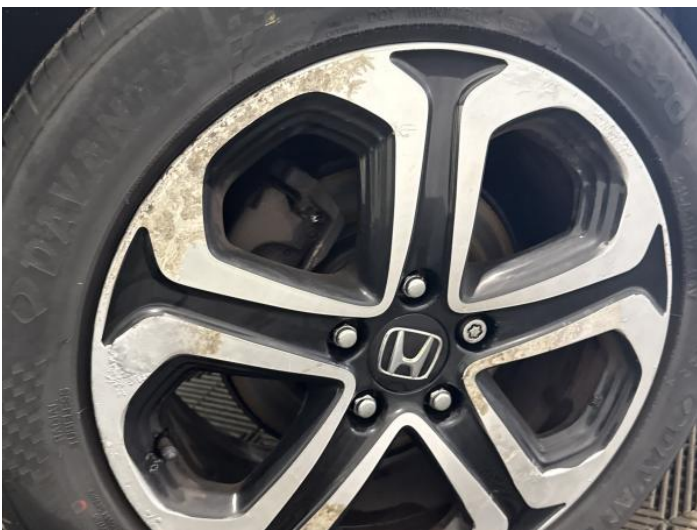
13: Wheel osr
Scratched
Over 50mm

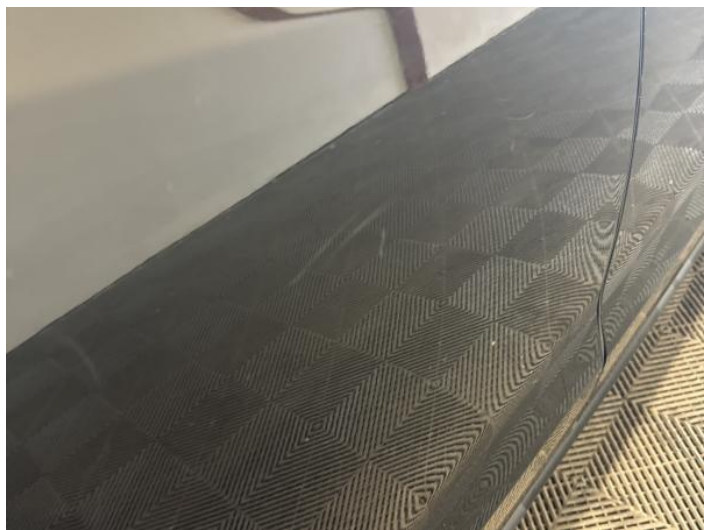
14: Door osr
Scratched
Over 25mm Thru Paint

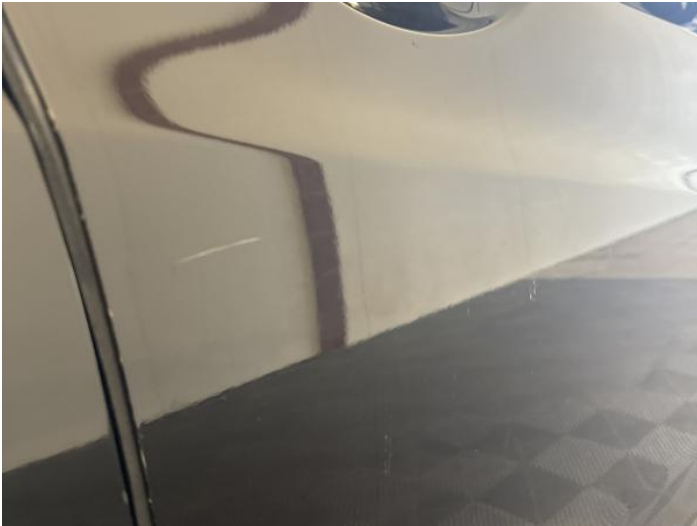
15: Door osf
Scratched
Over 25mm Thru Paint

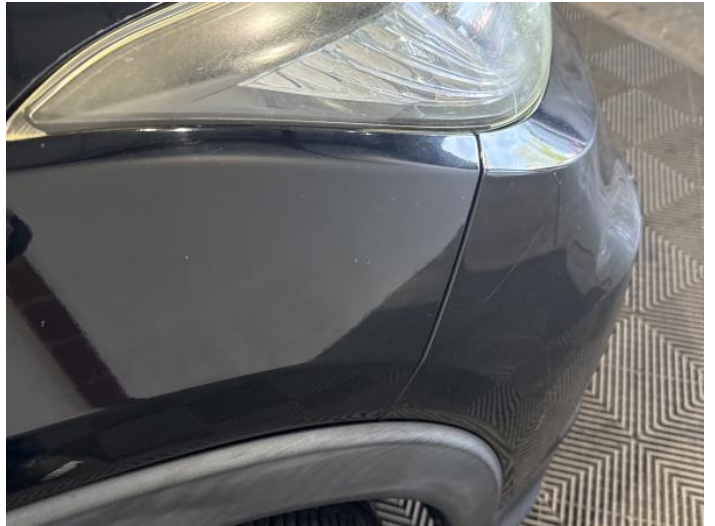
16: Wing osf
Chipped
1 To 5

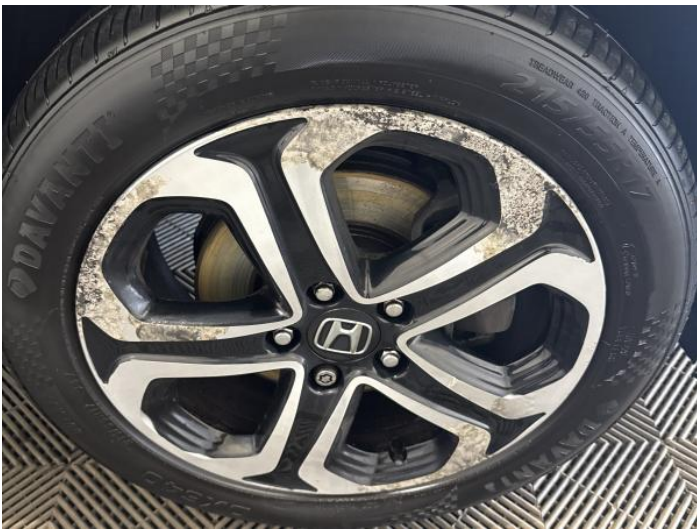
17: Wheel osf
Scratched
Over 50mm

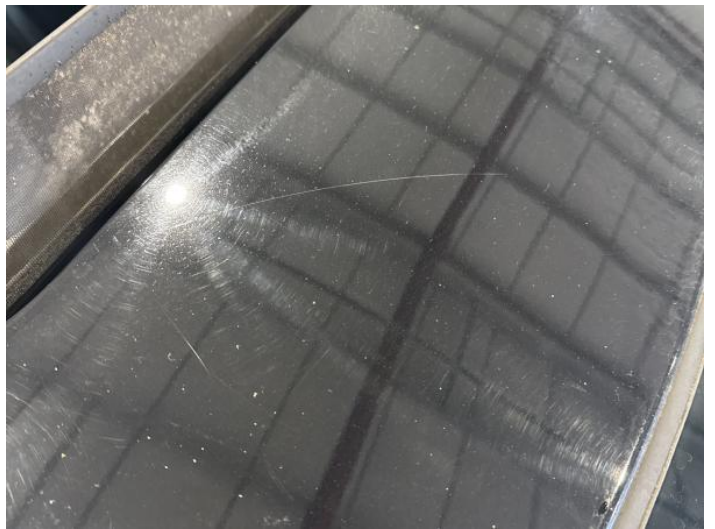
18: Roof
Scratched
Over 25mm Thru Paint

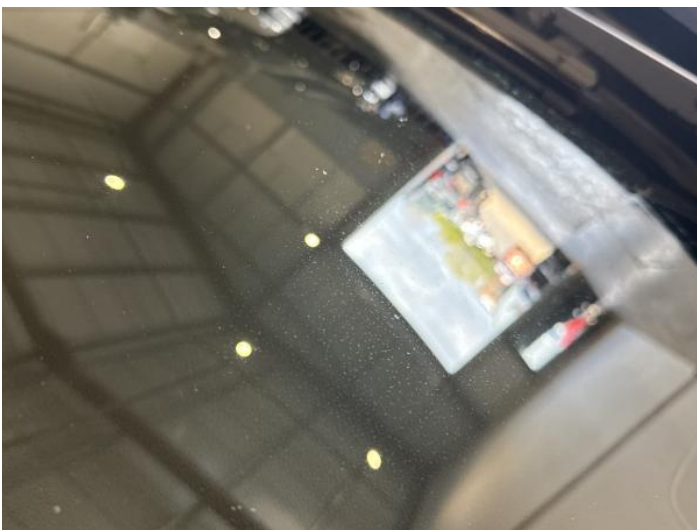
19: Screen Front
Chipped
UpTo 10mm
