# **VEHICLE INSPECTION REPORT**

**GU18MWX**

# Ford Fiesta 1.0 EcoBoost Zetec 5dr

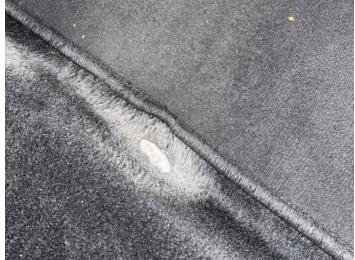
1: Carpets Front Holed Over 3mm

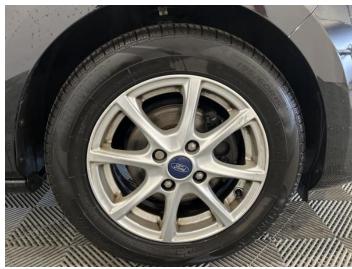
2: Wheel osf Scratched Over 50mm

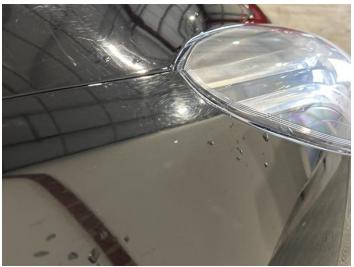
3: Wing osf Chipped 1 To 5

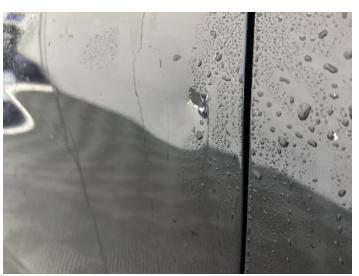
4: Door osf Dented With Paint Damage

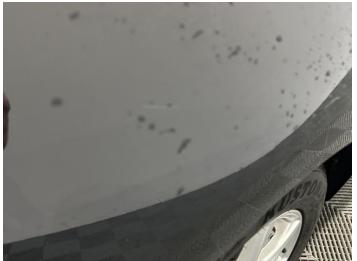
5: Qtr Panel osr Scratched Over 25mm Not Thru Paint

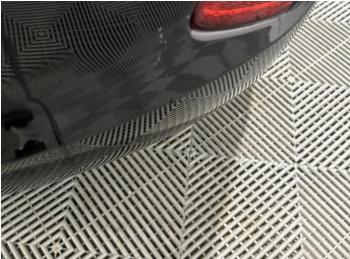
6: Bumper Rear Chipped 1 To 5

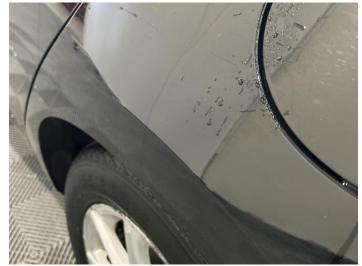
7: Qtr Panel nsr Scratched Over 25mm Not Thru Paint

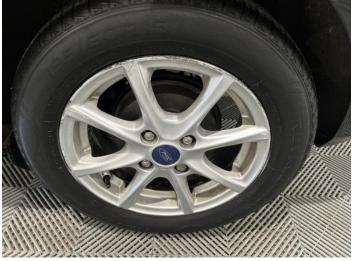
8: Wheel nsr Scratched Over 50mm

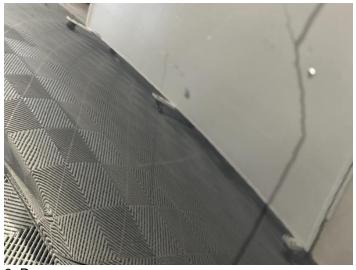
9: Door nsr Scratched Over 25mm Not Thru Paint

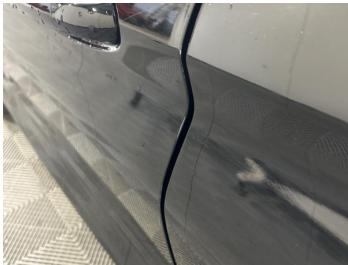
10: Door nsf Chipped Edge Chip

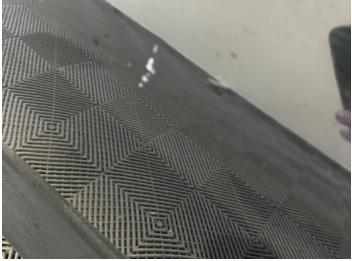
11: Door nsf Chipped 1 To 5

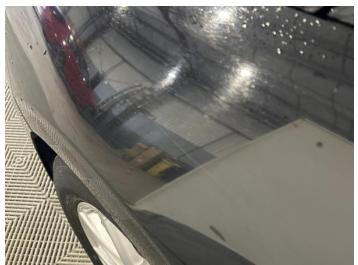
12: Wing nsf Scratched Over 25mm Not Thru Paint

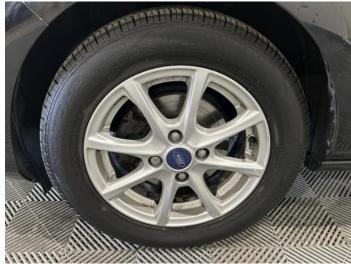
13: Wheel nsf Scratched Over 50mm

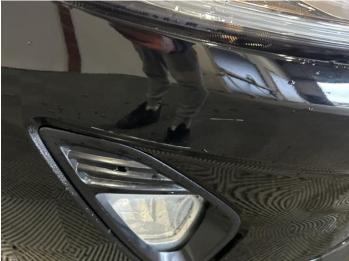
14: Bumper Front Scratched 25 to 100mm Thru Paint

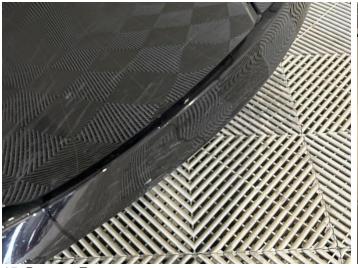
15: Bumper Front Scratched Over 25mm Not Thru Paint

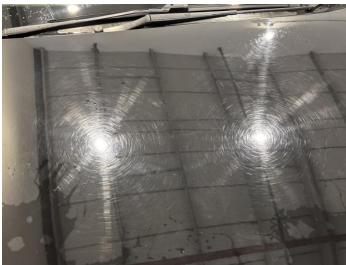
16: Bonnet Scratched Over 25mm Not Thru Paint
