VEHICLE INSPECTION REPORT

Jaguar XF 2.0d [180] R-Sport 4dr Auto AWD

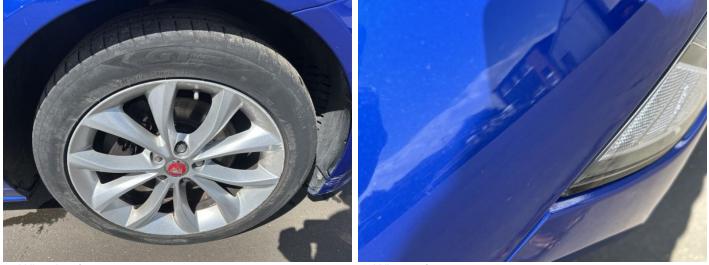
1: Wheel osf Scratched Over 50mm

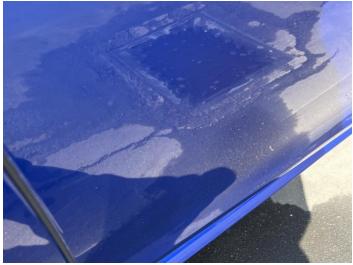
2: Wing osf Chipped 1 To 5

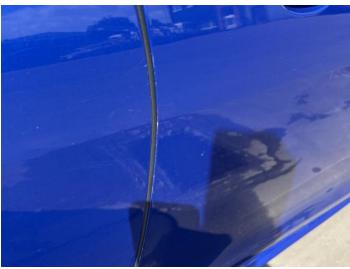
3: Door osf Chipped 1 To 5

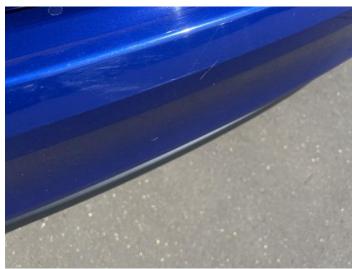
7: Bumper Rear Scratched Over 25mm Not Thru Paint

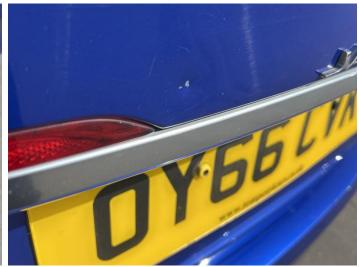
8: Tailgate Chipped 1 To 5

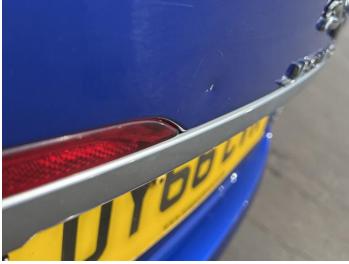
9: Tailgate Dented 2 Or Less UpTo 10mm

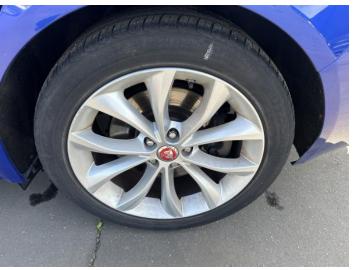
11: Wheel nsr Scratched Over 50mm

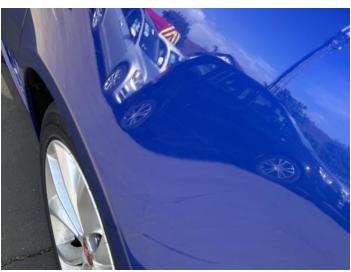
10: Qtr Panel nsr Scratched Over 25mm Not Thru Paint

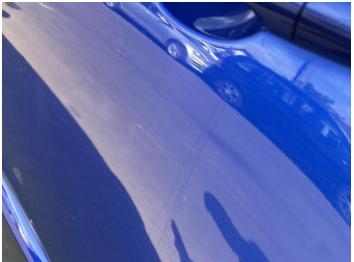
12: Door nsr Scratched Over 25mm Not Thru Paint

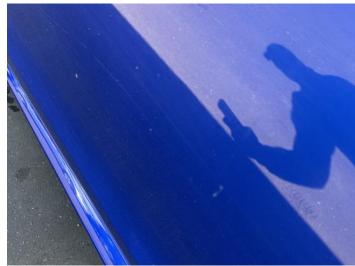
13: Door nsf Scratched Over 25mm Not Thru Paint

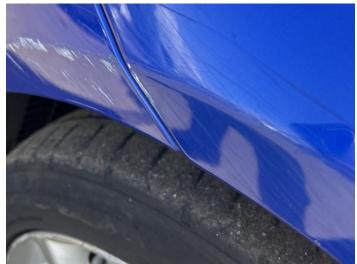
14: Wing nsf Scratched UpTo 25mm Thru Paint

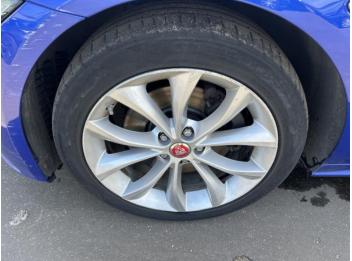
15: Wing nsf Scratched Over 25mm Not Thru Paint

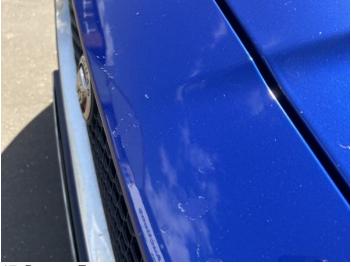
17: Bumper Front Poor Previous Repair Paint Flake

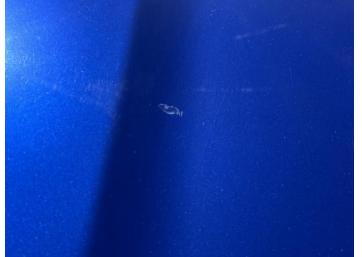
18: Bonnet Poor Previous Repair Paint Flake
