VEHICLE INSPECTION REPORT

KO15NWU

Nissan Qashqai 1.6 dCi N-Tec 5dr Xtronic

nama
GRADE
3

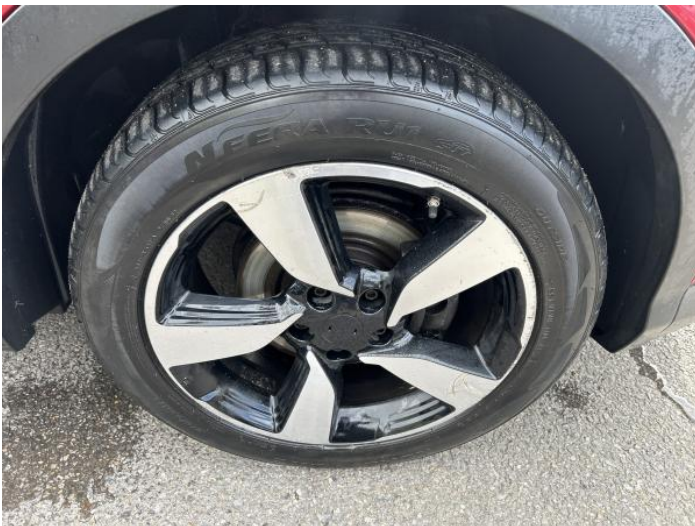
1: Wheel osf
Scratched
Over 50mm

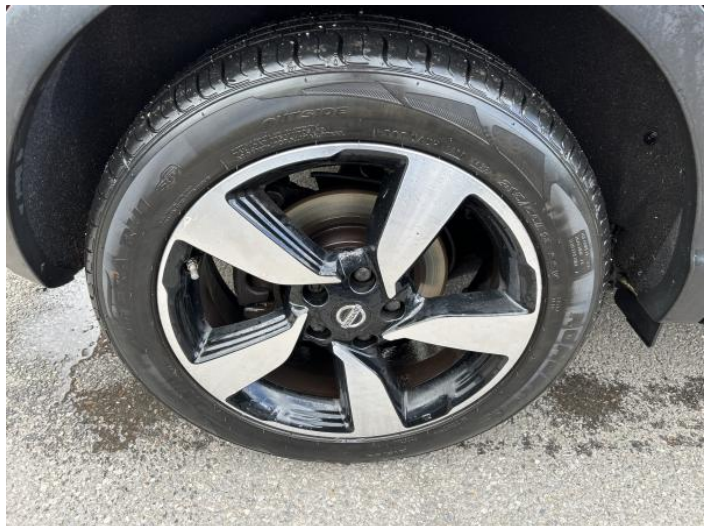
2: Wheel osr
Scratched
Up To 50mm

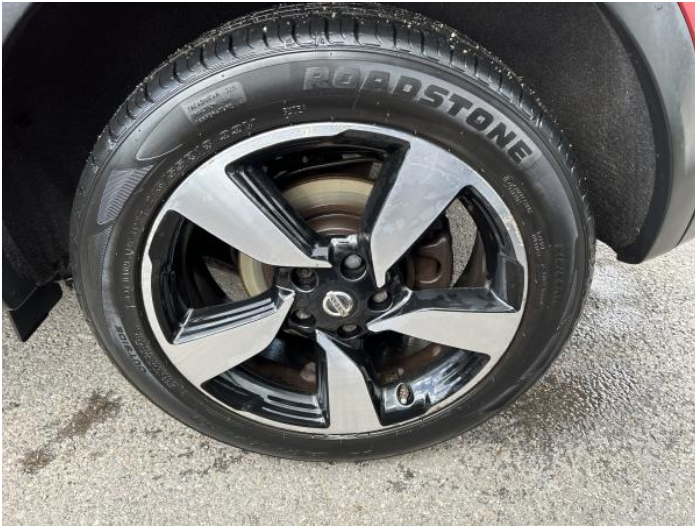
3: Wheel nsr
Scratched
Over 50mm

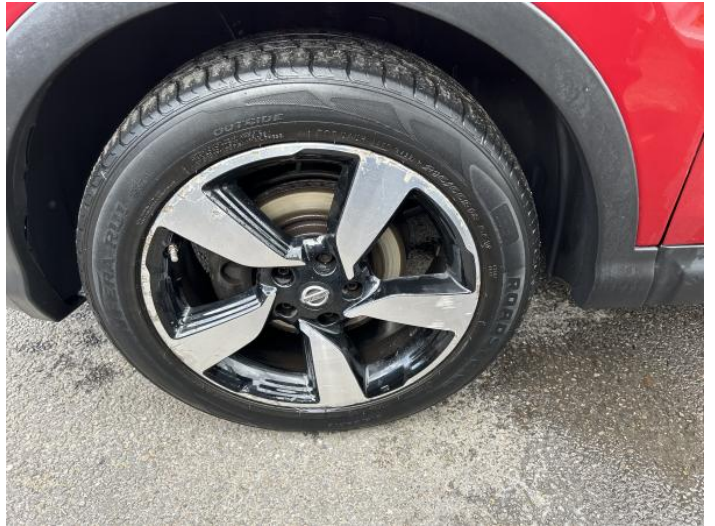
4: Wheel nsf
Scratched
Over 50mm

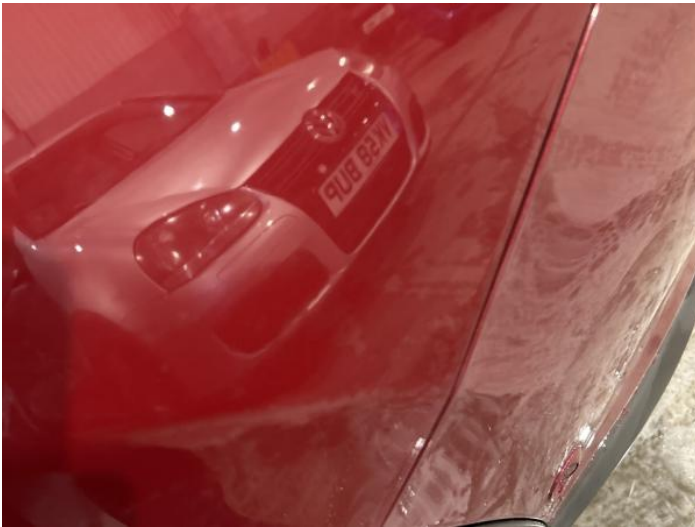
5: Wing osf
Chipped
1 To 5

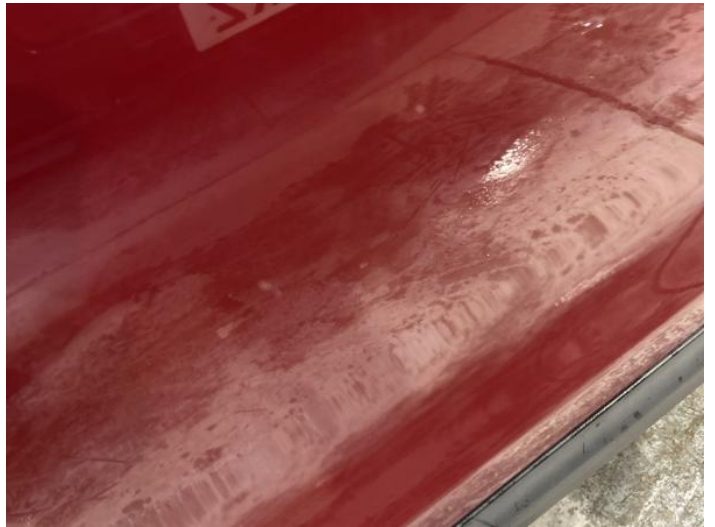
6: Door osf
Chipped
1 To 5

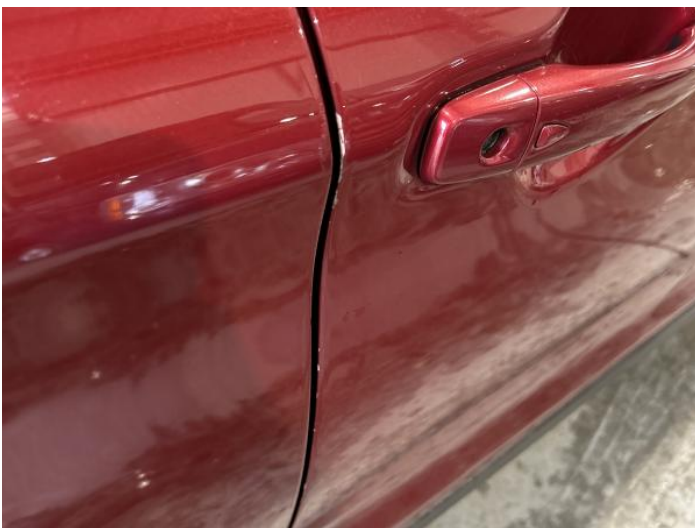
7: Door osf
Chipped
Edge Chip

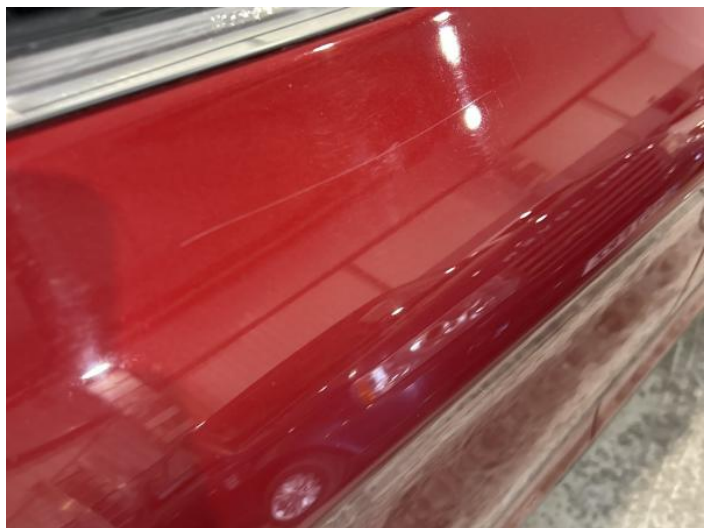
8: Door osr
Scratched
Over 25mm Not Thru Paint

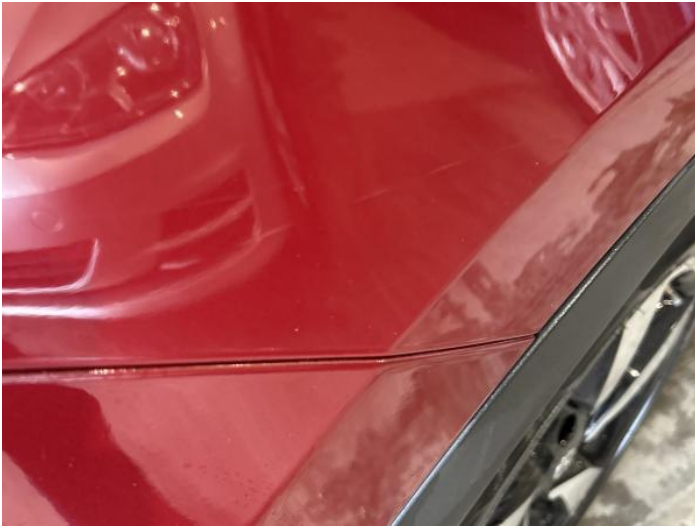
9: Qtr Panel osr
Scratched
Over 25mm Not Thru Paint

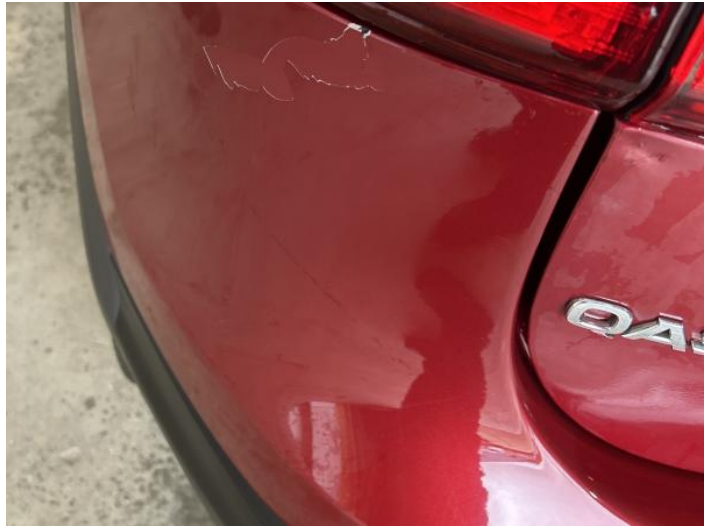
10: Bumper Rear
Poor Previous Repair
Paint Flake

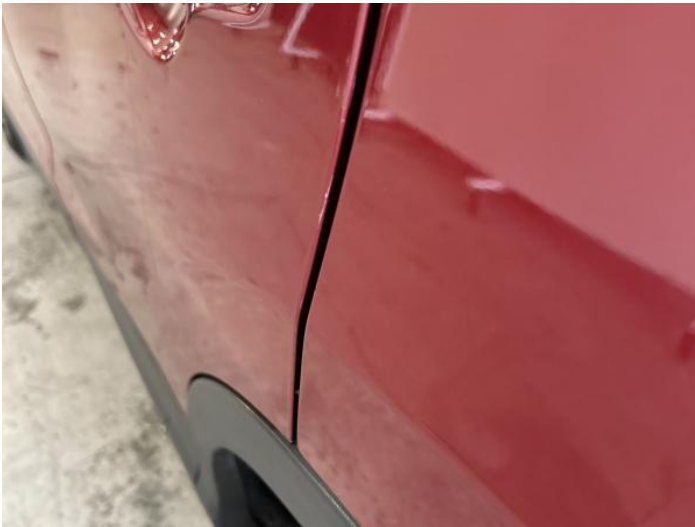
11: Door nsr
Chipped
Edge Chip

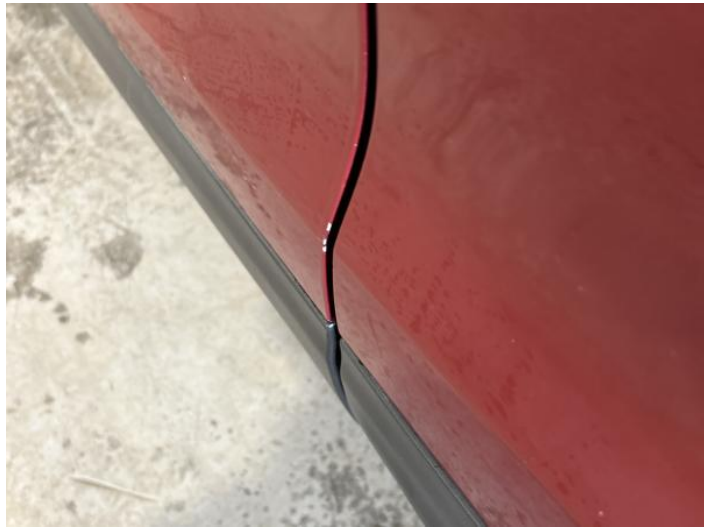
12: Door nsf
Chipped
Edge Chip

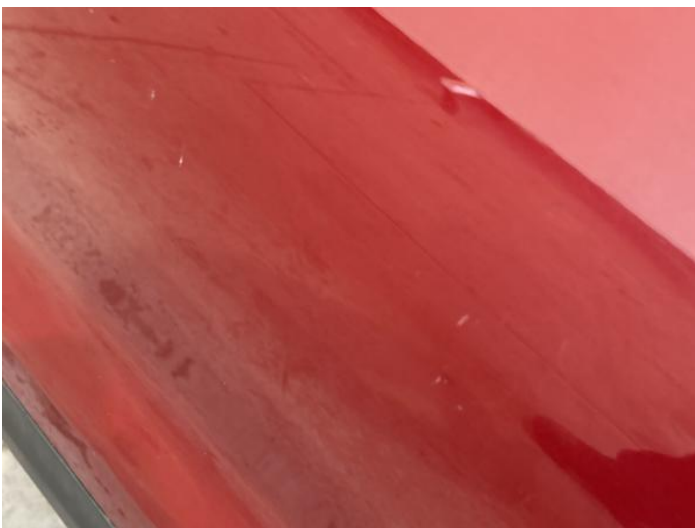
13: Door nsf
Chipped
1 To 5

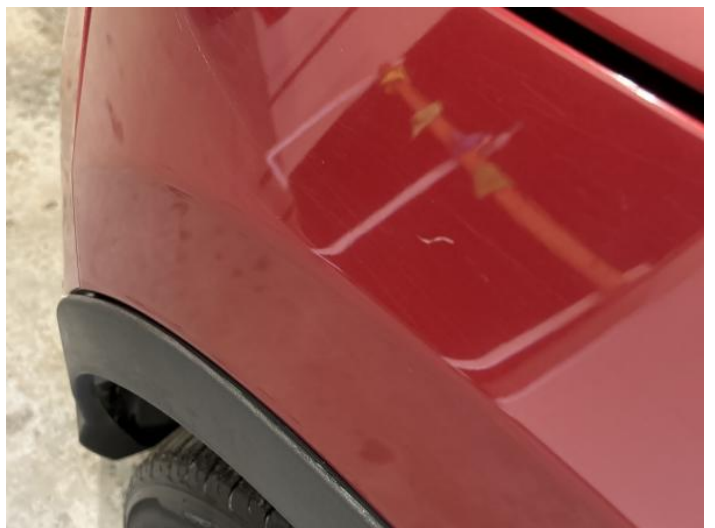
14: Wing nsf
Scratched
Over 25mm Not Thru Paint

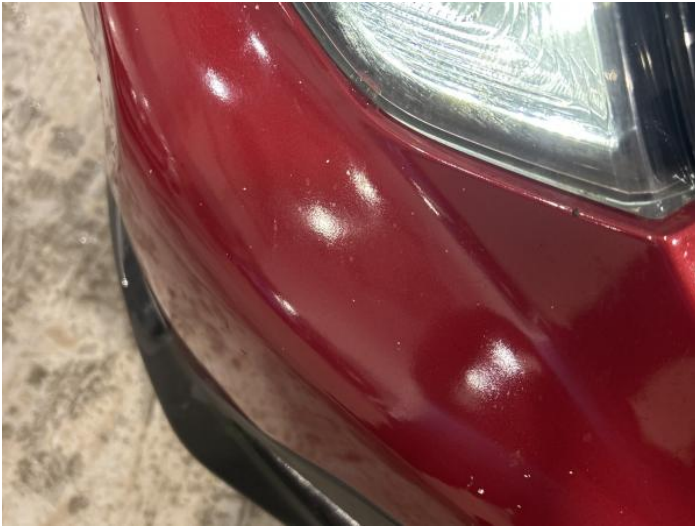
15: Bumper Front
Poor Previous Repair
Poor Paint

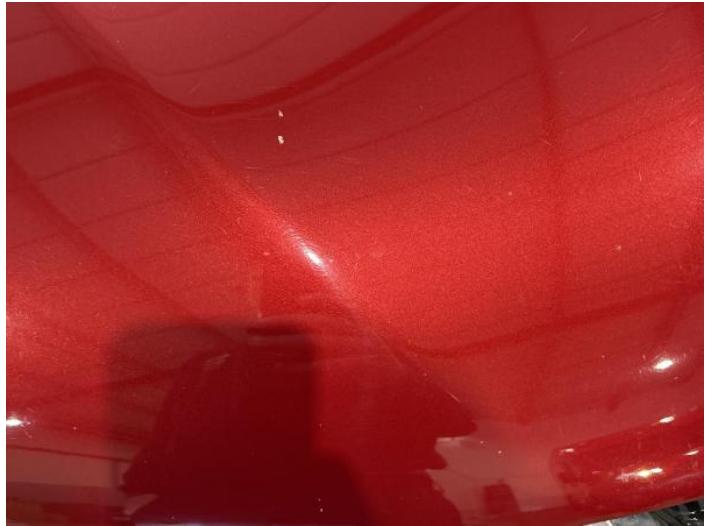
16: Bonnet
Chipped
1 To 5

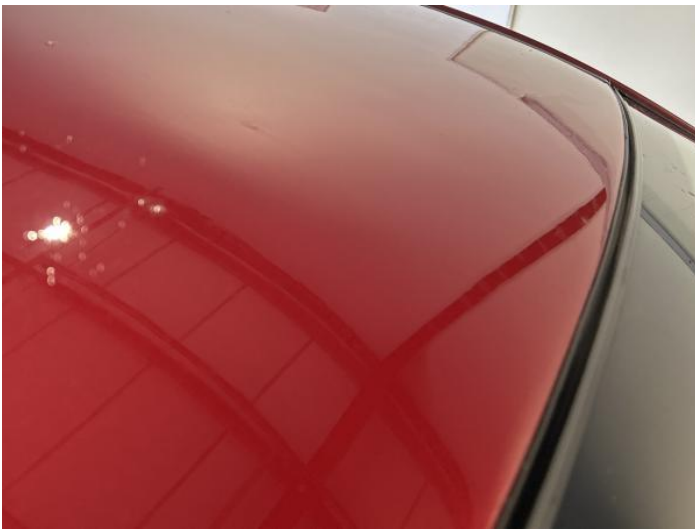
17: Roof
Dented
Between 10mm + 30mm

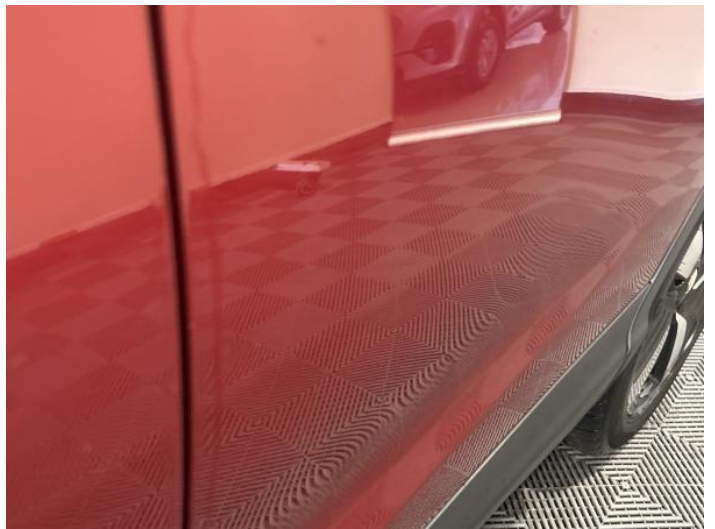
18: Door nsr
Dented
2 Or Less UpTo 10mm

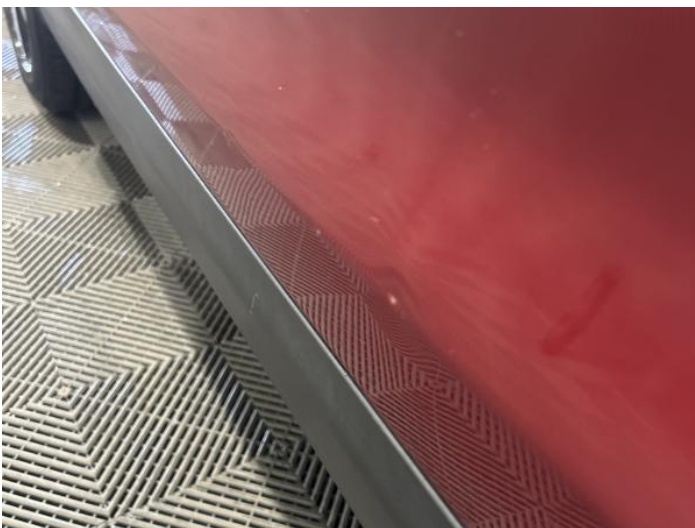
19: Door nsf
Dented
Between 10mm + 30mm

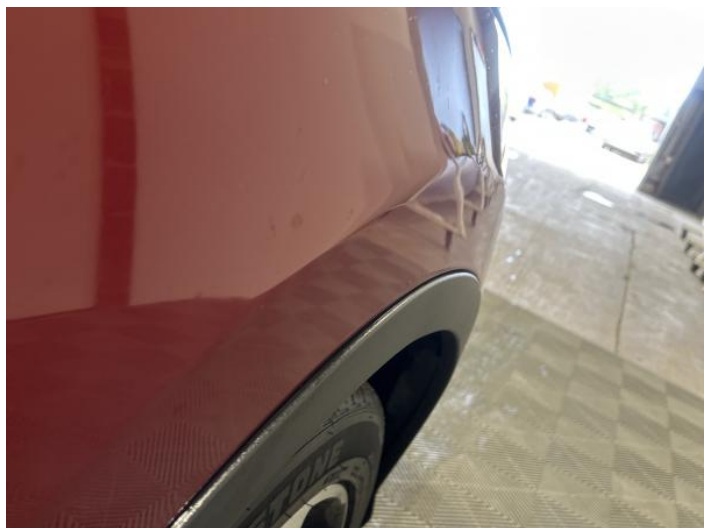
20: Wing osf
Dented
Over 2 UpTo 10mm
