# VEHICLE INSPECTION REPORT

**DK67OHD**

## Ford Kuga 1.5 EcoBoost 120 Zetec 5dr 2WD

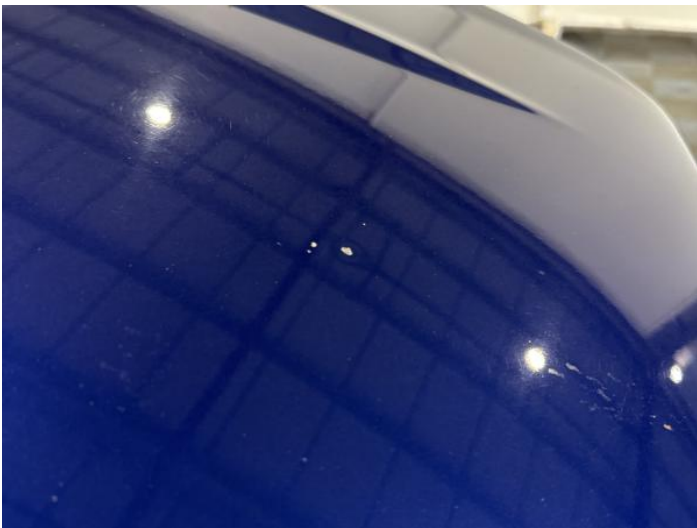
1: Bonnet  
Dented  
2 Or Less Up To 10mm

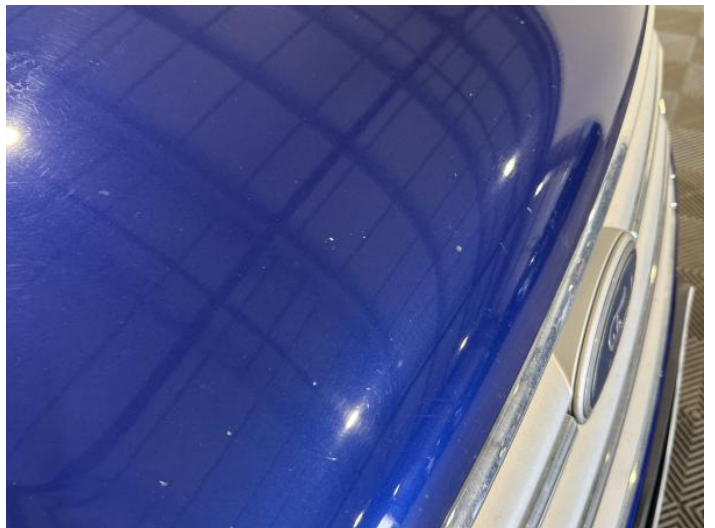
2: Bonnet  
Chipped  
Multiple Chips

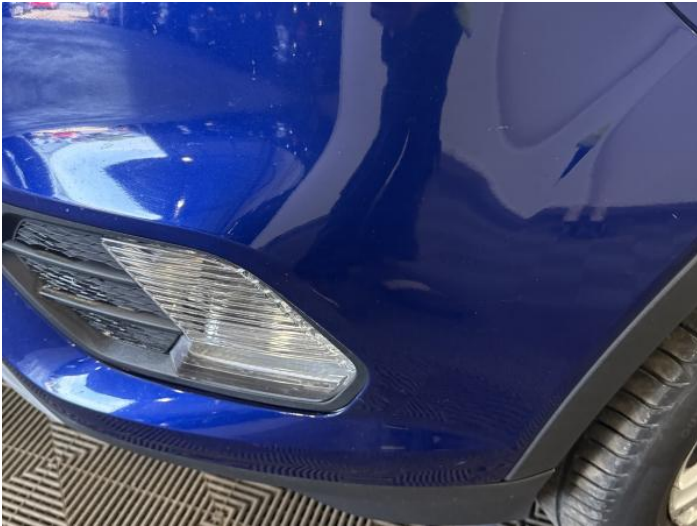
3: Bumper Front  
Scratched  
25 to 100mm Thru Paint

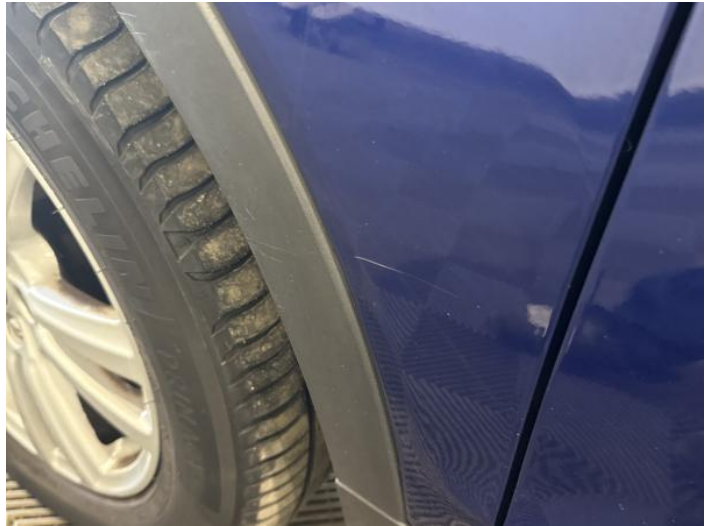
4: Wing nsf  
Scratched  
Over 25mm Thru Paint

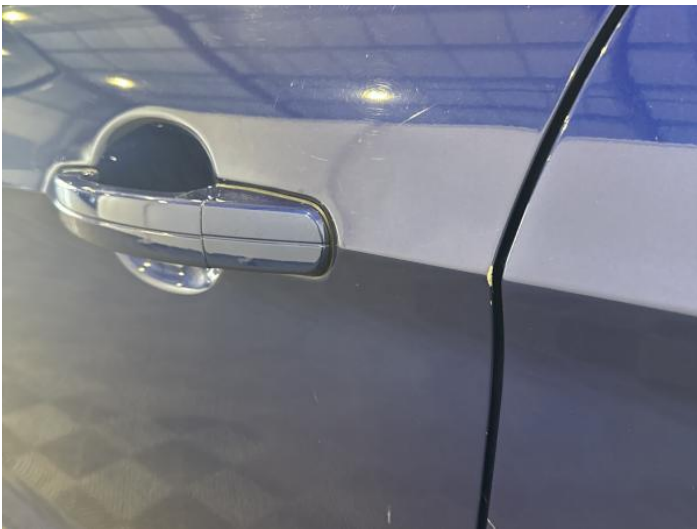
5: Door nsf  
Dented  
With Paint Damage

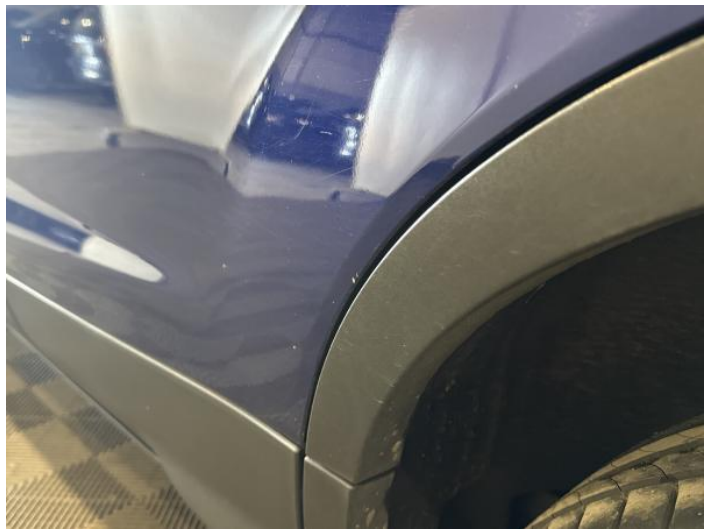
6: Door nsr  
Chipped  
1 To 5

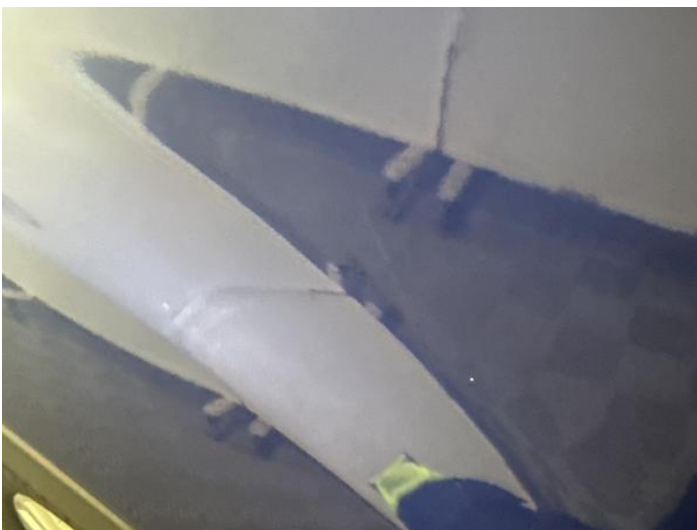
7: Qtr Panel nsr  
Scratched  
UpTo 25mm Thru Paint

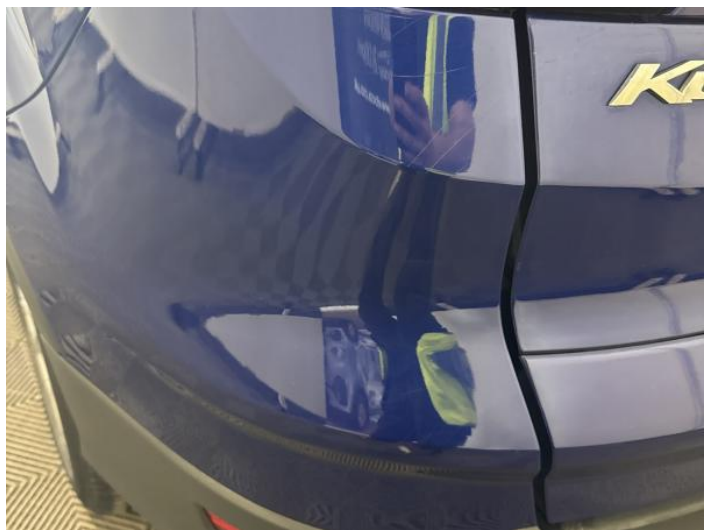
8: Bumper Rear Moulding  
Scratched (Painted)  
Over 25mm Thru Paint

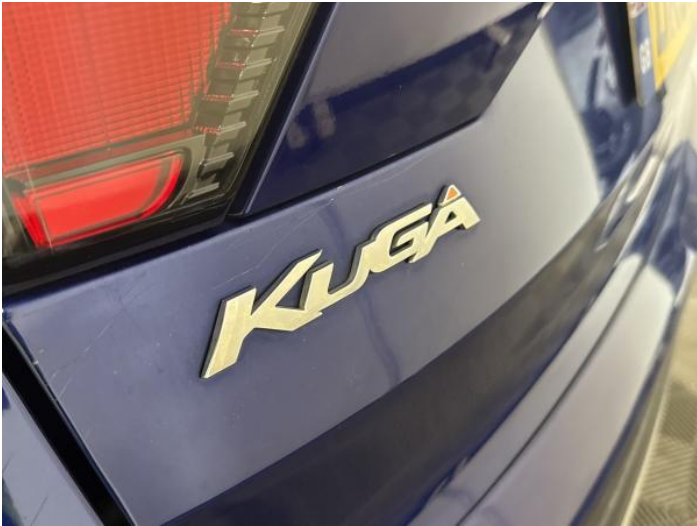
9: Tailgate  
Scratched  
Over 25mm Thru Paint

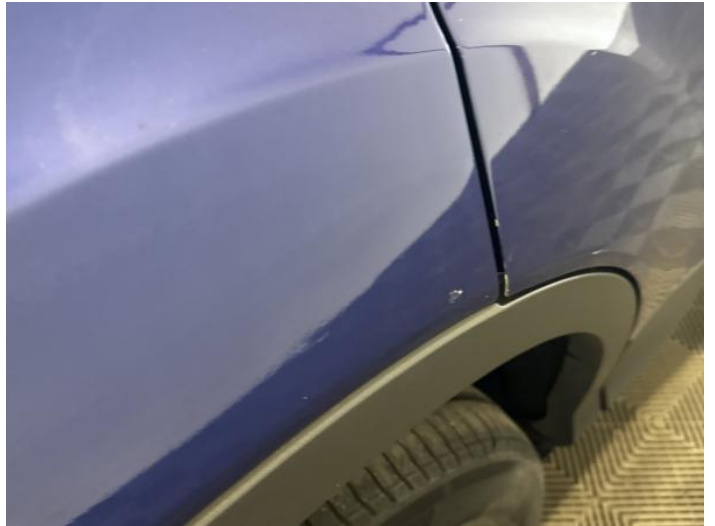
10: Qtr Panel osr  
Chipped  
1 To 5

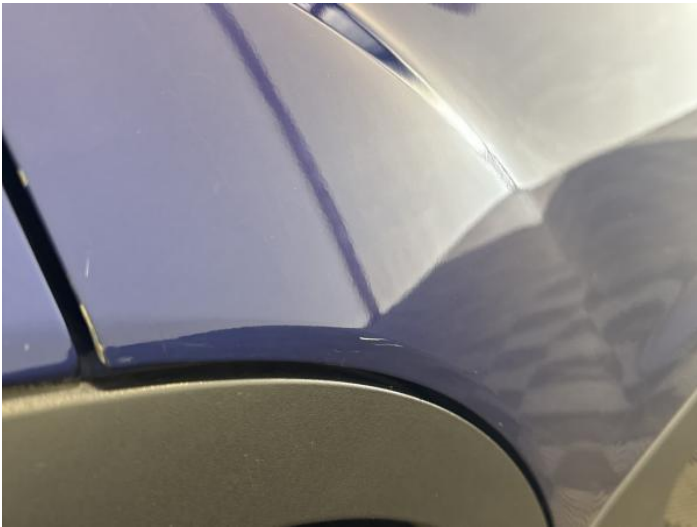
11: Door osr  
Scratched  
Over 25mm Thru Paint

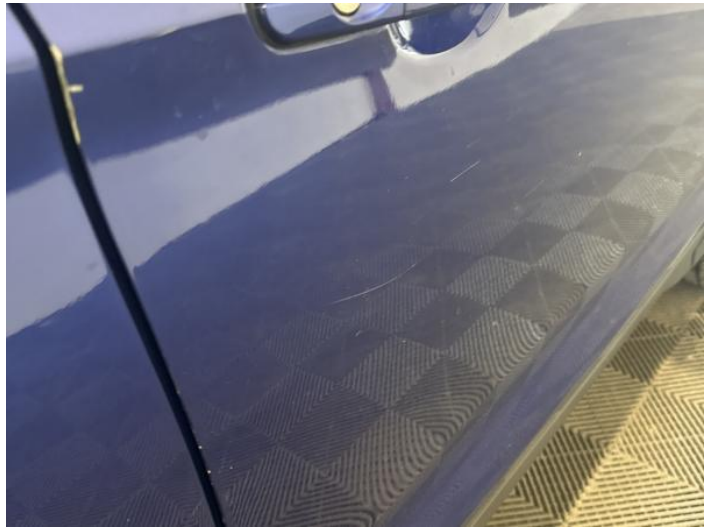
12: Door osf  
Scratched  
Over 25mm Thru Paint

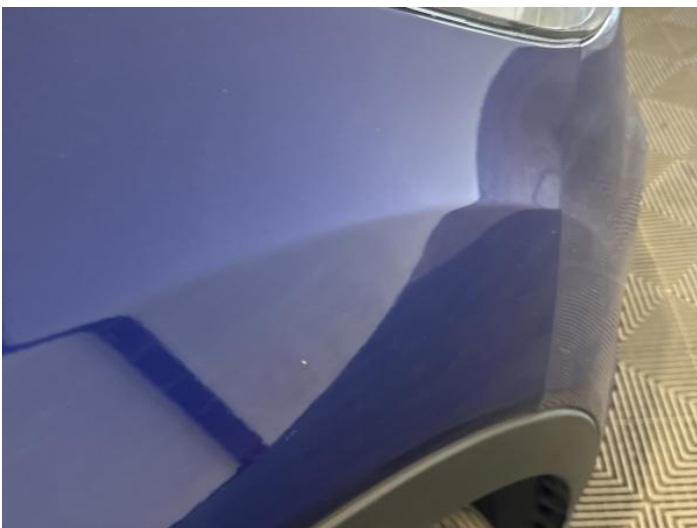
13: Wing osf  
Chipped  
1 To 5

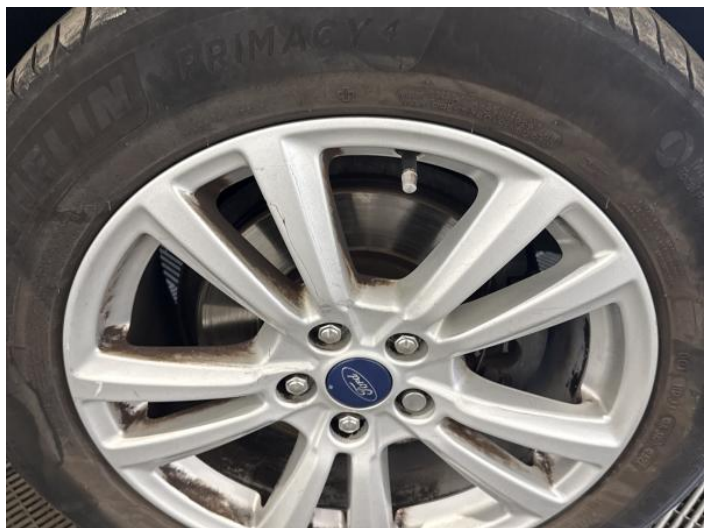
14: Wheel osf  
Scratched  
Over 50mm
