VEHICLE INSPECTION REPORT

NA67KUD

Nissan Juke 1.6 DiG-T Nismo RS 5dr

nama
GRADE
2

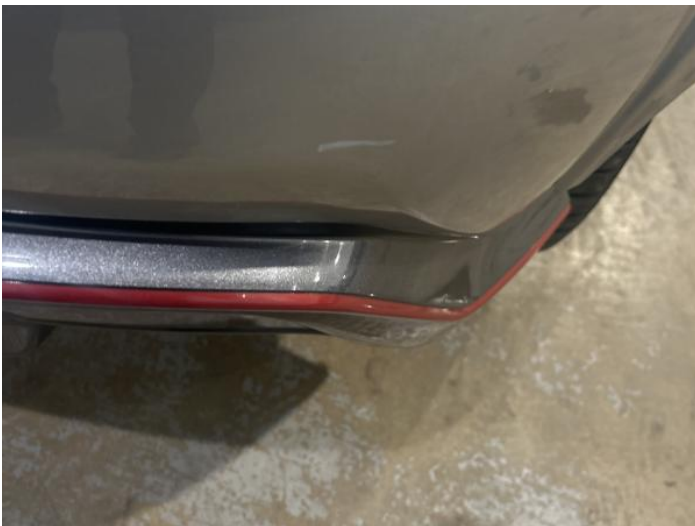
1: Bumper Rear
Scratched
Up To 25mm Thru Paint

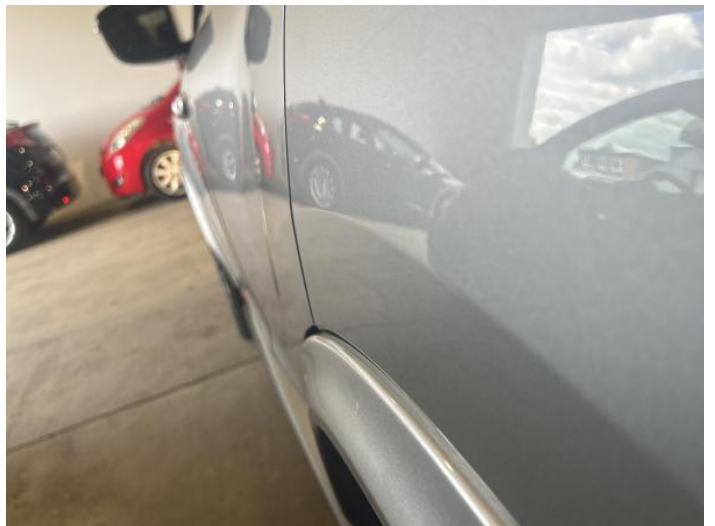
2: Qtr Panel nsr
Dented
2 Or Less UpTo 10mm

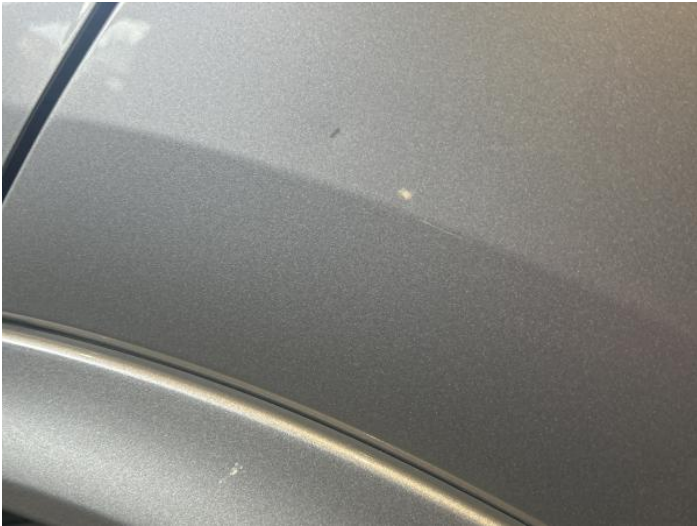
3: Qtr Panel nsr
Chipped
1 To 5

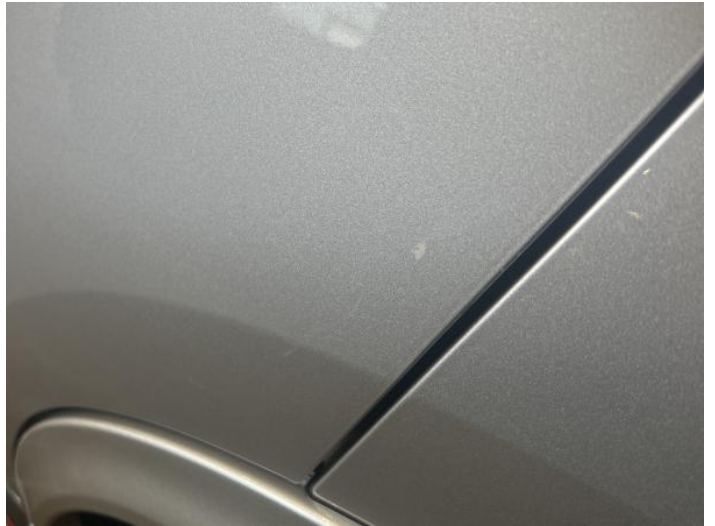
4: Door nsr
Chipped
1 To 5

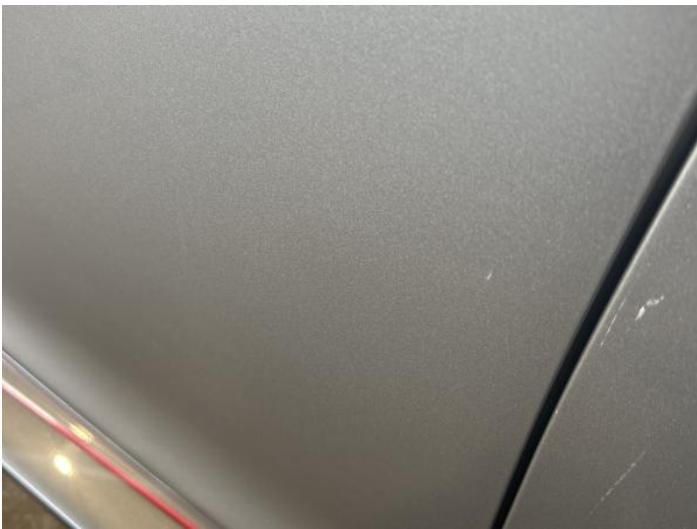
5: Door nsf
Chipped
1 To 5

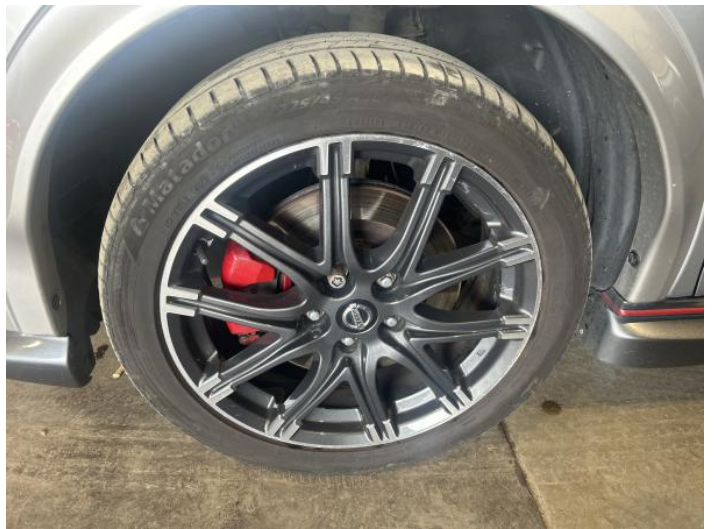
6: Wheel nsf
Corroded
Light

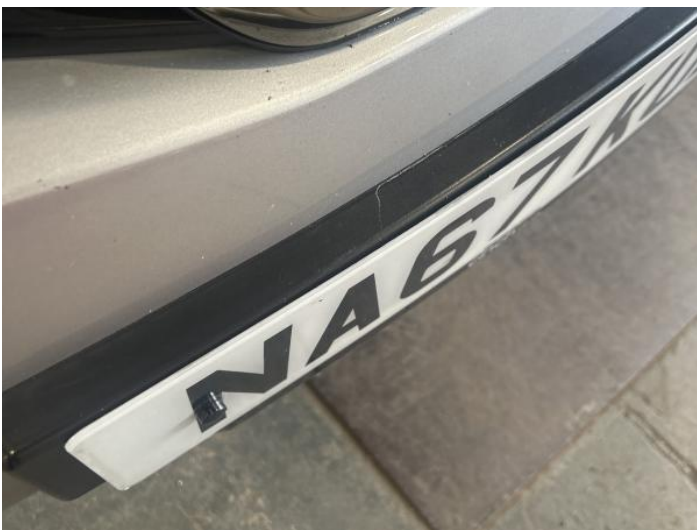
7: Bumper Front
Chipped
1 To 5

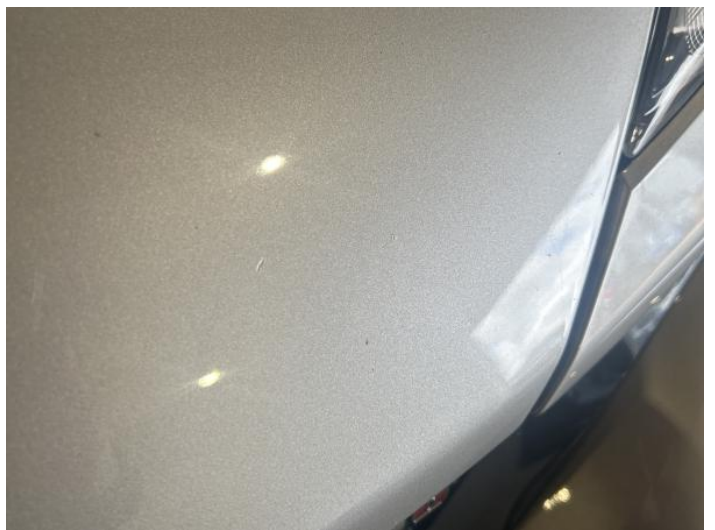
8: Bonnet
Chipped
1 To 5

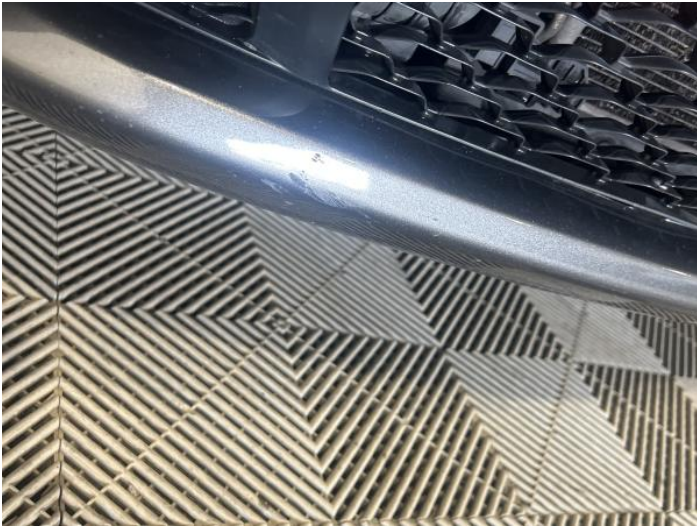
9: Bumper Front Moulding
 Scratched (Painted)
 UpTo 25mm Thru Paint
