VEHICLE INSPECTION REPORT

DE13MVK

Honda Civic 1.8 i-VTEC ES 5dr

nama
 GRADE
4

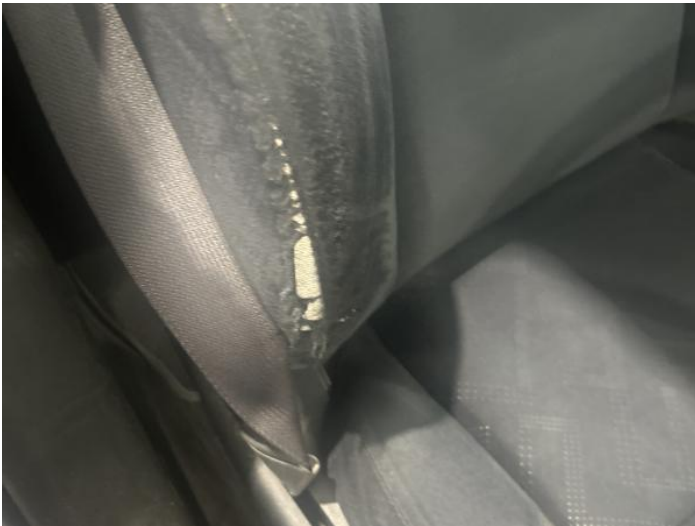
1: Seat Back Cover of
Torn
Over 3mm

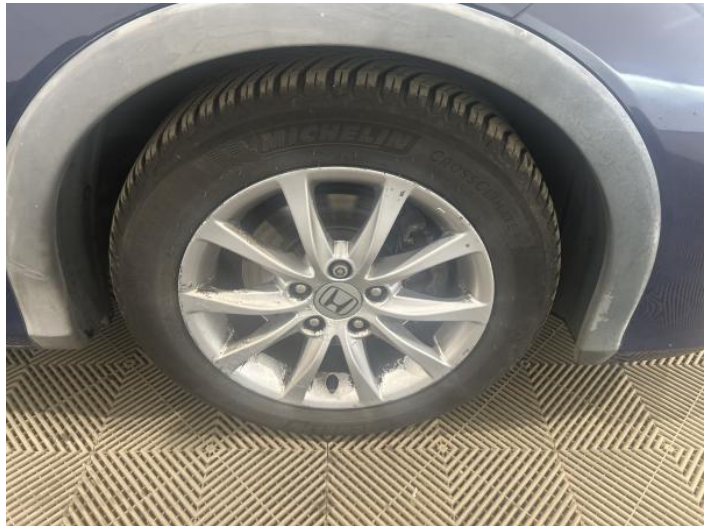
2: Wheel of
Corroded
Light

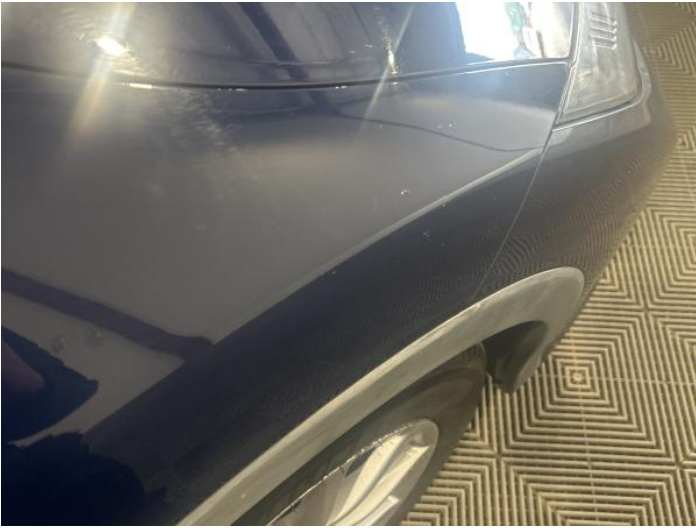
3: Wing osf
Chipped
1 To 5

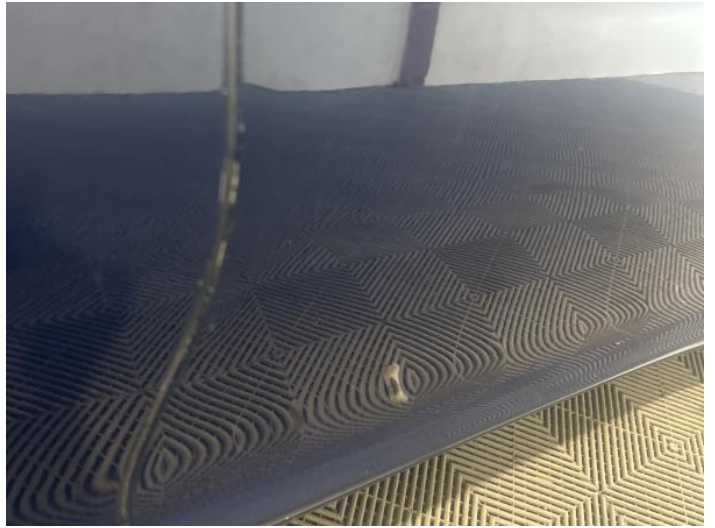
4: Door osf
Chipped
Edge Chip

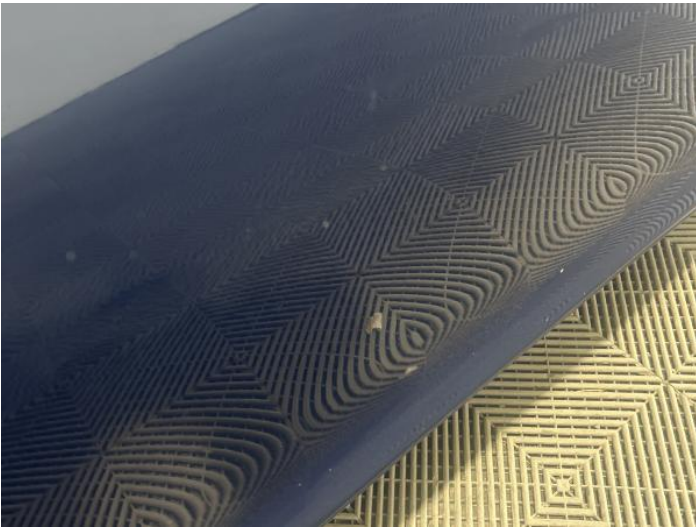
5: Door osf
Chipped
1 To 5

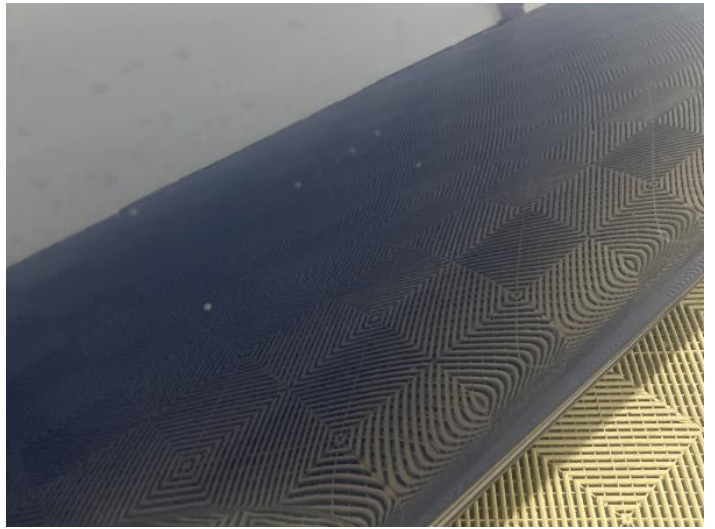
6: Door osr
Chipped
Multiple Chips

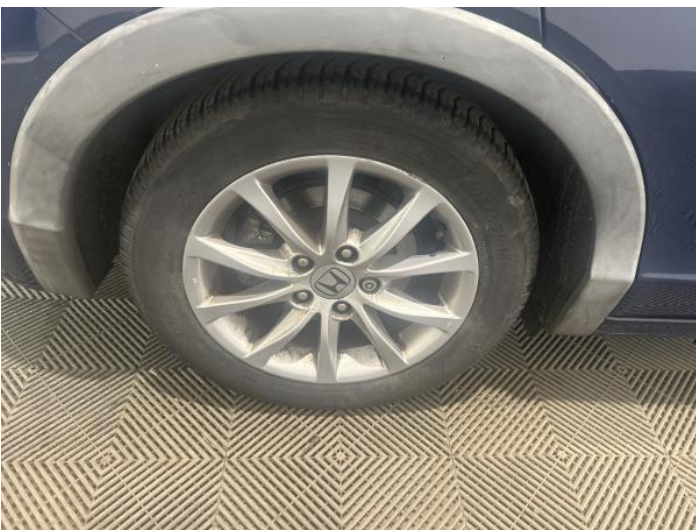
7: Wheel osr
Corroded
Light

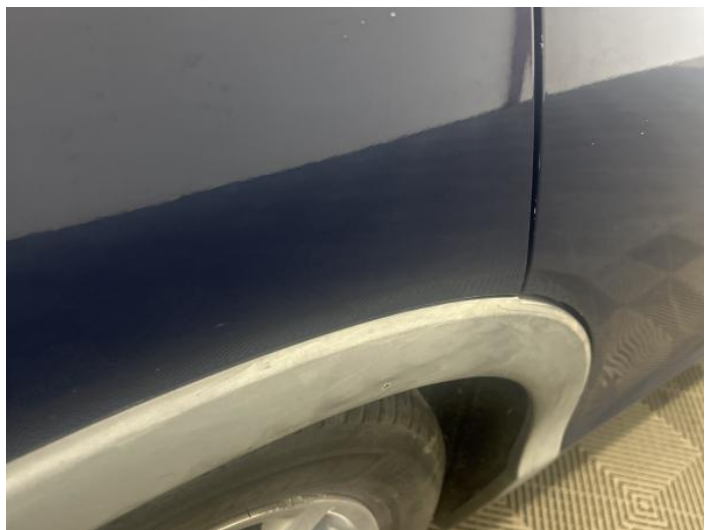
8: Qtr Panel osr
Chipped
1 To 5

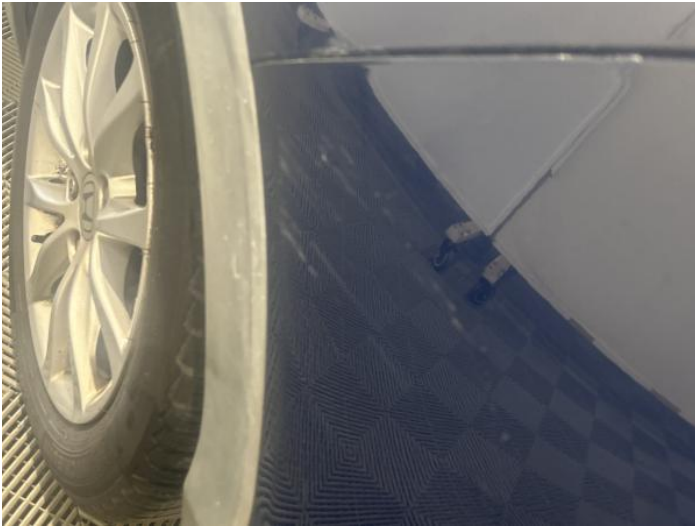
9: Bumper Rear
Scratched
Over 100mm Thru Paint

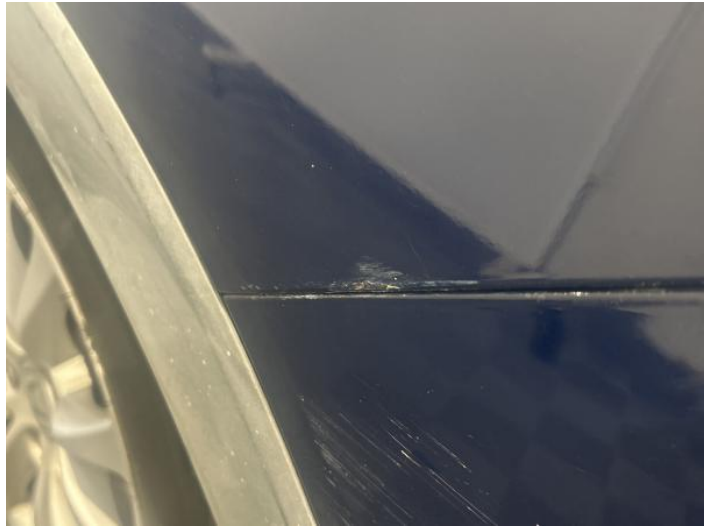
10: Qtr Panel nsr
Scratched
UpTo 25mm Thru Paint

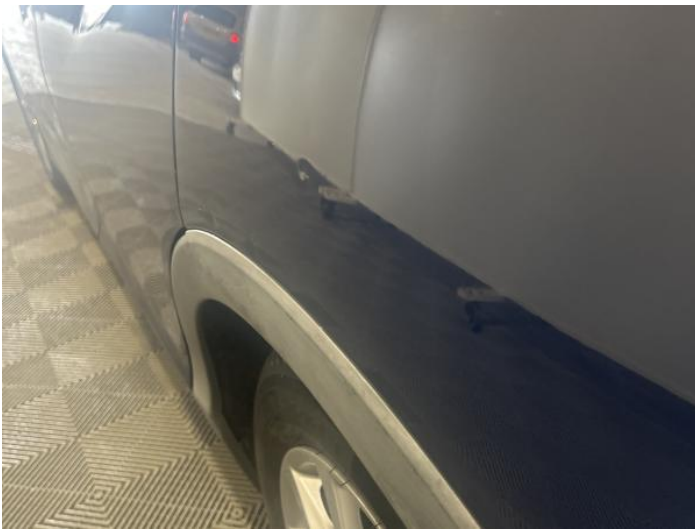
11: Qtr Panel nsr
Dented
With Paint Damage

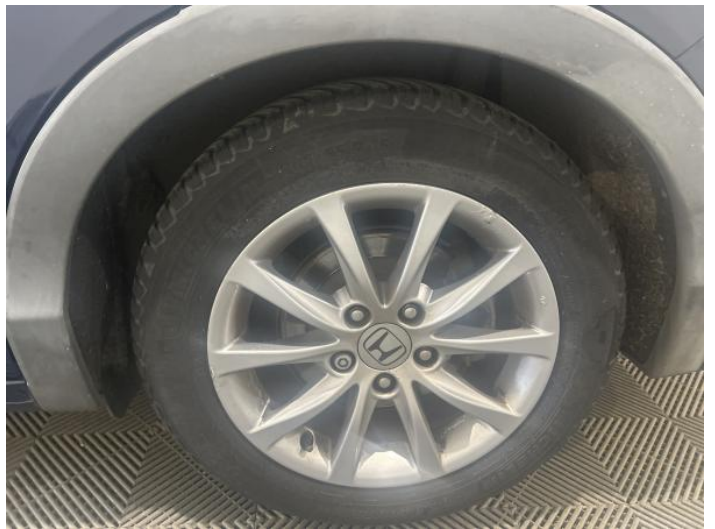
12: Wheel nsr
Corroded
Light

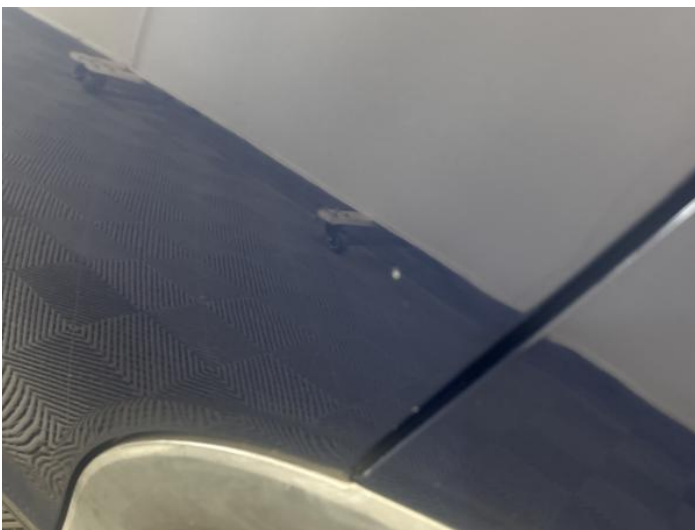
13: Door nsr
Chipped
1 To 5

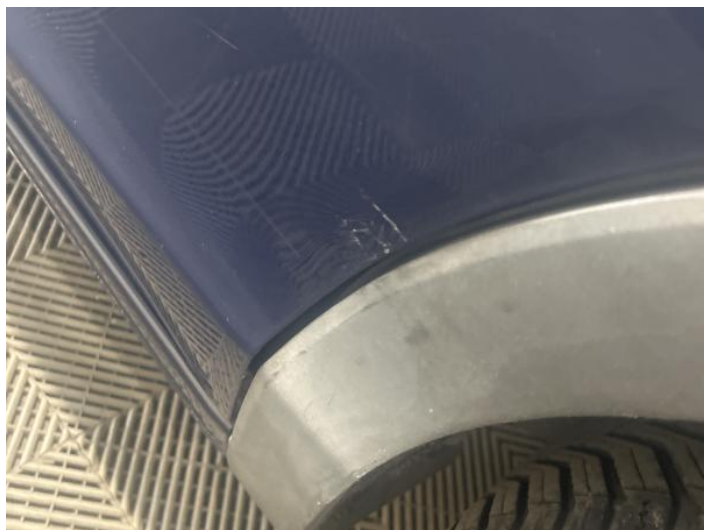
14: Door nsr
Scratched
UpTo 25mm Thru Paint

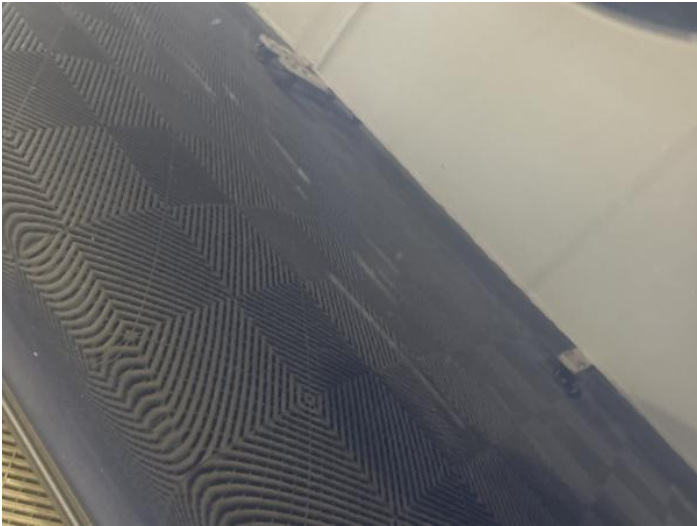
15: Door nsf
Scratched
Over 25mm Thru Paint

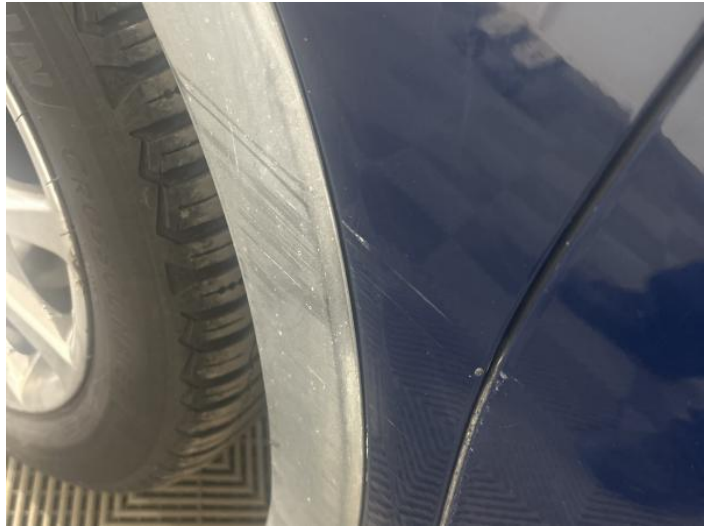
16: Wing nsf
Scratched
UpTo 25mm Thru Paint

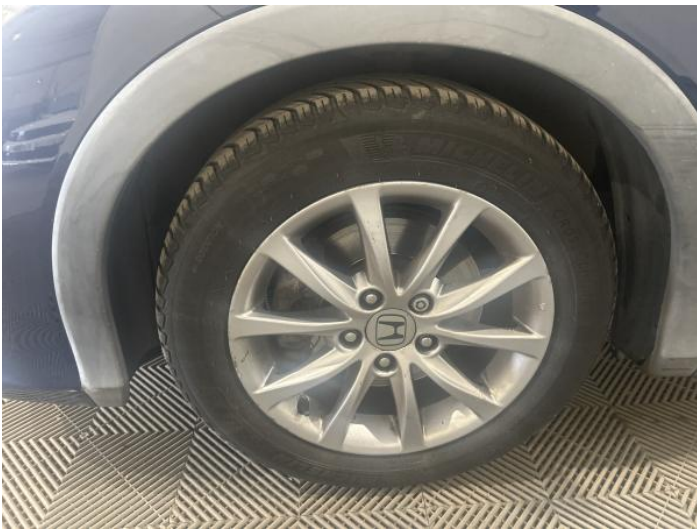
17: Wheel nsf
Corroded
Light

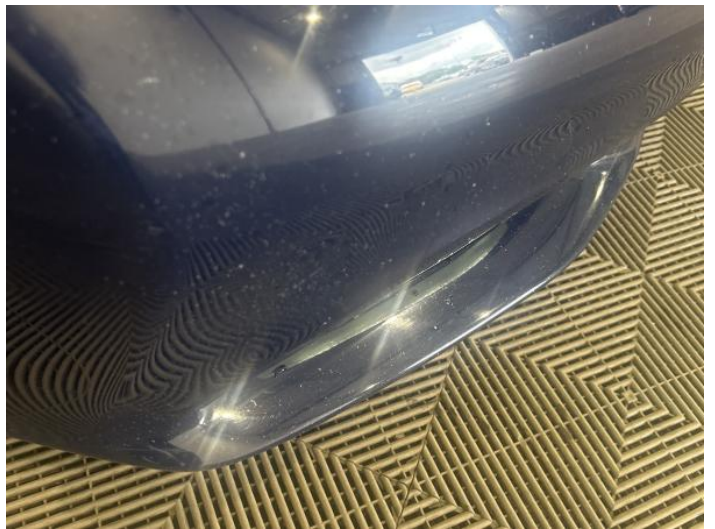
18: Bumper Front
Chipped
Multiple Chips

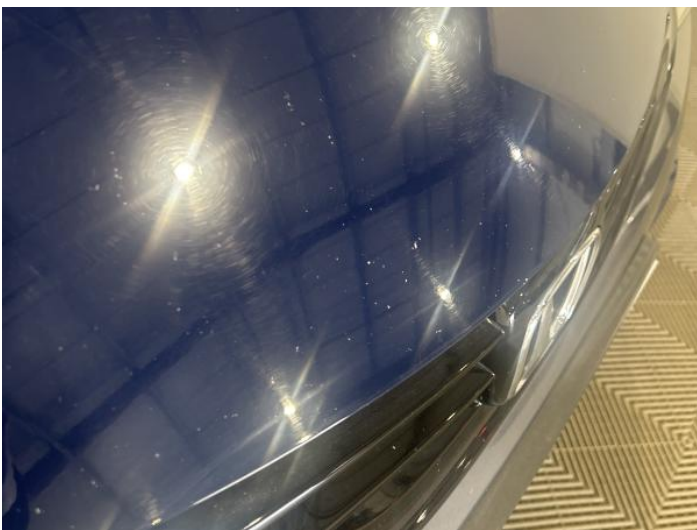
19: Bonnet
Chipped
Multiple Chips

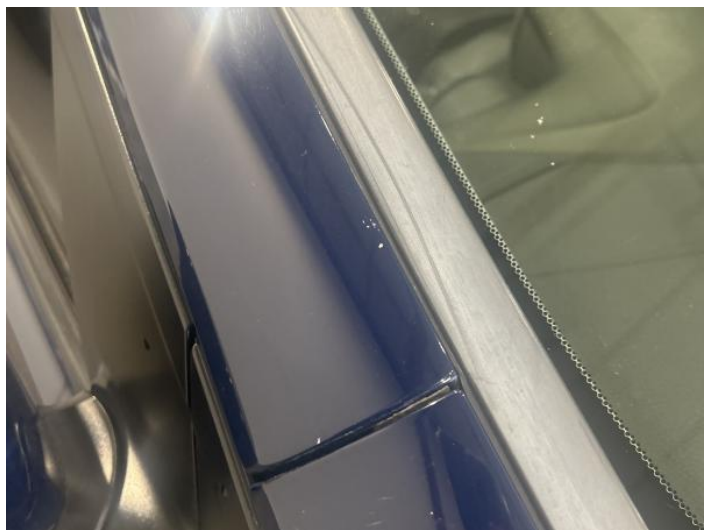
20: A Post os
Chipped
1 To 5

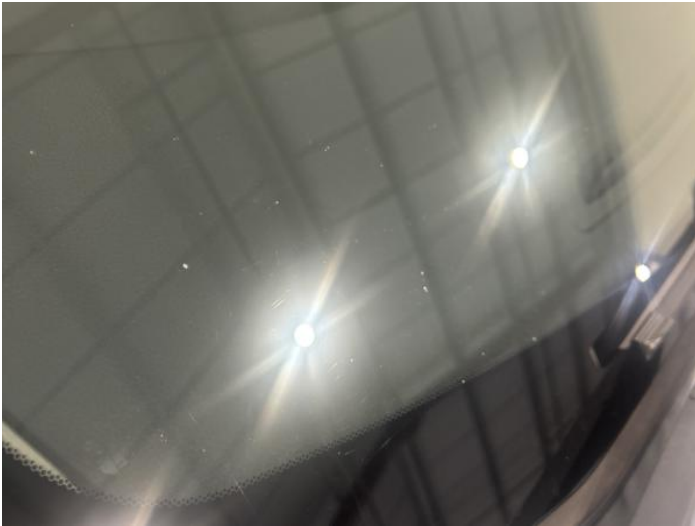
21: Screen Front
Chipped
UpTo 10mm

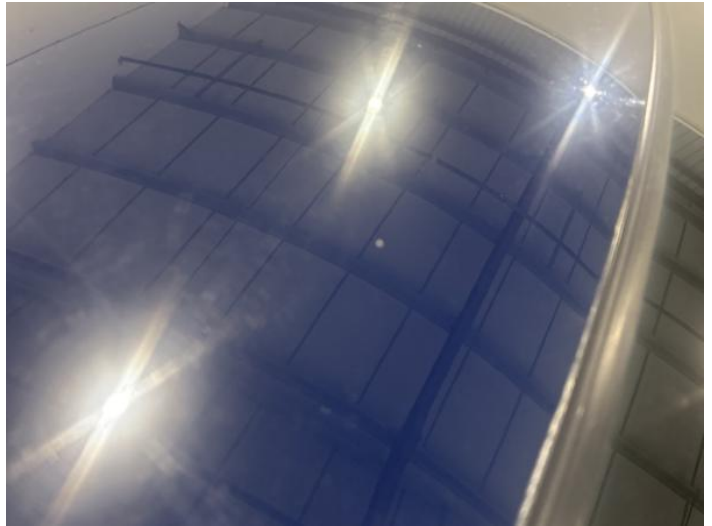
22: Roof
Chipped
1 To 5

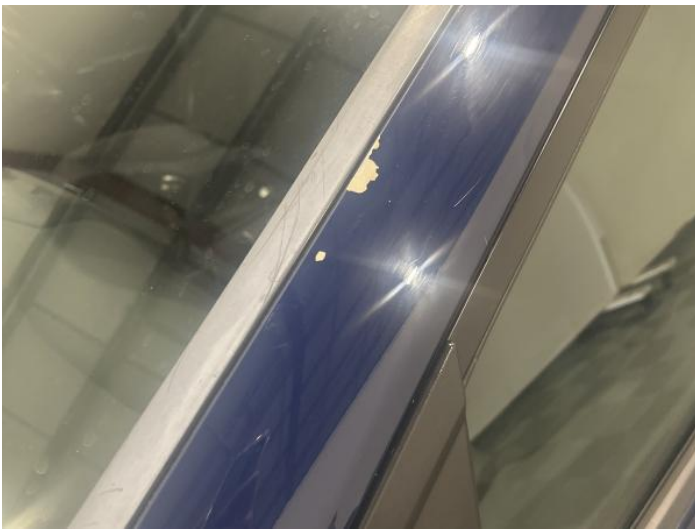
23: A Post ns
Poor Previous Repair
Paint Flake

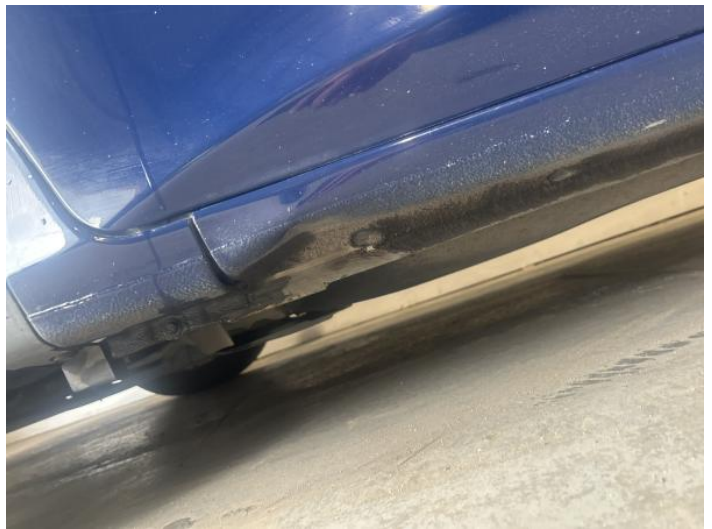
24: Sill ns
Dented
Over 30mm
