VEHICLE INSPECTION REPORT

GP19FYU

Volkswagen Golf 1.5 TSI EVO Match 5dr DSG

nama
GRADE
4

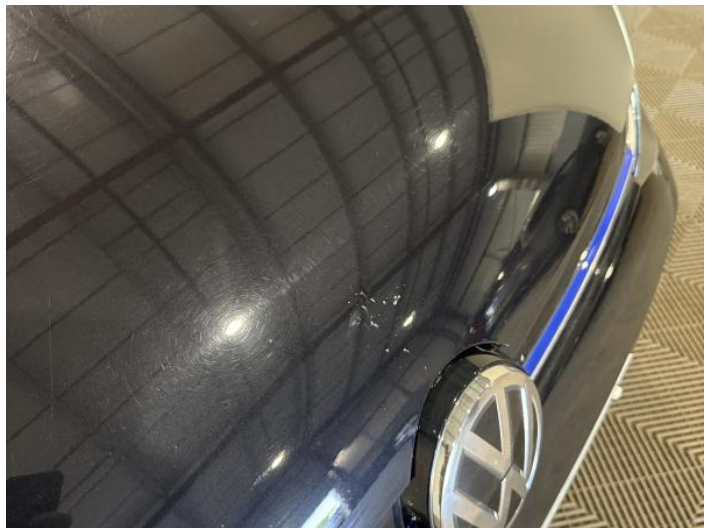
2: Bonnet
Chipped
Multiple Chips

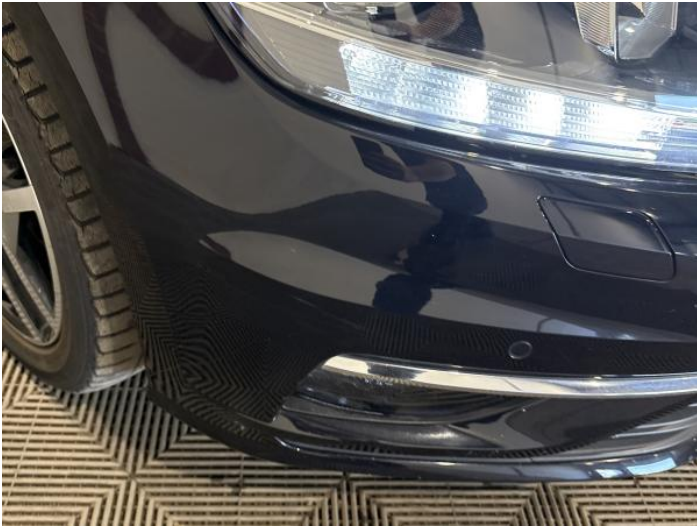
3: Bumper Front
Scratched
25 to 100mm Thru Paint

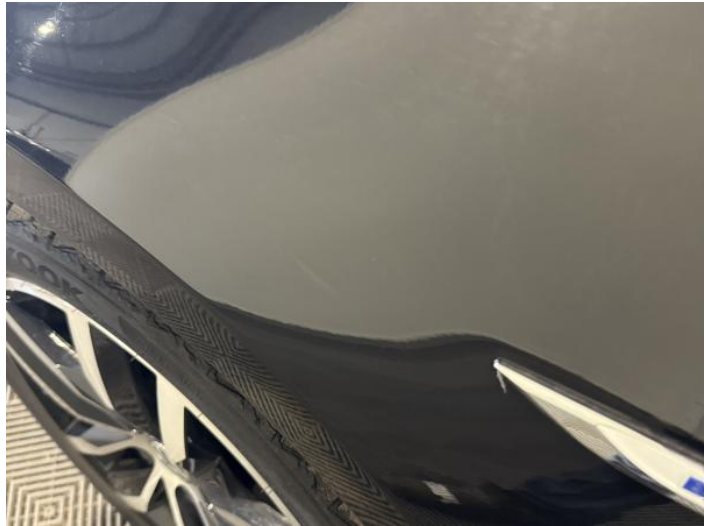
4: Wing nsf
Scratched
UpTo 25mm Thru Paint

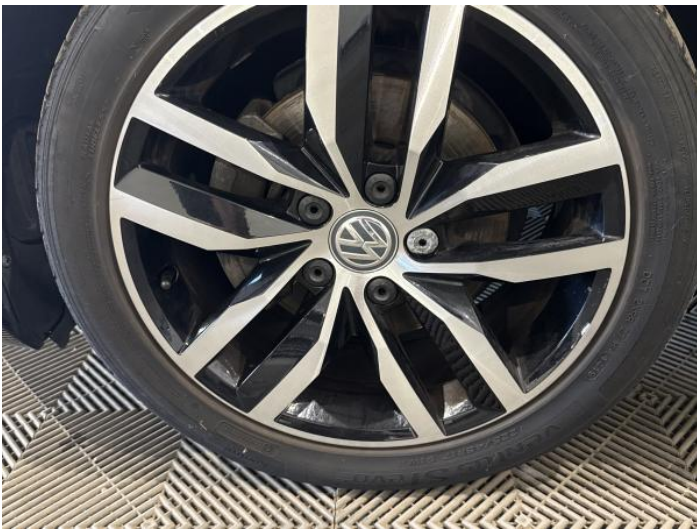
5: Wheel nsf
Scratched
Up To 50mm

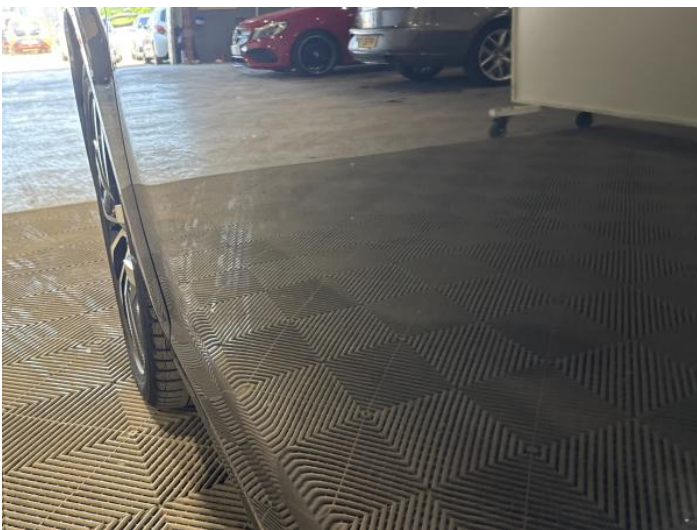
7: Door nsf
Dented
2 Or Less UpTo 10mm

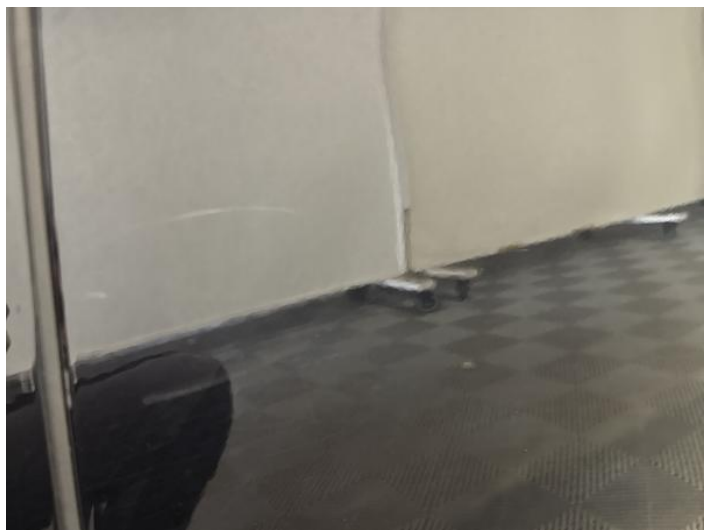
8: Door nsr
Scratched
Over 25mm Thru Paint

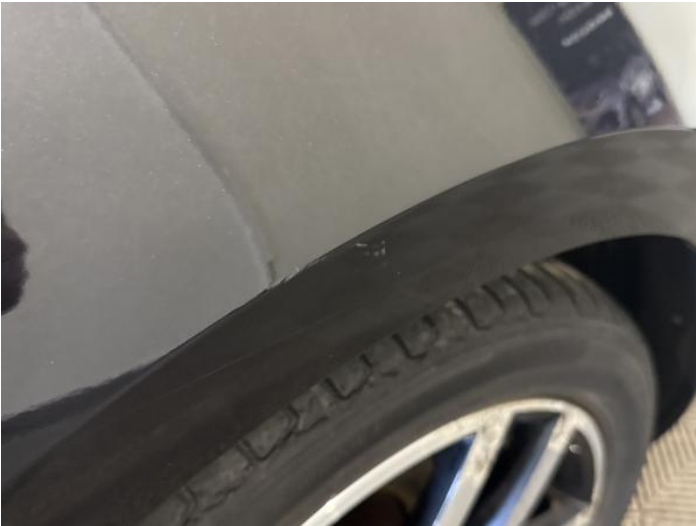
9: Qtr Panel nsr
Scratched
Over 25mm Thru Paint

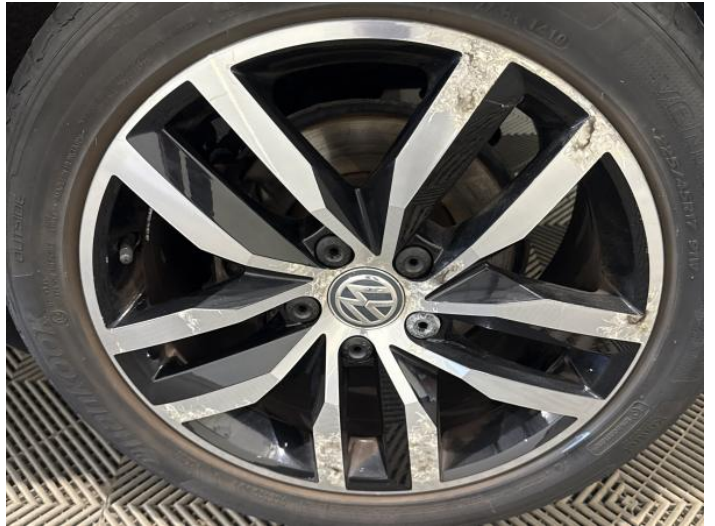
10: Wheel nsr
Scratched
Over 50mm

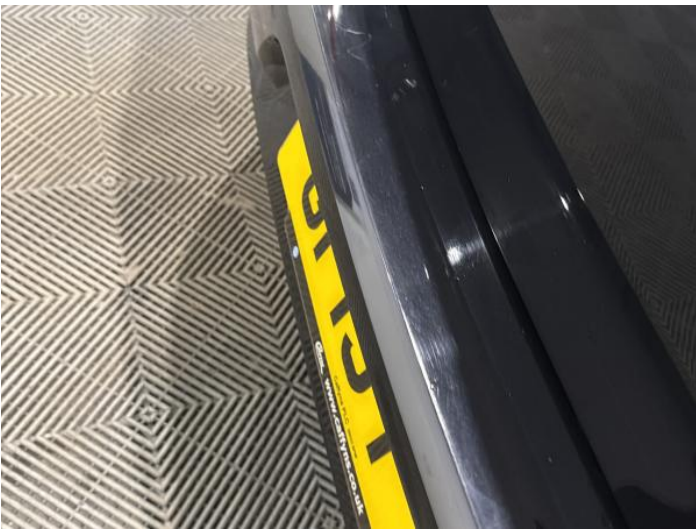
11: Bumper Rear
Scratched
25 to 100mm Thru Paint

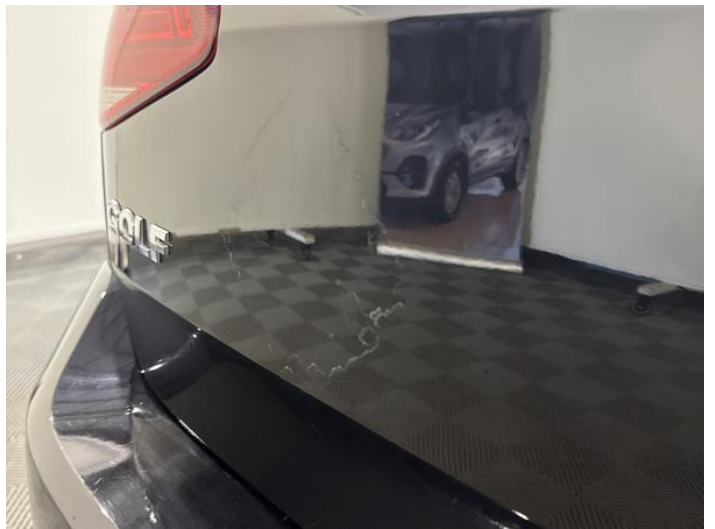
12: Tailgate
Scratched
Over 25mm Thru Paint

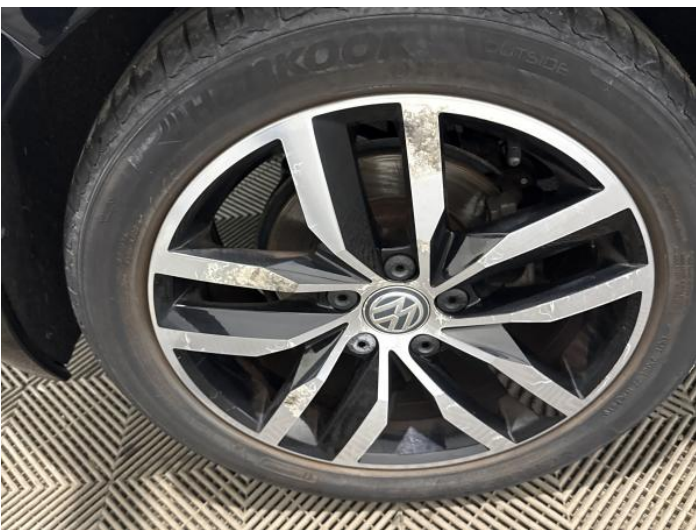
13: Wheel osr
Scratched
Over 50mm

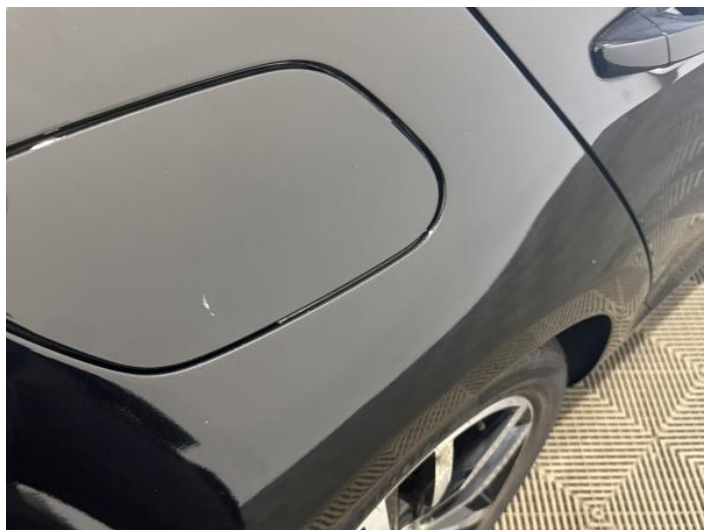
14: Qtr Panel osr
Scratched
UpTo 25mm Thru Paint

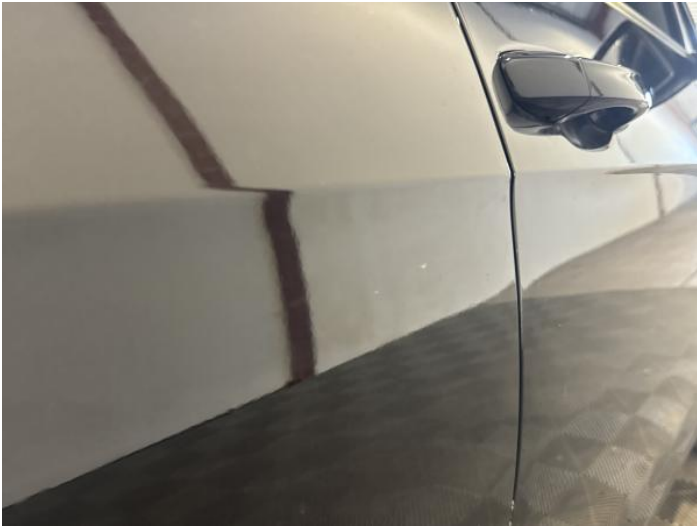
15: Door osr
Chipped
1 To 5

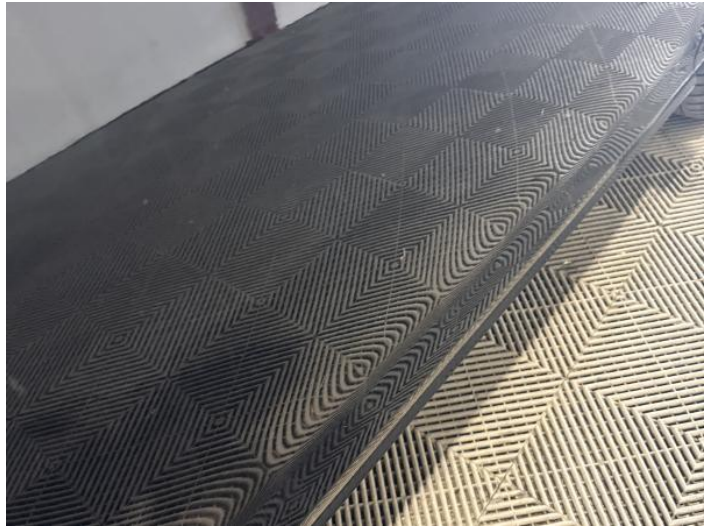
16: Door osf
Scratched
Over 25mm Thru Paint

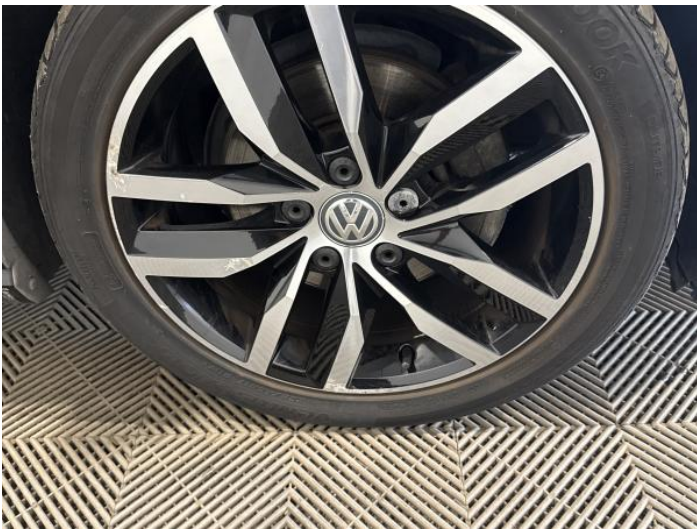
17: Wheel osf
Corroded
Light

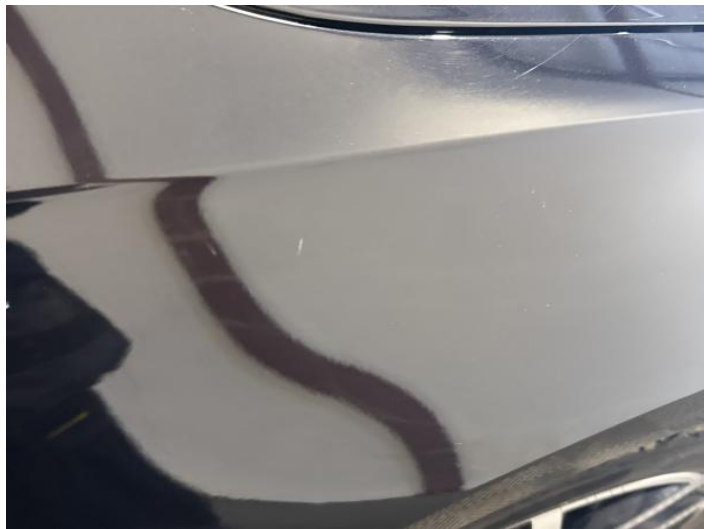
18: Wing osf
Chipped
1 To 5

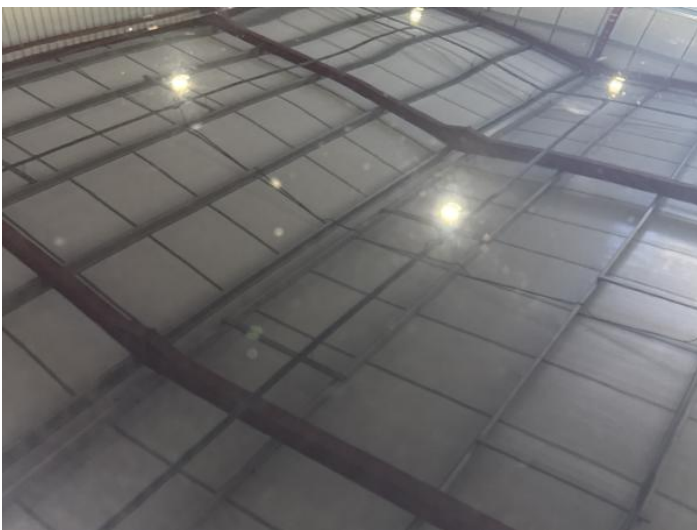
19: Roof
Dented
Over 30mm
