# **VEHICLE INSPECTION REPORT**

DS61SXK

## **BMW 3 Series 318d Exclusive Edition 5dr Step Auto**

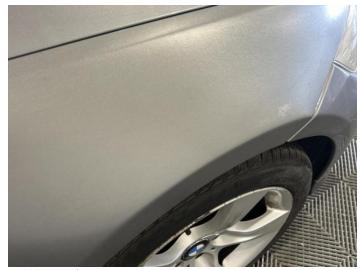
1: Wing osf Poor Previous Repair Poor Paint

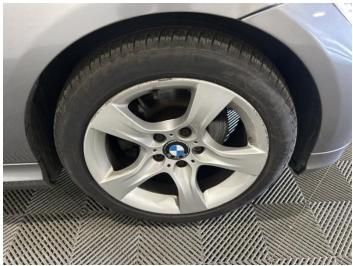
2: Wheel osf Scratched Over 50mm

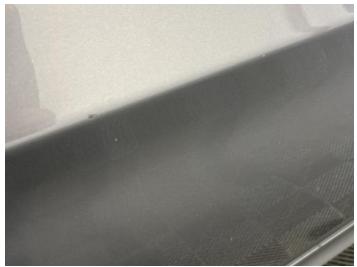
3: Door osf Chipped 1 To 5

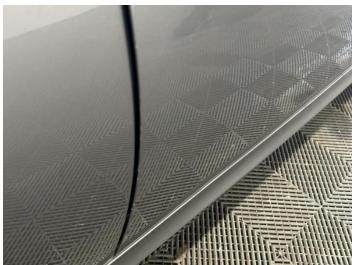
4: Door osf Chipped Edge Chip

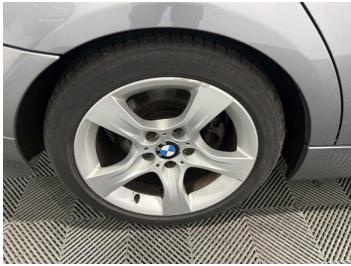
5: Wheel osr Scratched Over 50mm

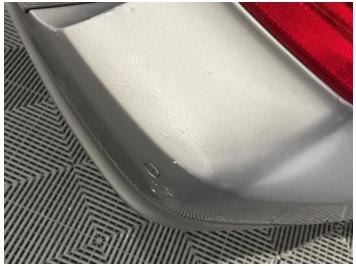
6: Bumper Rear Poor Previous Repair Paint Flake

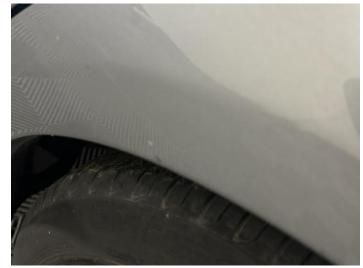
7: Qtr Panel nsr Scratched UpTo 25mm Not Thru Paint

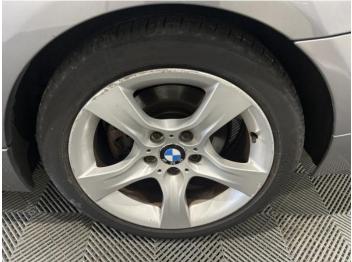
8: Wheel nsr Scratched Over 50mm

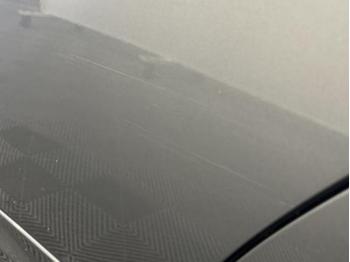
9: Door nsr Scratched Over 25mm Thru Paint

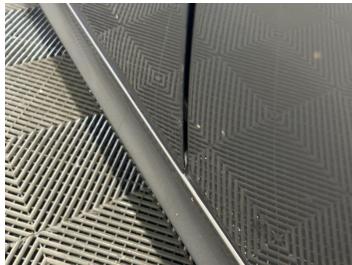
10: Door nsf Chipped Edge Chip

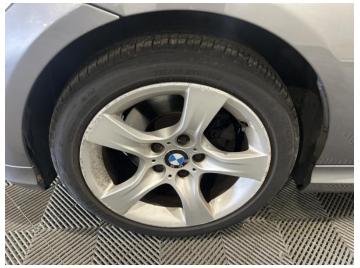
11: Wheel nsf Scratched Over 50mm

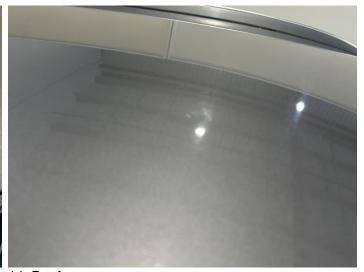
14: Roof Dented Between 10mm + 30mm
