VEHICLE INSPECTION REPORT

CV08AVF

Hyundai Coupe 2.0 SIII 3dr Auto

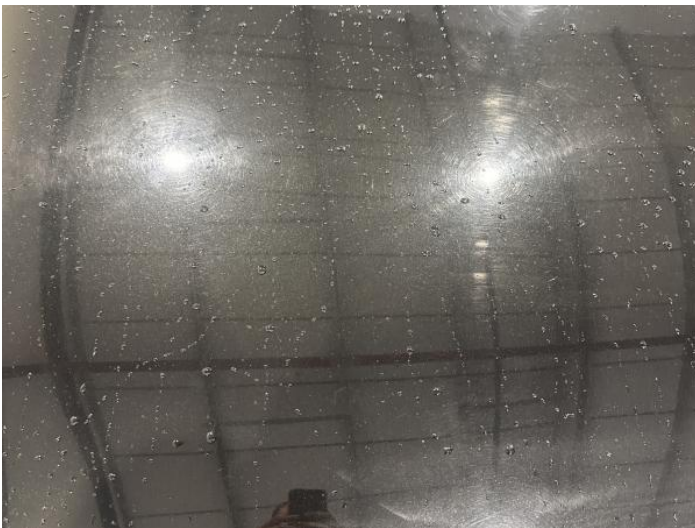
1: Bonnet
Poor Previous Repair
Poor Paint

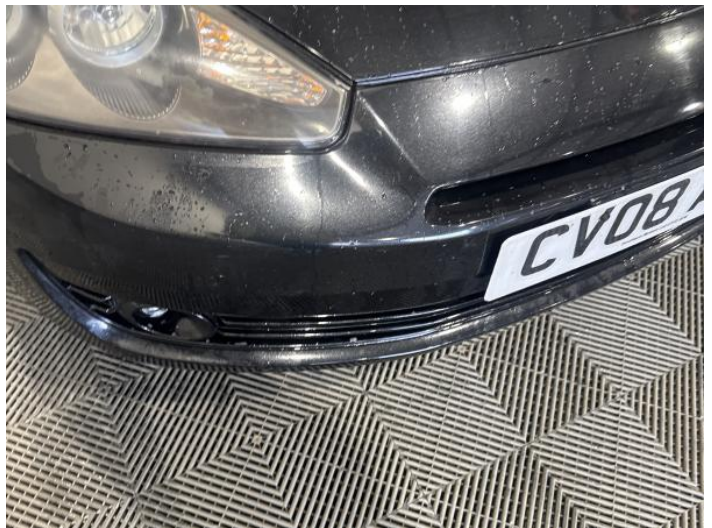
2: Bumper Front
Poor Previous Repair
Poor Paint

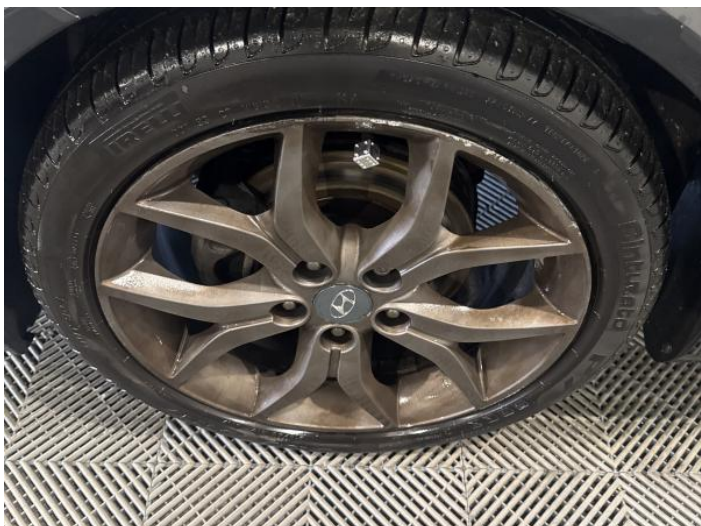
3: Wheel nsf
Scratched
Over 50mm

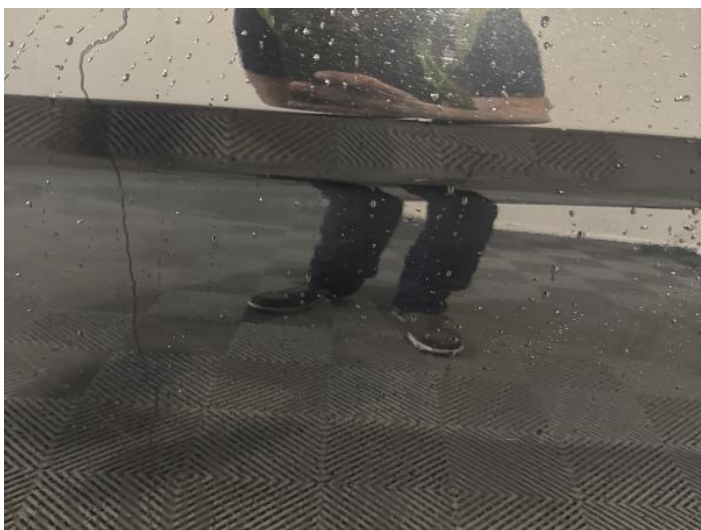
5: Door nsf
Chipped
1 To 5

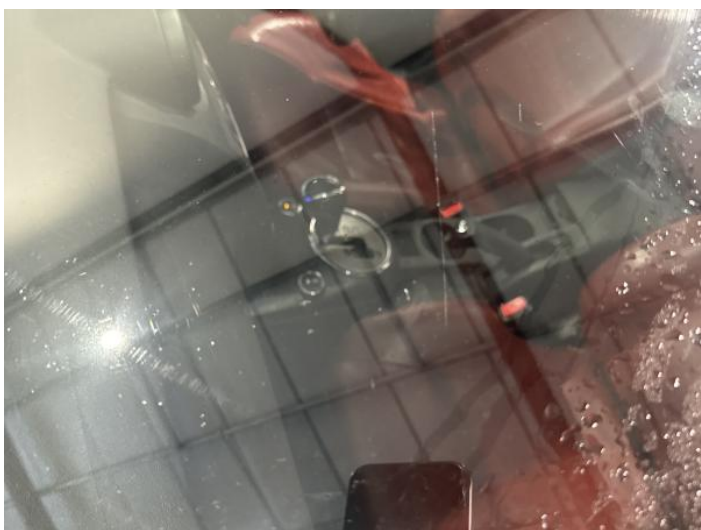
7: Screen Front
Chipped
UpTo 10mm

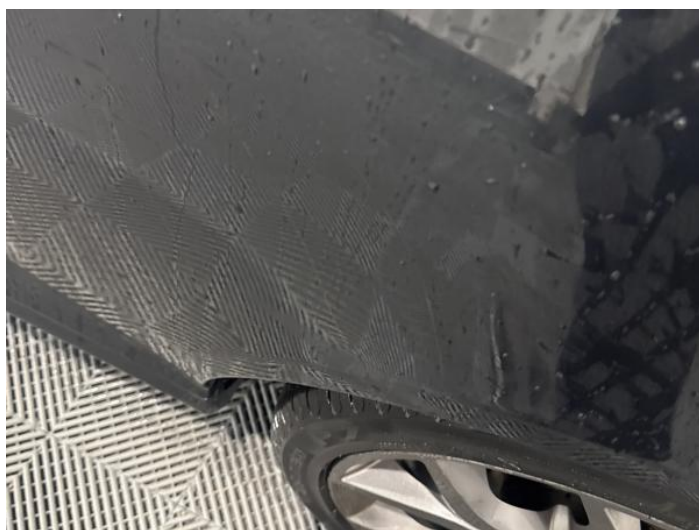
8: Qtr Panel nsr
Dented
With Paint Damage

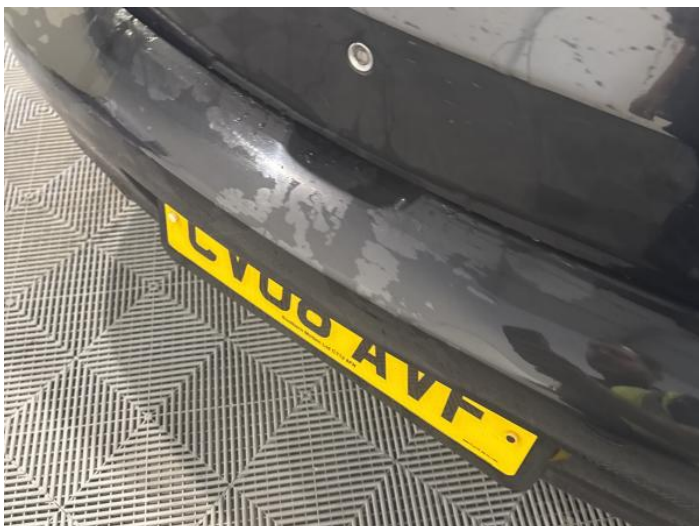
9: Bumper Rear
Scratched
25 to 100mm Thru Paint

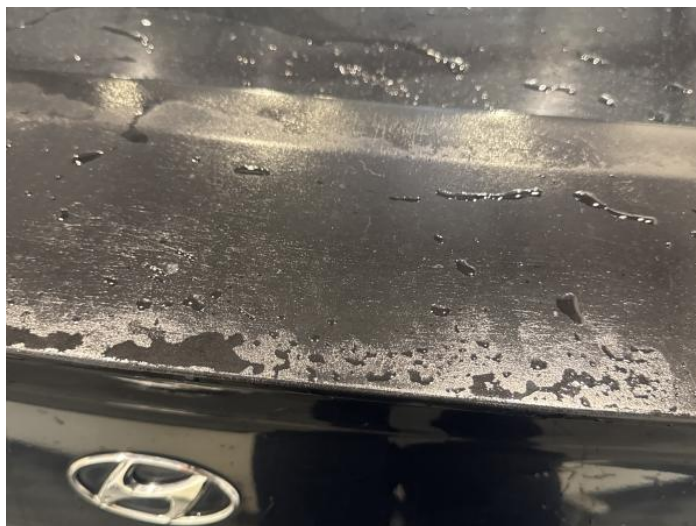
10: Boot Lid
Poor Previous Repair
Poor Paint

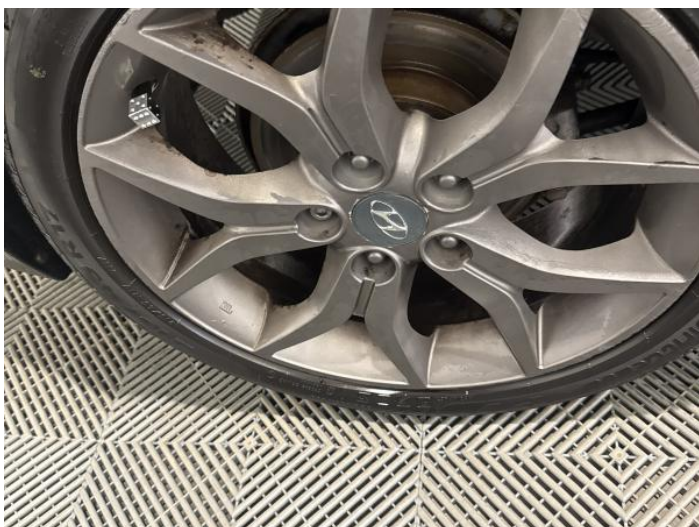
11: Wheel osr
Scratched
Over 50mm

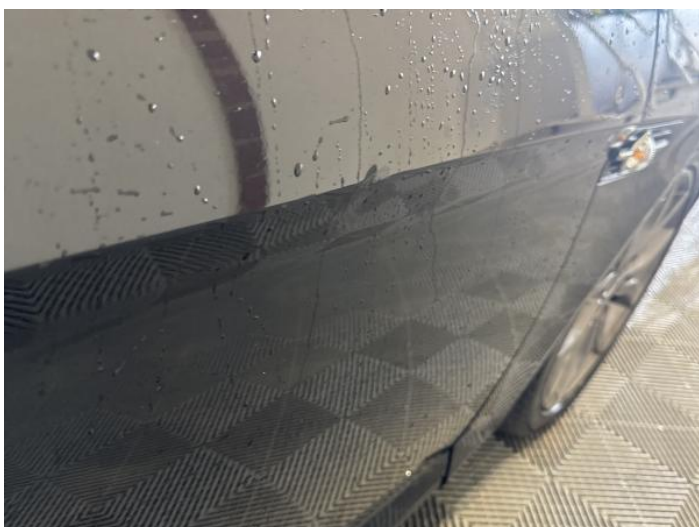
13: Door osf
Dented
Over 2 UpTo 10mm

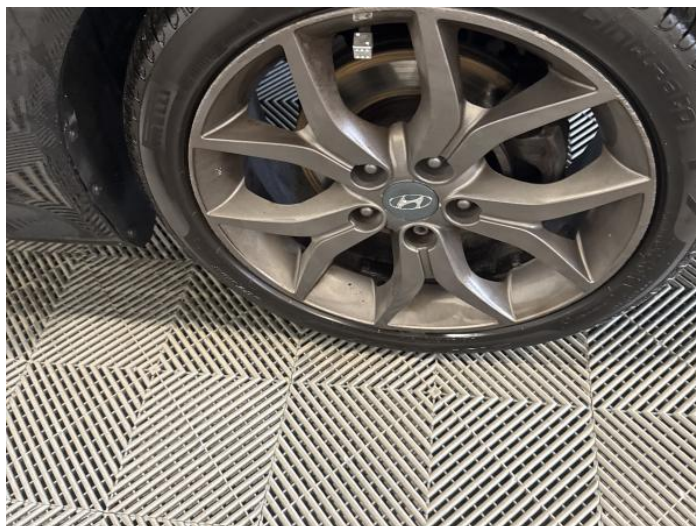
15: Wing osf
Scratched
Over 25mm Not Thru Paint
