VEHICLE INSPECTION REPORT

GU60EEG

Ford Focus 1.8 Zetec 5dr

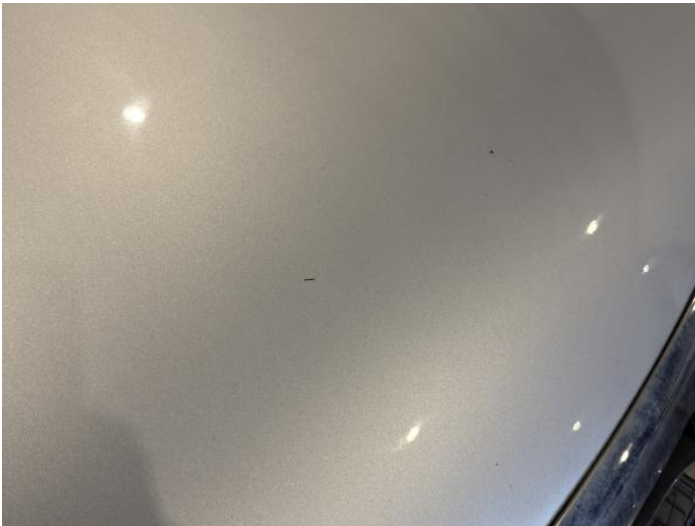
1: Bonnet
Chipped
Multiple Chips

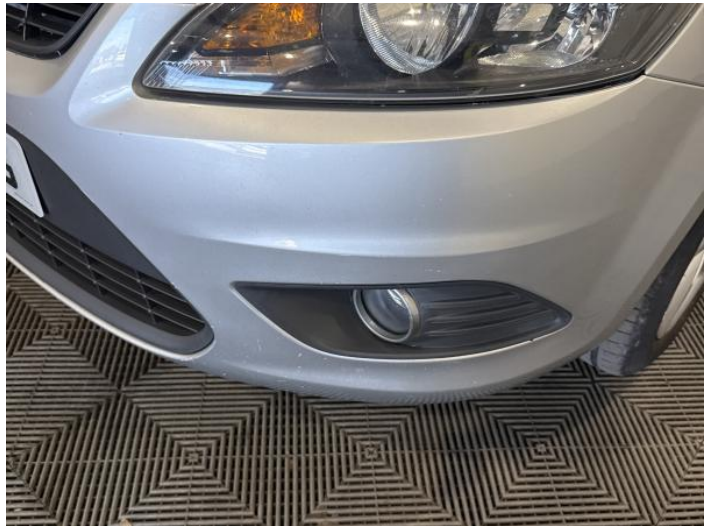
2: Bumper Front
Scratched
25 to 100mm Thru Paint

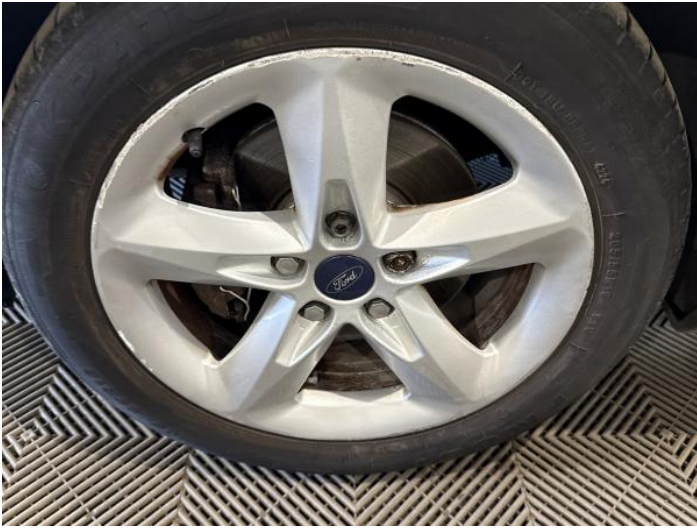
3: Wheel nsf
Scratched
Over 50mm

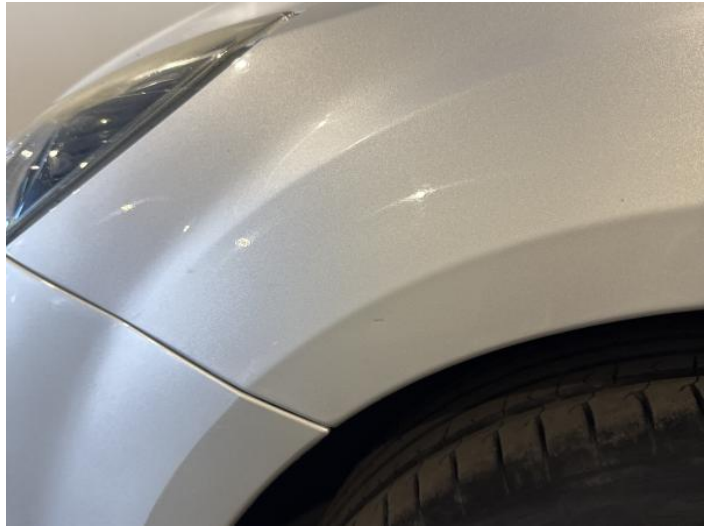
4: Wing nsf
Chipped
1 To 5

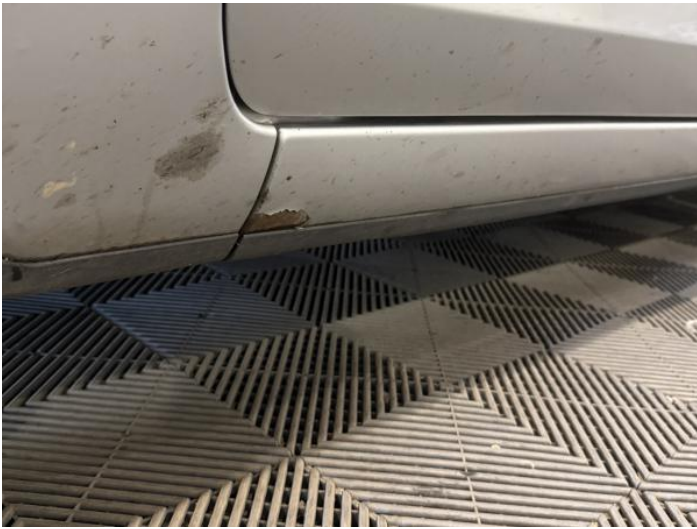
5: Sill ns
Rusted
Over 5mm

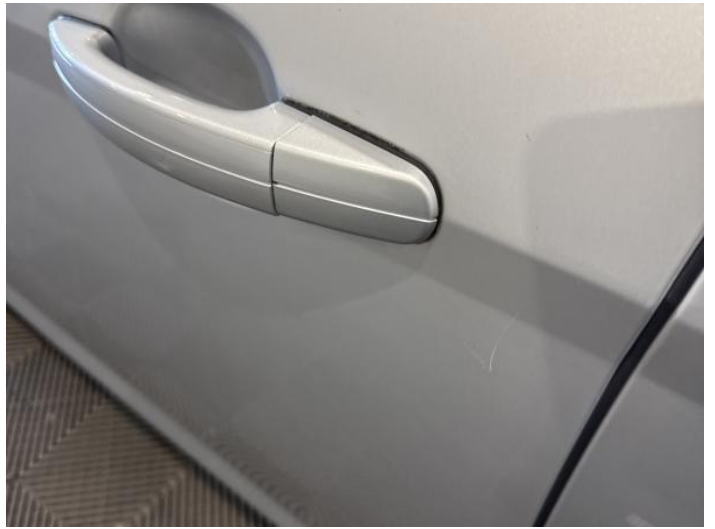
6: Door nsf
Scratched
Over 25mm Thru Paint

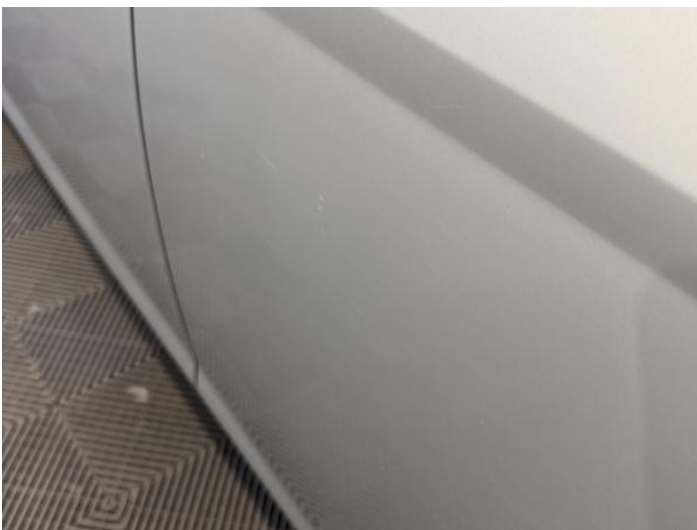
7: Door nsr
Scratched
Over 25mm Thru Paint

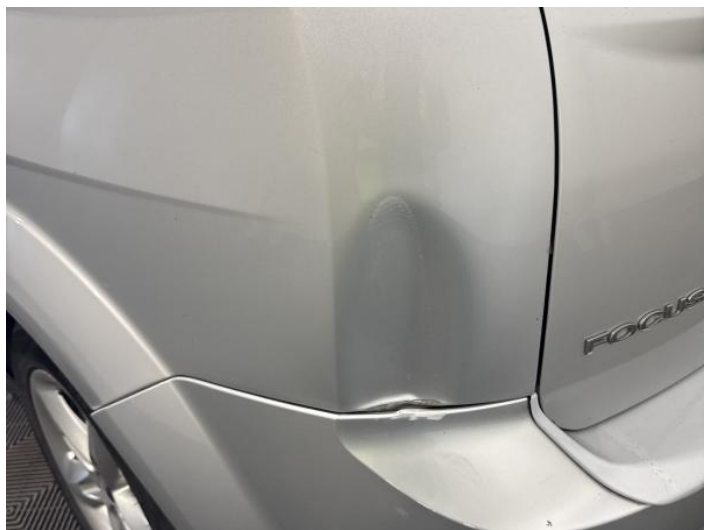
8: Qtr Panel nsr
Dented
With Paint Damage

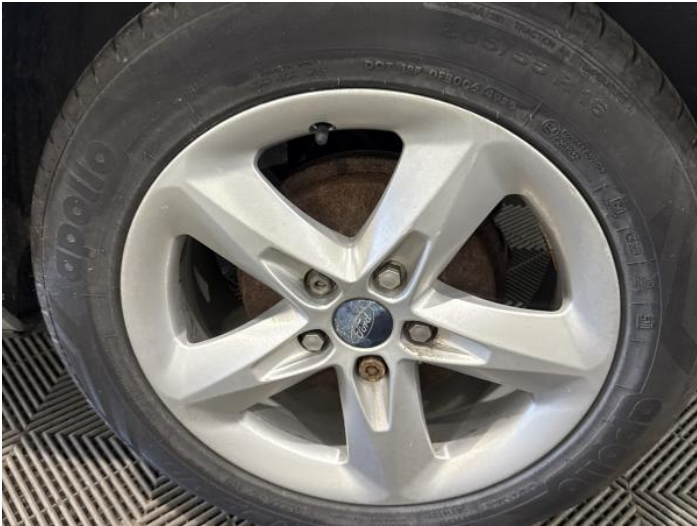
9: Wheel nsr
Scratched
Over 50mm

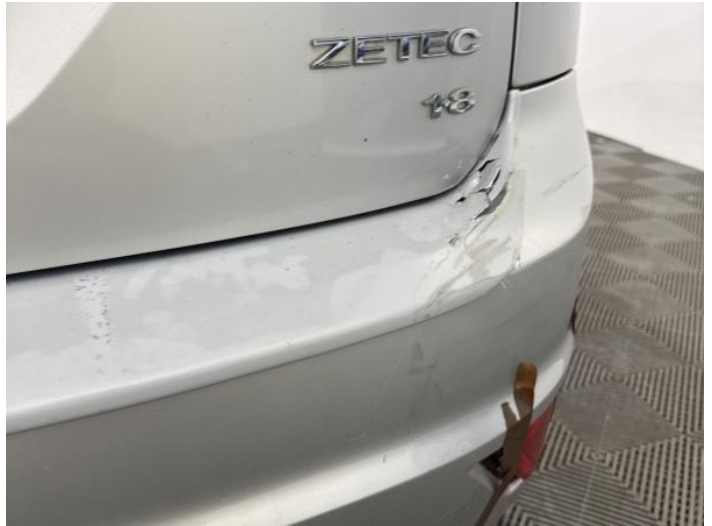
10: Bumper Rear
Cracked
Over 25mm

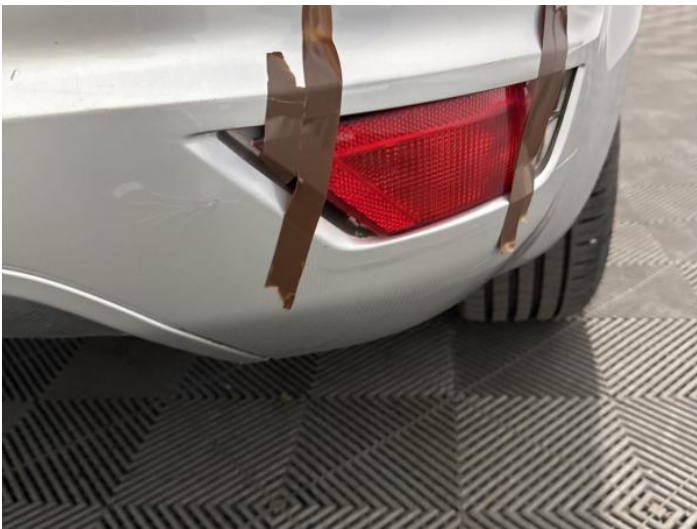
11: Bumper Reflector osr
Broken
Replace

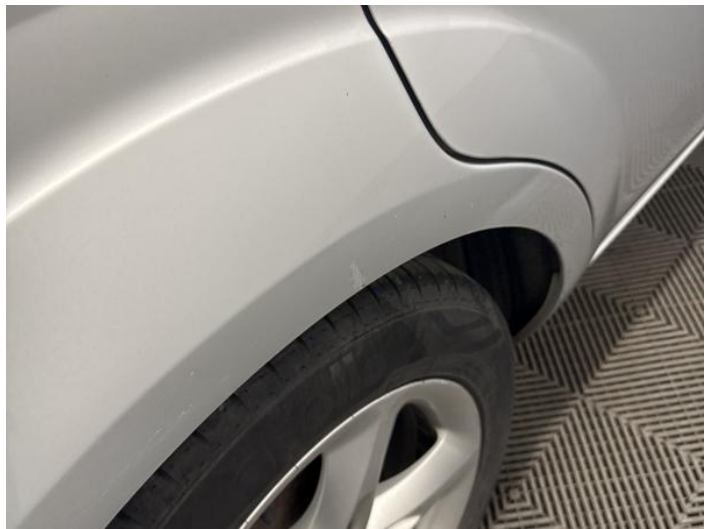
12: Qtr Panel osr
Dented
With Paint Damage

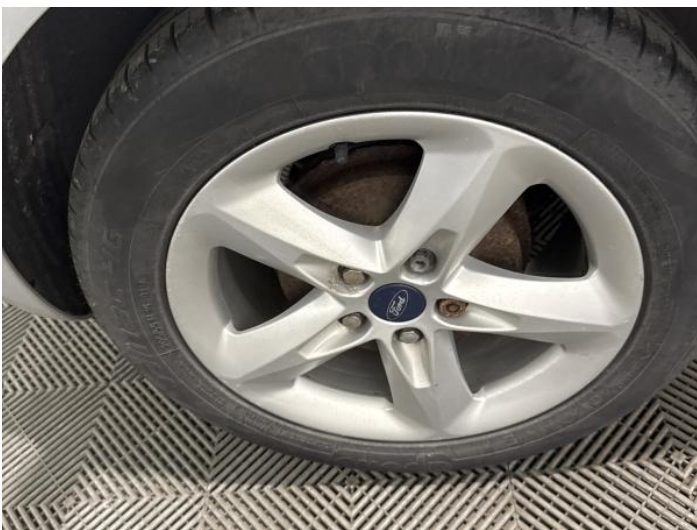
13: Wheel osr
Scratched
Over 50mm

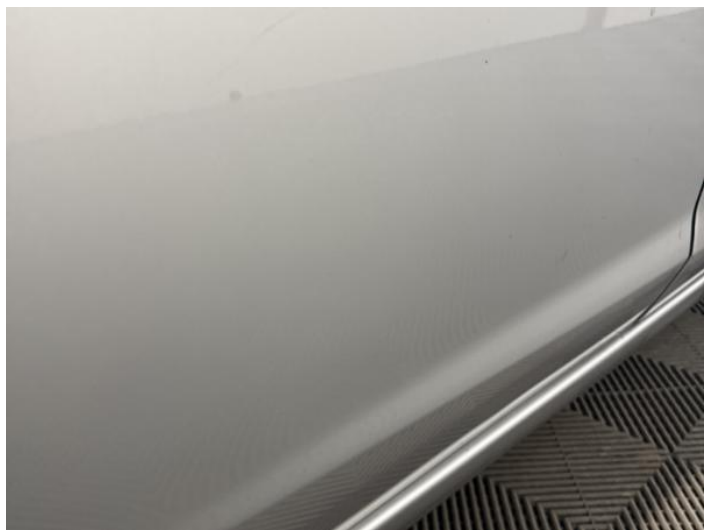
14: Door osr
Scratched
UpTo 25mm Thru Paint

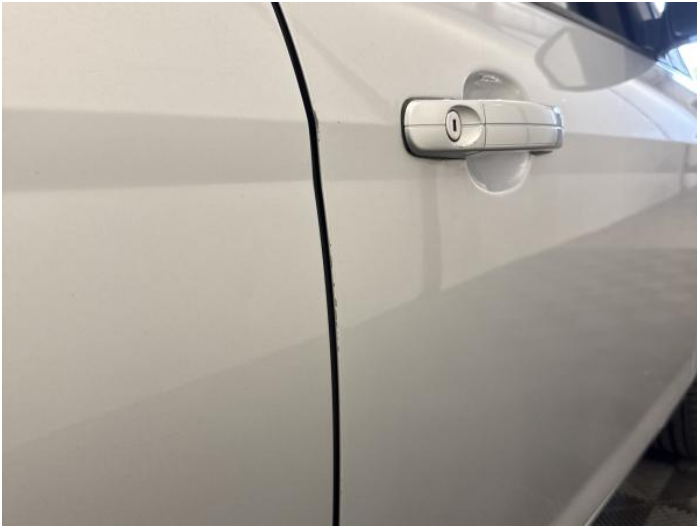
15: Door osf
Chipped
Edge Chip

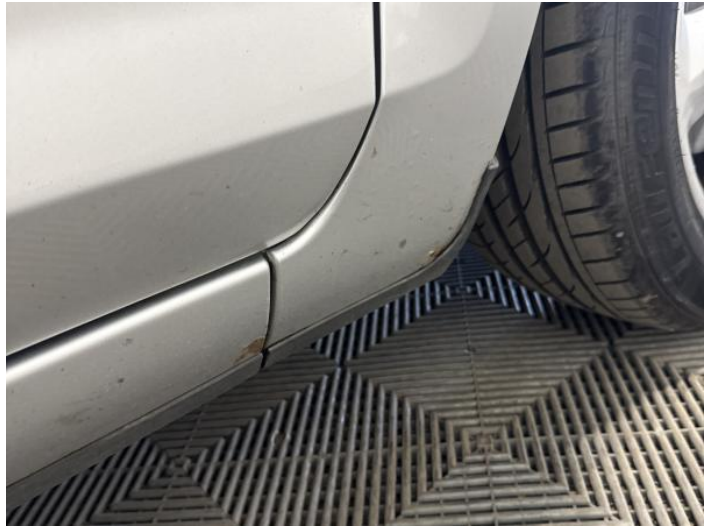
16: Sill os
Rusted
Over 5mm

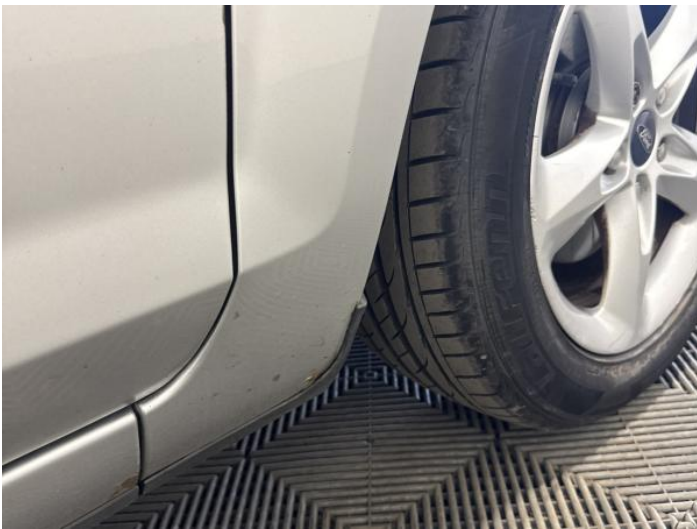
17: Wing osf
Rusted
Over 5mm

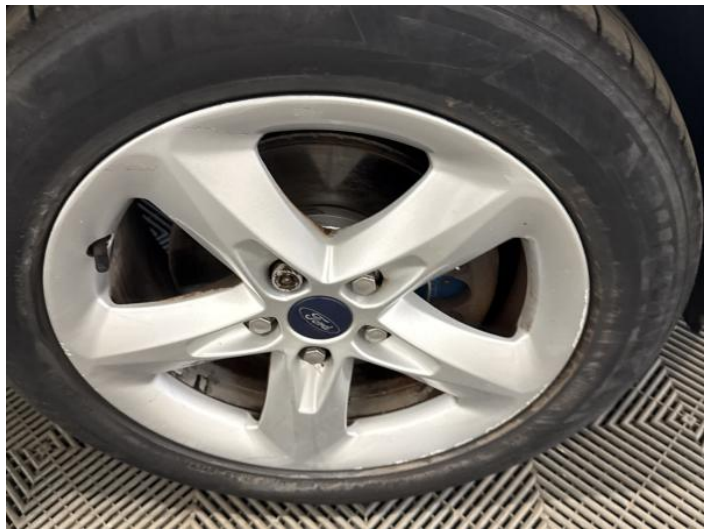
18: Wheel osf
Scratched
Over 50mm
