VEHICLE INSPECTION REPORT

LD61XAX

Land Rover Range Rover Evoque 2.2 SD4 Dynamic 5dr Auto

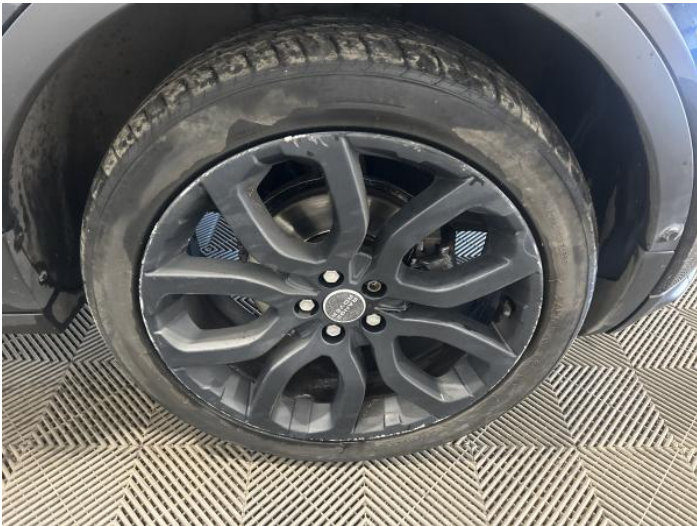
1: Wheel osf
Scratched
Over 50mm

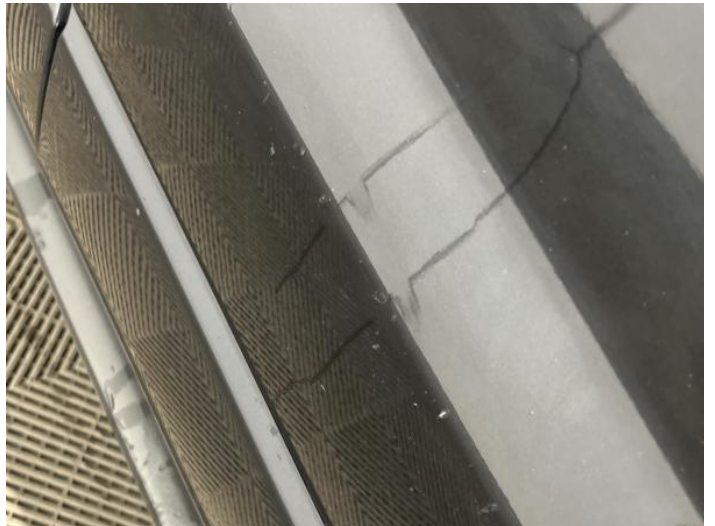
2: Door osf
Chipped
Multiple Chips

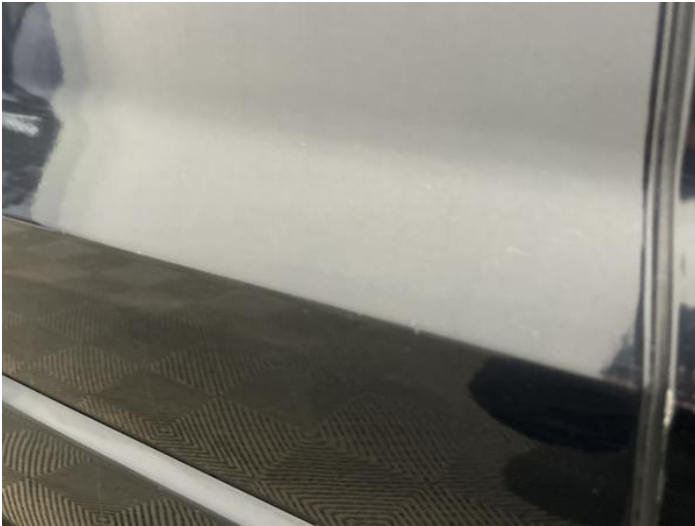
3: Door osr
Chipped
1 To 5

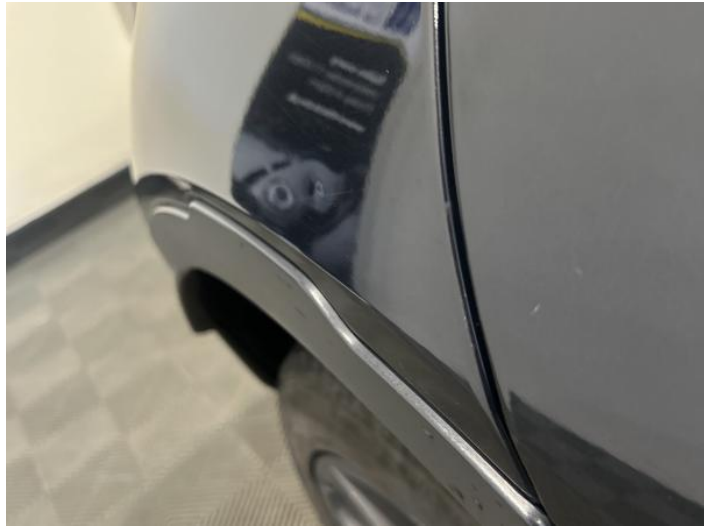
4: Qtr Panel osr
Dented
2 Or Less UpTo 10mm

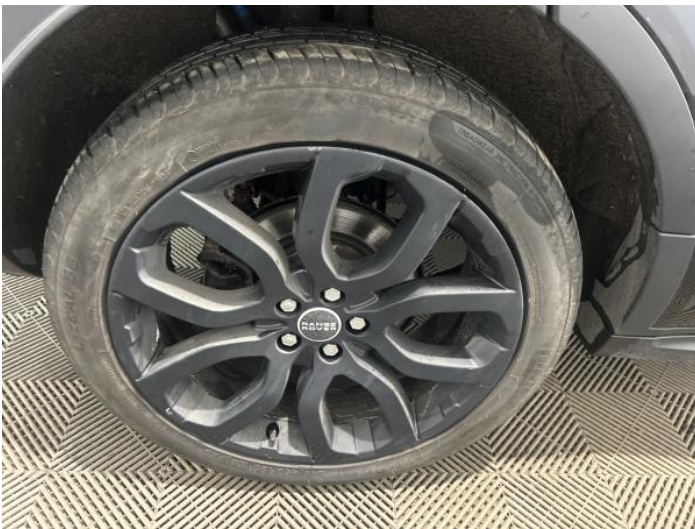
5: Wheel osr
Scratched
Up To 50mm

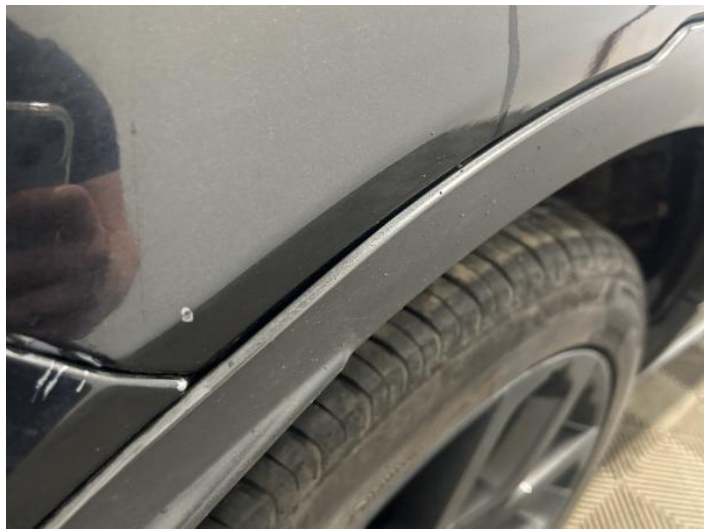
6: Qtr Panel osr
Chipped
1 To 5

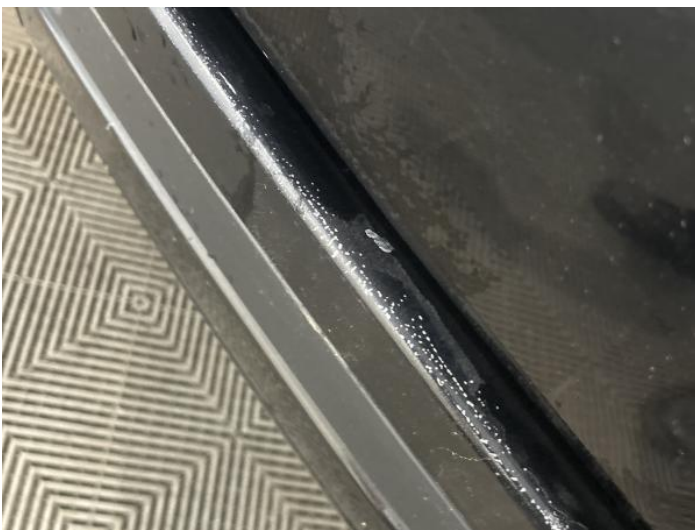
7: Bumper Rear
Poor Previous Repair
Paint Flake

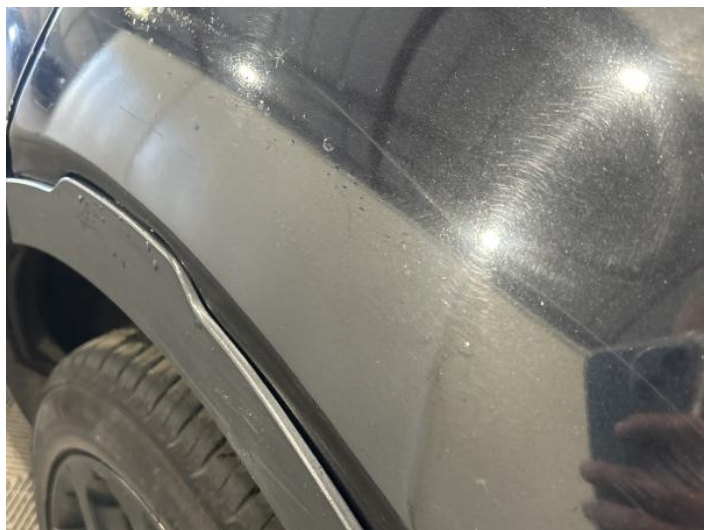
8: Qtr Panel nsr
Poor Previous Repair
Poor Paint

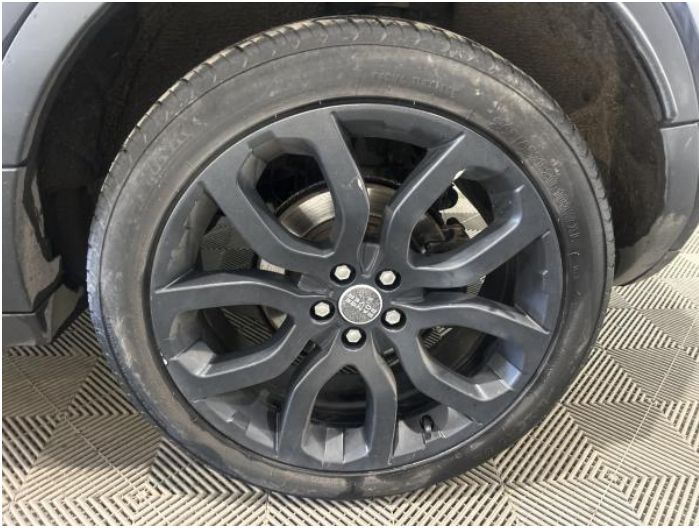
9: Wheel nsr
Scratched
Up To 50mm

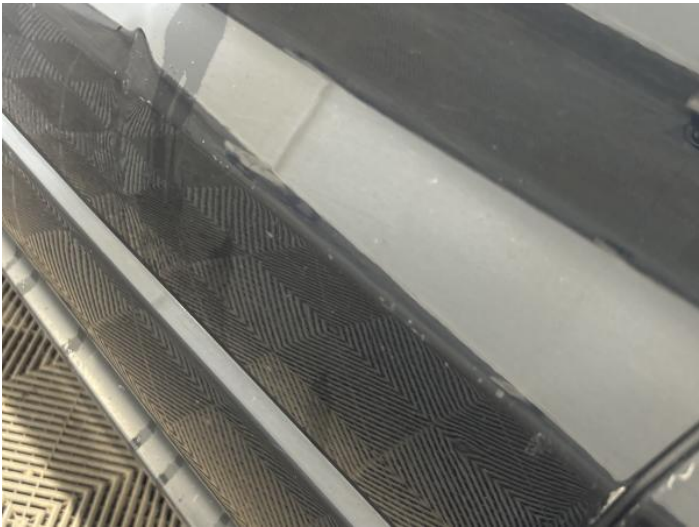
11: Door nsf
Chipped
Multiple Chips

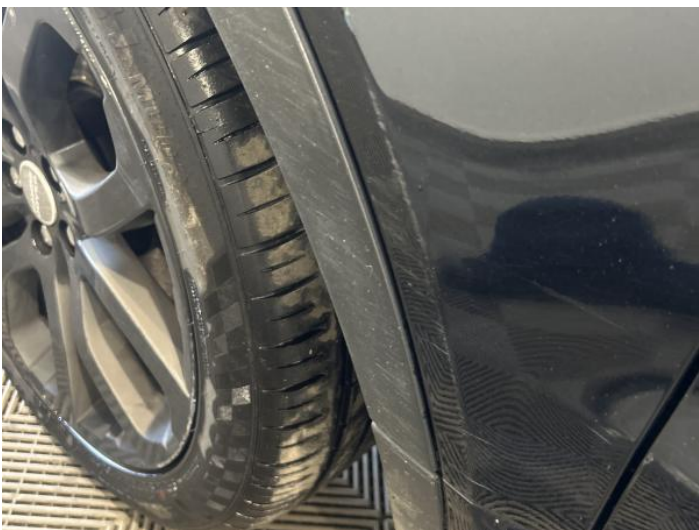
13: Wing nsf
Scratched
Over 25mm Thru Paint

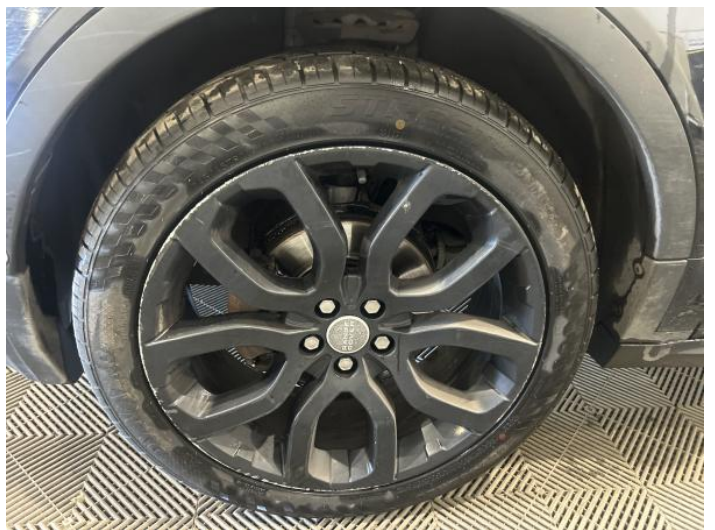
14: Wheel nsf
Scratched
Over 50mm

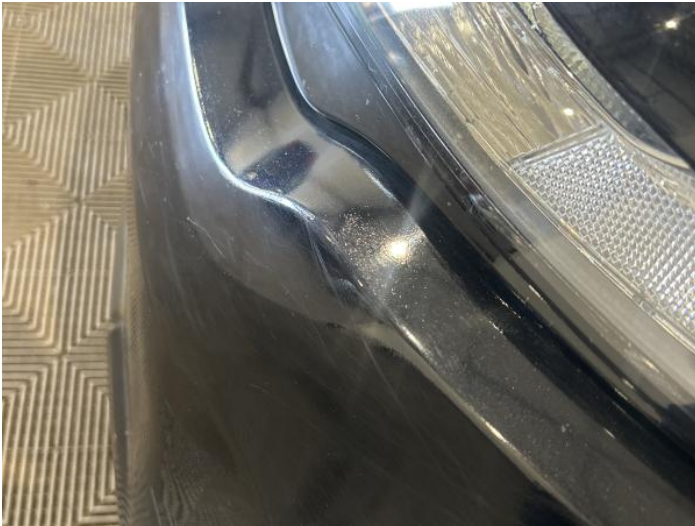
15: Bumper Front
Poor Previous Repair
Poor Paint

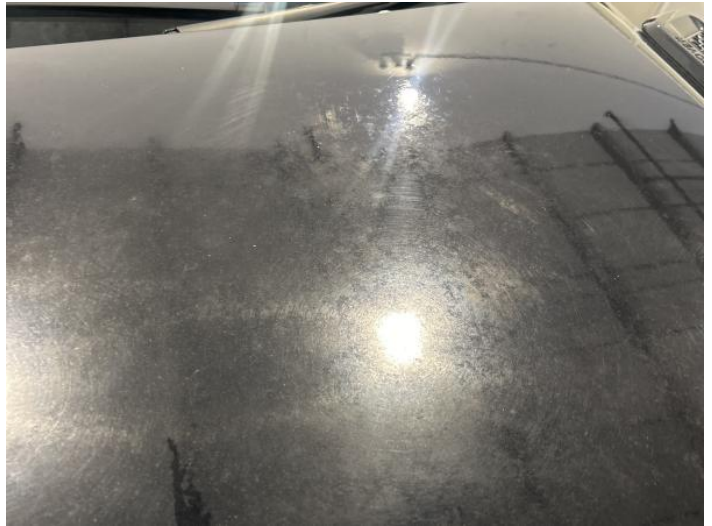
16: Bonnet
Poor Previous Repair
Poor Paint

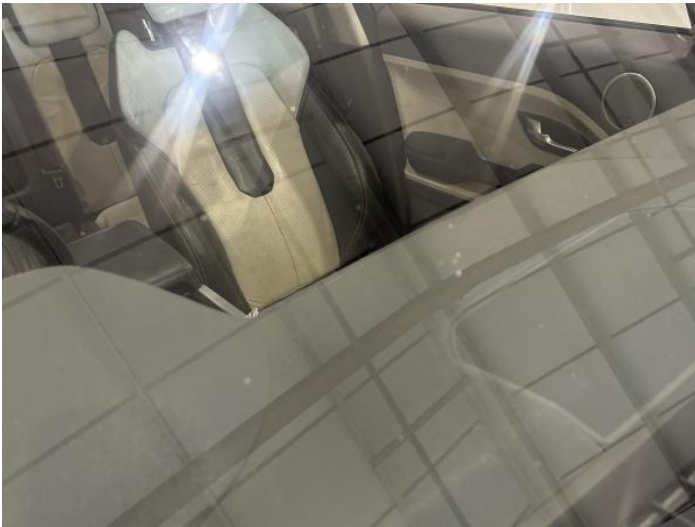
17: Screen Front
Chipped
Up To 10mm

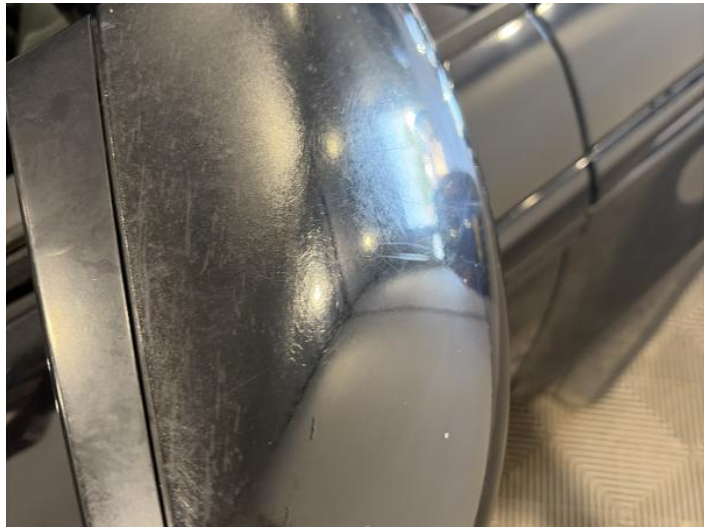
18: Door Moulding of
Scratched (Painted)
Over 25mm Thru Paint
