VEHICLE INSPECTION REPORT

LC120VS

Ford Focus 1.6 TDCi 115 Zetec 5dr

nama
GRADE
4

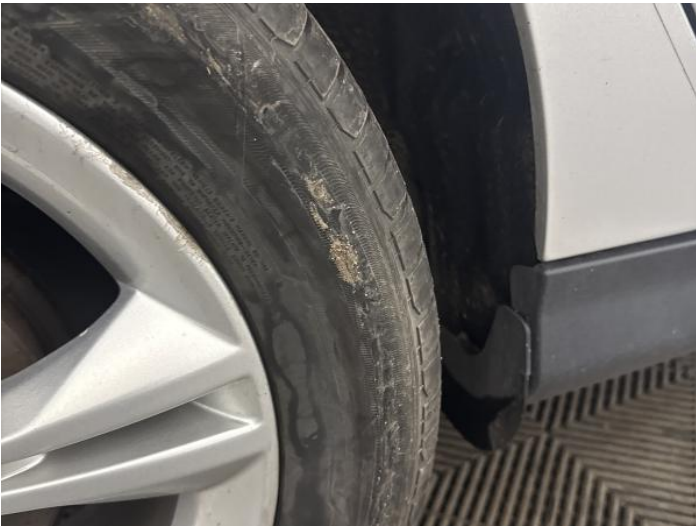
1: Tyre osr
Damaged
Replace

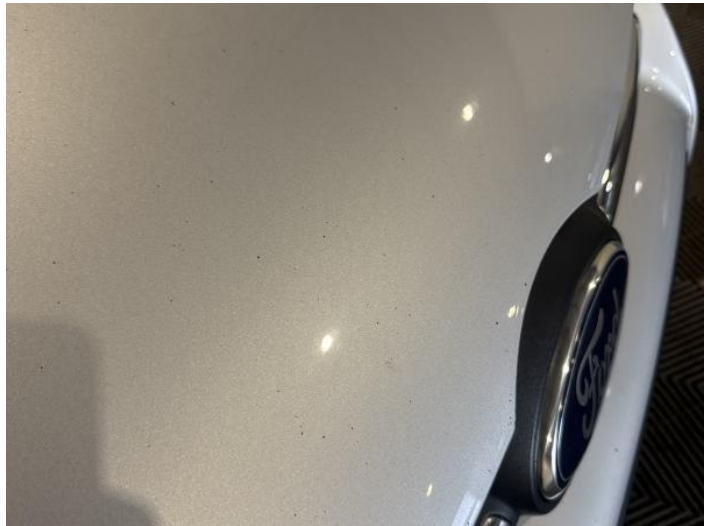
2: Bonnet
Chipped
Multiple Chips

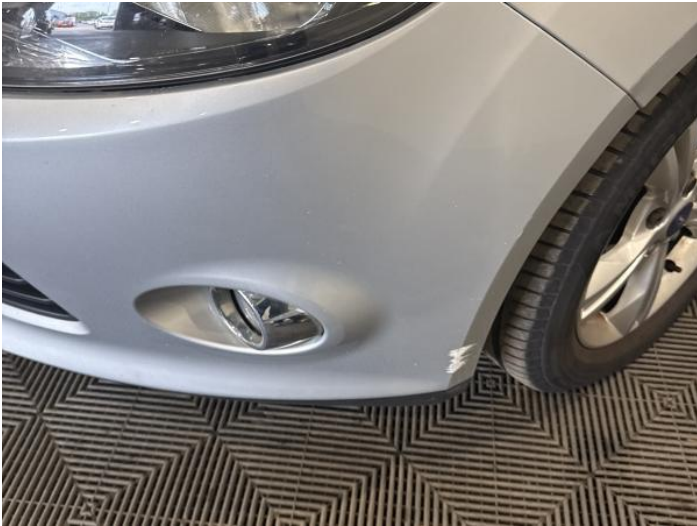
3: Bumper Front
Scratched
25 to 100mm Thru Paint

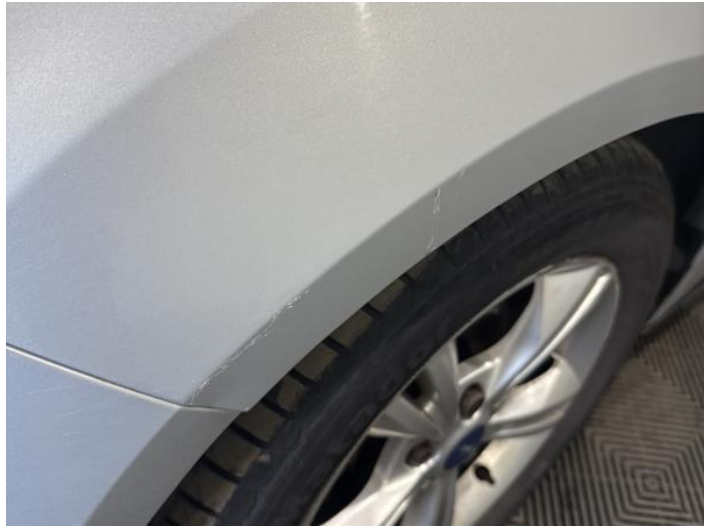
4: Wing nsf
Scratched
Over 25mm Thru Paint

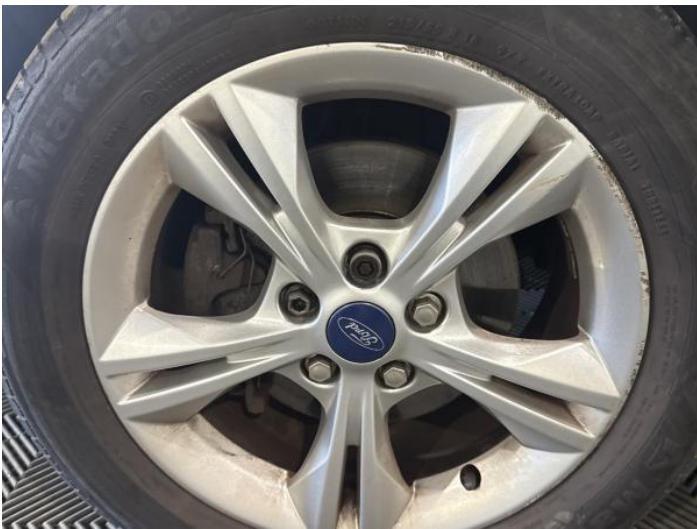
5: Wheel nsf
Scratched
Over 50mm

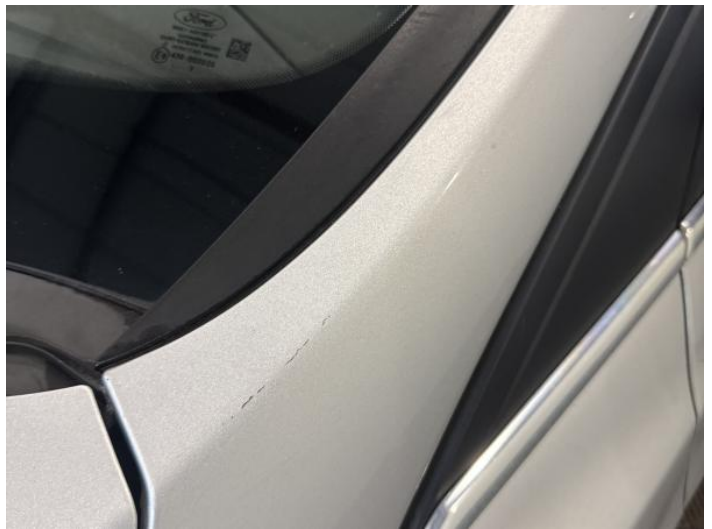
6: A Post ns
Scratched
UpTo 25mm Thru Paint

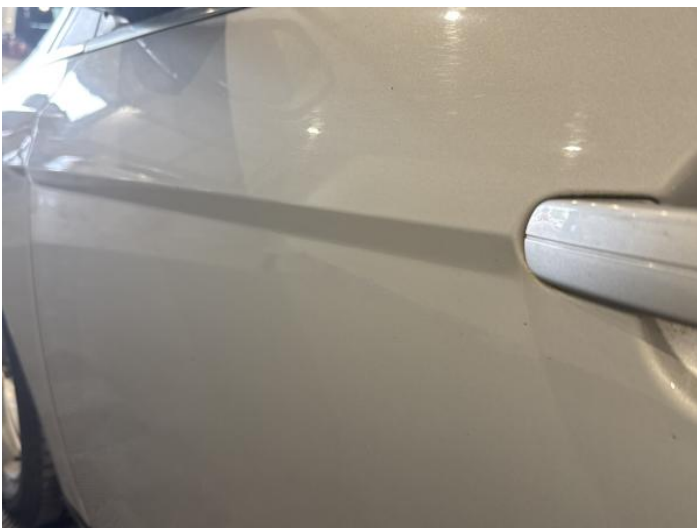
7: Door nsf
Dented
Between 10mm + 30mm

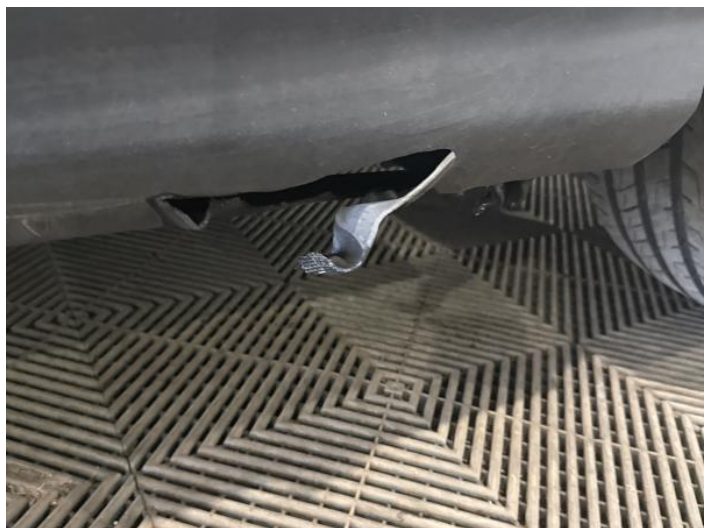
8: Sill Panel Trim ns
Broken
Replace

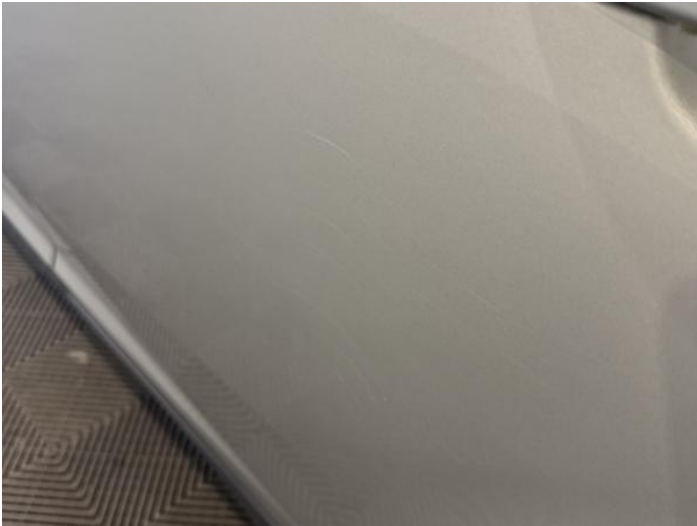
9: Door nsr
Scratched
Over 25mm Thru Paint

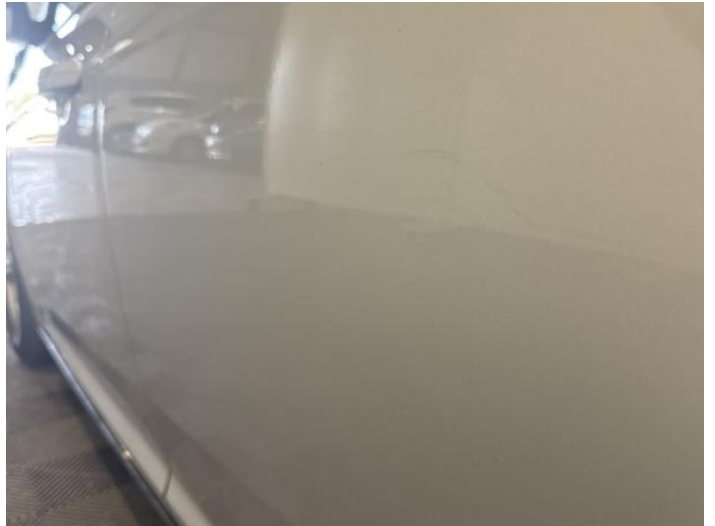
10: Door nsr
Dented
Between 10mm + 30mm

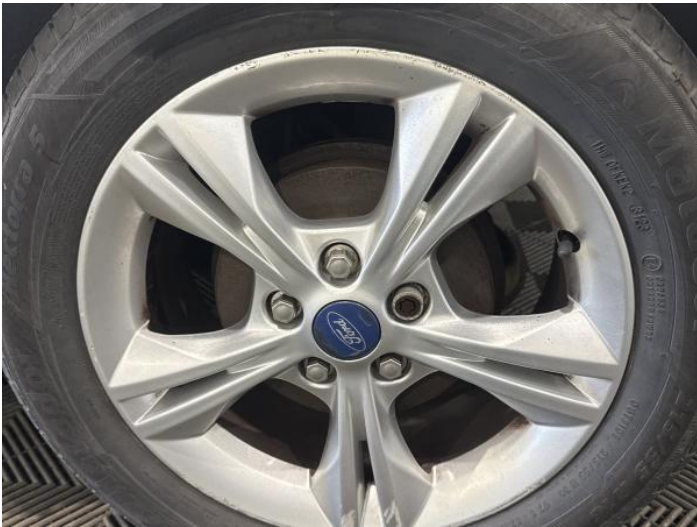
11: Wheel osr
Scratched
Over 50mm

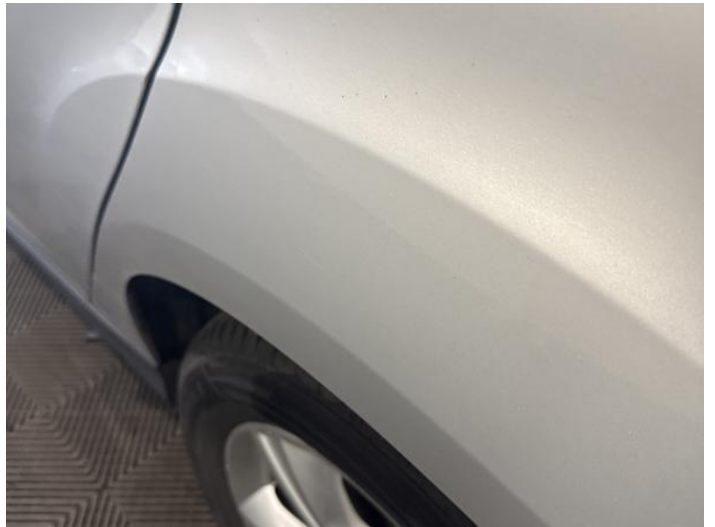
12: Qtr Panel osr
Scratched
UpTo 25mm Thru Paint

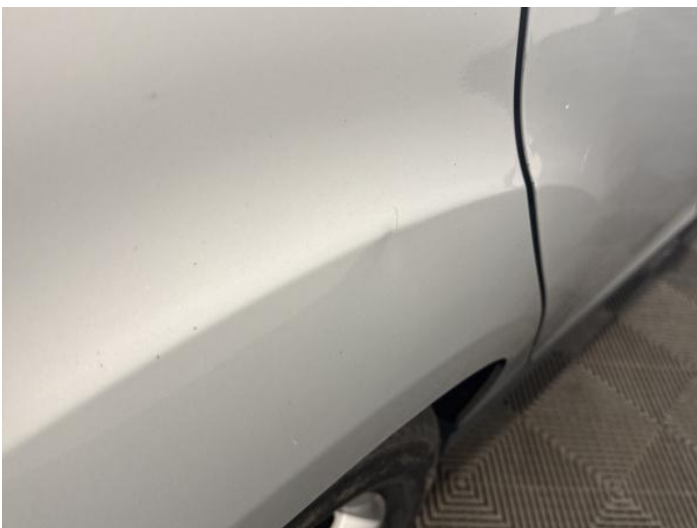
13: Qtr Panel osr
Dented
Between 10mm + 30mm

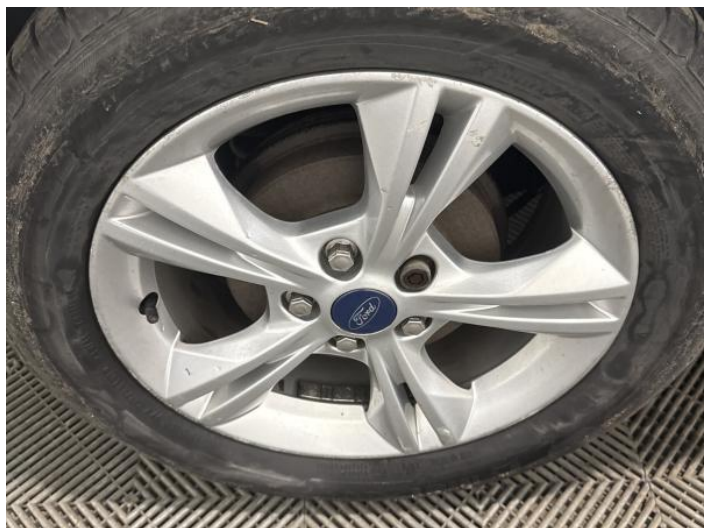
14: Wheel osr
Scratched
Over 50mm

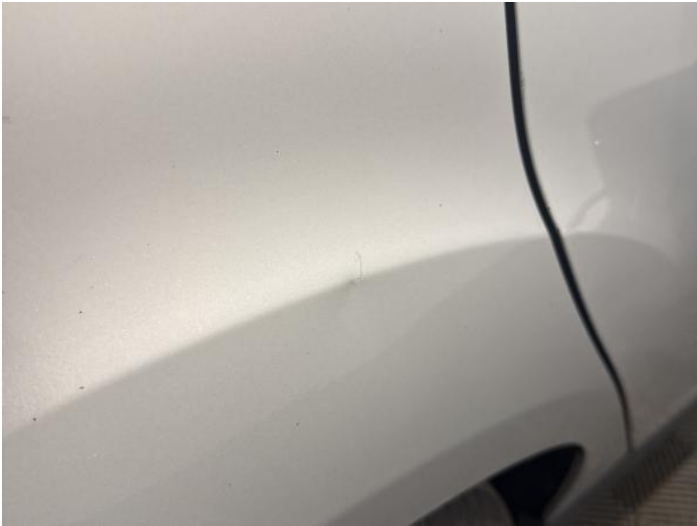
15: Qtr Panel osr
Scratched
Over 25mm Thru Paint

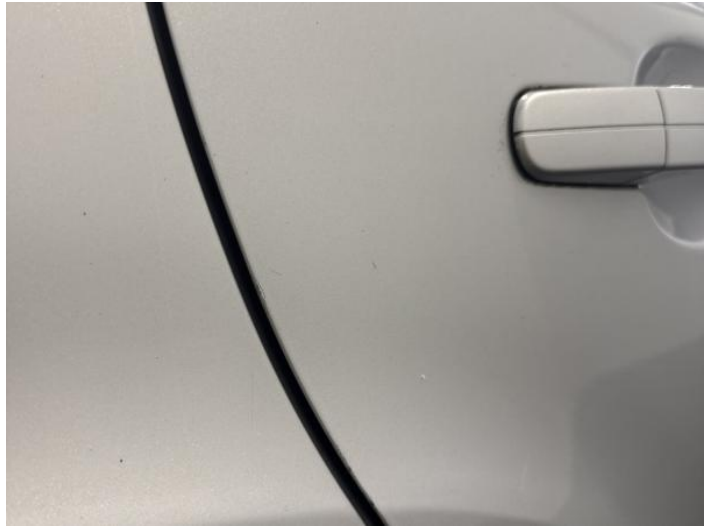
16: Door osr
Scratched
Over 25mm Thru Paint

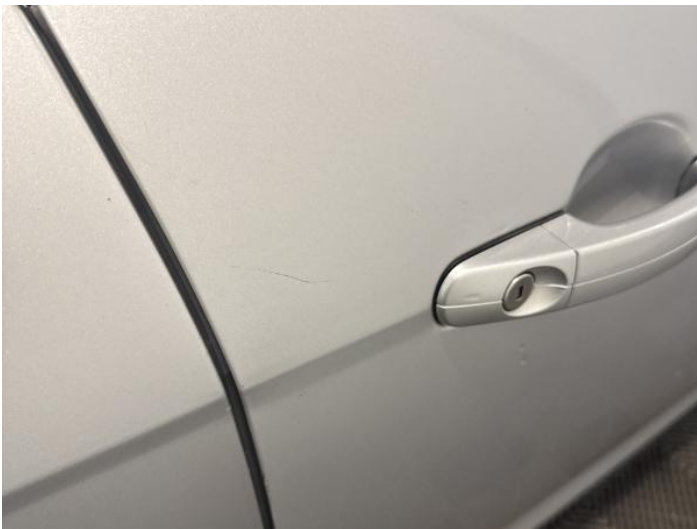
17: Door osf
Scratched
UpTo 25mm Thru Paint

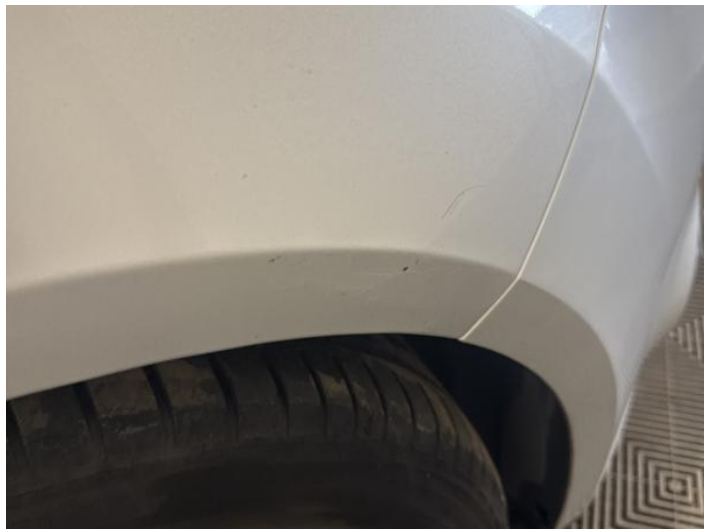
18: Wing osf
Scratched
Over 25mm Thru Paint

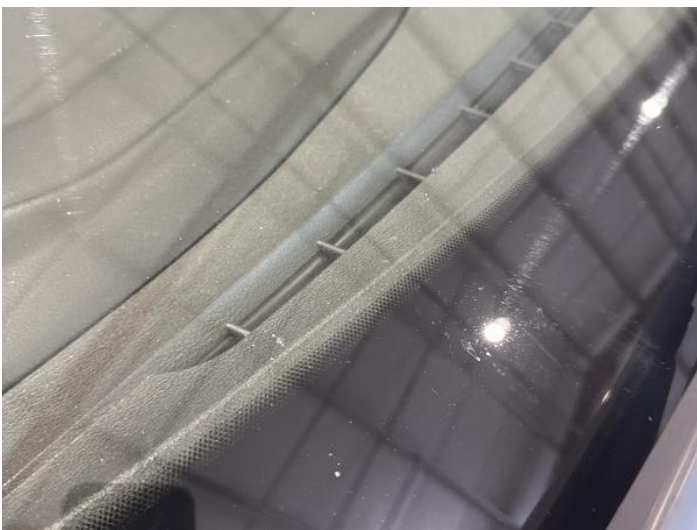
19: Screen Front
Chipped
UpTo 10mm
