# VEHICLE INSPECTION REPORT

**DV67VNP**

## Vauxhall Astra 1.4i 16V Design 5dr

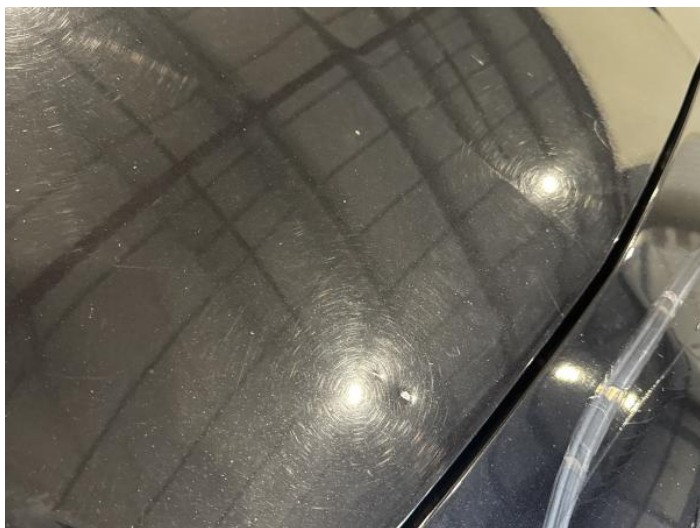
1: Bonnet  
Dented  
With Paint Damage

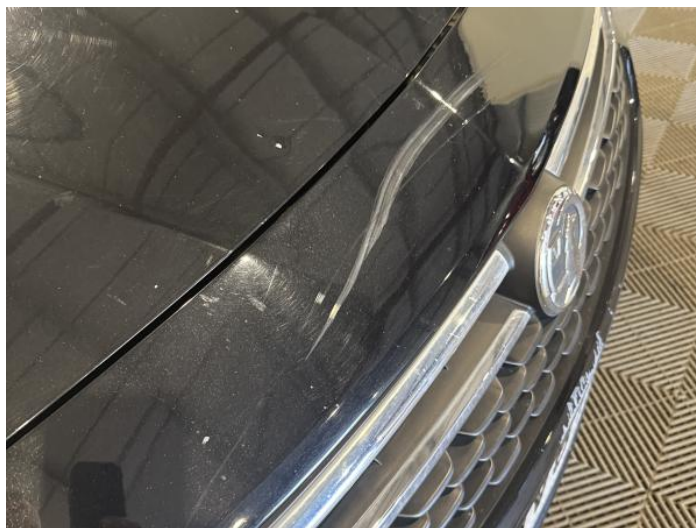
2: Bumper Front  
Dented  
With Paint Damage

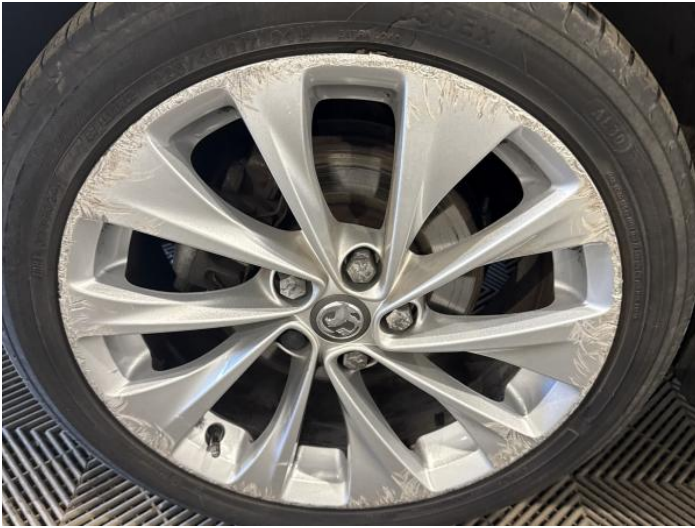
3: Wheel nsf  
Scratched  
Over 50mm

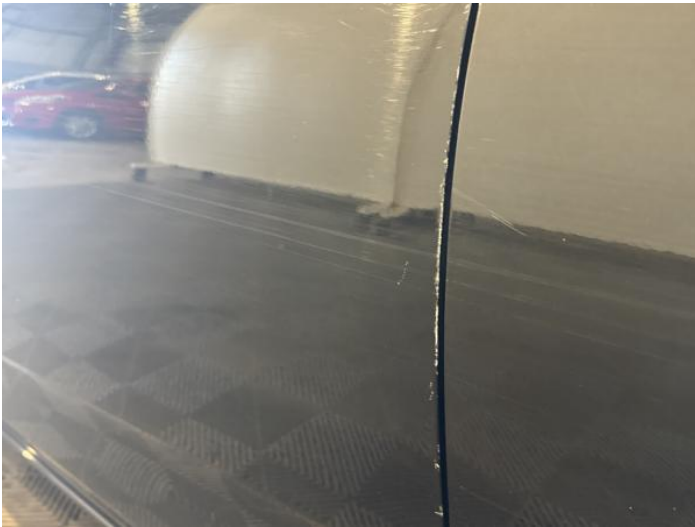
5: Door nsf  
Chipped  
Edge Chip

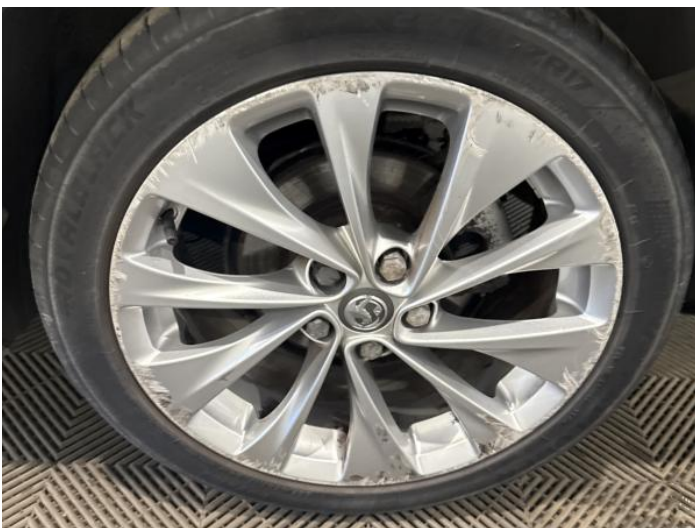
7: Wheel nsr  
Scratched  
Over 50mm

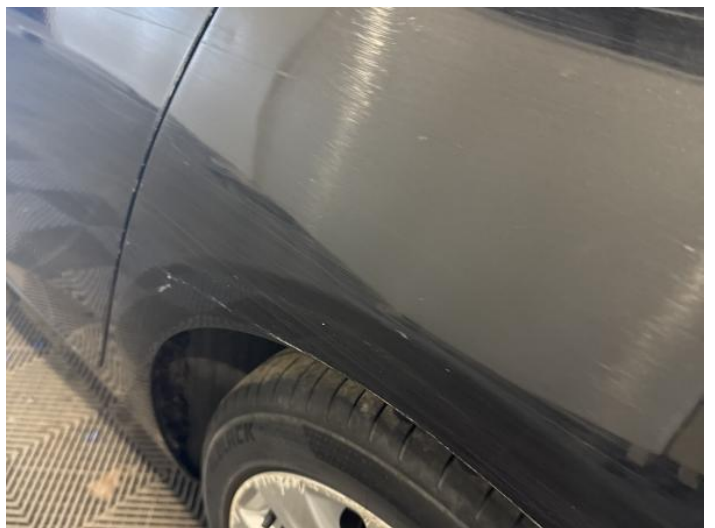
8: Qtr Panel nsr  
Dented  
With Paint Damage

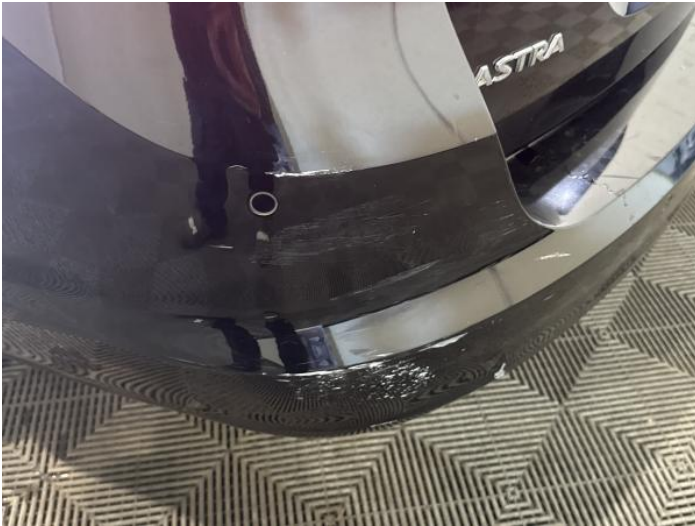
9: Bumper Rear  
Scratched  
Over 100mm Thru Paint

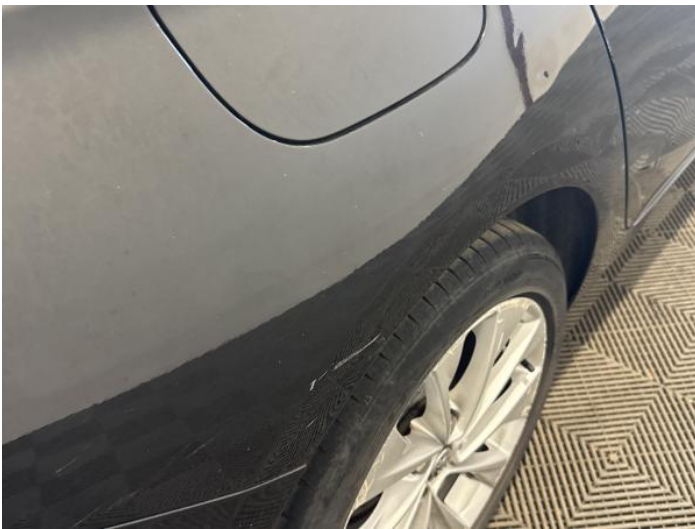
11: Qtr Panel osr  
Dented  
With Paint Damage

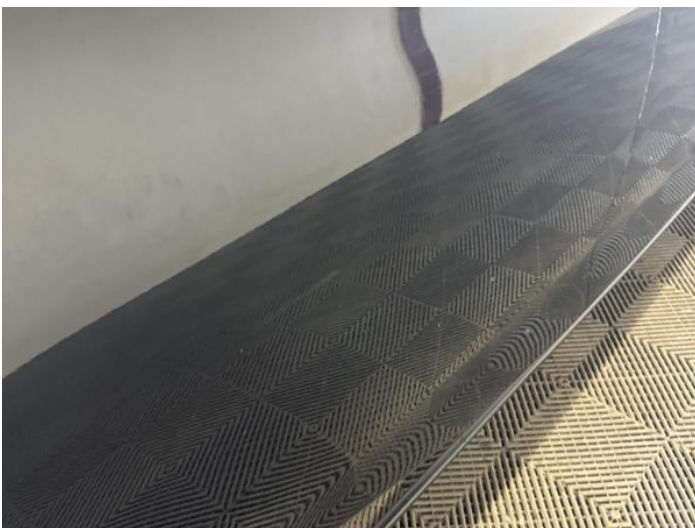
13: Door osr  
Scratched  
Over 25mm Thru Paint

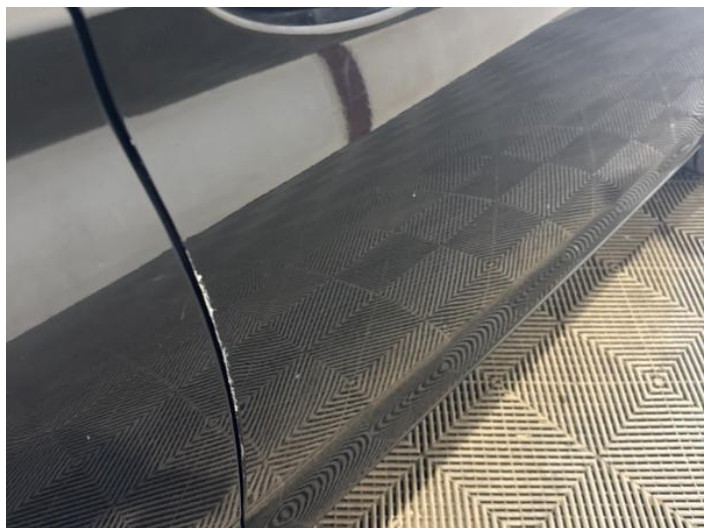
14: Door osf  
Dented  
With Paint Damage

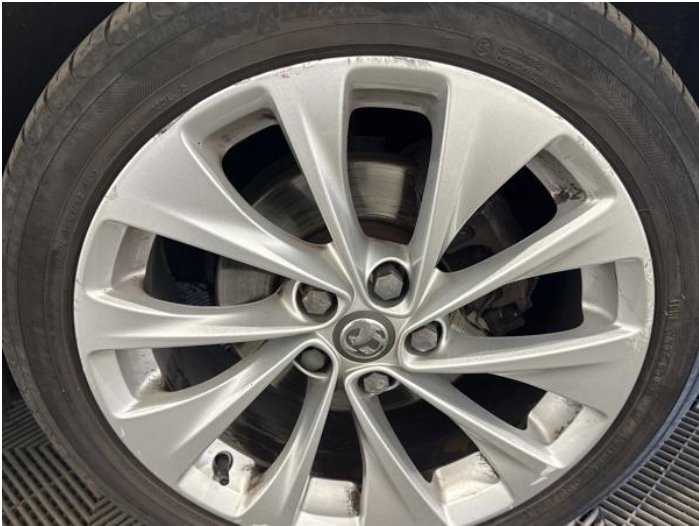
15: Wheel of  
Scratched  
Over 50mm

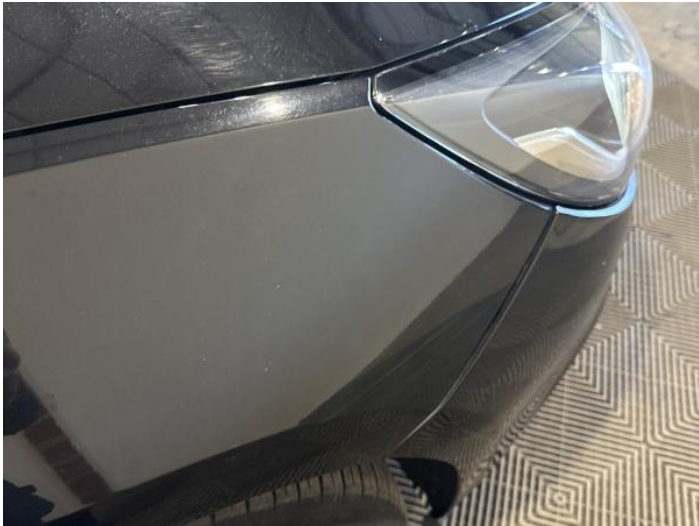
16: Wing of  
Chipped  
1 To 5

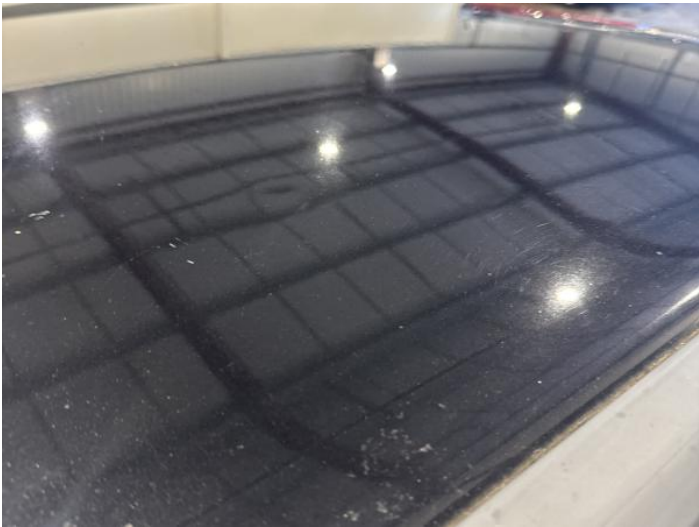
17: Roof  
Dented  
Between 10mm + 30mm
