# VEHICLE INSPECTION REPORT

**OU60BZE**

## Volkswagen Golf 1.6 TDi 105 SE 5dr

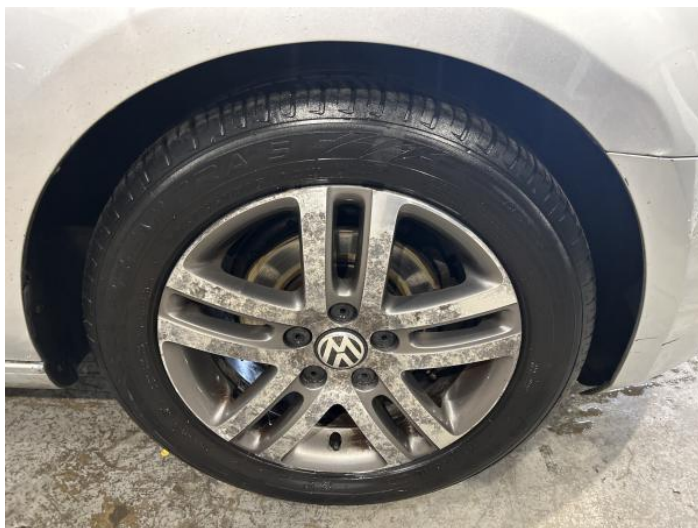
1: Wheel osf  
Corroded  
Light

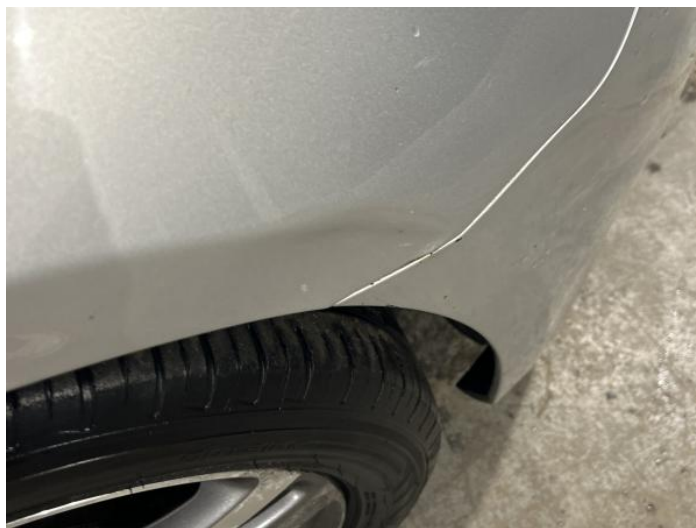
2: Wing osf  
Dented  
Over 30mm

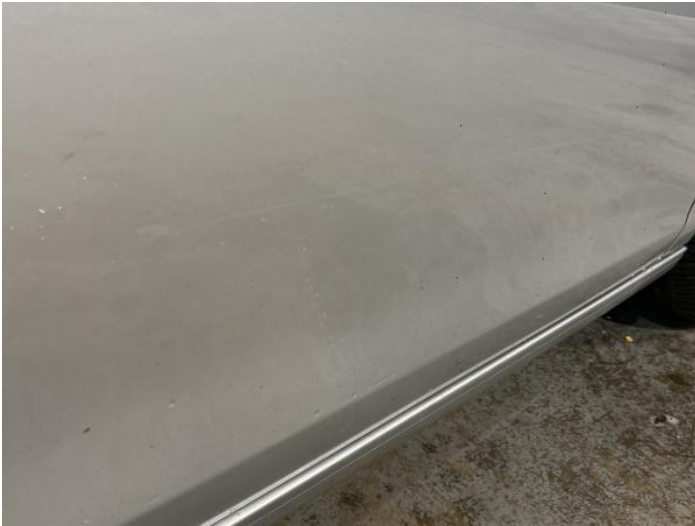
3: Door osf  
Scratched  
Over 25mm Not Thru Paint

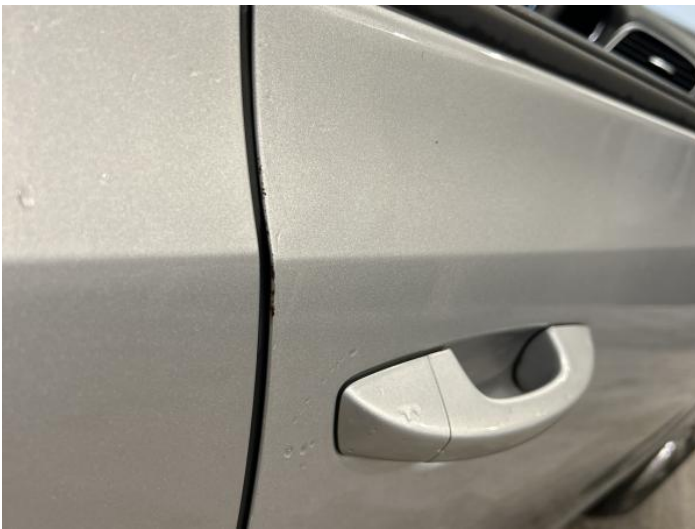
5: Door osf  
Chipped  
Edge Chip

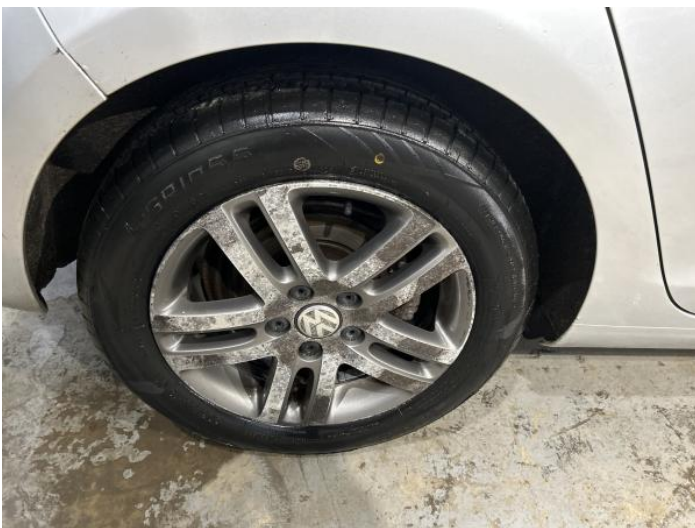
7: Wheel osr  
Corroded  
Light

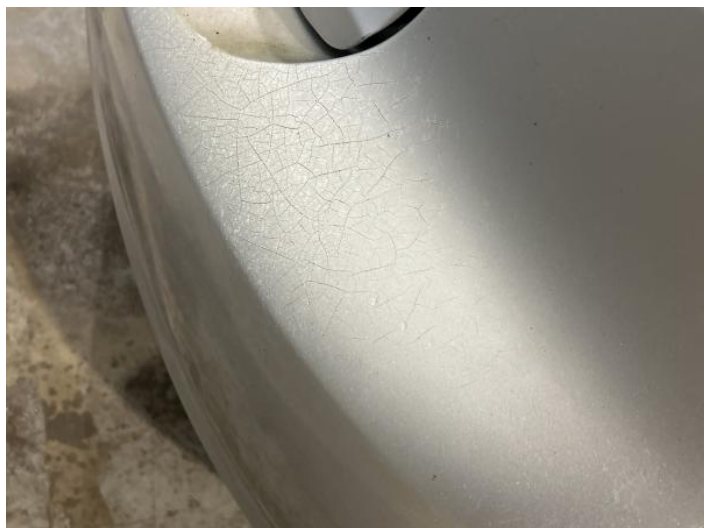
8: Bumper Rear  
Poor Previous Repair  
Paint Flake

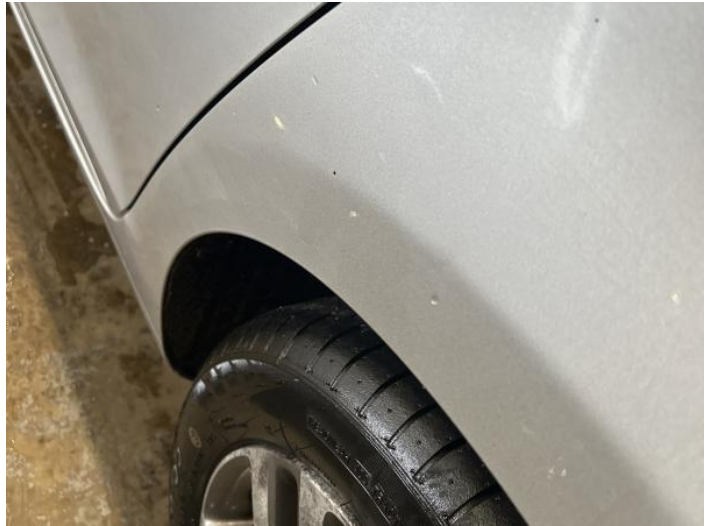
10: Qtr Panel nsr  
Dented  
Over 30mm

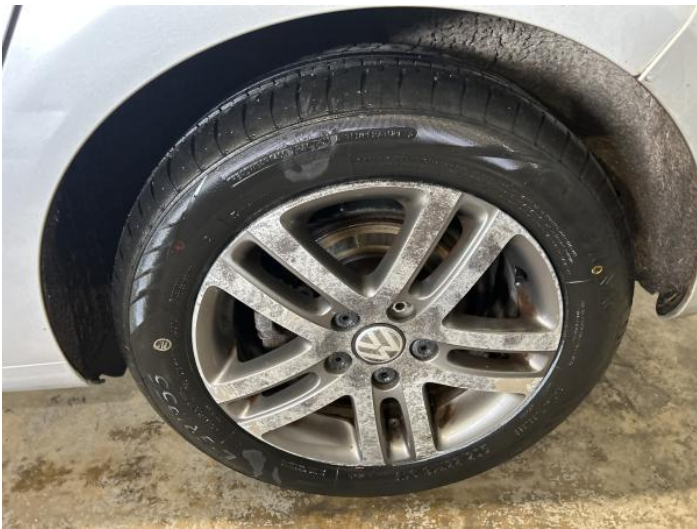
11: Wheel nsr  
Corroded  
Light

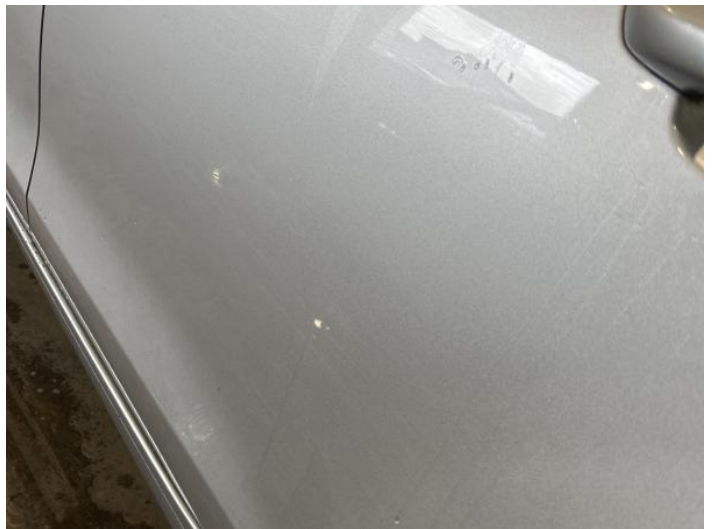
12: Door nsr  
Scratched  
Over 25mm Not Thru Paint

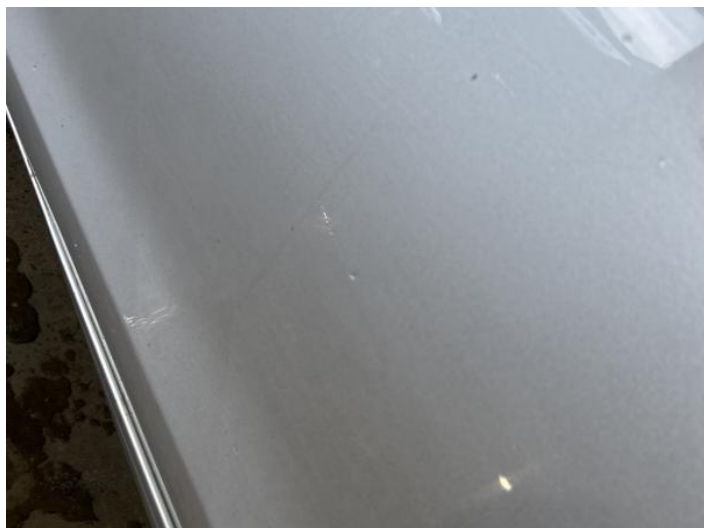
14: Door nsf  
Scratched  
Over 25mm Not Thru Paint

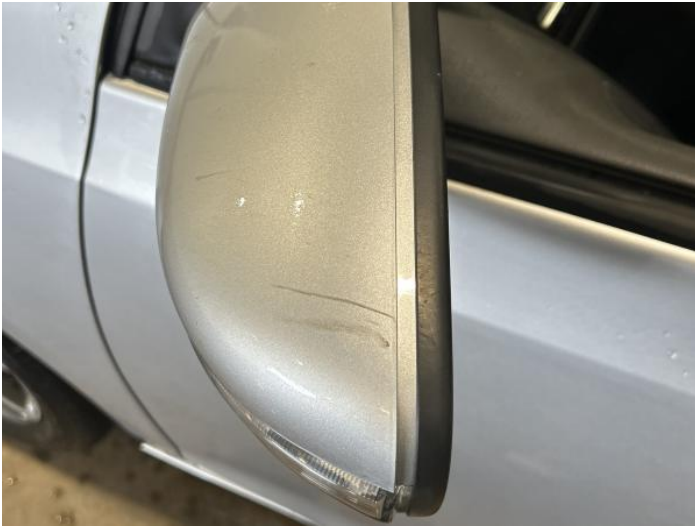
15: Door Mirror Assy nsf  
Scratched (Painted)  
Over 25mm Not Thru Paint

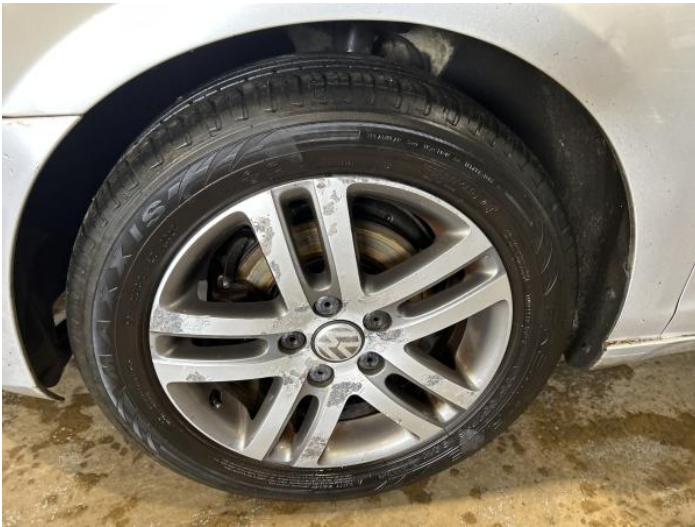
17: Wheel nsf  
Corroded  
Light

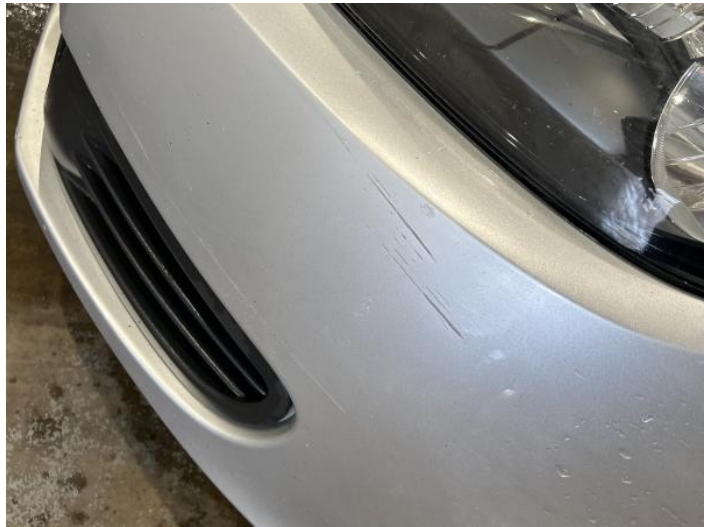
18: Bumper Front  
Scratched  
Over 100mm Thru Paint

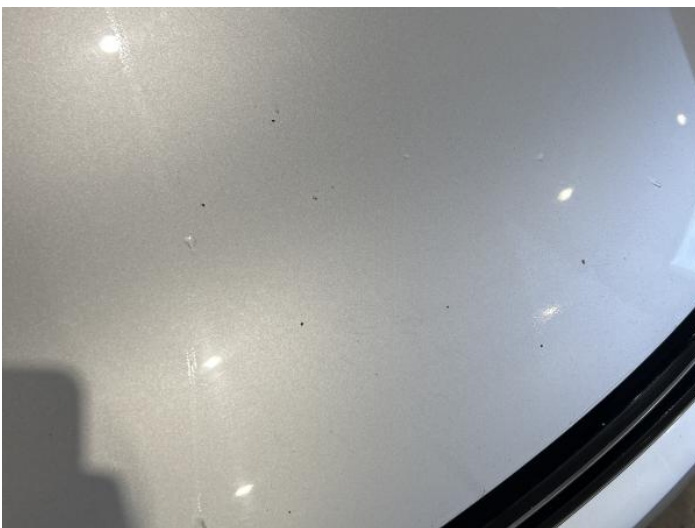
19: Bonnet  
Chipped  
Multiple Chips

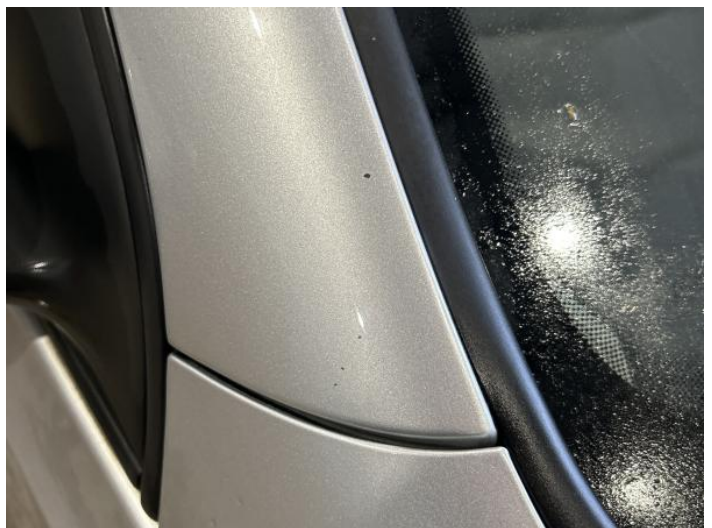
20: A Post os  
Chipped  
1 To 5
