# VEHICLE INSPECTION REPORT

**GP16PVJ**

## Skoda Fabia 1.2 TSI SE L 5dr

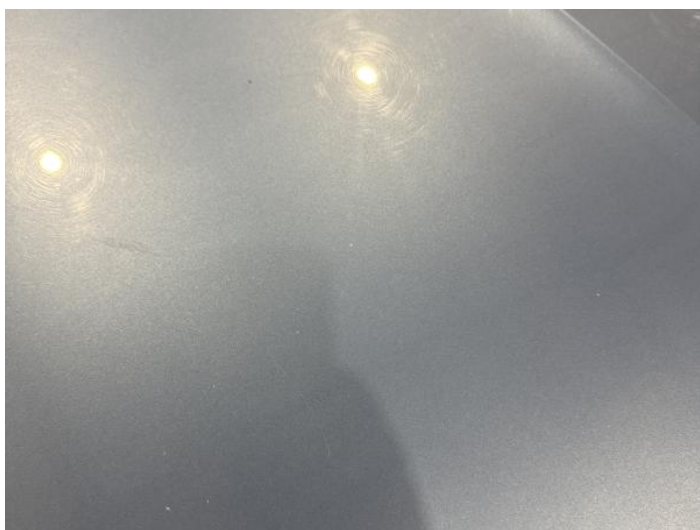
1: Bonnet  
Dented  
With Paint Damage

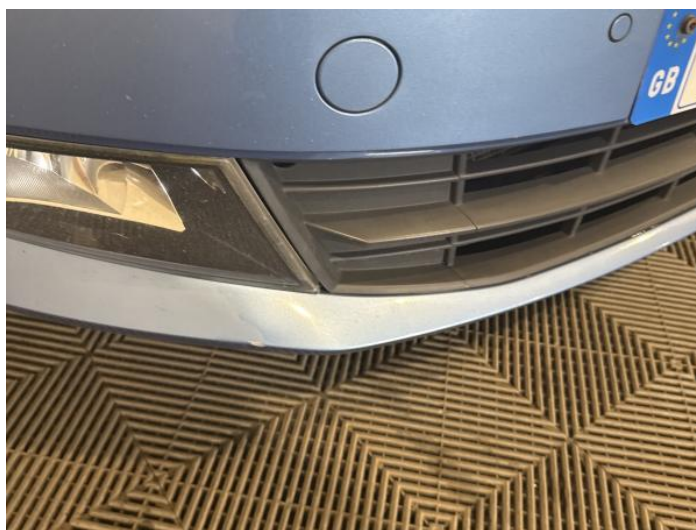
2: Bumper Front  
Dented  
With Paint Damage

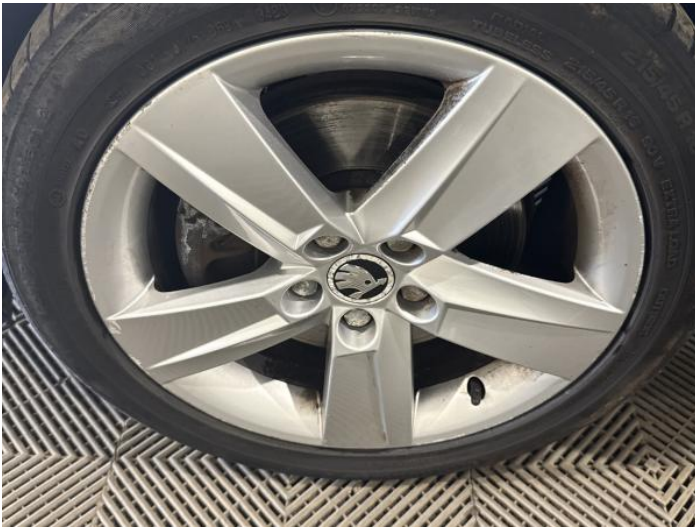
5: Wheel nsf  
Scratched  
Over 50mm

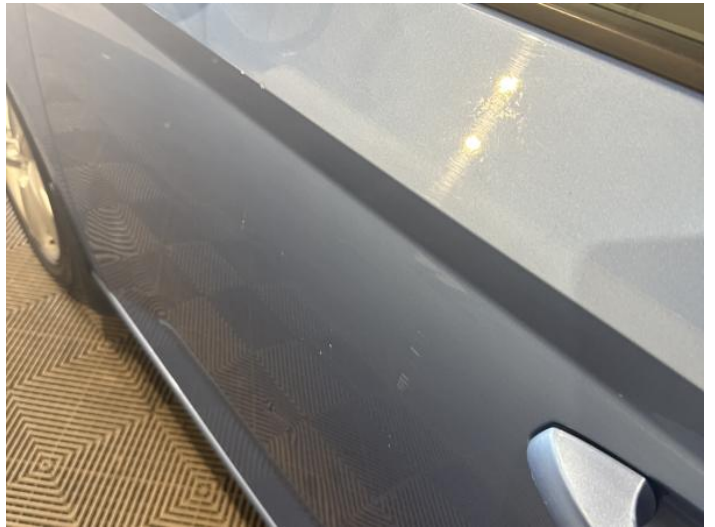
6: Door nsf  
Dented  
With Paint Damage

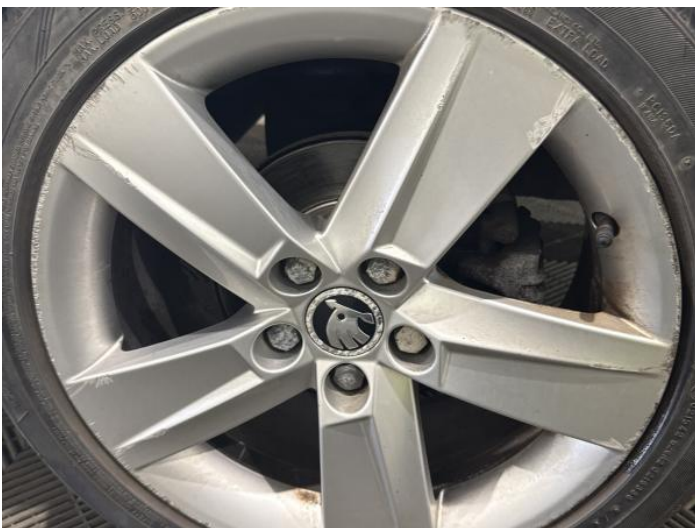
7: Wheel nsr  
Scratched  
Over 50mm

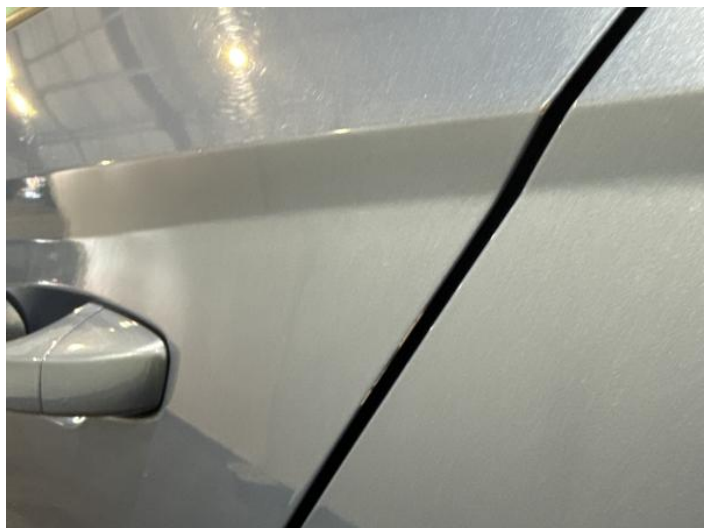
8: Door nsr  
Chipped  
Edge Chip

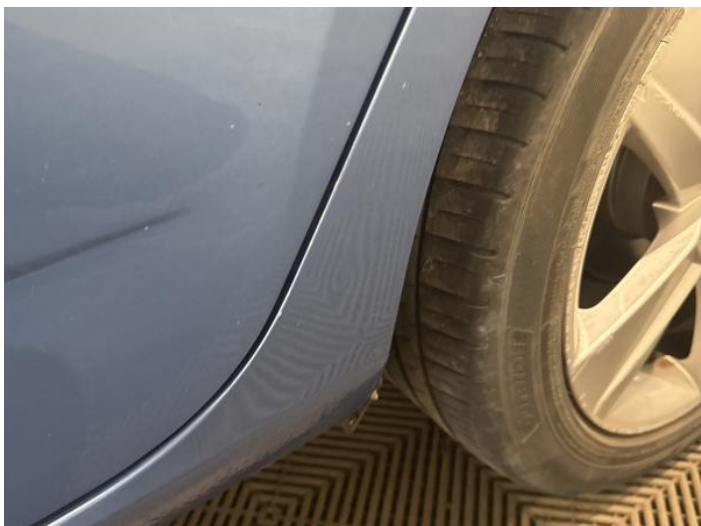
9: Qtr Panel nsr  
Dented  
With Paint Damage

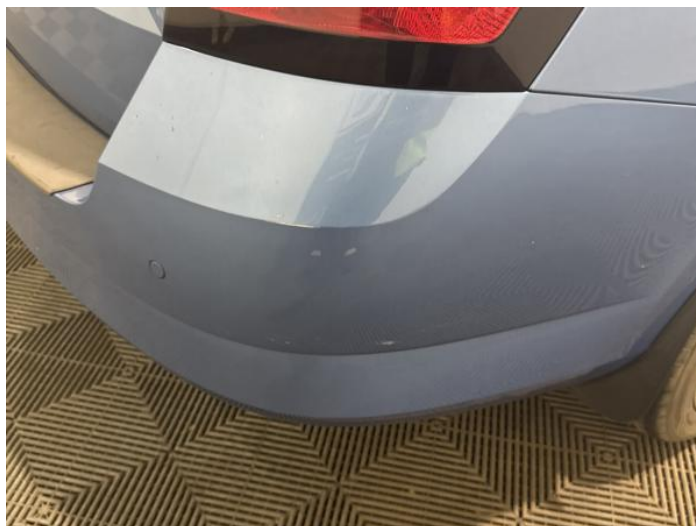
10: Bumper Rear  
Scratched  
25 to 100mm Thru Paint

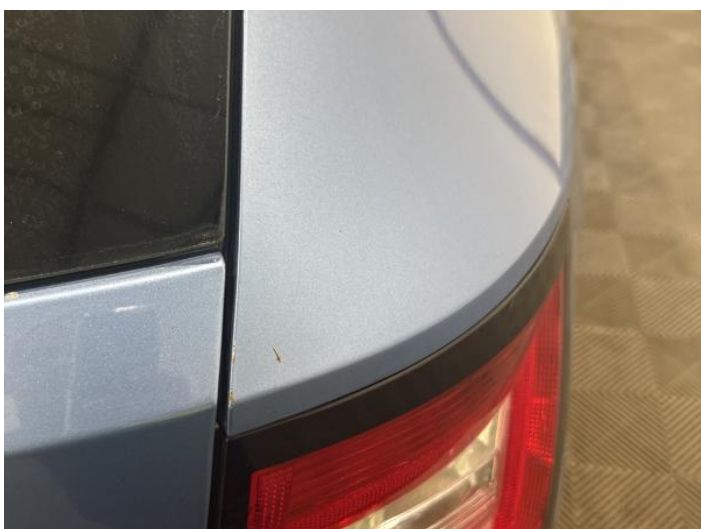
11: Qtr Panel osr  
Scratched  
Rusted

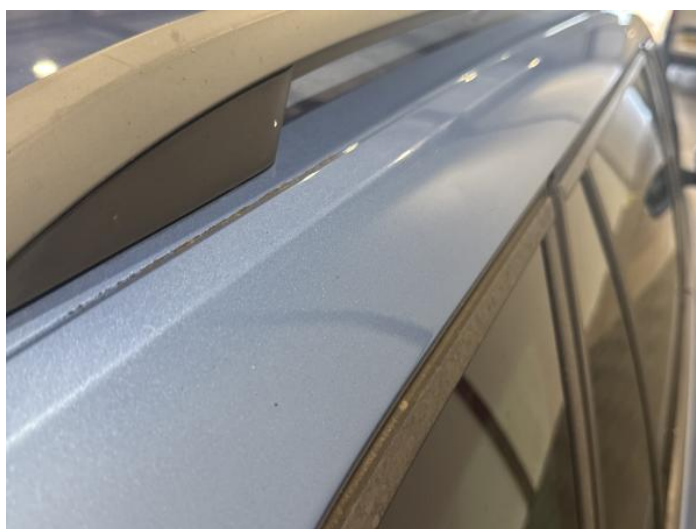
12: C Post os  
Dented  
Between 10mm + 30mm

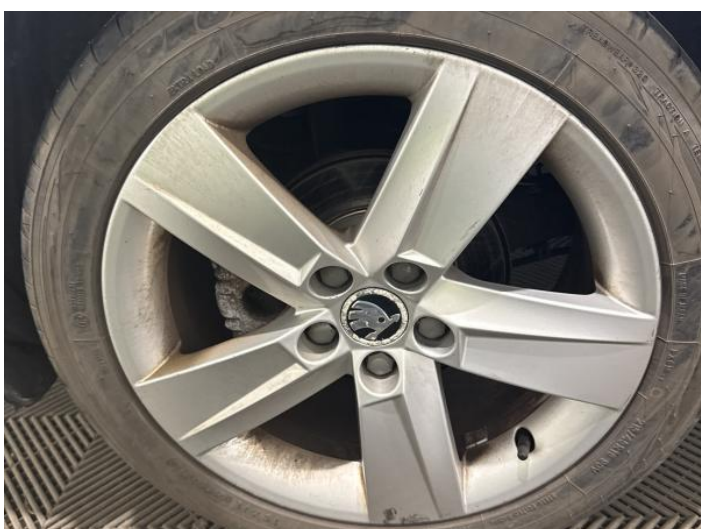
13: Wheel osr  
Scratched  
Up To 50mm

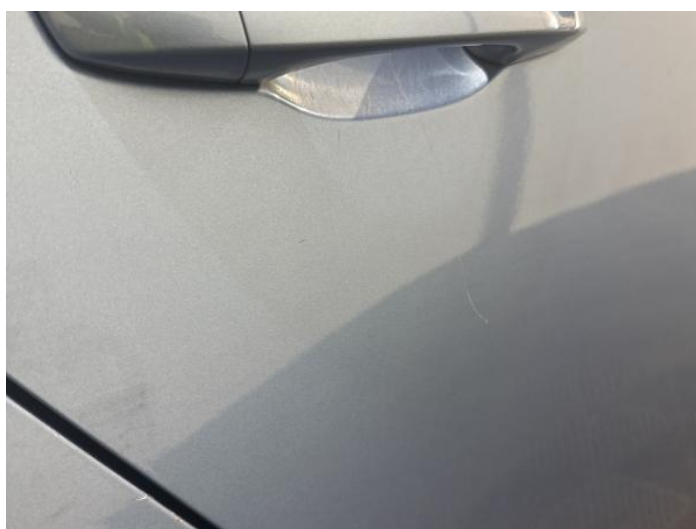
14: Door osr  
Scratched  
UpTo 25mm Thru Paint

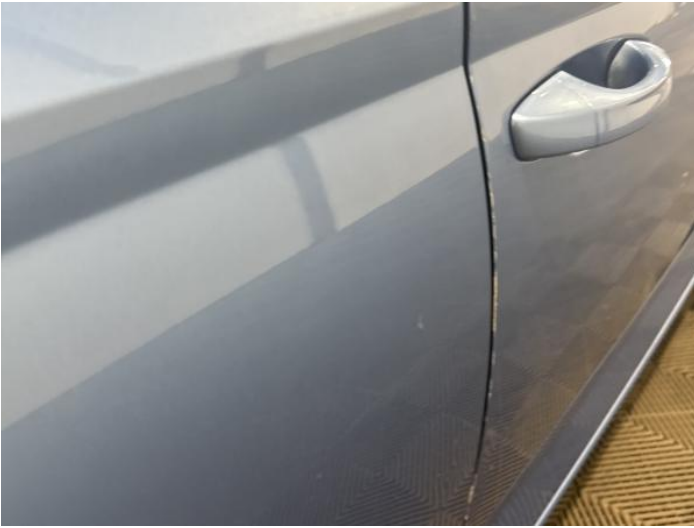
15: Door osr  
Dented  
Between 10mm + 30mm

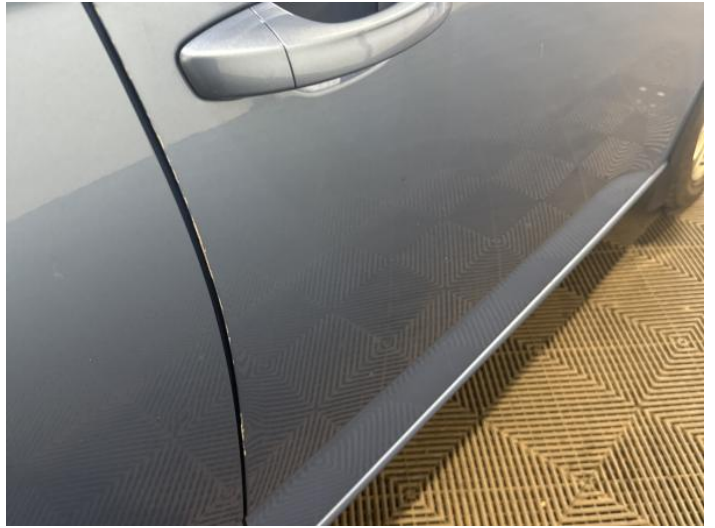
16: Door osf  
Dented  
With Paint Damage

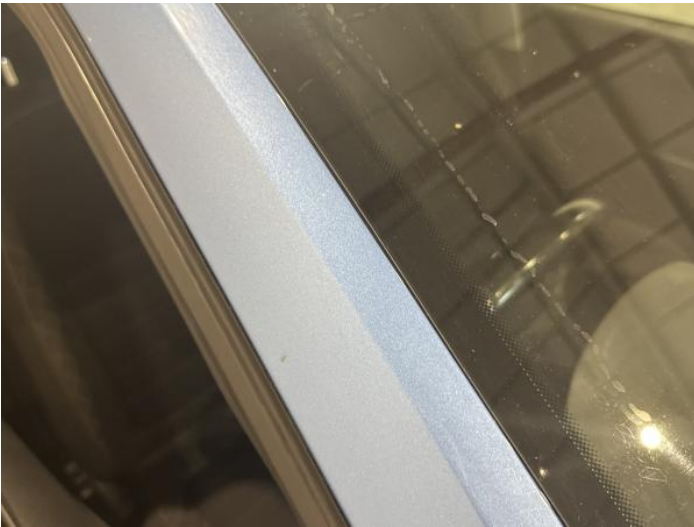
17: A Post os  
Chipped  
1 To 5

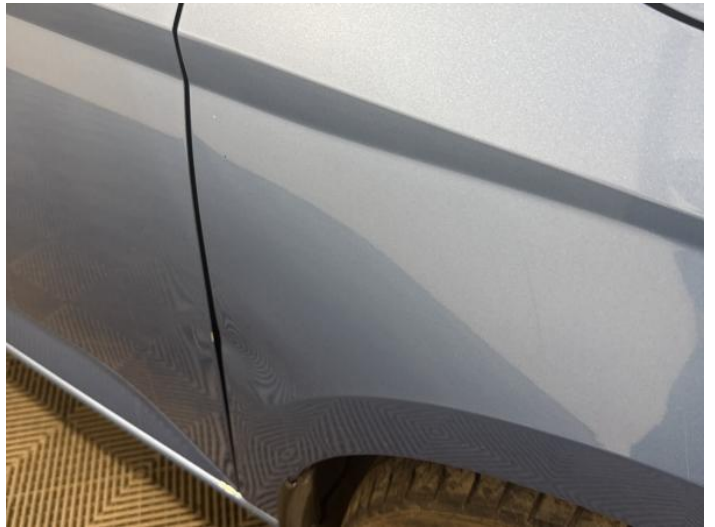
18: Wing nsf  
Dented  
Over 30mm

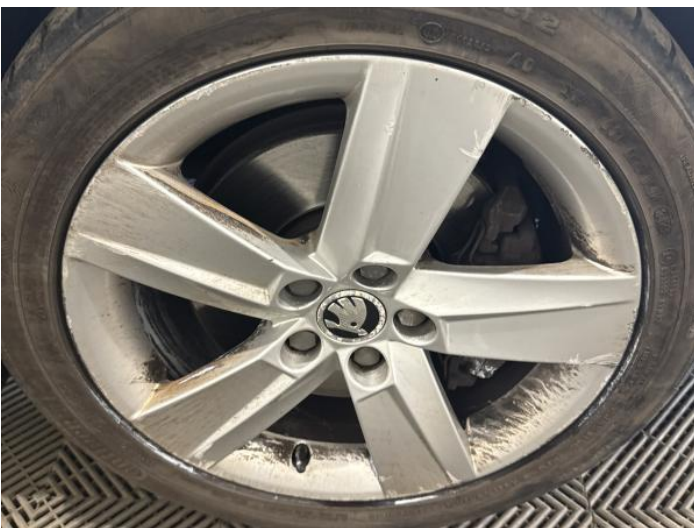
19: Wheel osf  
Scratched  
Over 50mm

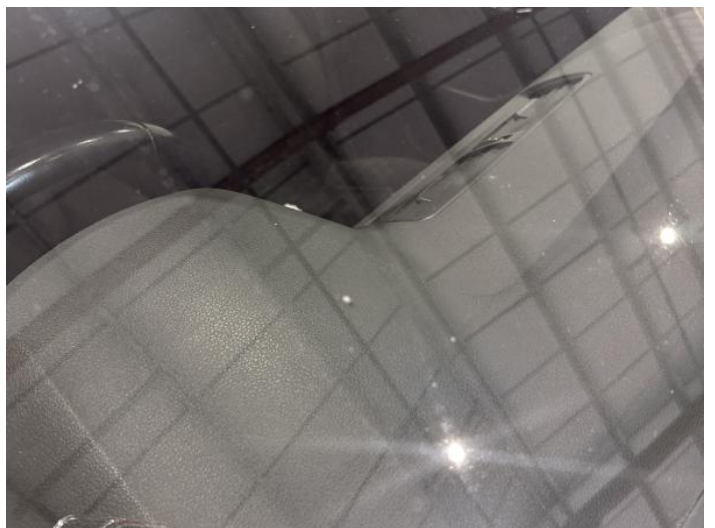
20: Screen Front  
Chipped  
UpTo 10mm

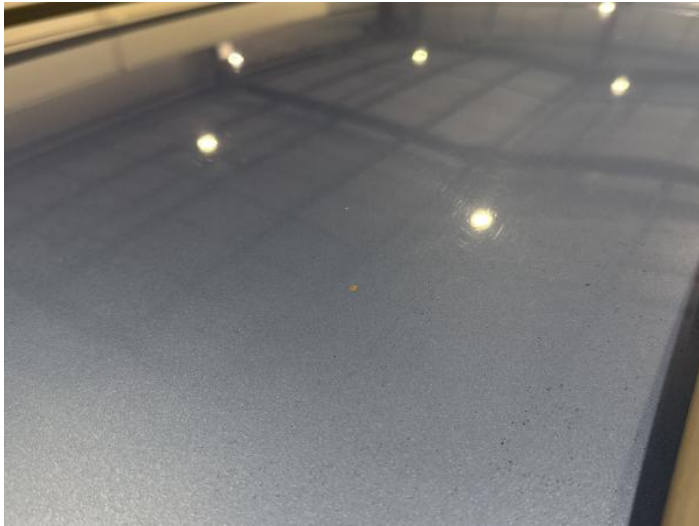
21: Roof  
Dented  
Over 30mm
