VEHICLE INSPECTION REPORT

YF62RWU

Mini Countryman 1.6 Cooper S ALL4 5dr

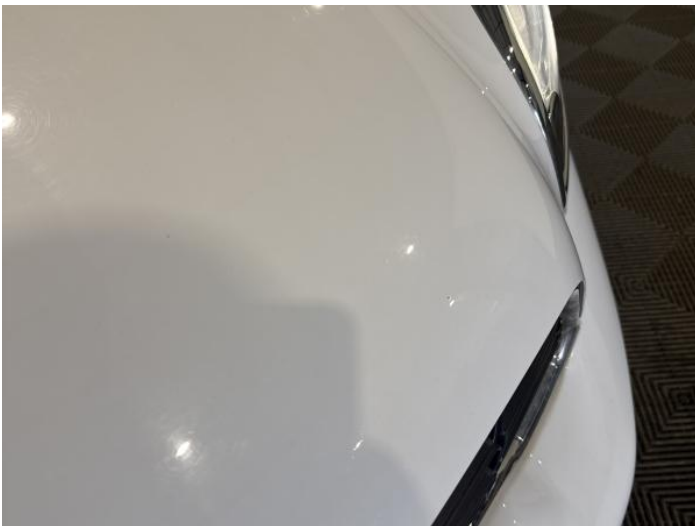
1: Bonnet
Chipped
1 To 5

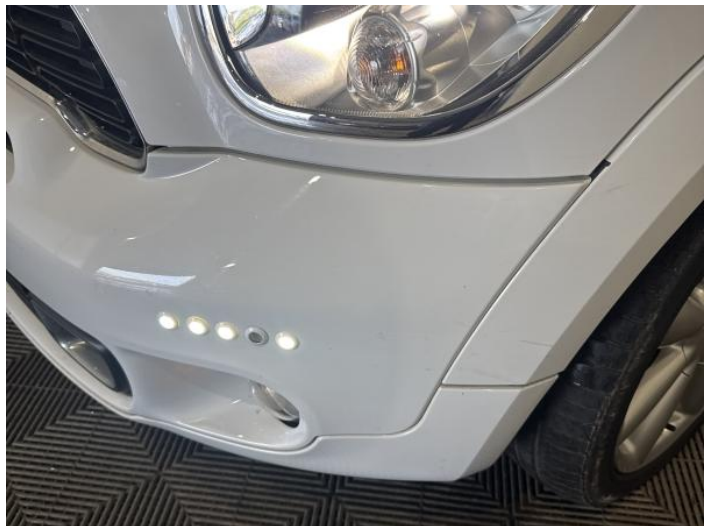
2: Bumper Front
Scratched
25 to 100mm Thru Paint

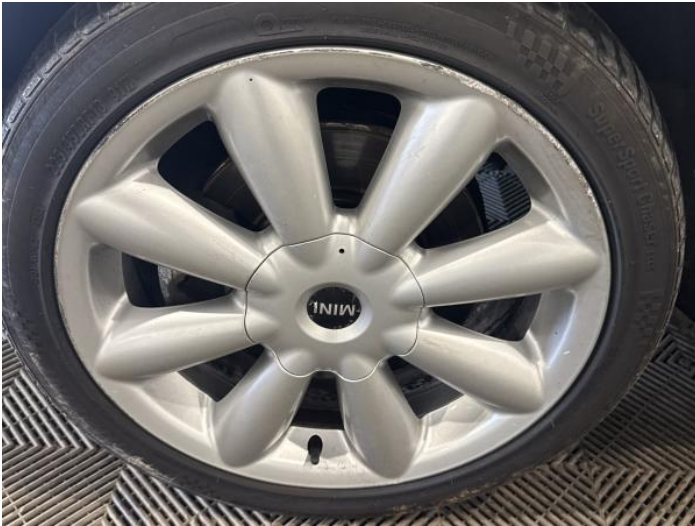
3: Wheel nsf
Scratched
Over 50mm

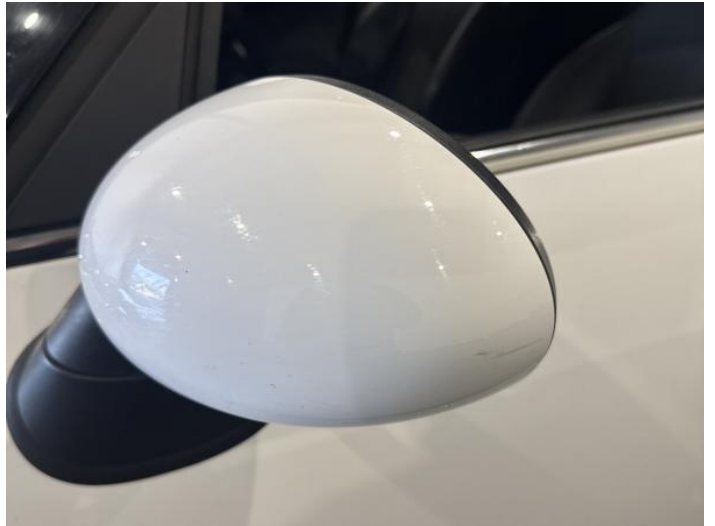
4: Door Mirror Assy nsf
Scratched (Painted)
UpTo 25mm Thru Paint

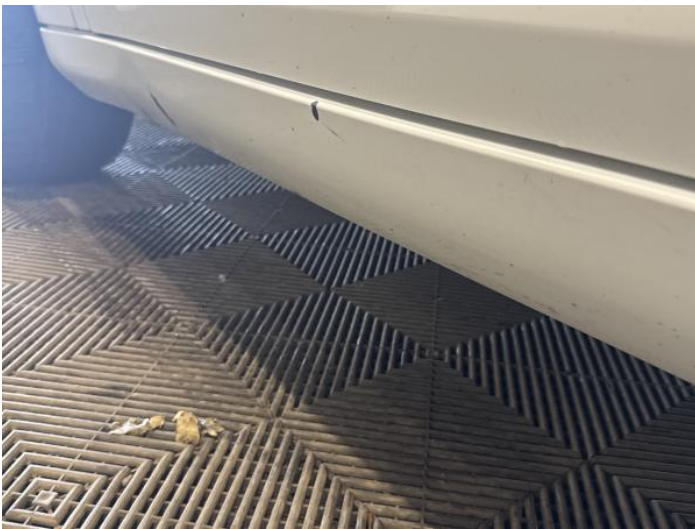
5: Sill ns
Scratched
Over 25mm Thru Paint

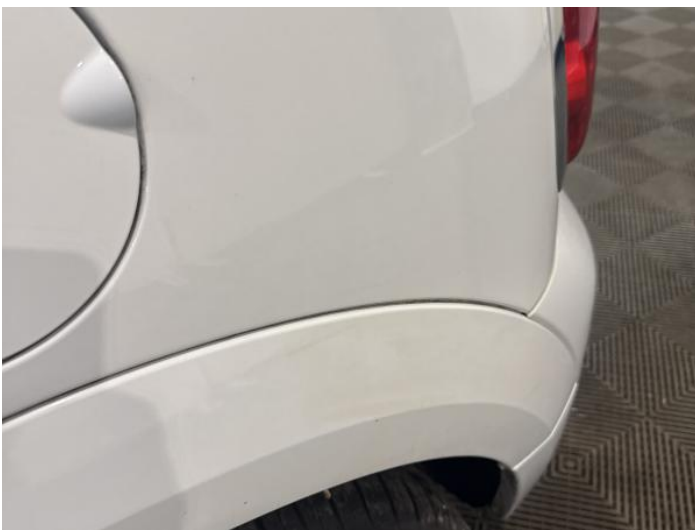
7: Qtr Panel nsr
Chipped
1 To 5

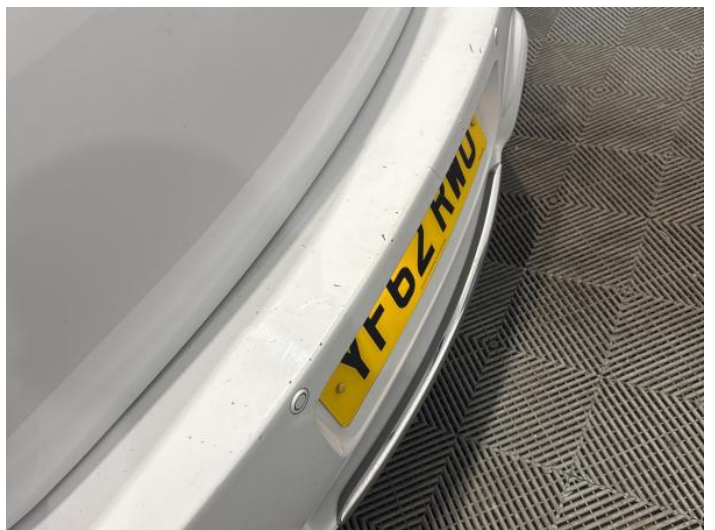
8: Bumper Rear
Dented
With Paint Damage

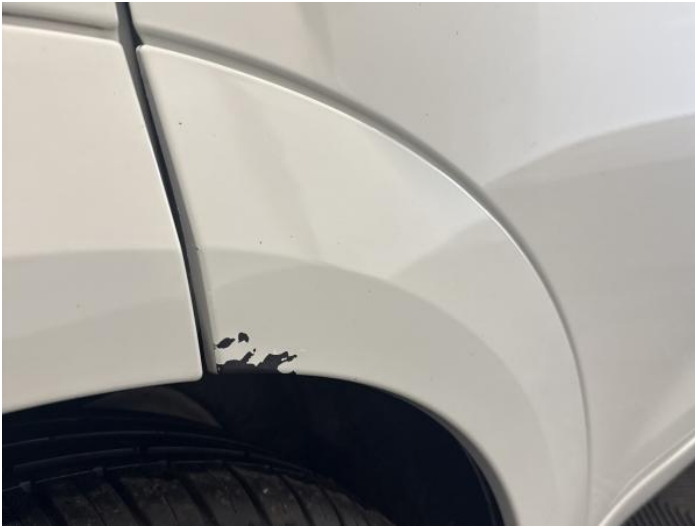
9: Door Moulding osr
Scratched (Painted)
Over 25mm Thru Paint

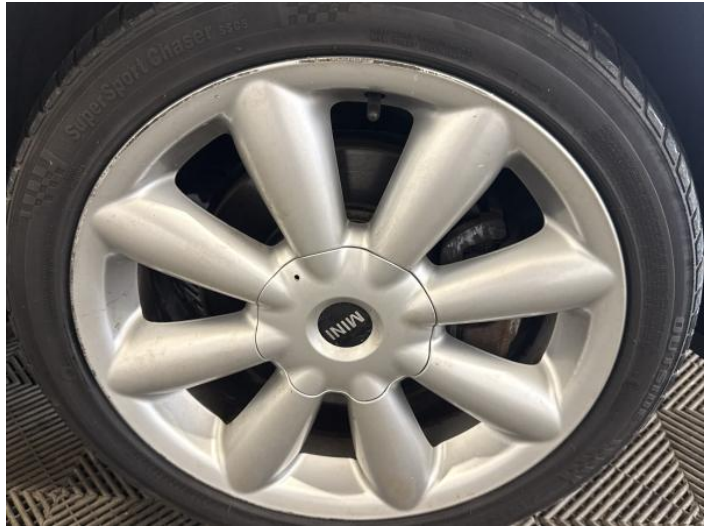
10: Wheel osf
Scratched
Over 50mm

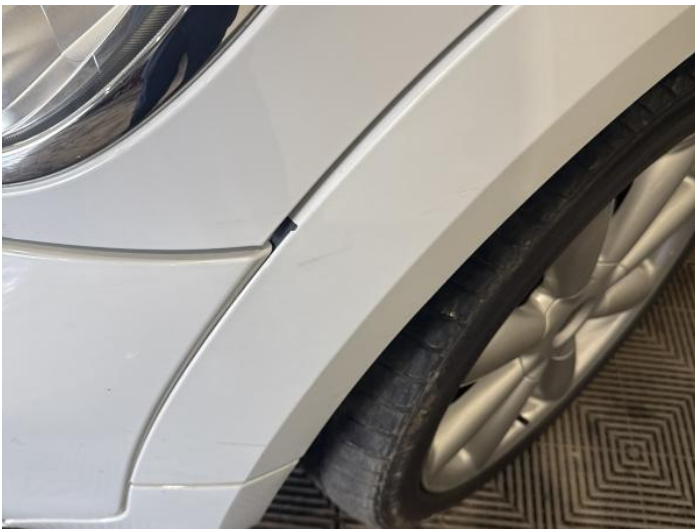
11: Wing Front Arch Extension ns
Scratched (Painted)
Over 25mm Thru Paint

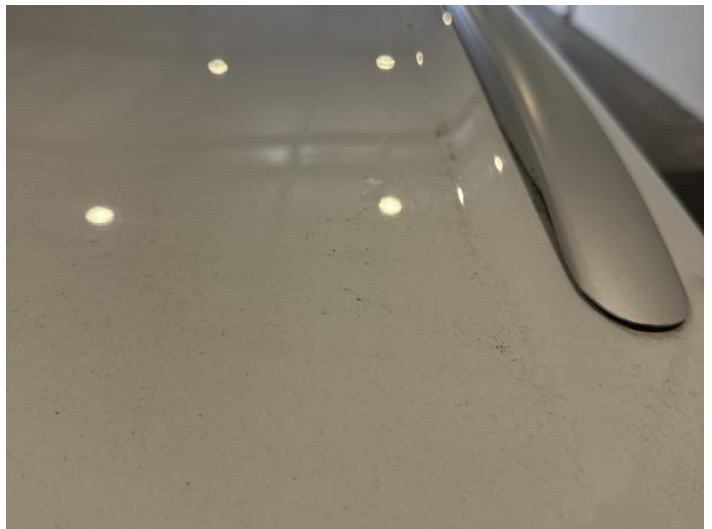
12: Roof
Dented
Between 10mm + 30mm
