VEHICLE INSPECTION REPORT

CF17ODK

Kia Soul 1.6 GDi 2 5dr

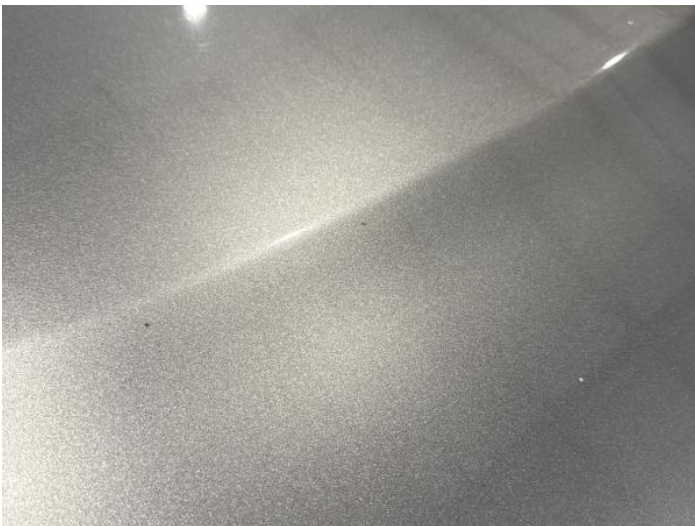
1: Bonnet
Chipped
1 To 5

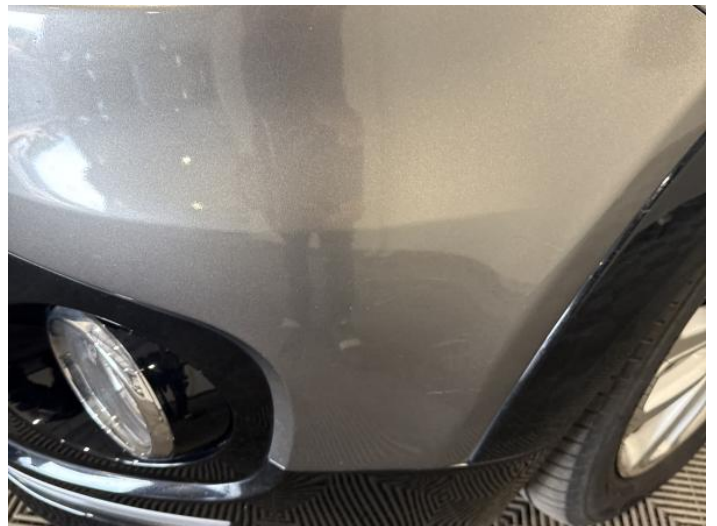
2: Bumper Front
Scratched
25 to 100mm Thru Paint

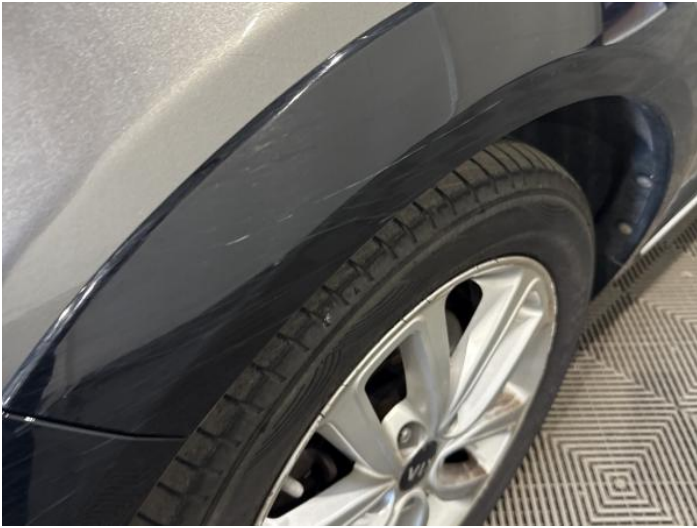
3: Wing Front Arch Extension ns
Scratched (Painted)
Over 25mm Thru Paint

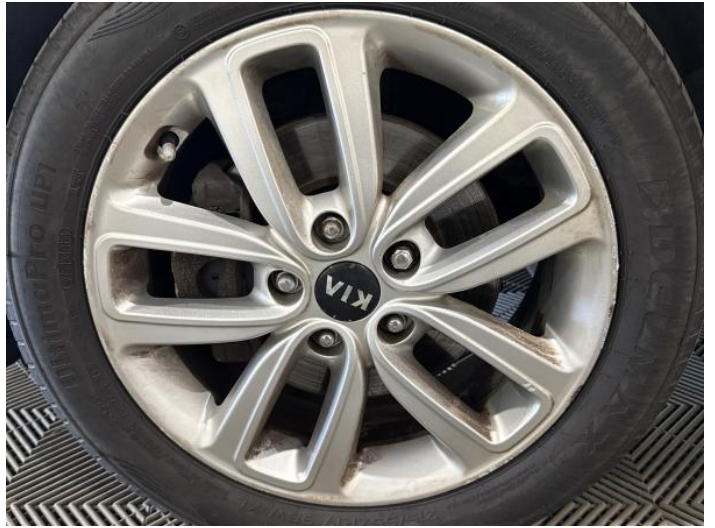
4: Wheel nsf
Scratched
Over 50mm

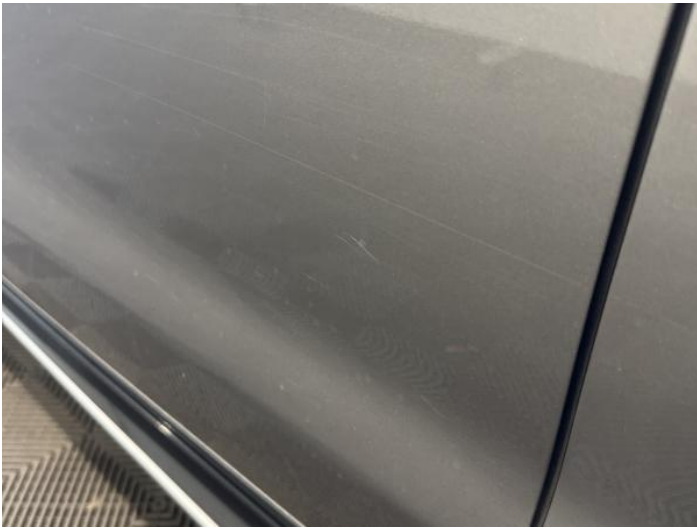
5: Door nsf
Scratched
UpTo 25mm Thru Paint

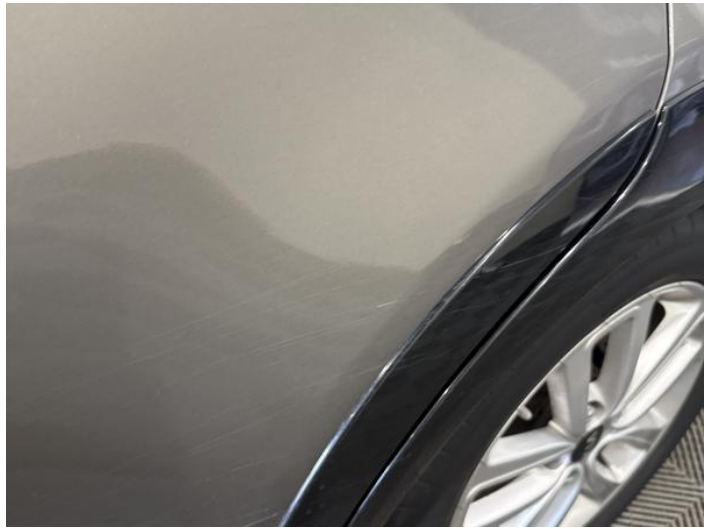
6: Door nsr
Scratched
Over 25mm Thru Paint

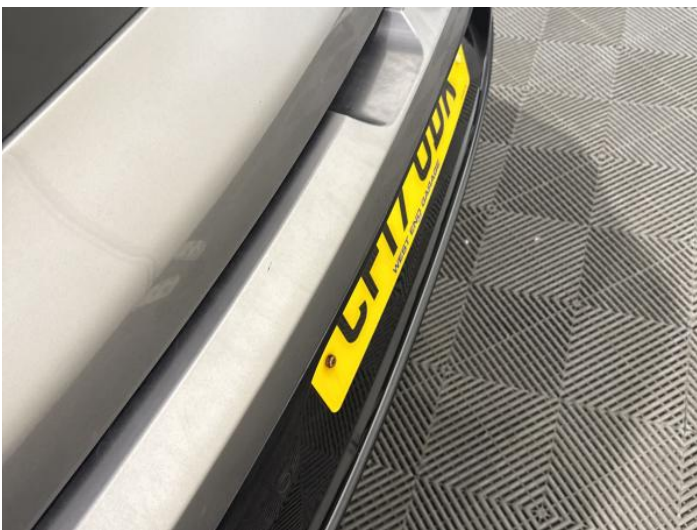
7: Bumper Rear
Scratched
25 to 100mm Thru Paint

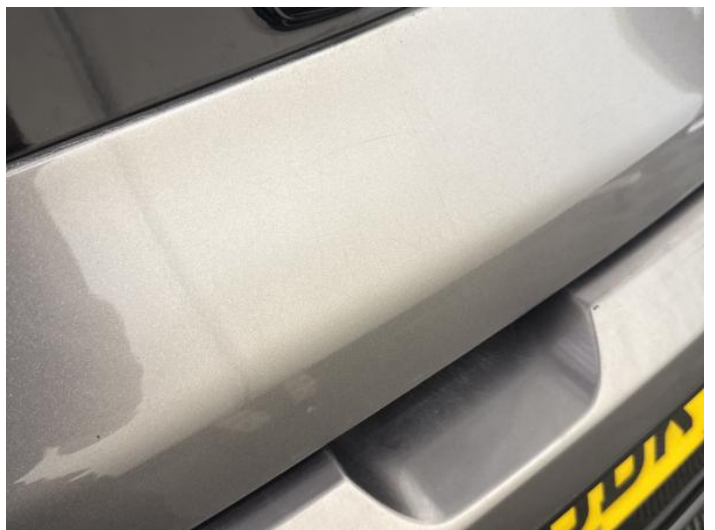
8: Tailgate
Scratched
UpTo 25mm Thru Paint

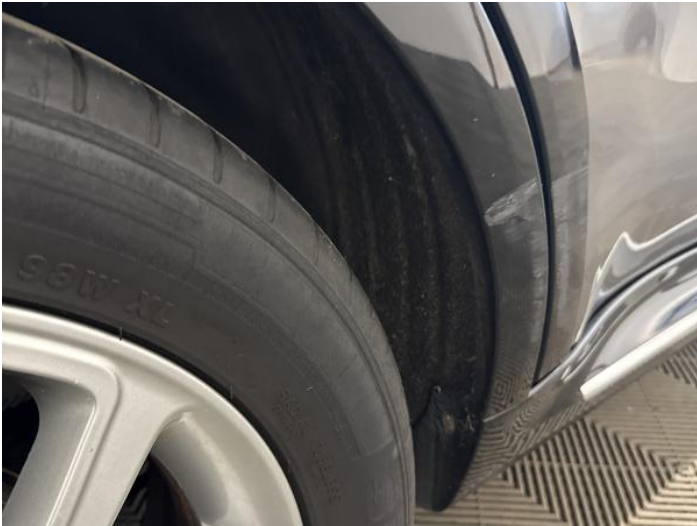
9: Qtr Panel Arch Extension os
Scratched (Painted)
Over 25mm Thru Paint

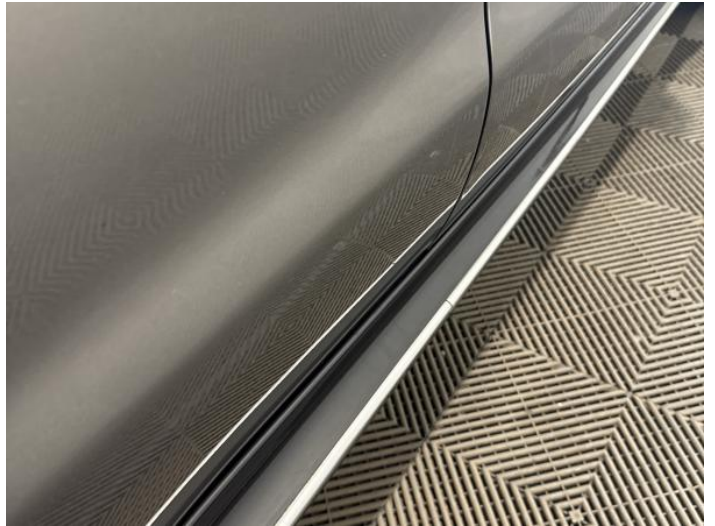
10: Door osr
Dented
Between 10mm + 30mm

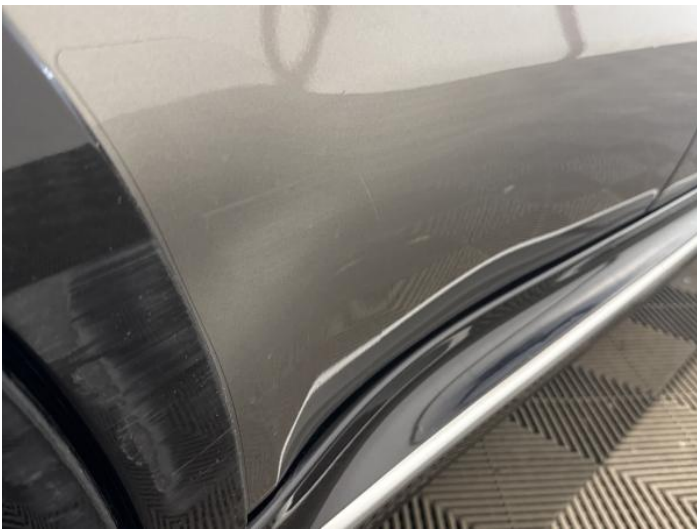
11: Door osr
Scratched
Over 25mm Thru Paint

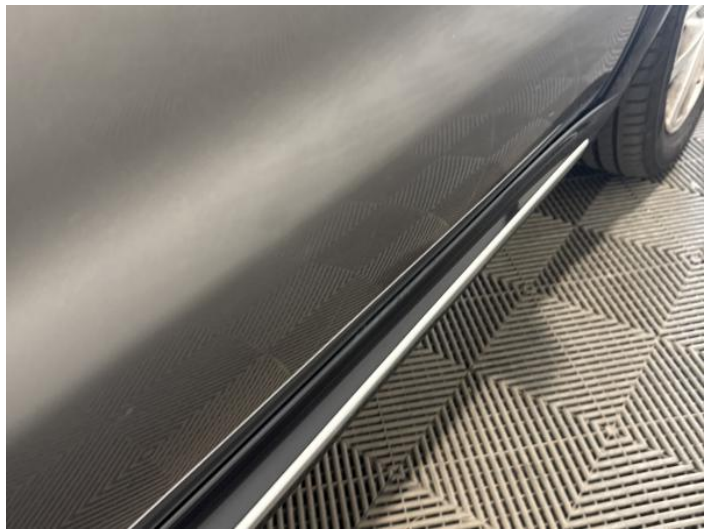
12: Door osf
Dented
Between 10mm + 30mm

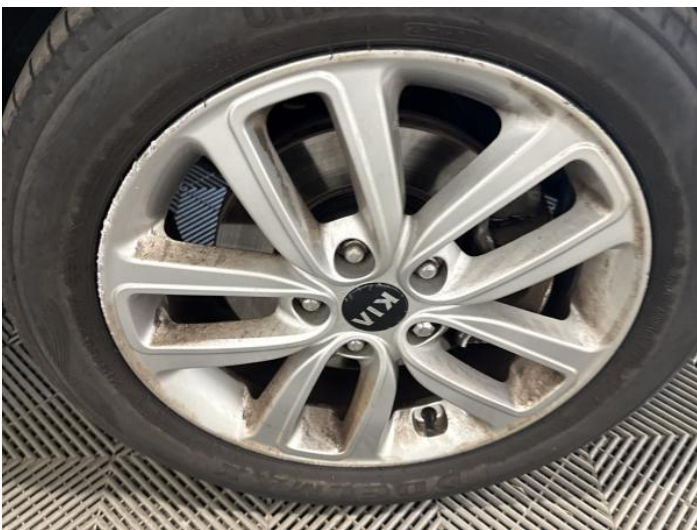
13: Wheel osf
Scratched
Over 50mm

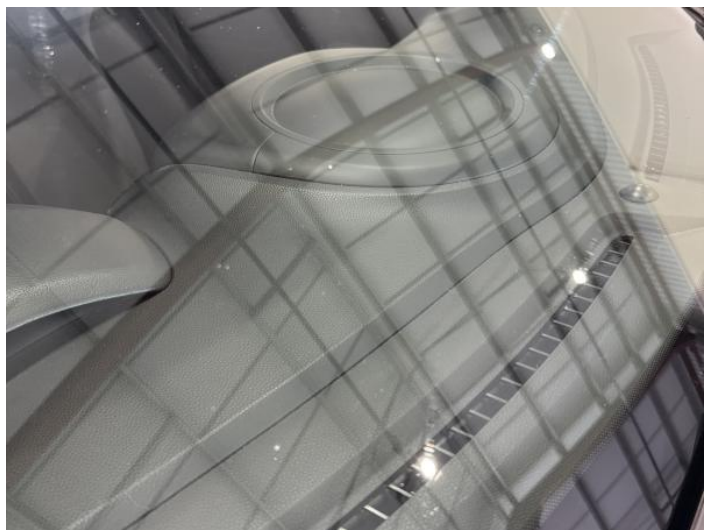
14: Screen Front
Chipped
UpTo 10mm

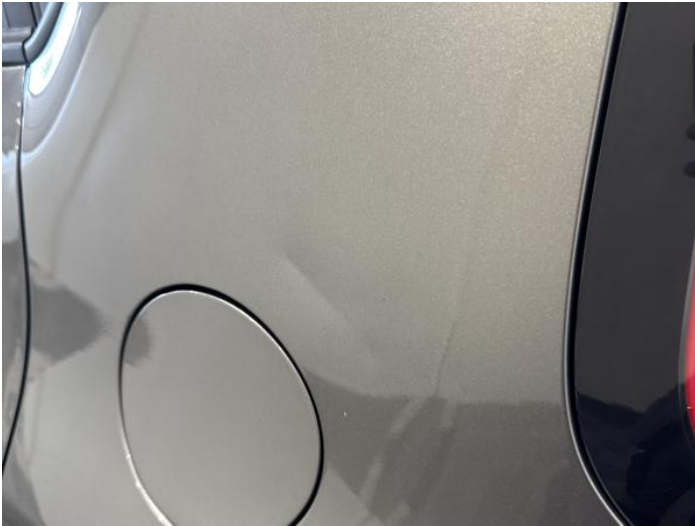
15: Qtr Panel nsr
Dented
Over 30mm
