# VEHICLE INSPECTION REPORT

**LG17YYC**

## Kia Ceed 1.6 CRDi ISG 2 5dr DCT

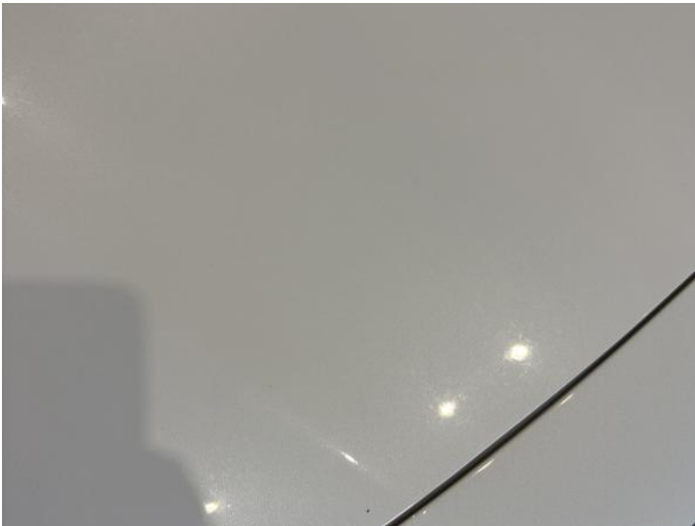
1: Bonnet  
Chipped  
1 To 5

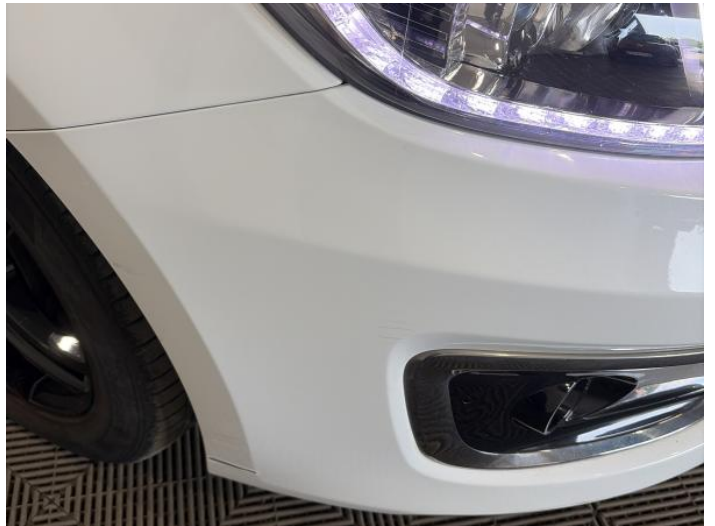
2: Bumper Front  
Scratched  
25 to 100mm Thru Paint

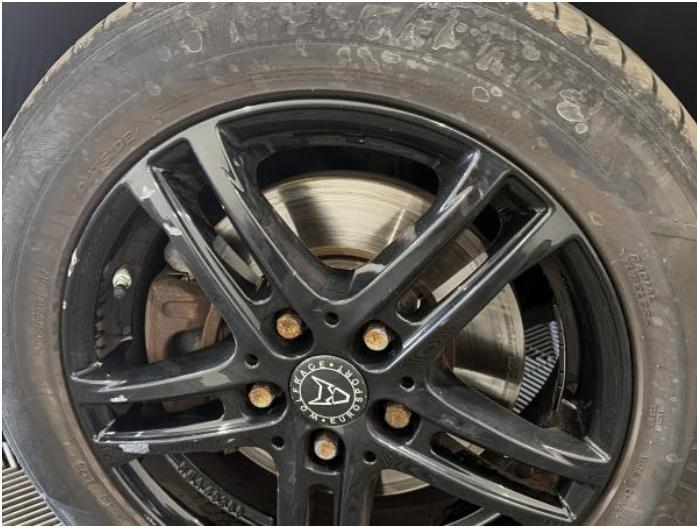
3: Wheel nsf  
Scratched  
Over 50mm

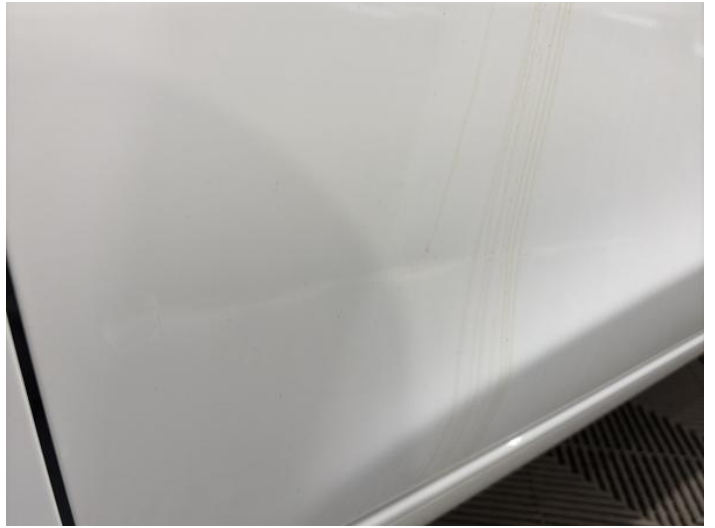
4: Door nsf  
Dented  
Over 30mm

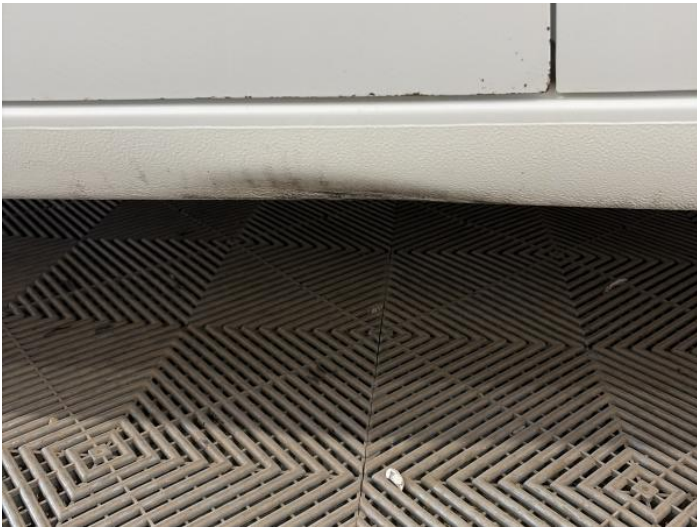
5: Sill ns  
Dented  
Over 30mm

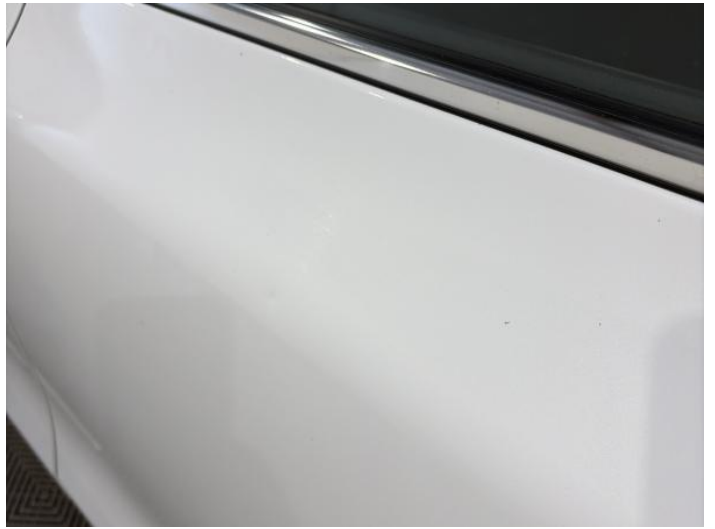
6: Door nsr  
Dented  
Between 10mm + 30mm

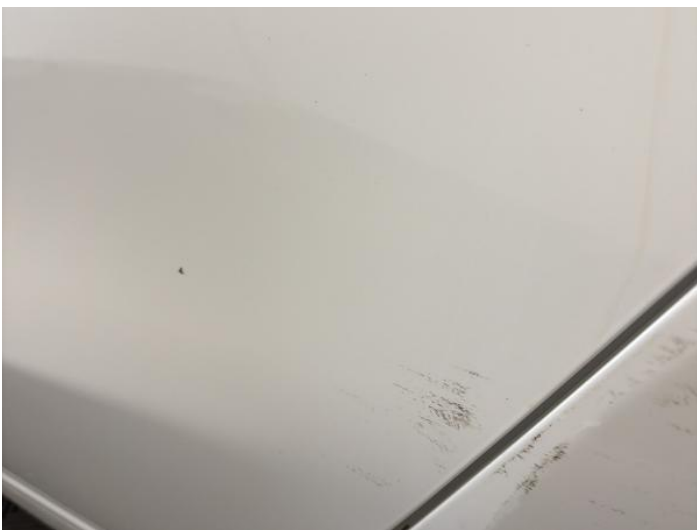
7: Door nsr  
Scratched  
Over 25mm Thru Paint

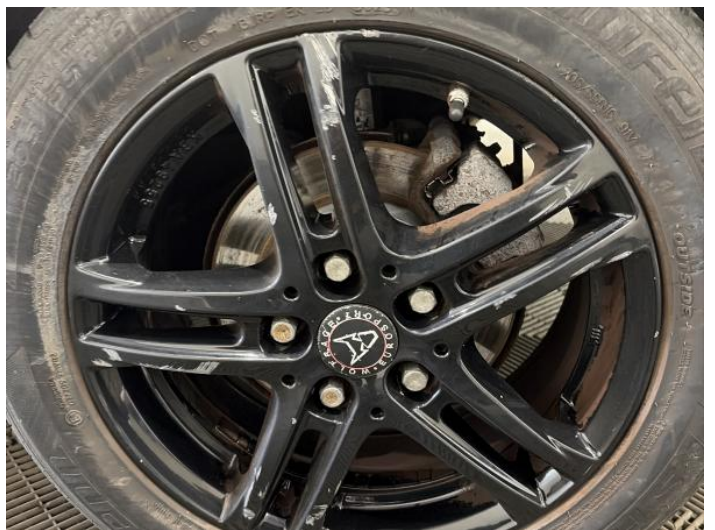
8: Wheel nsr  
Scratched  
Over 50mm

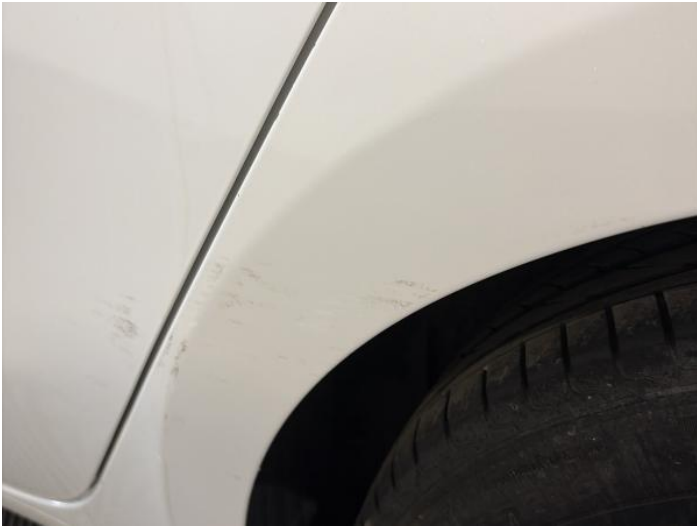
9: Qtr Panel nsr  
Scratched  
Over 25mm Thru Paint

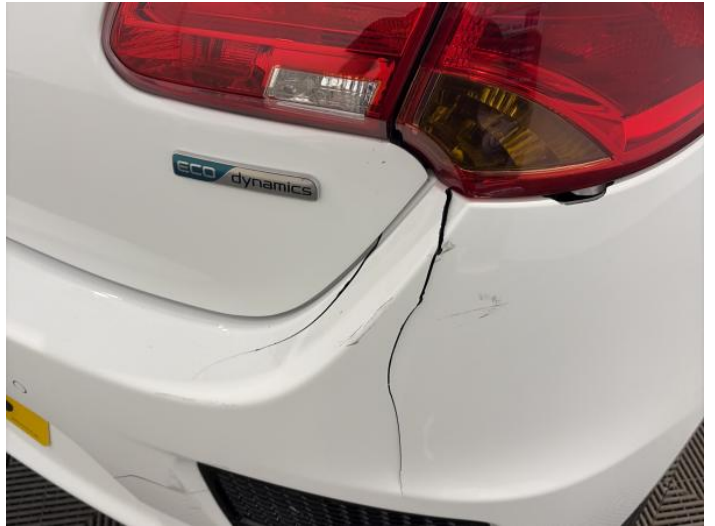
10: Bumper Rear  
Cracked  
Over 25mm

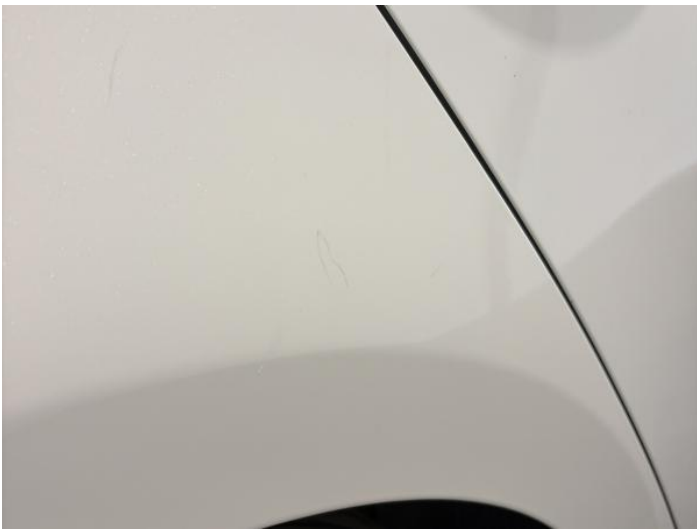
11: Qtr Panel osr  
Scratched  
UpTo 25mm Thru Paint

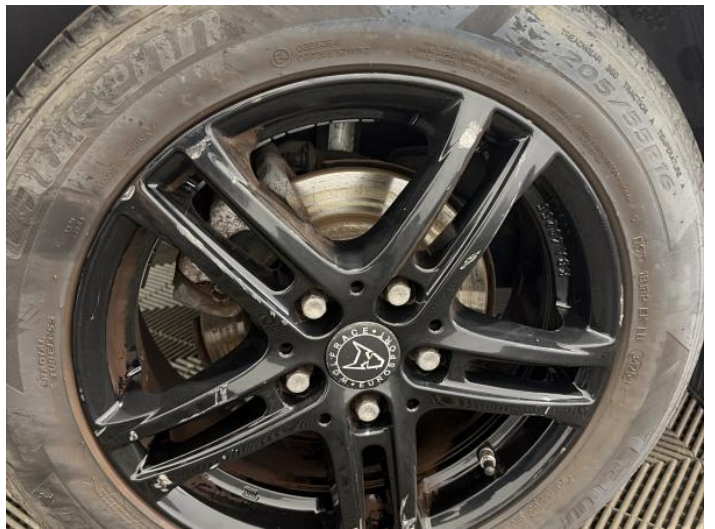
12: Wheel osr  
Scratched  
Over 50mm

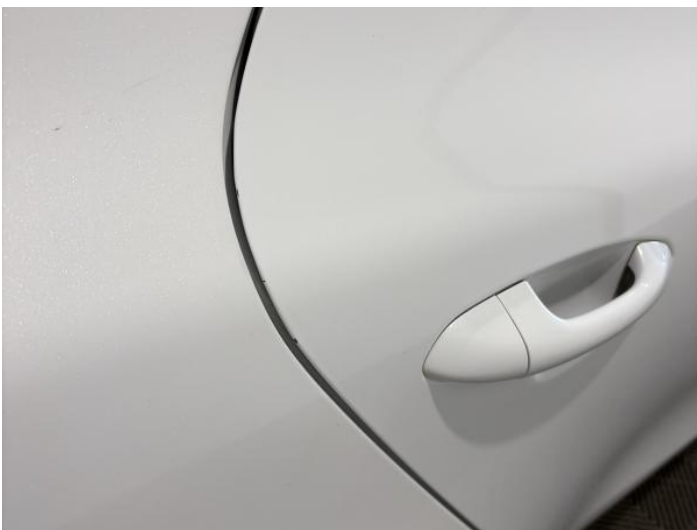
13: Door osr  
Chipped  
Edge Chip

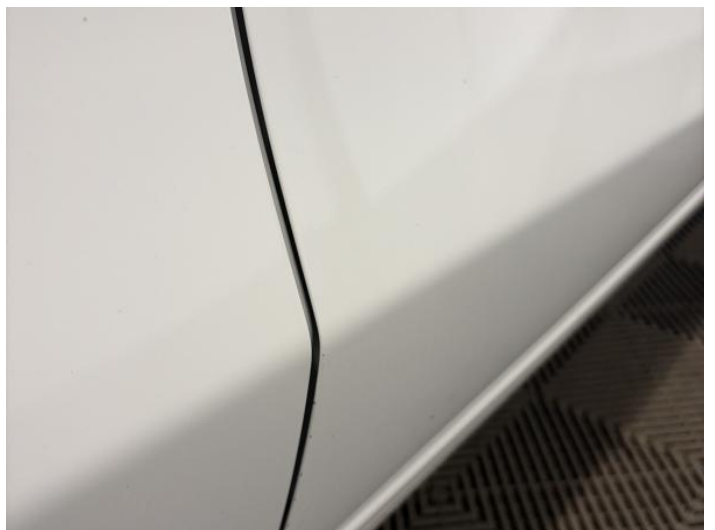
14: Door osf  
Chipped  
Edge Chip

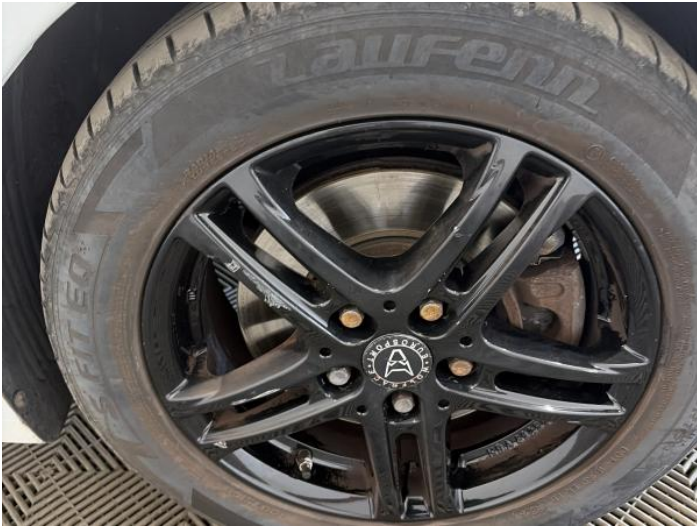
15: Wheel osf  
Scratched  
Over 50mm

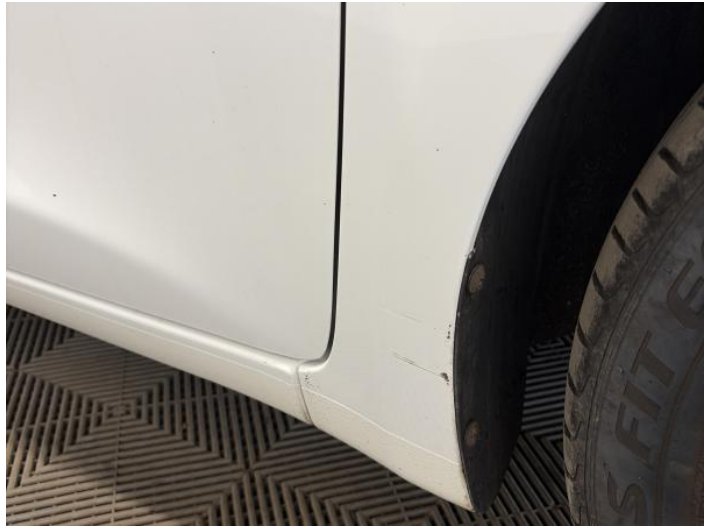
16: Wing osf  
Scratched  
Over 25mm Thru Paint

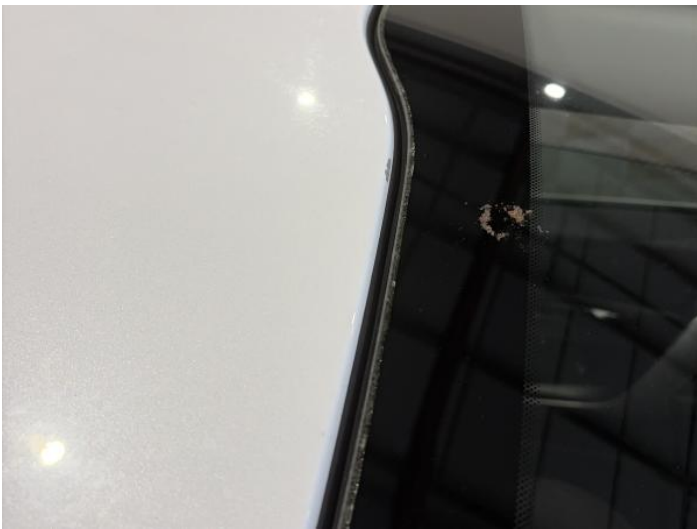
17: Roof  
Chipped  
Edge Chip
