# VEHICLE INSPECTION REPORT

**ND18DPF**

## Nissan Qashqai 1.6 dCi N-Connecta 5dr Xtronic

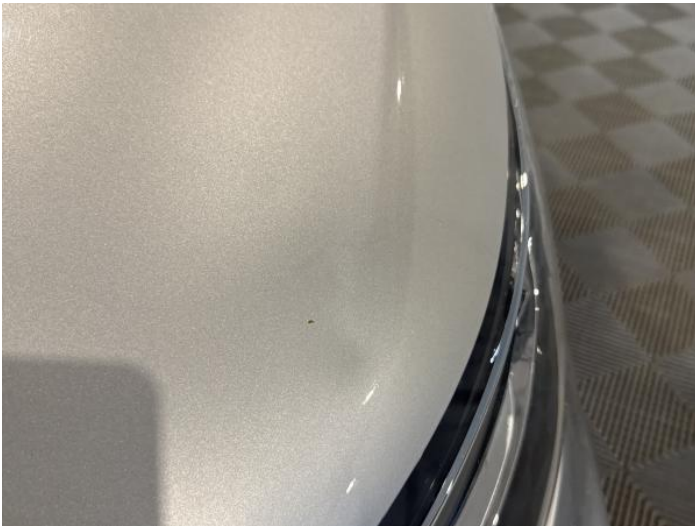
1: Bonnet  
Dented  
Over 30mm

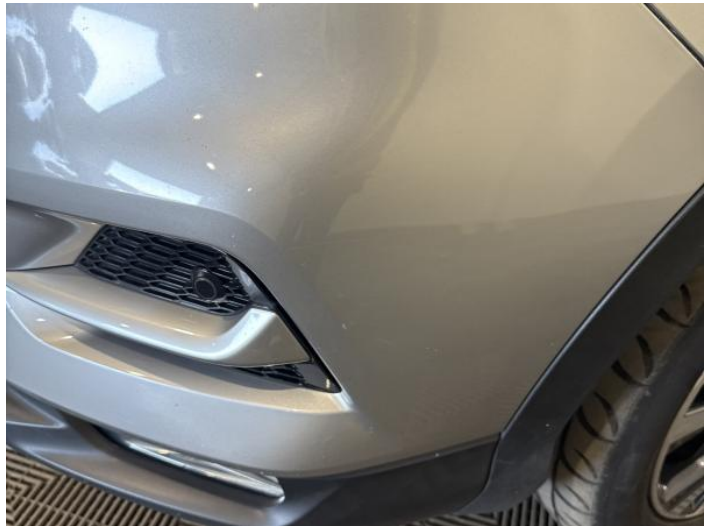
2: Bumper Front  
Scratched  
25 to 100mm Thru Paint

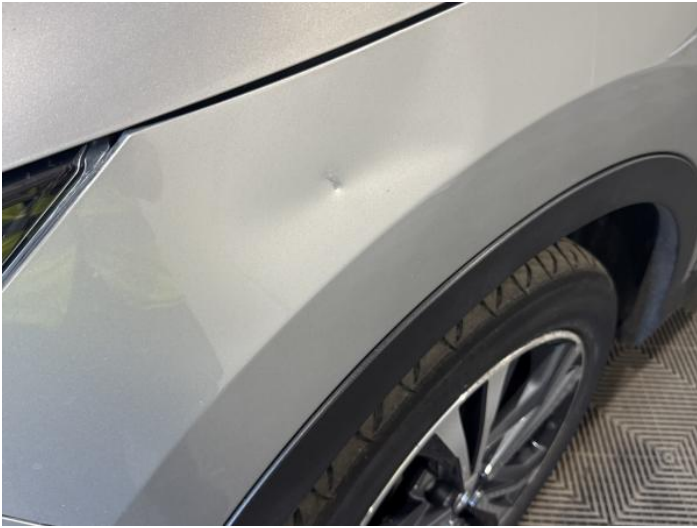
3: Wing nsf  
Dented  
With Paint Damage

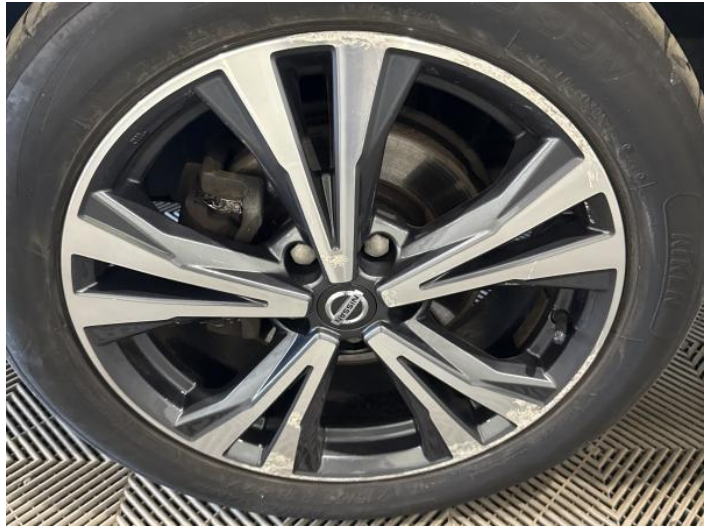
4: Wheel nsf  
Scratched  
Over 50mm

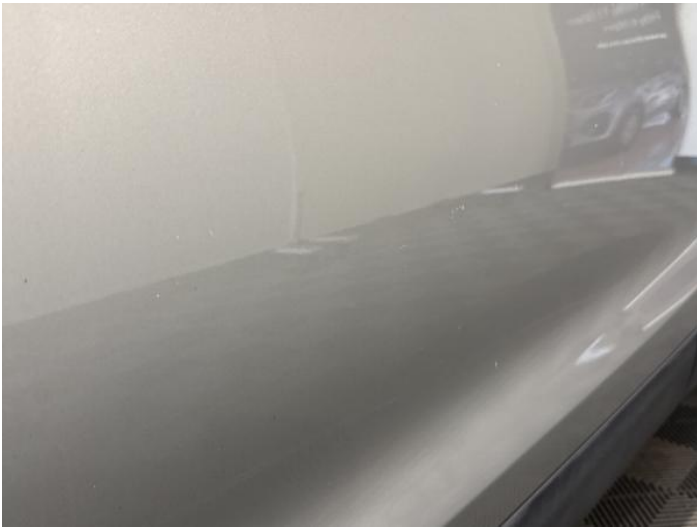
5: Door nsf  
Chipped  
Multiple Chips

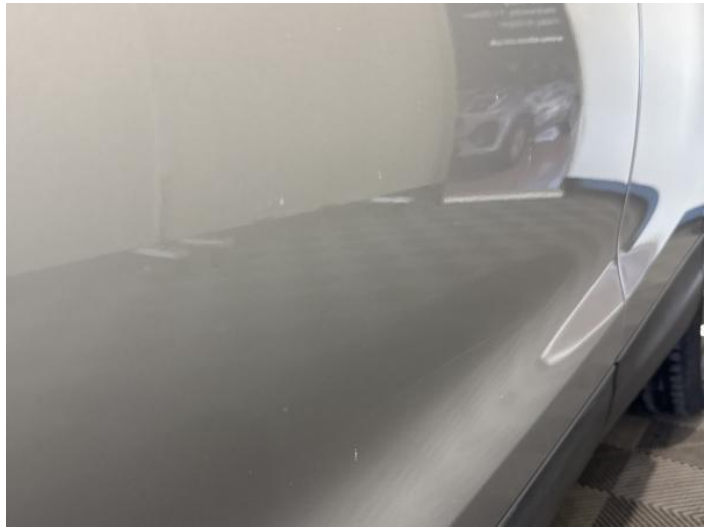
6: Door nsf  
Dented  
Between 10mm + 30mm

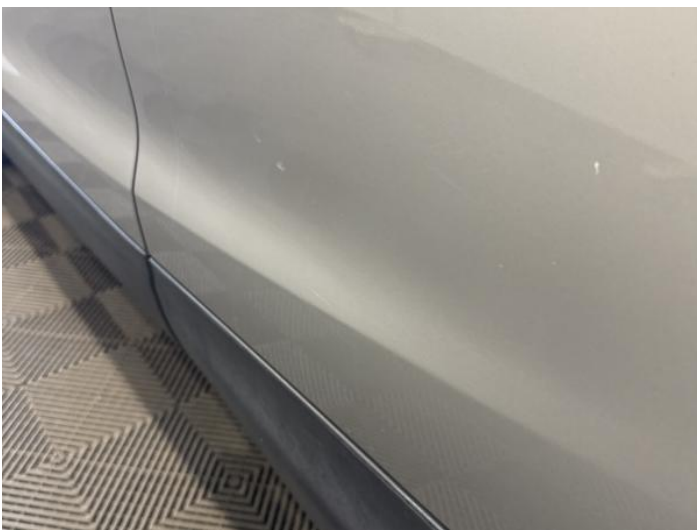
7: Door nsr  
Scratched  
Up To 25mm Thru Paint

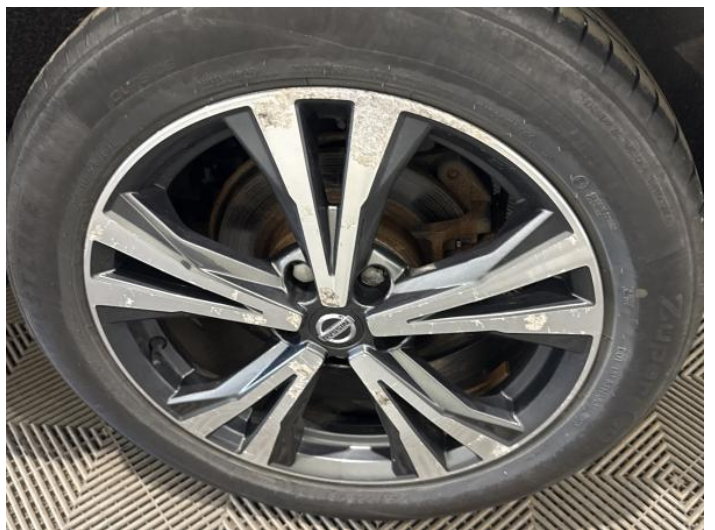
8: Wheel nsr  
Scratched  
Over 50mm

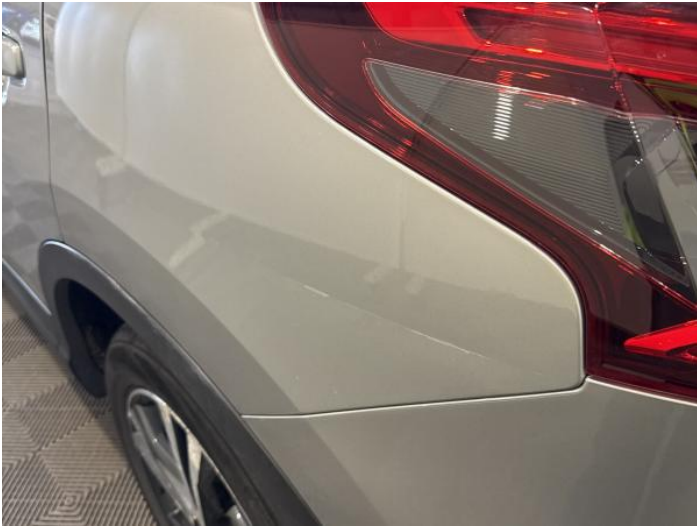
9: Qtr Panel nsr  
Dented  
With Paint Damage

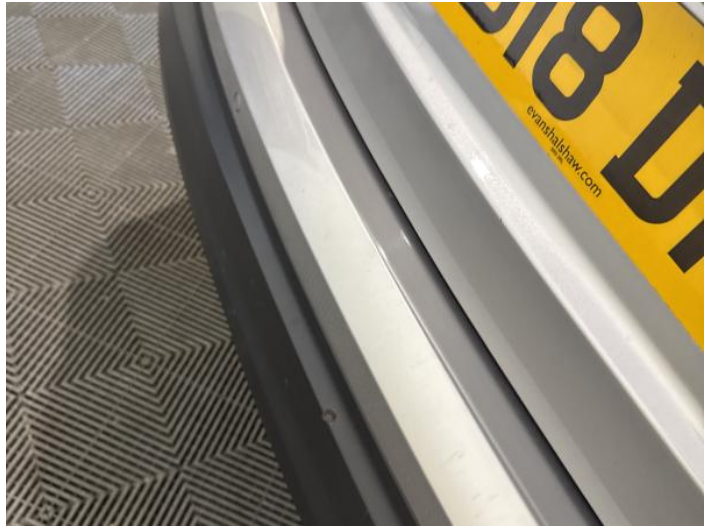
10: Bumper Rear  
Scratched  
25 to 100mm Thru Paint

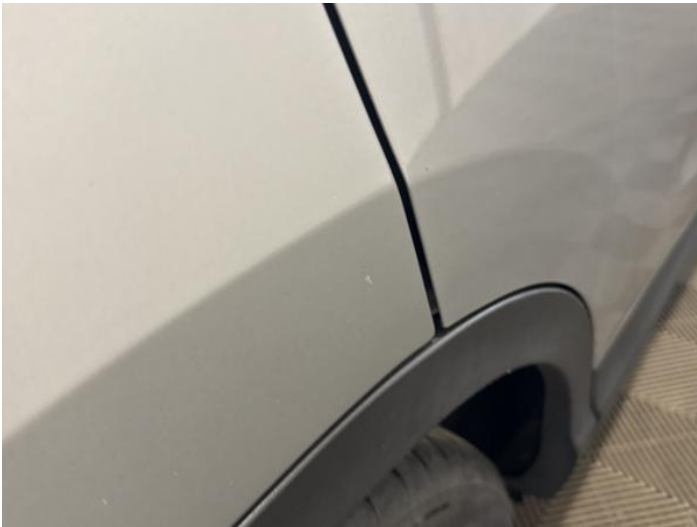
11: Qtr Panel osr  
Dented  
Between 10mm + 30mm

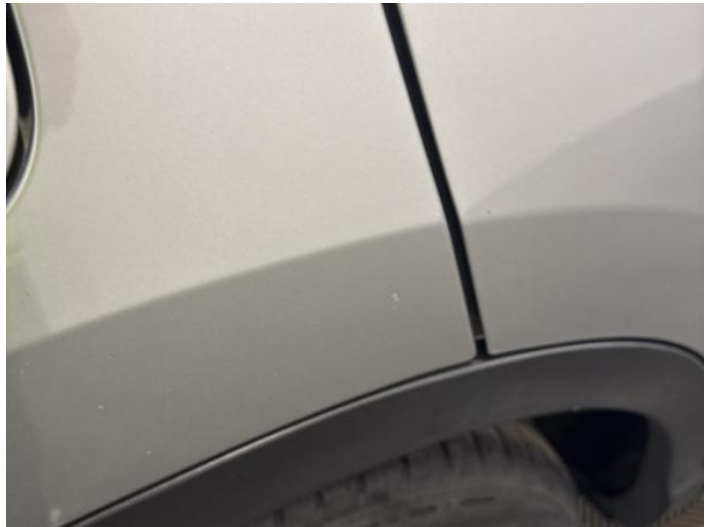
12: Qtr Panel osr  
Chipped  
1 To 5

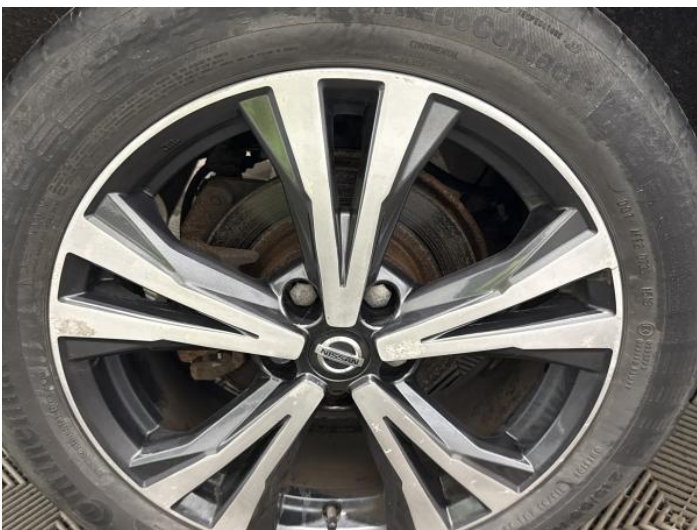
13: Wheel osr  
Corroded  
Light

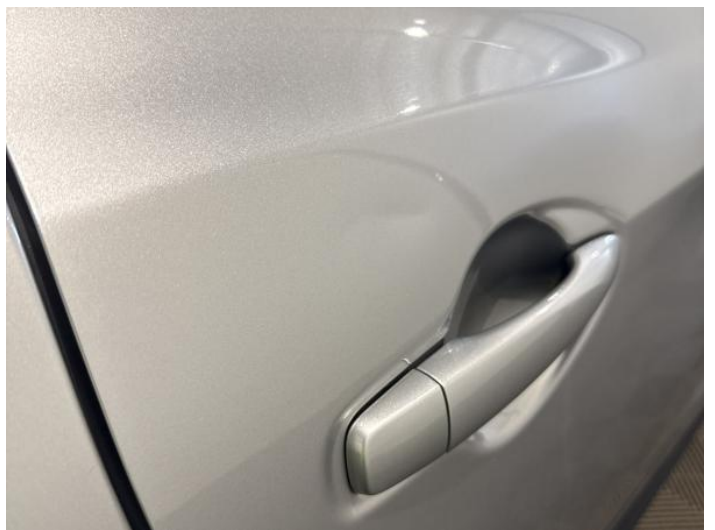
14: Door osr  
Dented  
Over 30mm

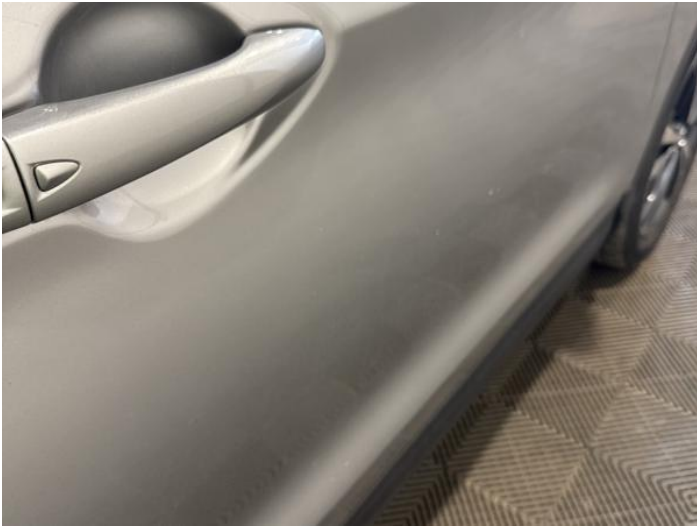
15: Door osf  
Chipped  
Multiple Chips

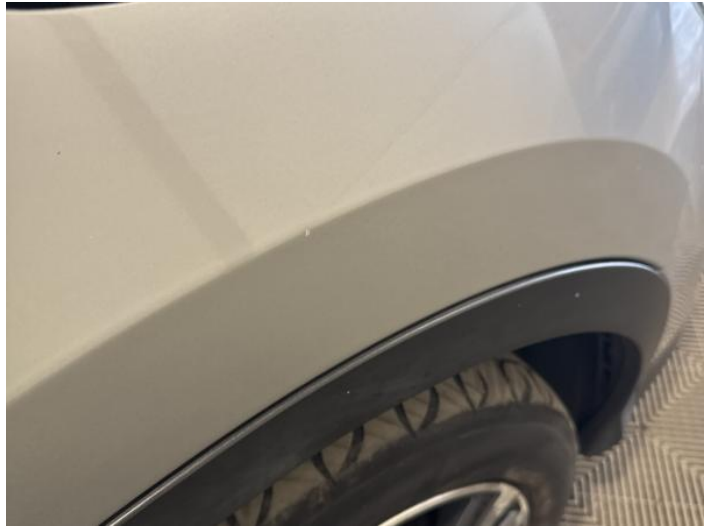
16: Wing osf  
Chipped  
1 To 5

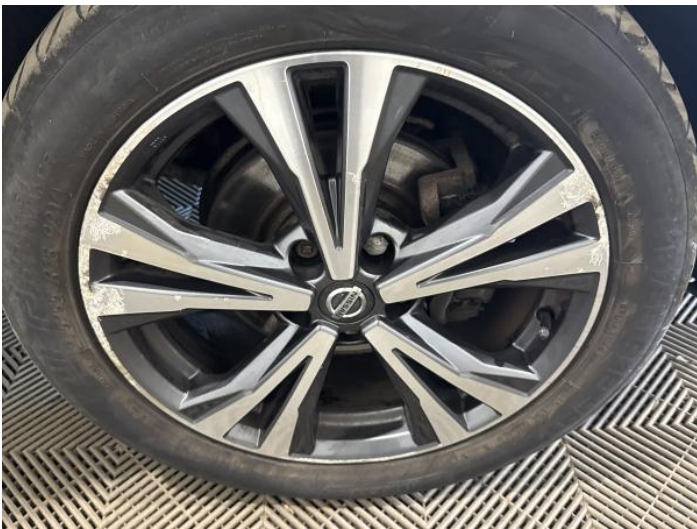
17: Wheel osf  
Scratched  
Over 50mm
