VEHICLE INSPECTION REPORT

HW18KPU

Ford Kuga 2.0 TDCi 180 Titanium 5dr Auto

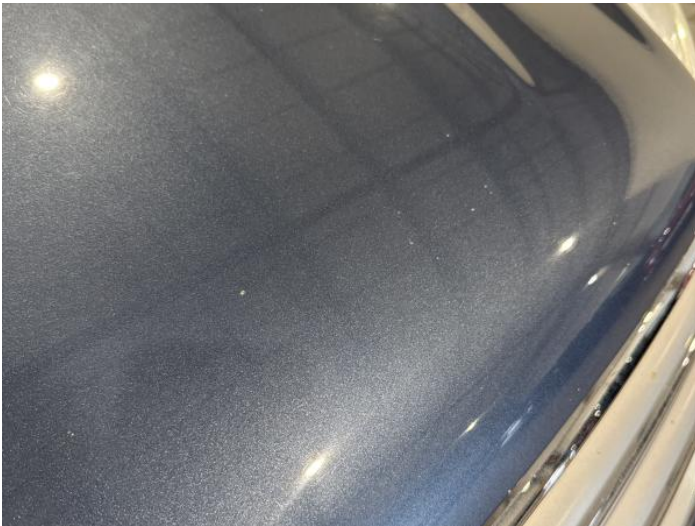
1: Bonnet
Chipped
Multiple Chips

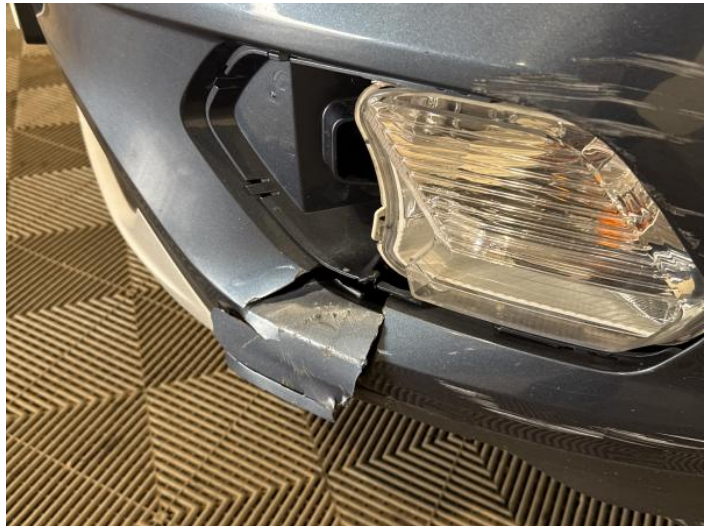
2: Bumper Front
Cracked
Over 25mm

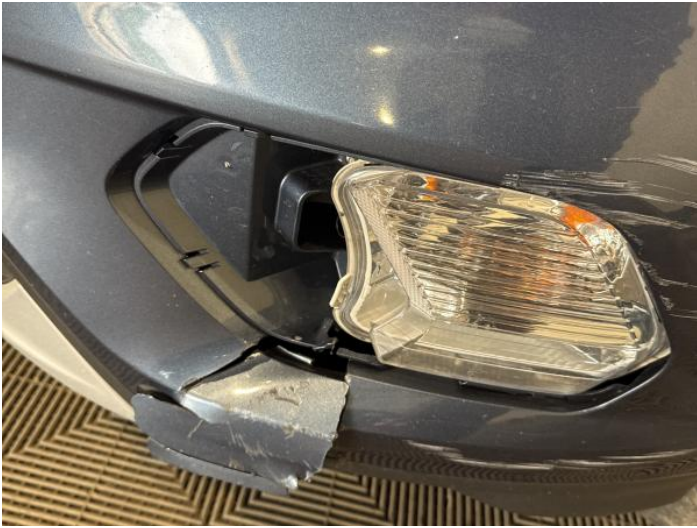
3: Fog Lamp Surround ns
Broken
Replace

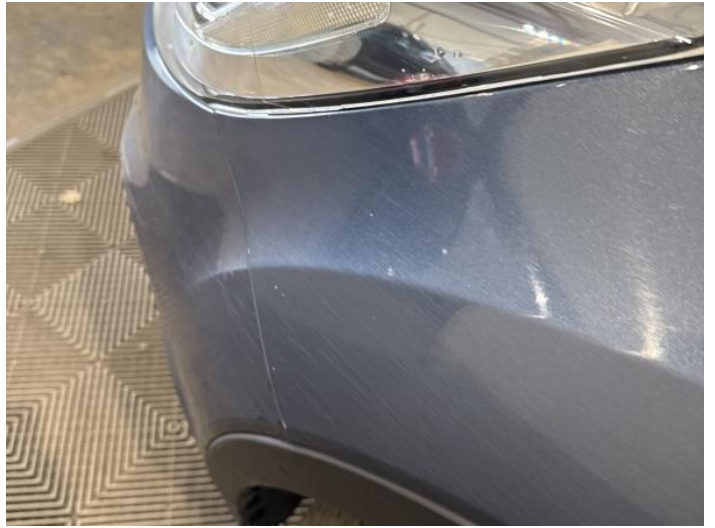
4: Wing nsf
Chipped
1 To 5

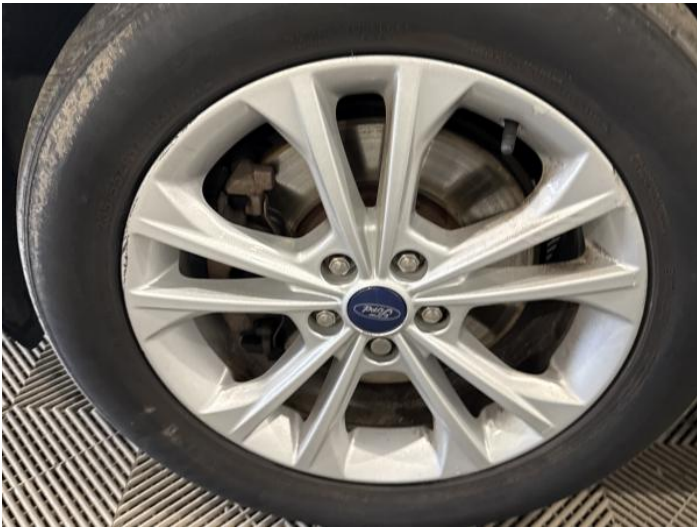
5: Wheel nsf
Scratched
Over 50mm

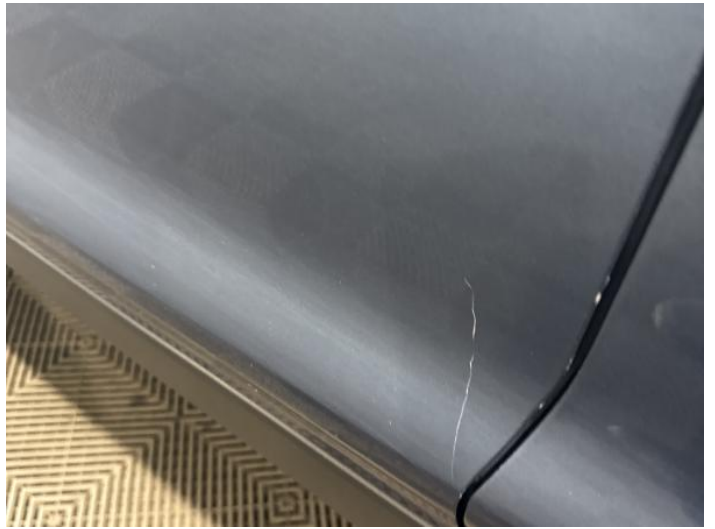
6: Door nsf
Scratched
Over 25mm Thru Paint

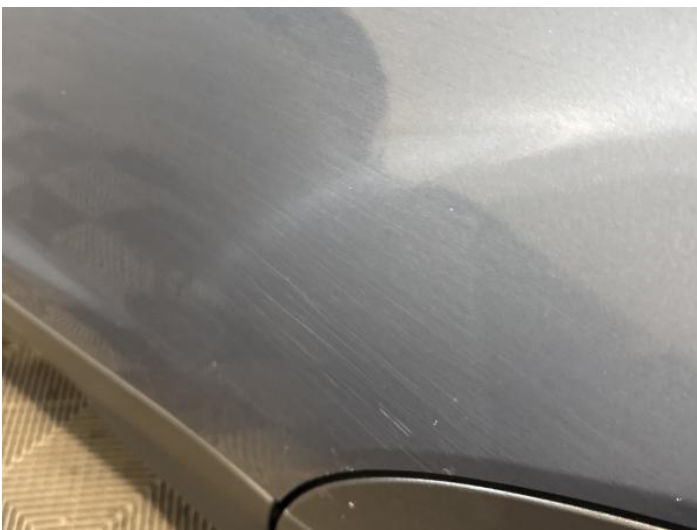
7: Door nsr
Scratched
Over 25mm Thru Paint

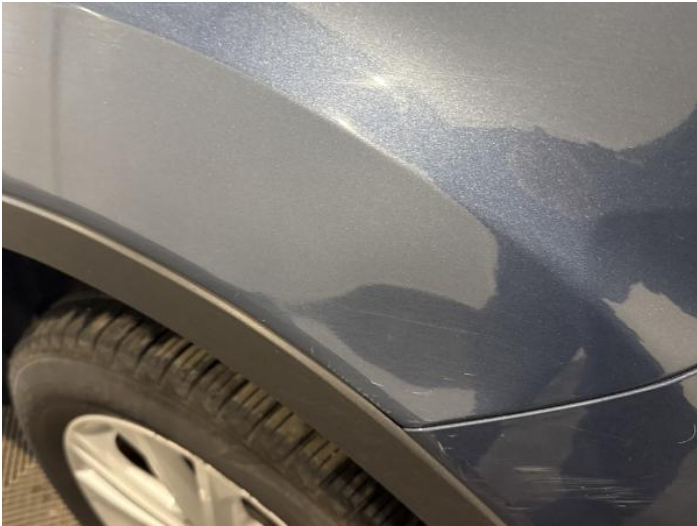
9: Qtr Panel nsr
Dented
Over 30mm

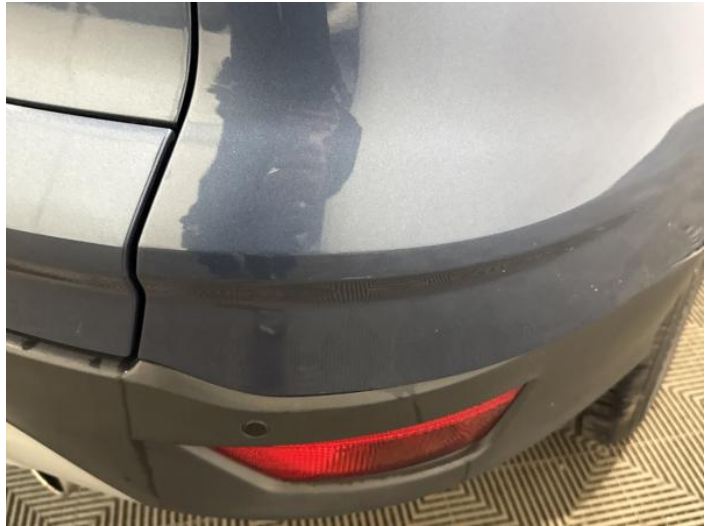
10: Bumper Rear
Scratched
25 to 100mm Thru Paint

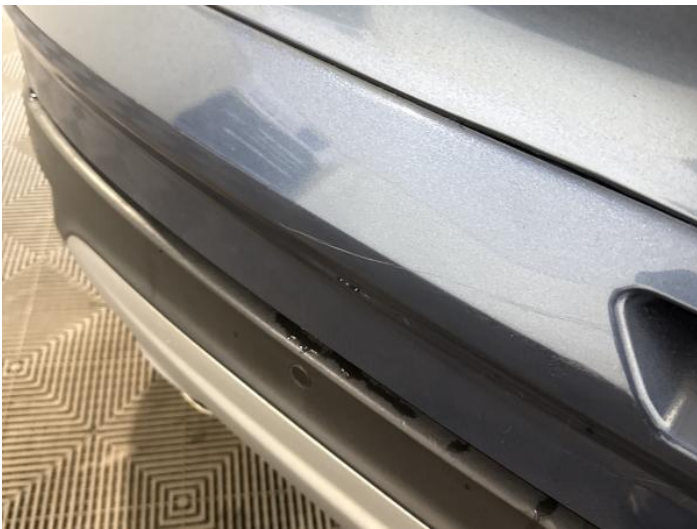
11: Tailgate
Scratched
Over 25mm Thru Paint

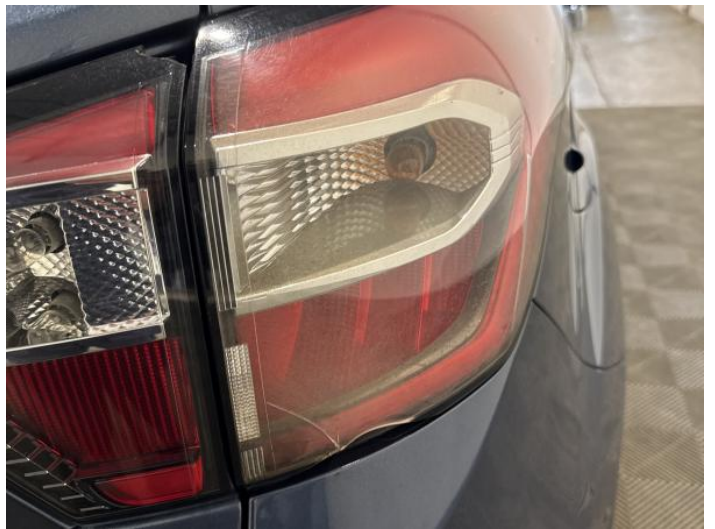
12: Lamp nsr
Broken
Replace

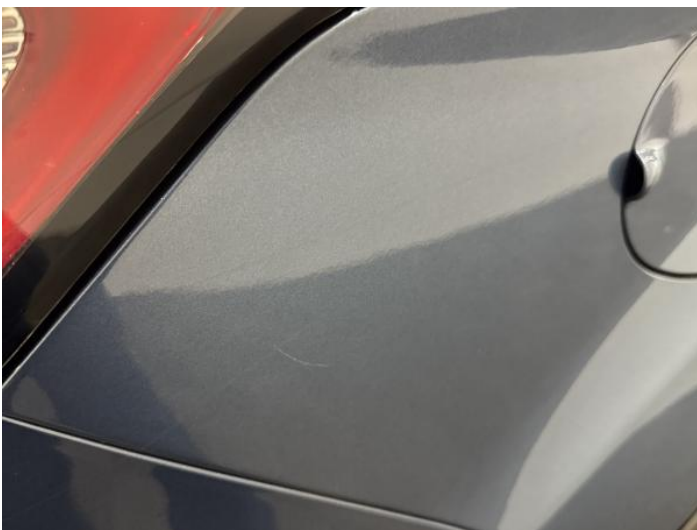
13: Qtr Panel osr
Scratched
Up To 25mm Thru Paint

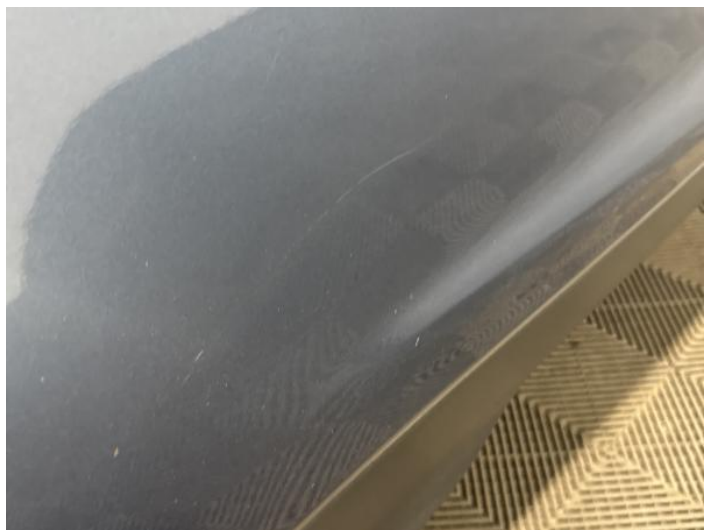
14: Door osr
Scratched
Over 25mm Thru Paint

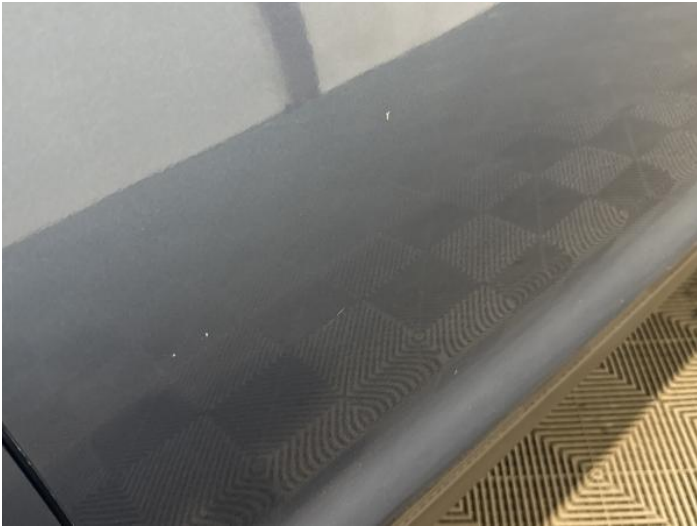
15: Door osf
Chipped
1 To 5

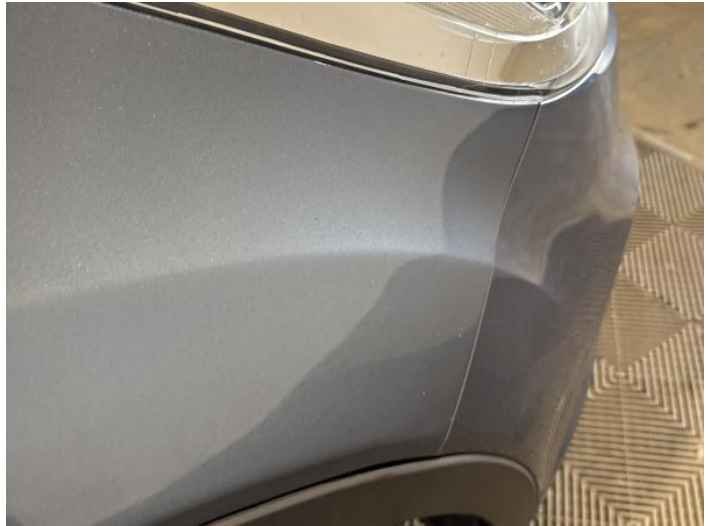
16: Wing osf
Chipped
1 To 5

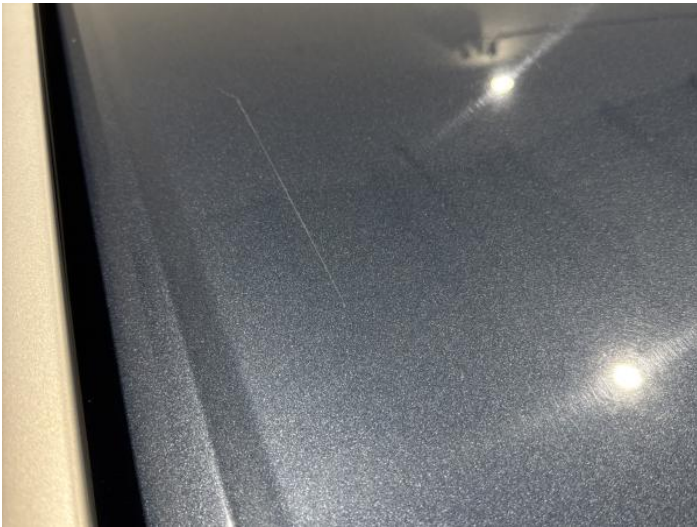
17: Roof
Scratched
Over 25mm Thru Paint

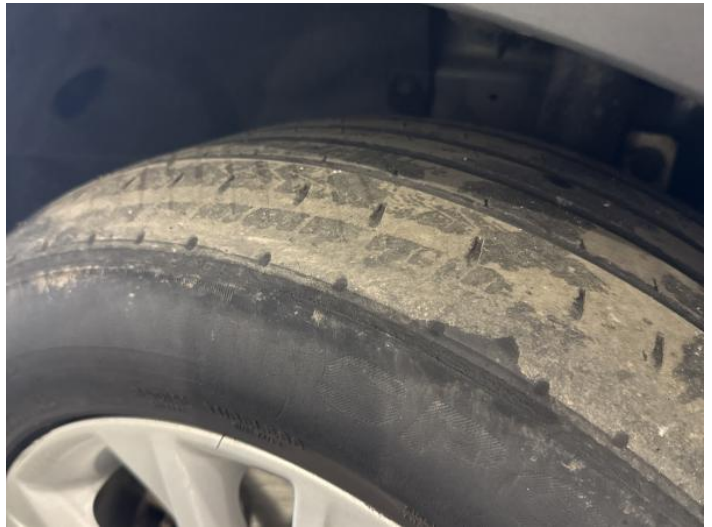
| NSF | SUNNY | Damaged |

18: Tyre nsf
Damaged
Replace
