VEHICLE INSPECTION REPORT

MK13BMY

Kia Venga 1.4 EcoDynamics 2 5dr

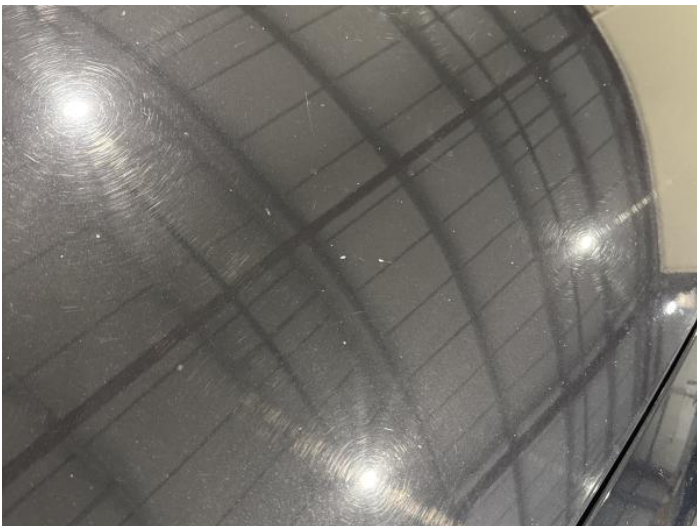
1: Bonnet
Chipped
Multiple Chips

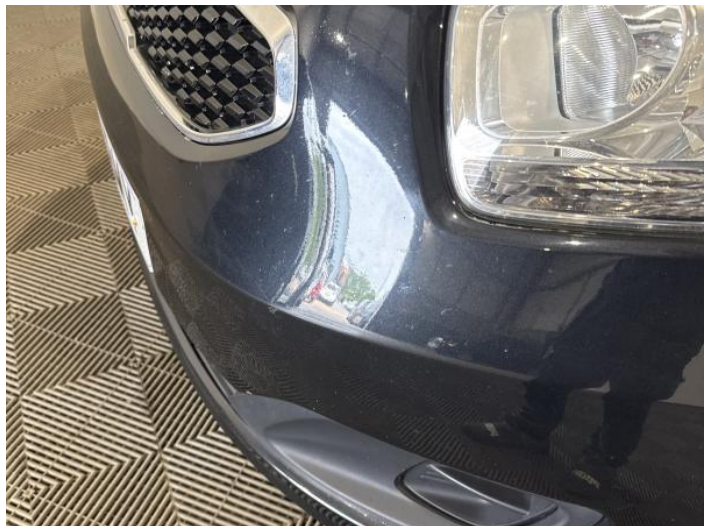
2: Bumper Front
Poor Previous Repair
Poor Paint

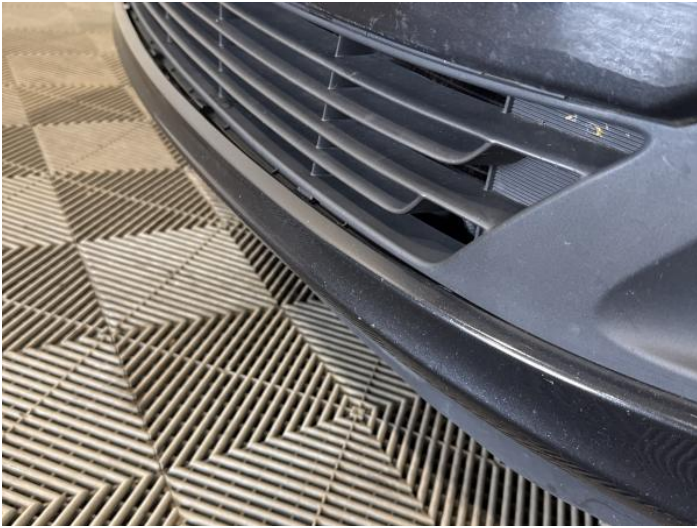
3: Bumper Front Grill
Broken
Replace

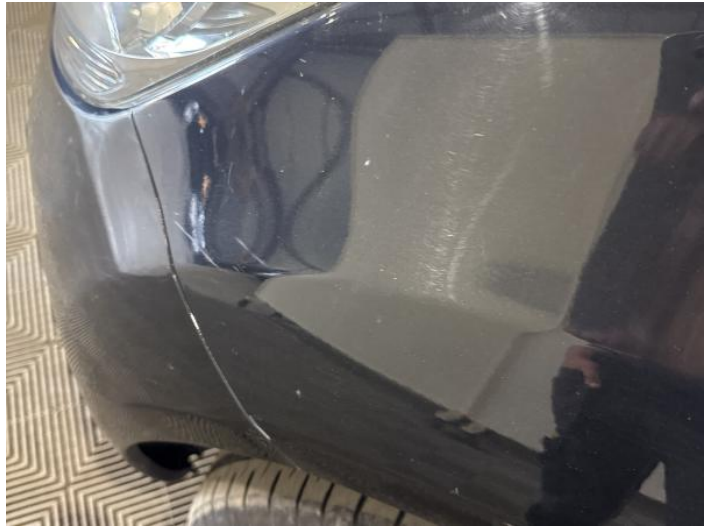
4: Wing nsf
Scratched
Over 25mm Thru Paint

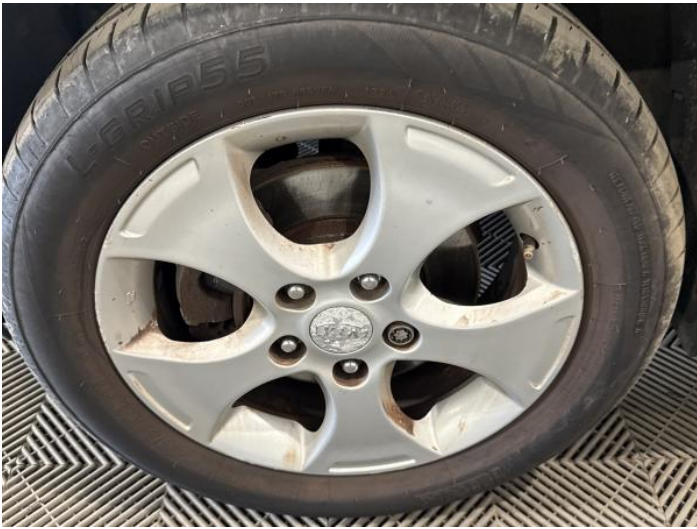
5: Wheel nsf
Scratched
Over 50mm

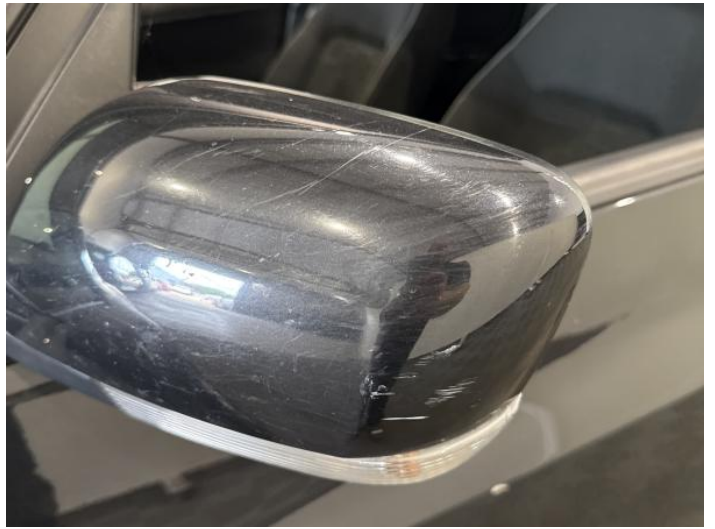
6: Door Mirror Assy nsf
Scratched (Painted)
UpTo 25mm Thru Paint

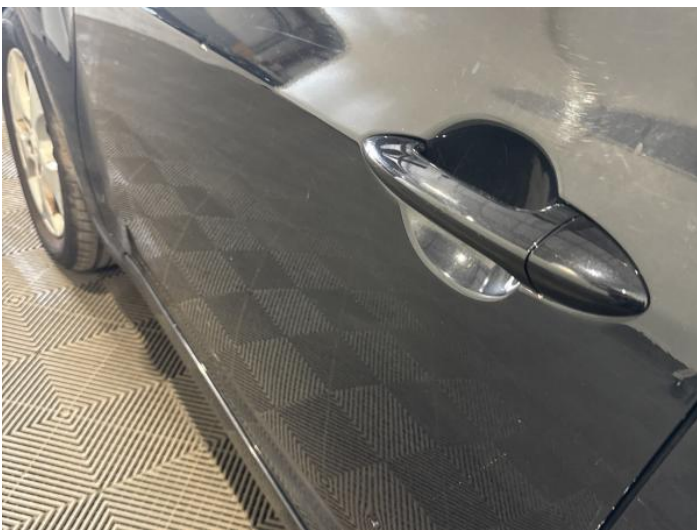
7: Door nsf
Dented
With Paint Damage

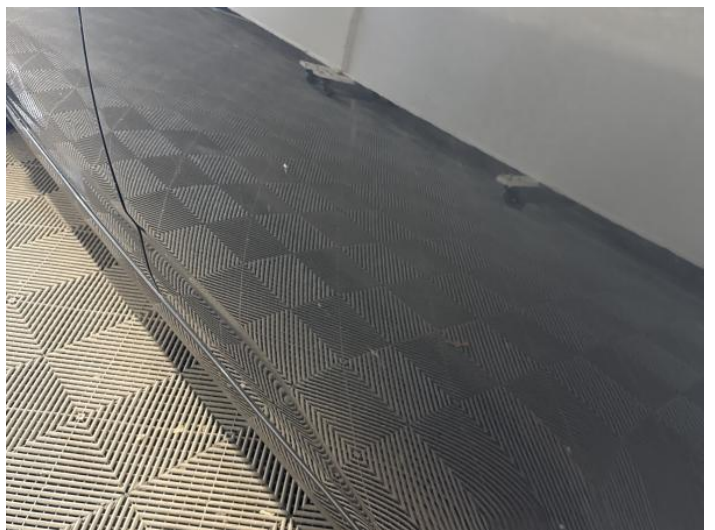
8: Door nsr
Scratched
Over 25mm Thru Paint

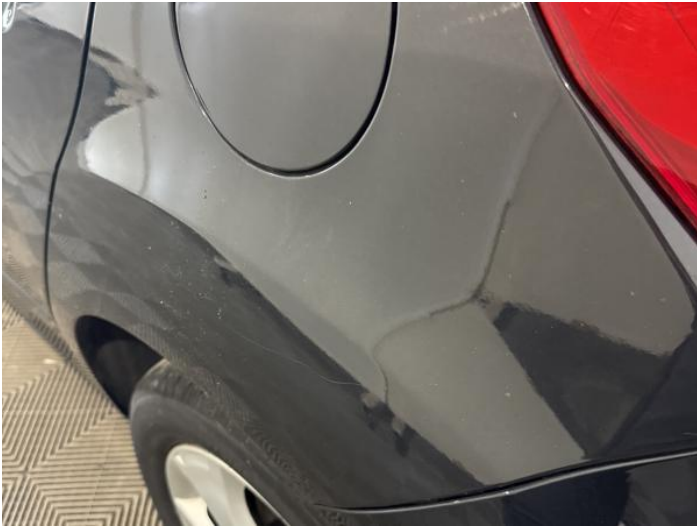
9: Qtr Panel nsr
Scratched
Over 25mm Thru Paint

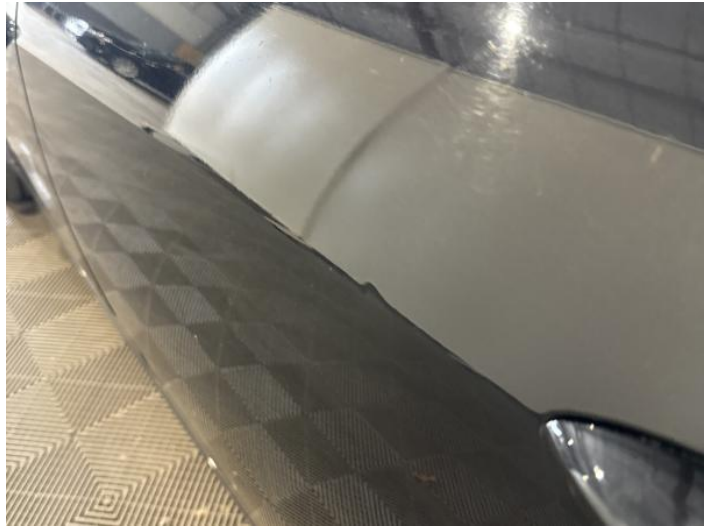
10: Door nsr
Dented
Between 10mm + 30mm

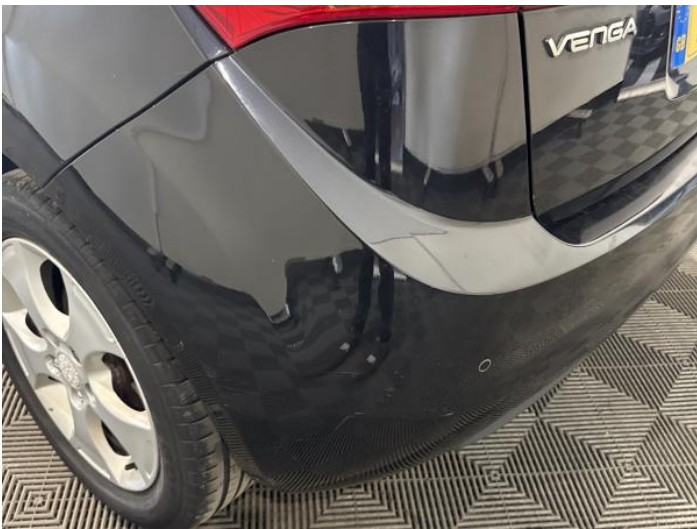
11: Bumper Rear
Scratched
25 to 100mm Thru Paint

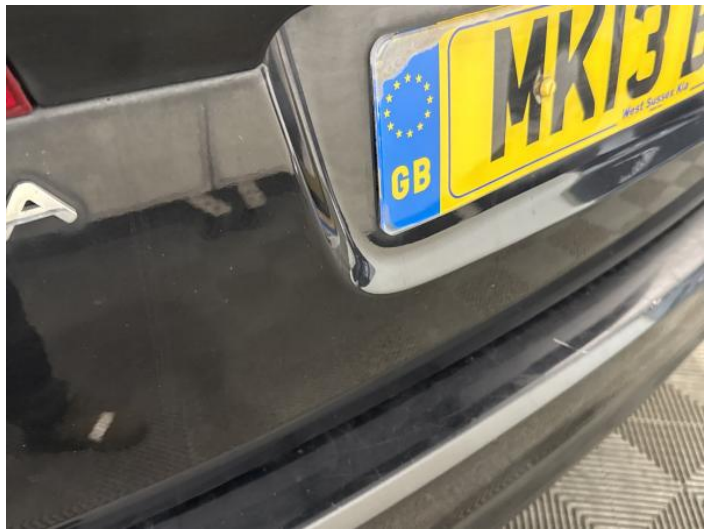
12: Tailgate
Scratched
UpTo 25mm Thru Paint

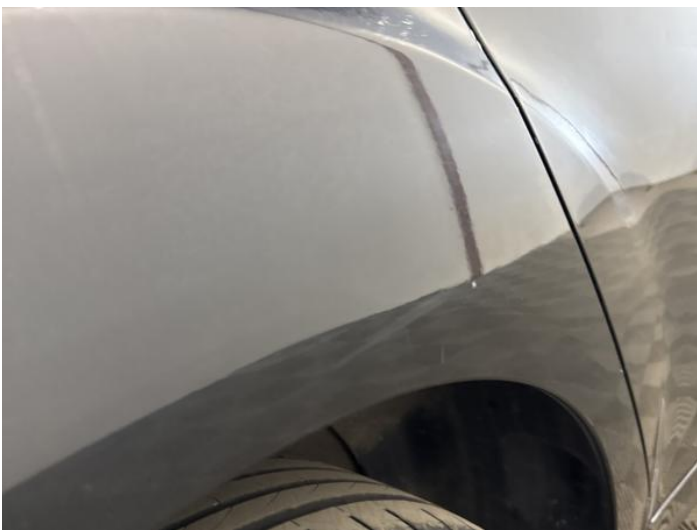
13: Qtr Panel osr
Scratched
Over 25mm Thru Paint

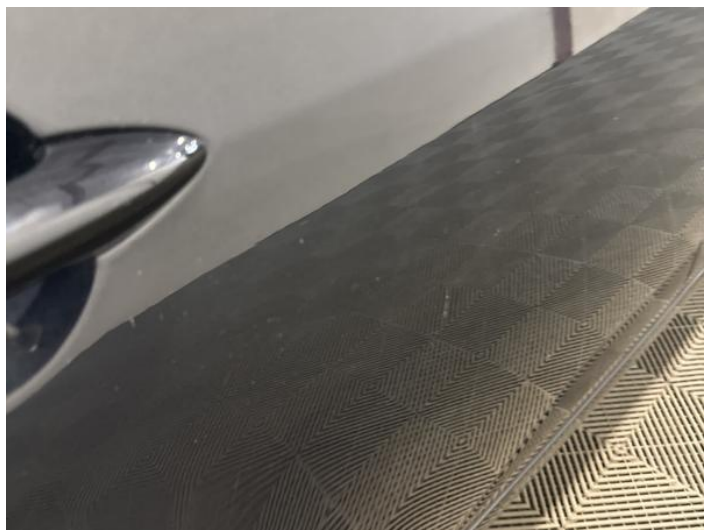
14: Door osr
Dented
Between 10mm + 30mm

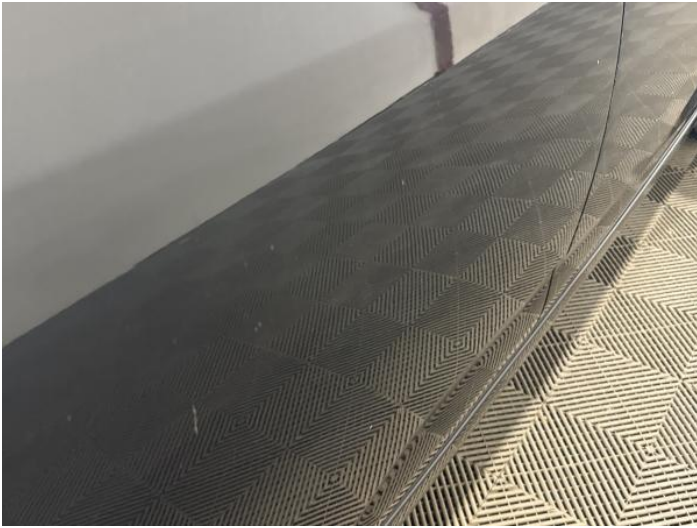
15: Door osr
Scratched
Over 25mm Thru Paint

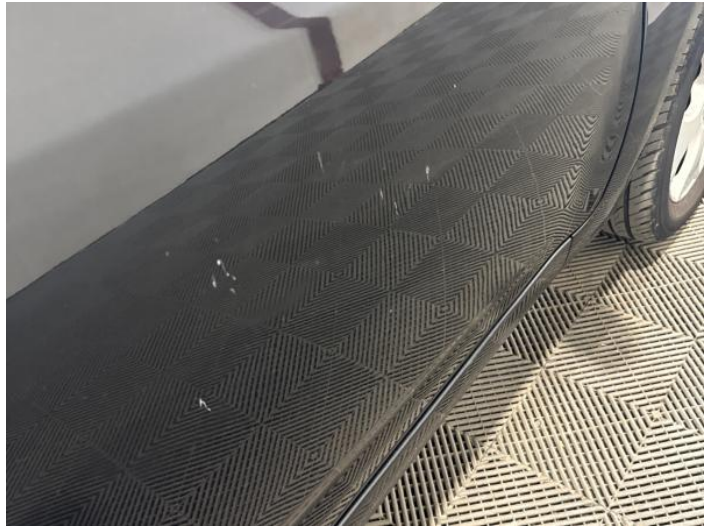
16: Door osf
Scratched
Over 25mm Thru Paint

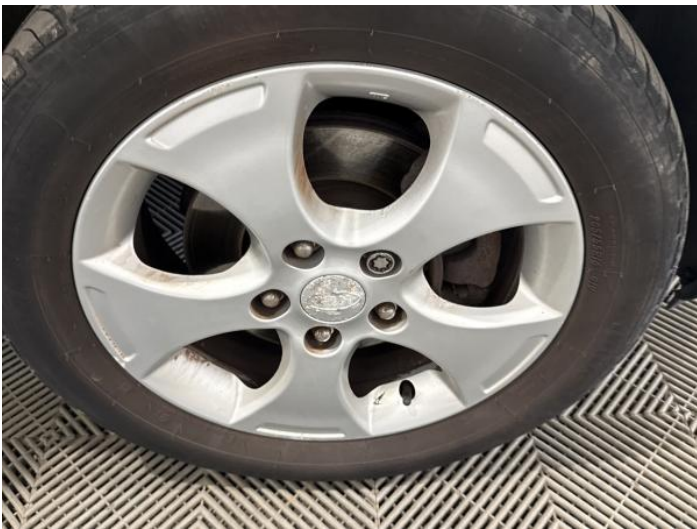
17: Wheel osf
Scratched
Over 50mm

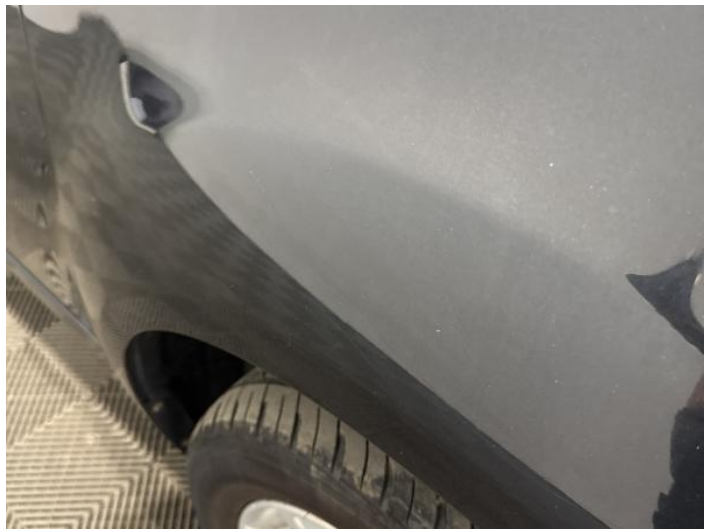
18: Wing osf
Scratched
Over 25mm Thru Paint

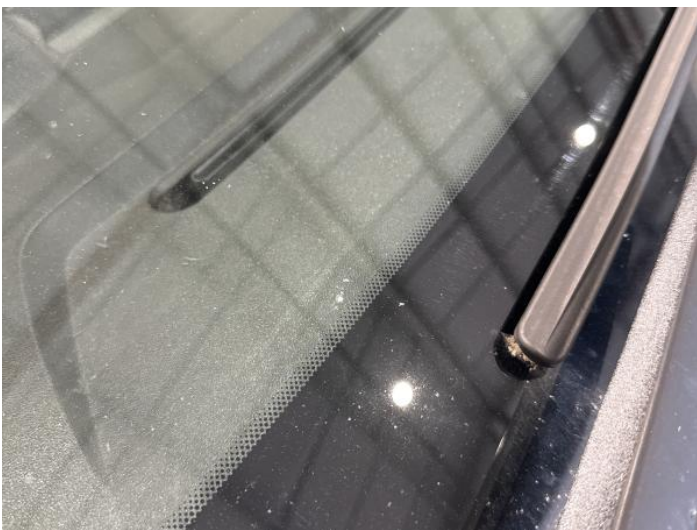
19: Screen Front
Chipped
UpTo 10mm

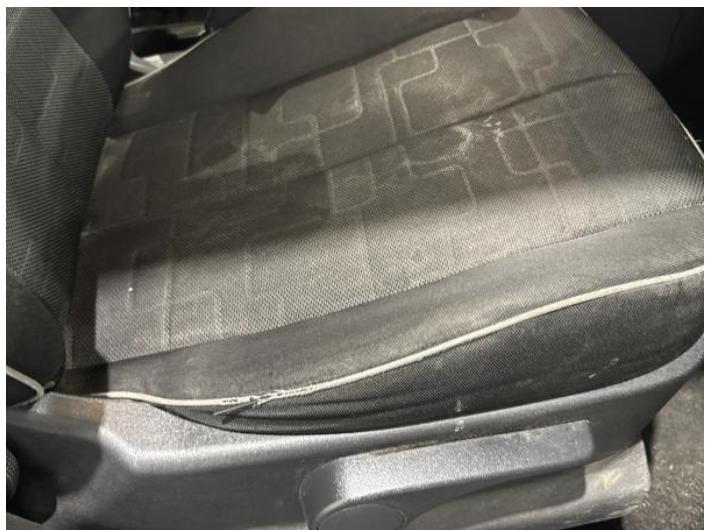
20: Seat Base Cover osf
Scuffed
Over 25mm
