VEHICLE INSPECTION REPORT

BJ63TWZ

Ford Focus 1.6 TDCi 115 Zetec 5dr

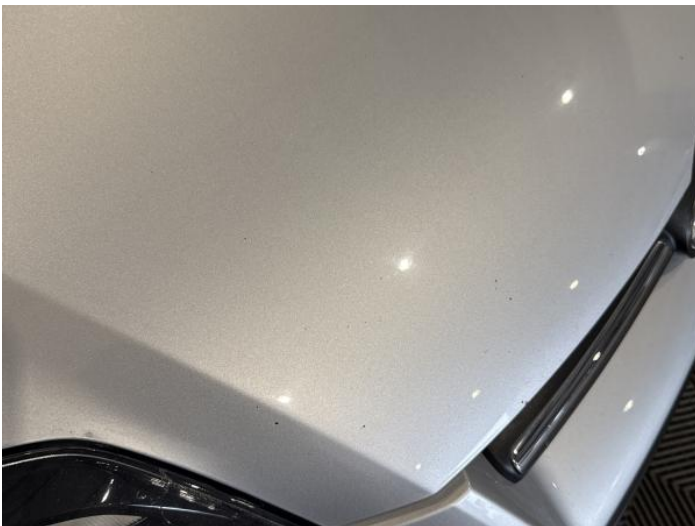
1: Bonnet
Chipped
Multiple Chips

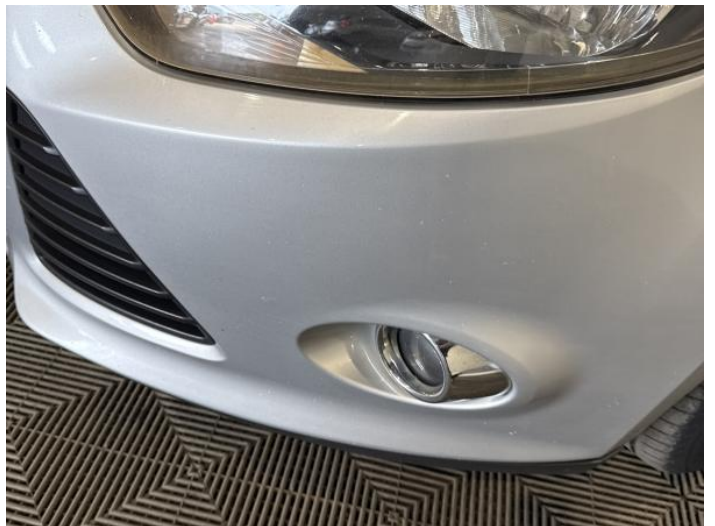
2: Bumper Front
Chipped
Multiple Chips

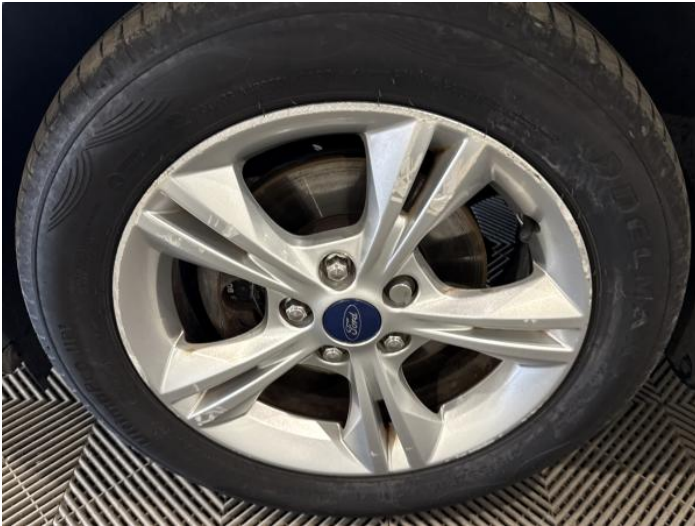
3: Wheel nsf
Scratched
Over 50mm

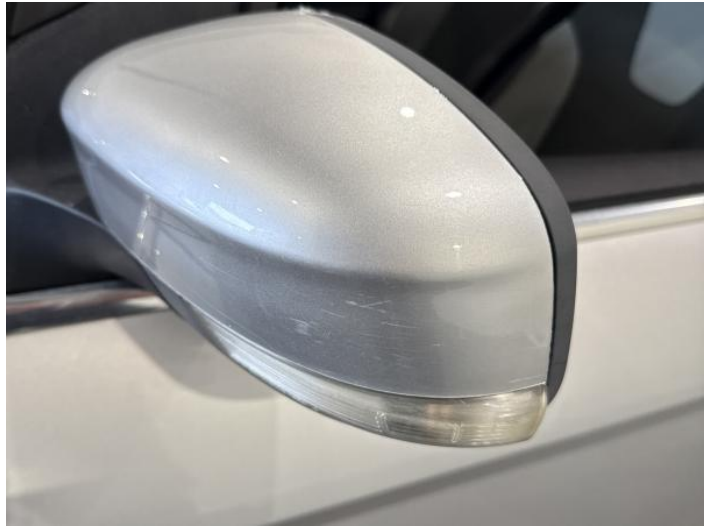
4: Door Mirror Assy nsf
Scratched (Painted)
UpTo 25mm Thru Paint

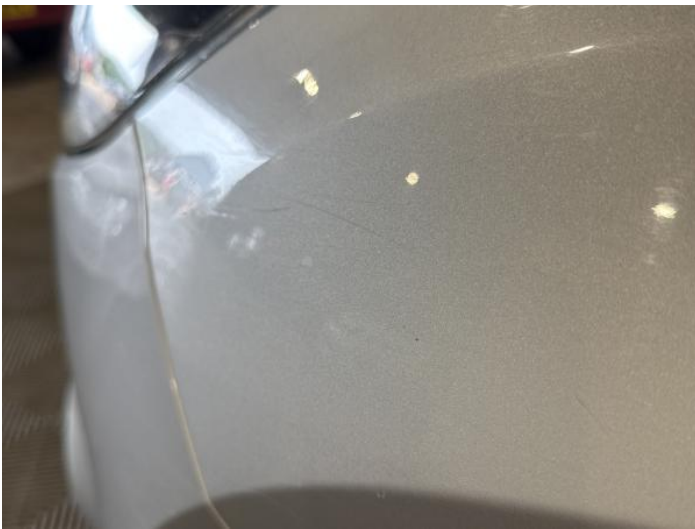
5: Wing nsf
Chipped
1 To 5

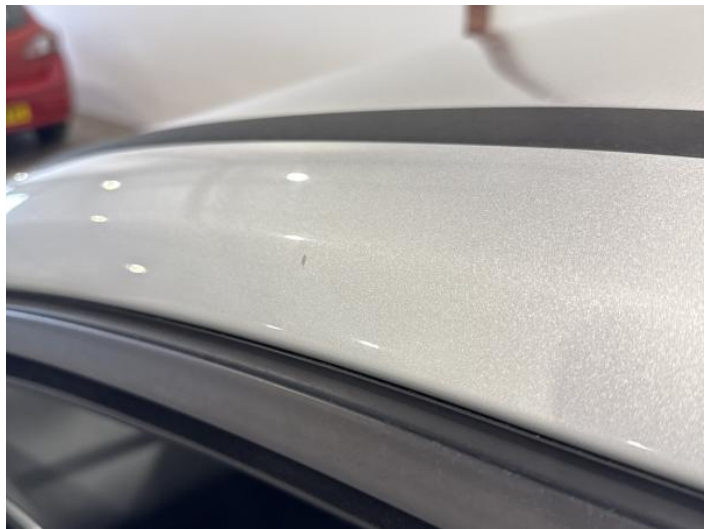
6: A Post ns
Dented
2 Or Less UpTo 10mm

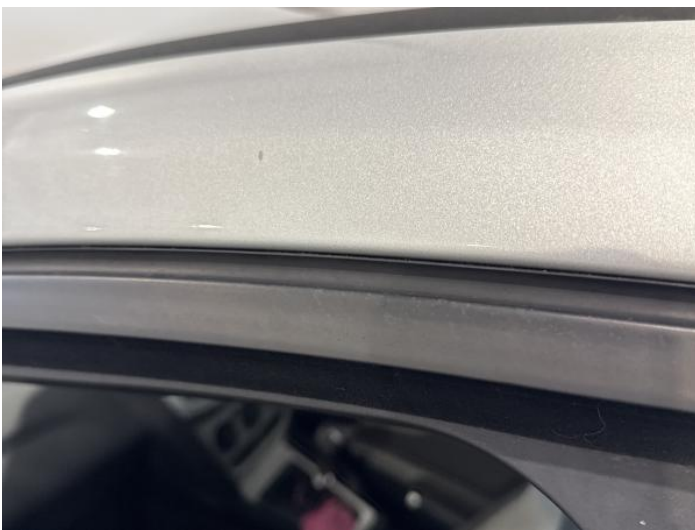
7: A Post ns
Chipped
1 To 5

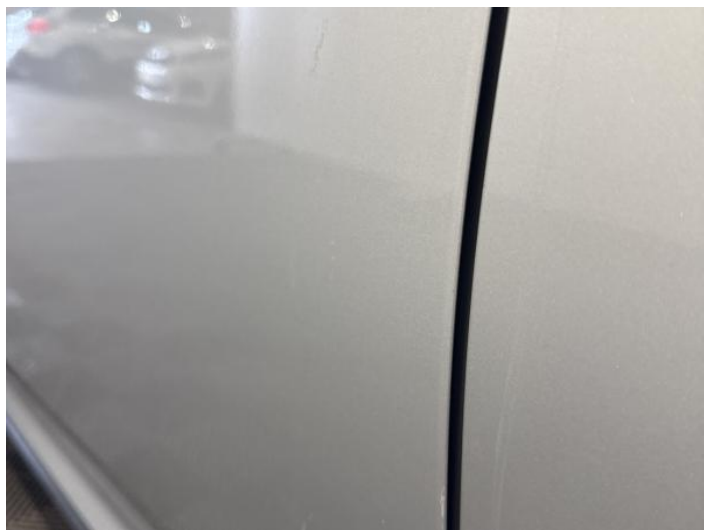
8: Door nsf
Scratched
Over 25mm Thru Paint

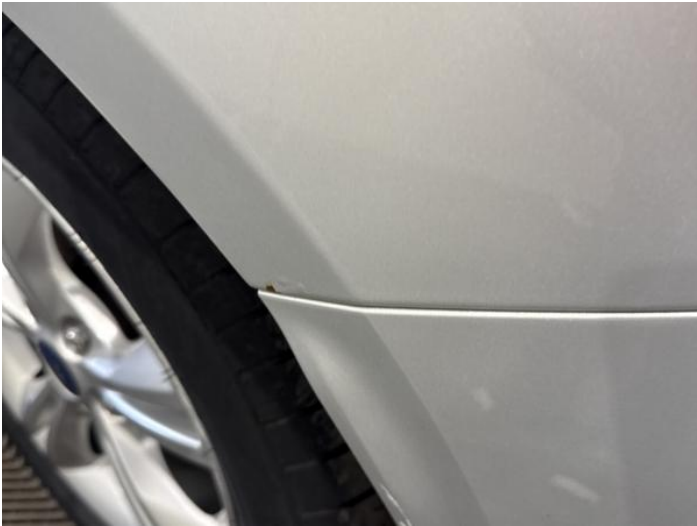
9: Qtr Panel nsr
Scratched
Rusted

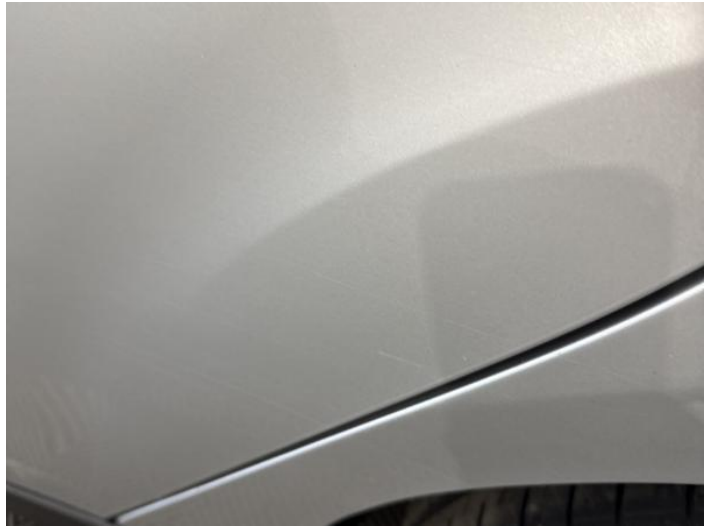
10: Door nsr
Dented
Over 30mm

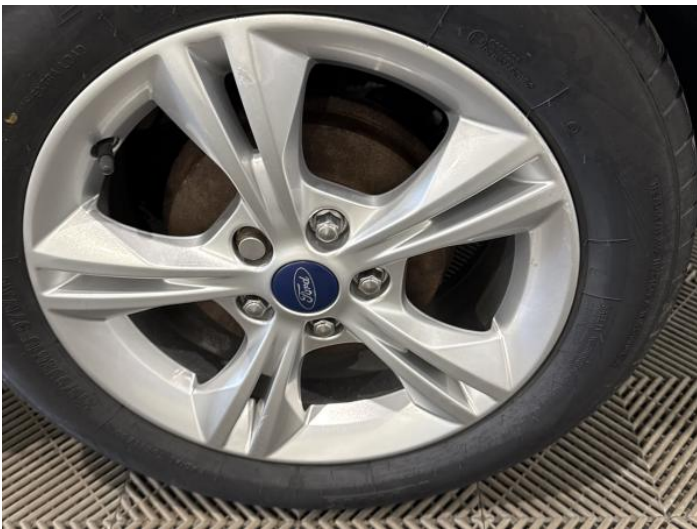
11: Wheel nsr
Scratched
Over 50mm

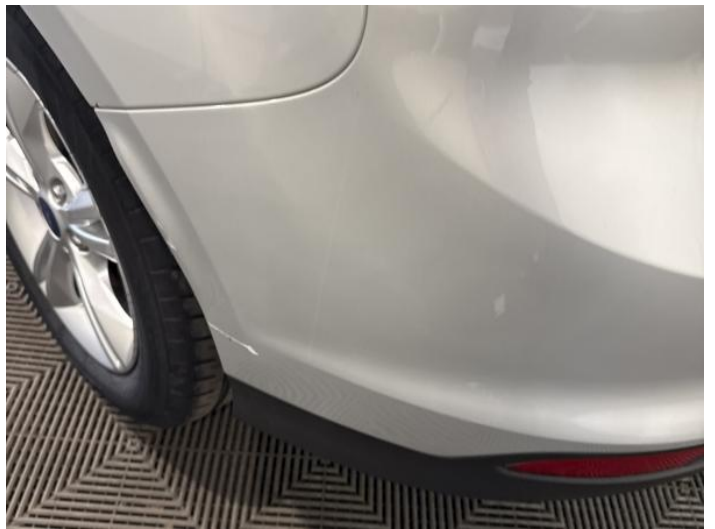
12: Bumper Rear
Scratched
25 to 100mm Thru Paint

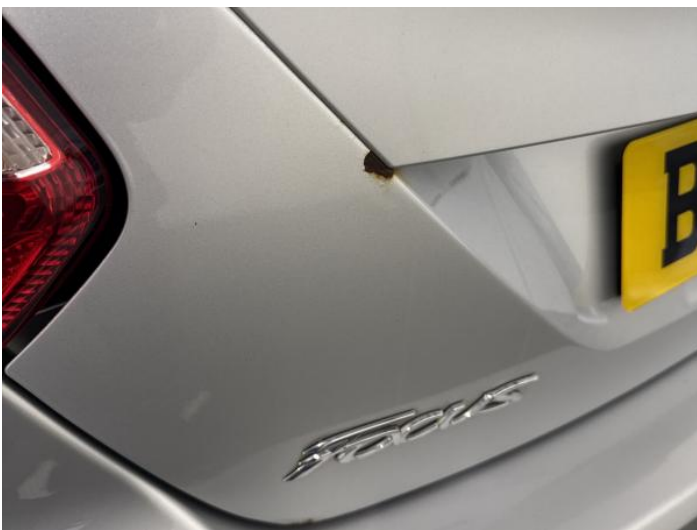
13: Tailgate
Rusted
Over 5mm

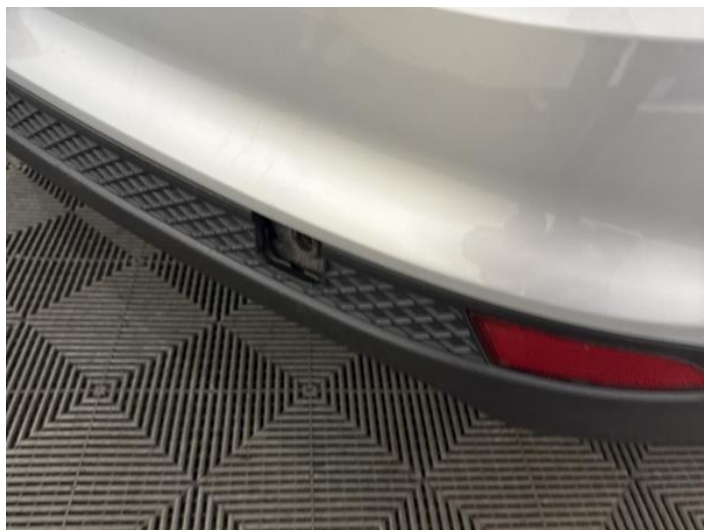
14: Rear TowEye Cvr
Missing
Replace

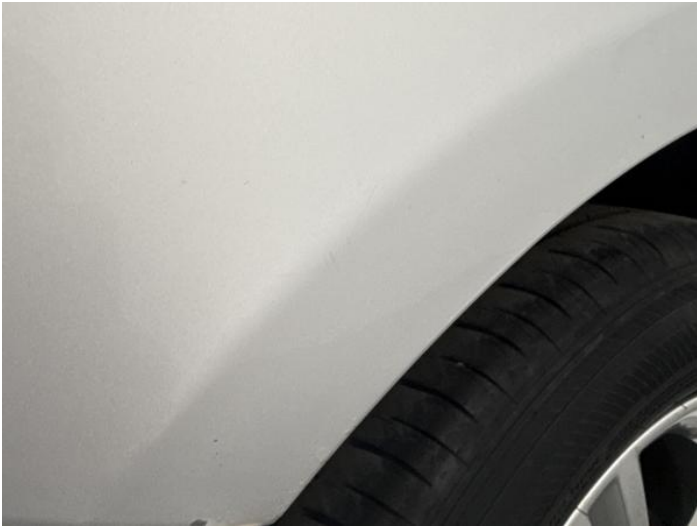
15: Qtr Panel osr
Scratched
Rusted

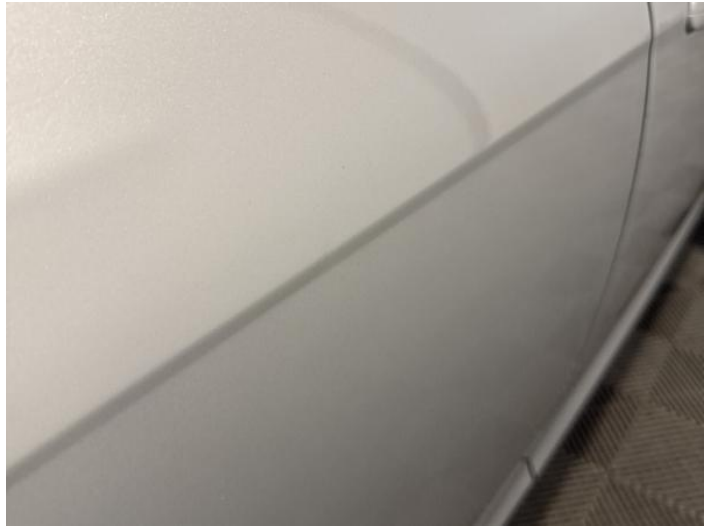
16: Door osr
Dented
Between 10mm + 30mm

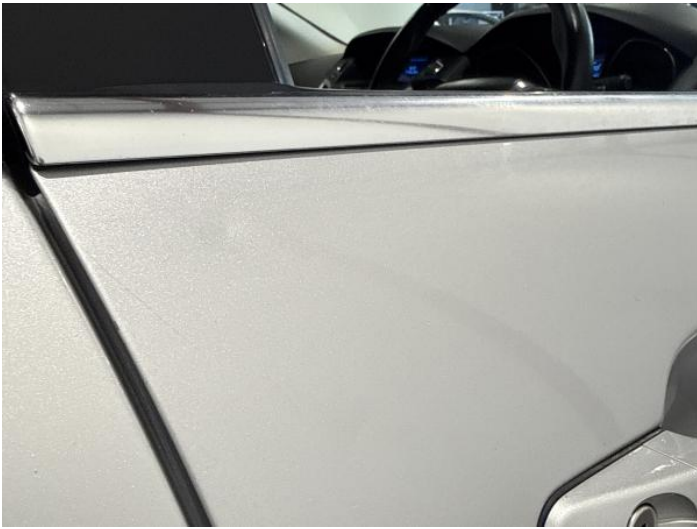
17: Door osf
Dented
Between 10mm + 30mm

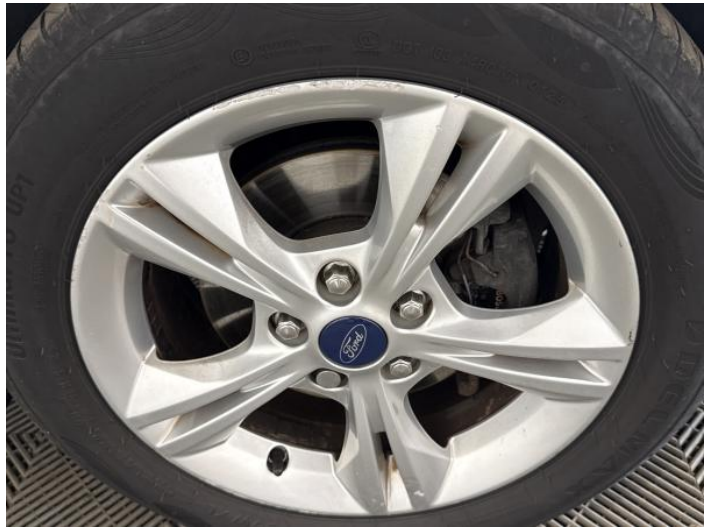
18: Wheel osf
Scratched
Over 50mm

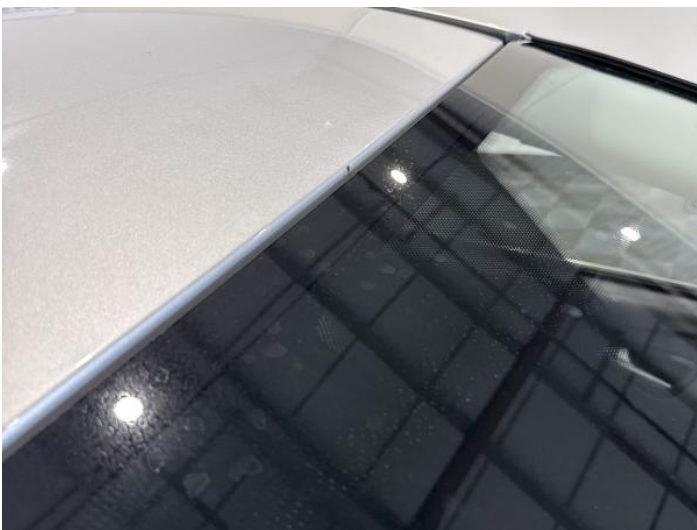
19: Roof
Chipped
Edge Chip
