# VEHICLE INSPECTION REPORT

**HN67EUV**

## Peugeot 2008 1.2 PureTech Allure 5dr

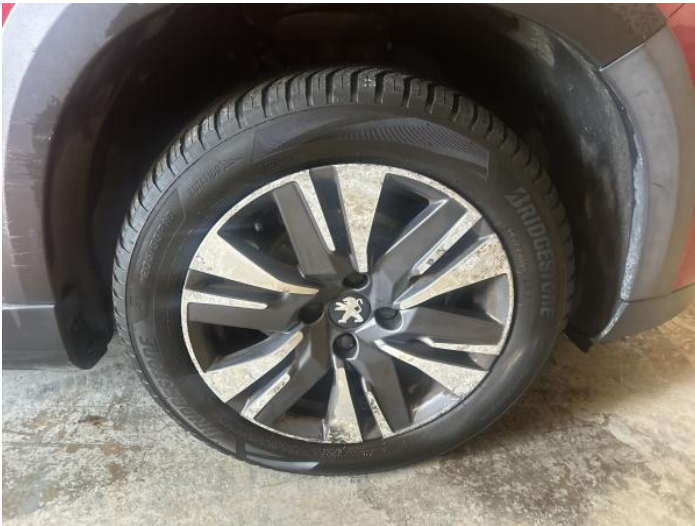
1: Wheel osf  
Corroded  
Light

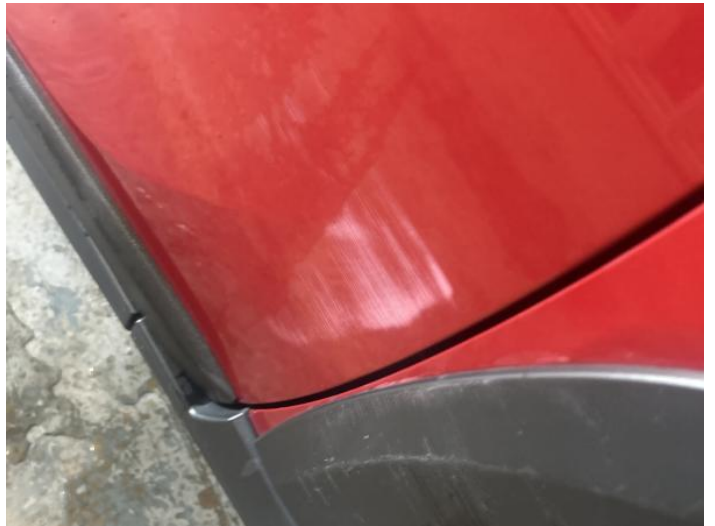
2: Door osf  
Scratched  
Over 25mm Thru Paint

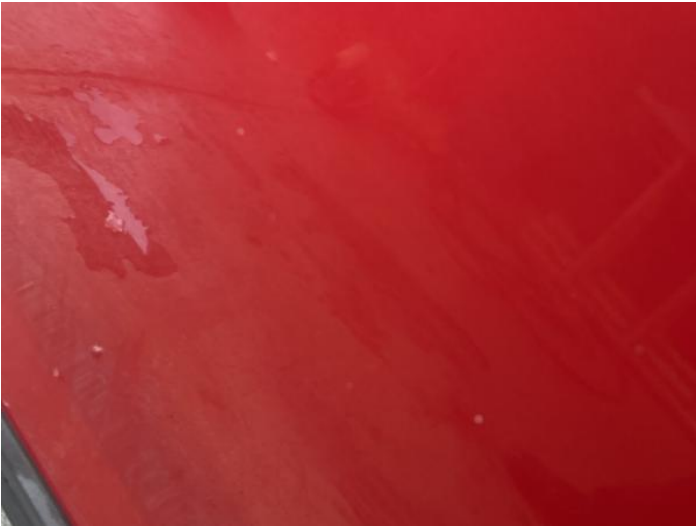
3: Door osr  
Chipped  
1 To 5

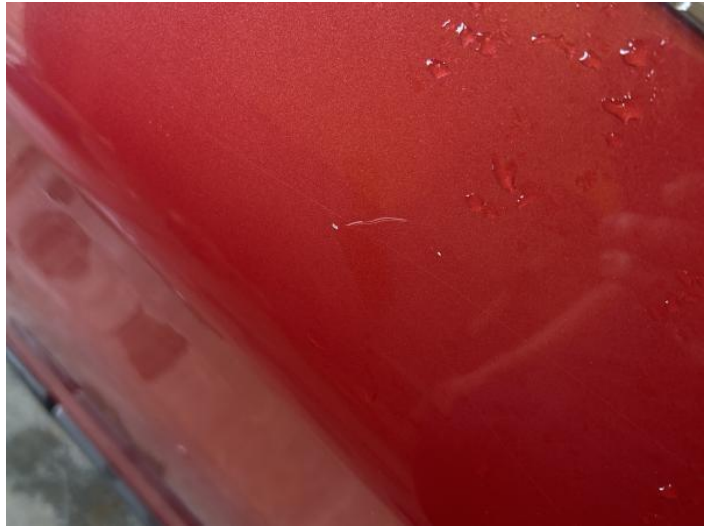
4: Door osr  
Scratched  
Up To 25mm Thru Paint

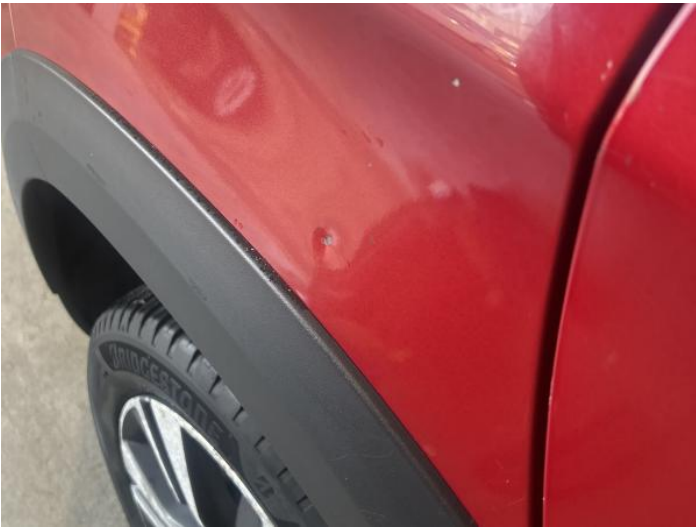
5: Qtr Panel osr  
Dented  
With Paint Damage

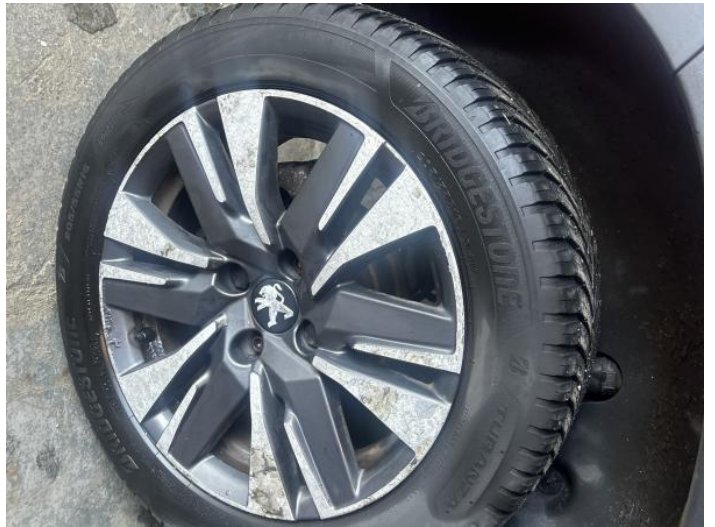
6: Wheel osr  
Corroded  
Light

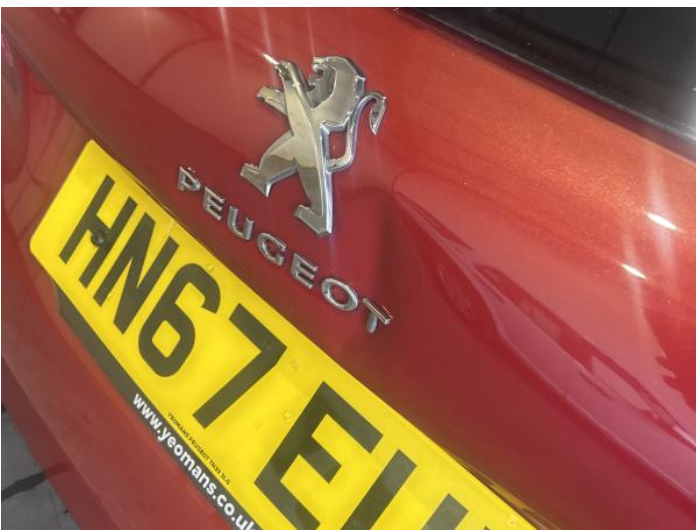
7: Tailgate  
Dented  
Over 30mm

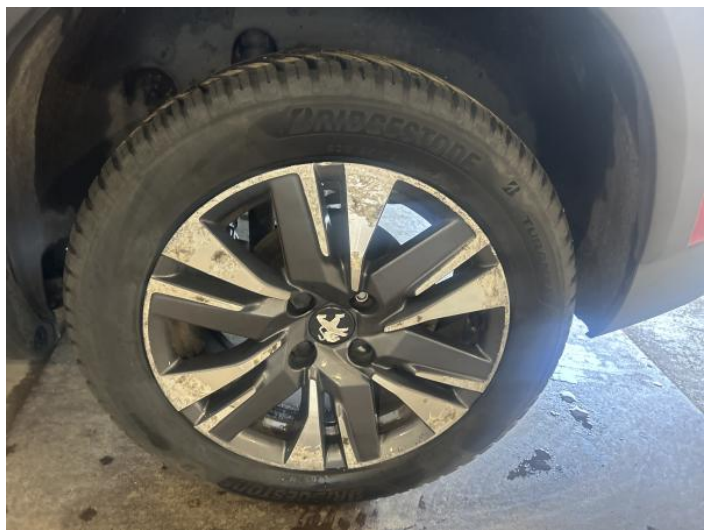
8: Wheel nsr  
Corroded  
Light

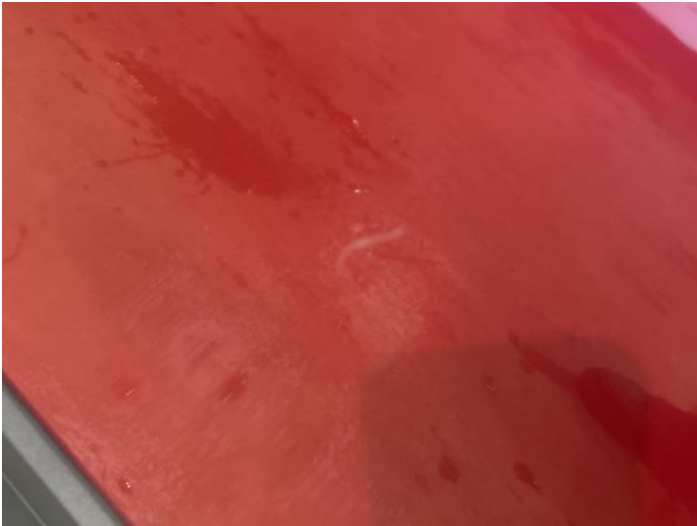
9: Door nsr  
Scratched  
UpTo 25mm Thru Paint

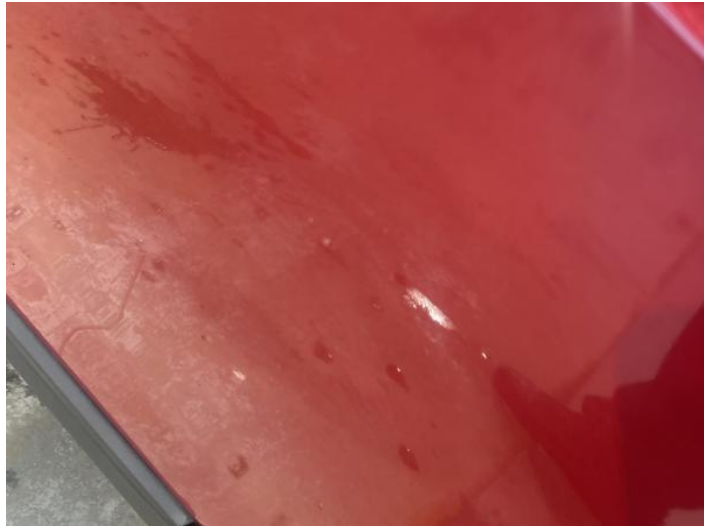
10: Door nsr  
Chipped  
1 To 5

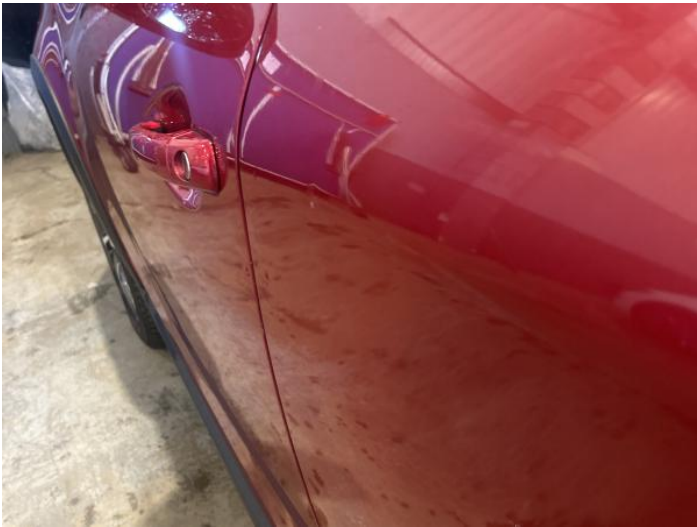
11: Door nsr  
Dented  
2 Or Less UpTo 10mm

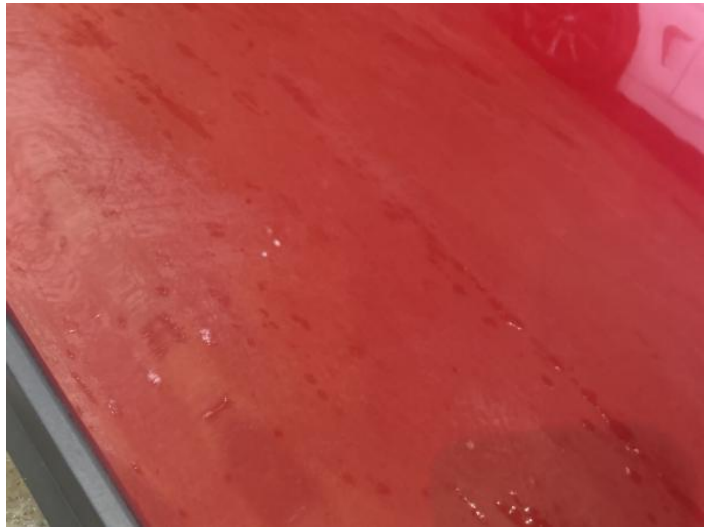
12: Door nsf  
Chipped  
1 To 5

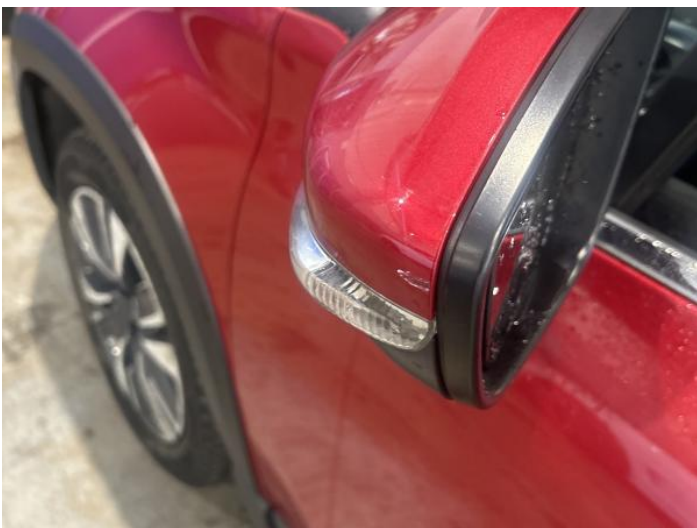
13: Door Mirror Assy nsf  
Scratched (Painted)  
UpTo 25mm Thru Paint

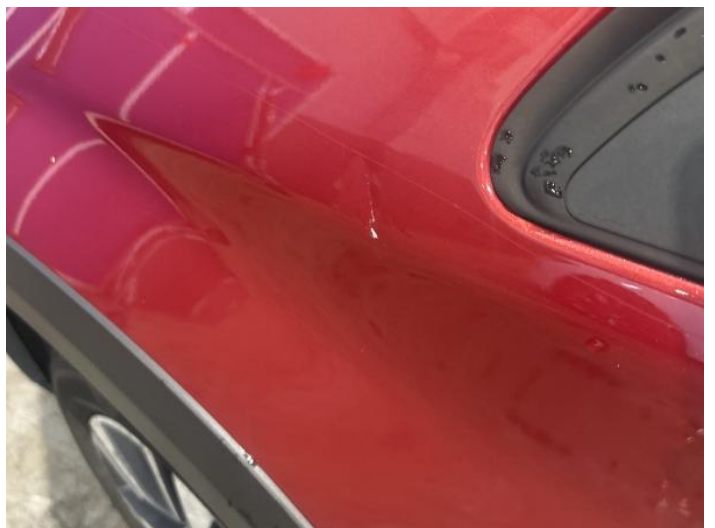
14: Wing nsf  
Dented  
With Paint Damage

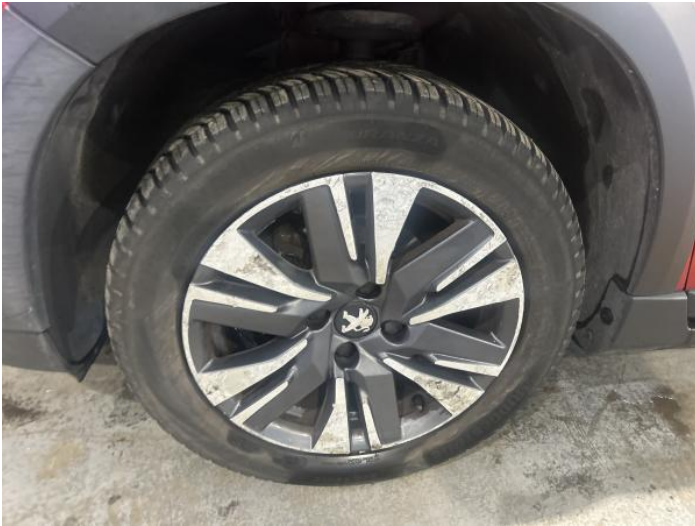
15: Wheel nsf  
Corroded  
Light

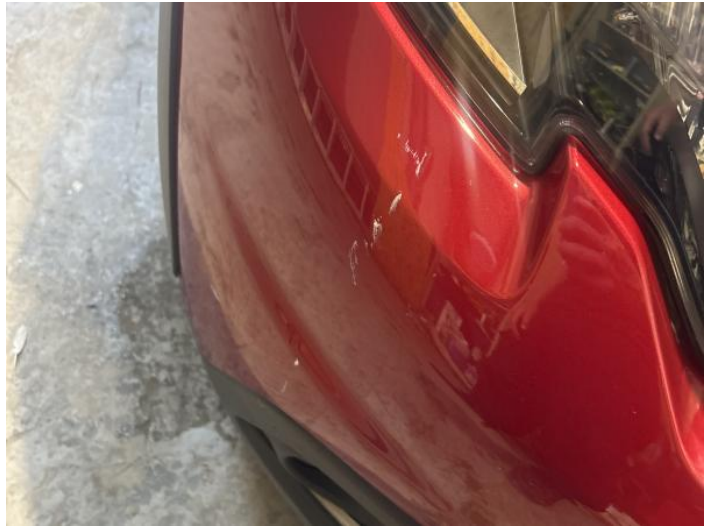
16: Bumper Front  
Scratched  
25 to 100mm Thru Paint

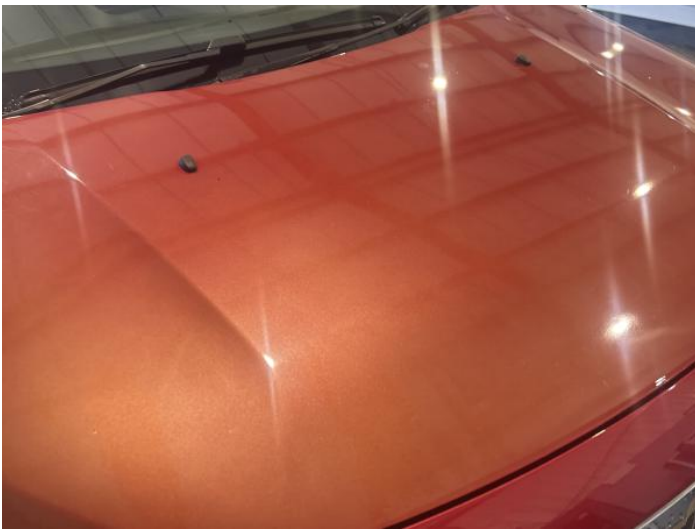
17: Bonnet  
Poor Previous Repair  
Poor Colour

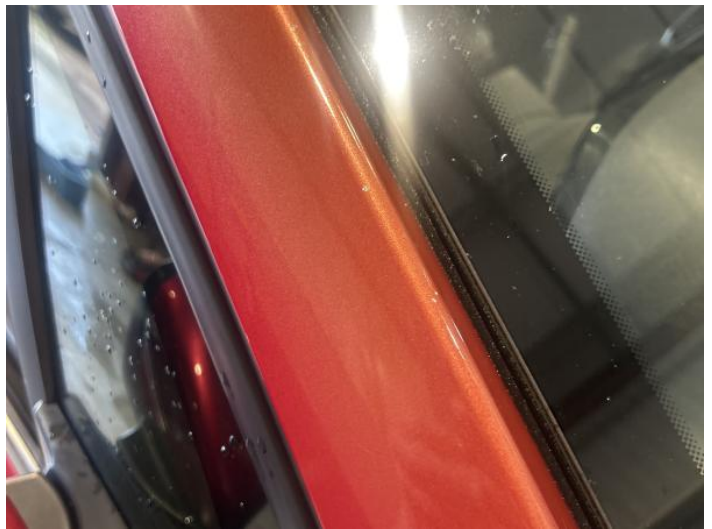
18: A Post os  
Chipped  
1 To 5
