VEHICLE INSPECTION REPORT

YJ14WNV

BMW X3 xDrive35d M Sport 5dr Step Auto

nama
GRADE
4

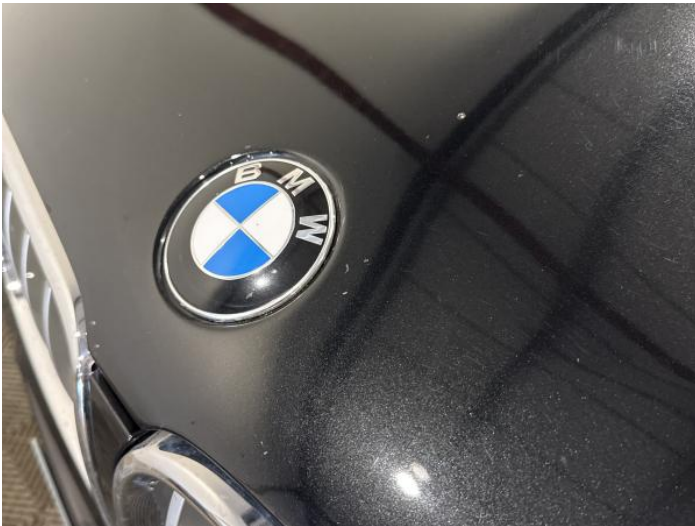
1: Bonnet
Chipped
1 To 5

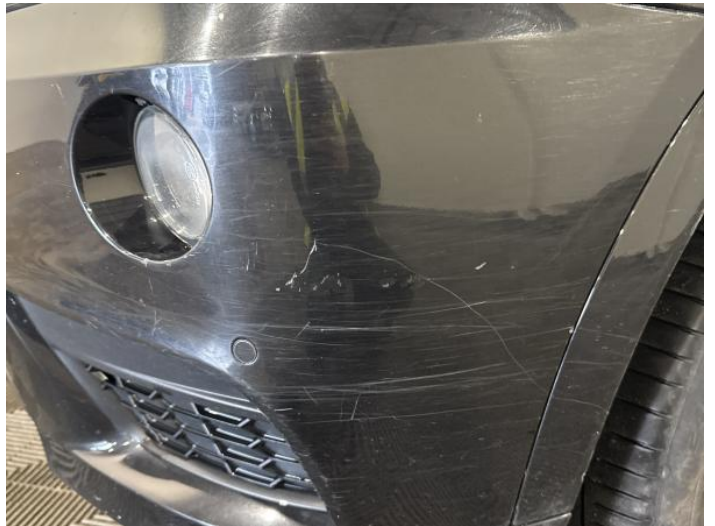
2: Bumper Front
Scratched
25 to 100mm Thru Paint

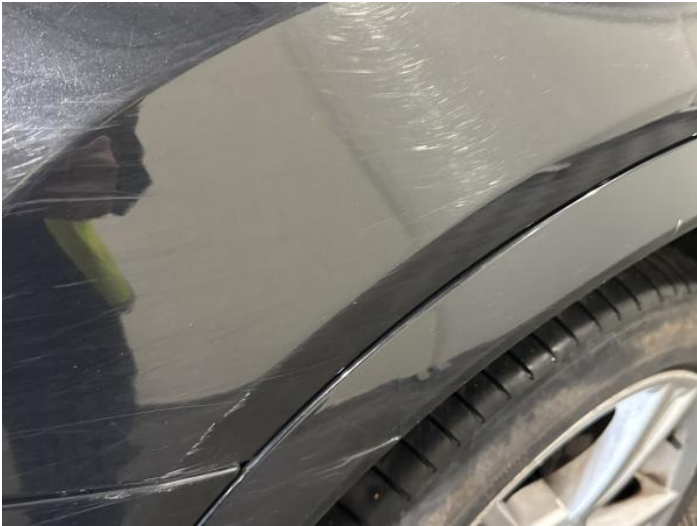
3: Wing nsf
Scratched
Over 25mm Thru Paint

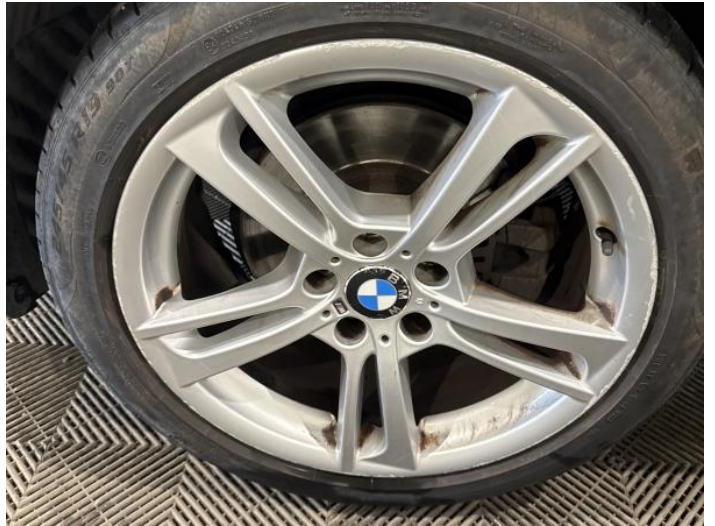
4: Wheel nsf
Scratched
Over 50mm

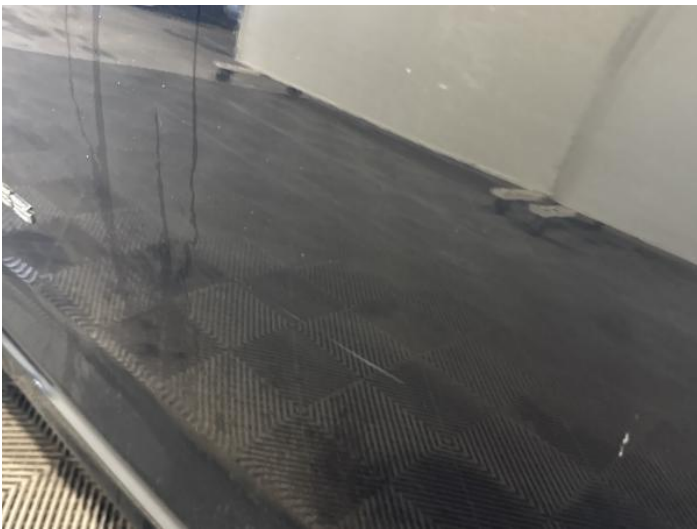
5: Door nsf
Dented
With Paint Damage

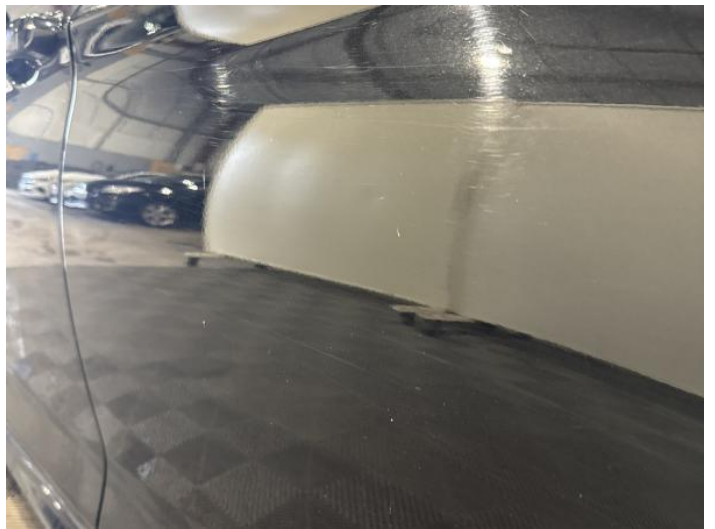
6: Door nsr
Dented
Between 10mm + 30mm

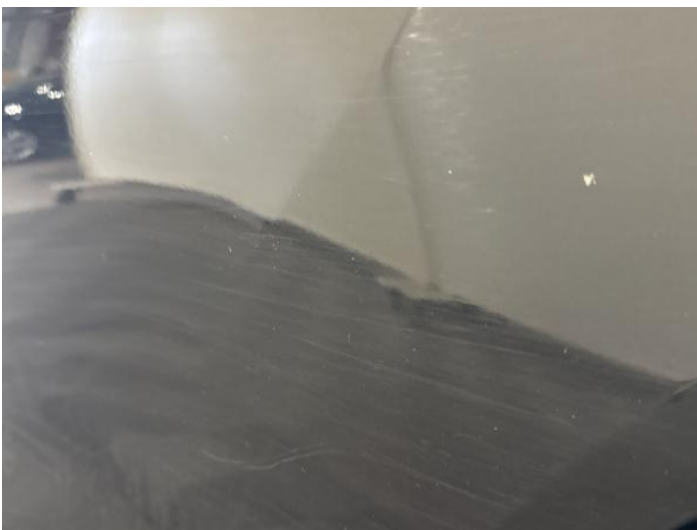
7: Door nsr
Scratched
Over 25mm Thru Paint

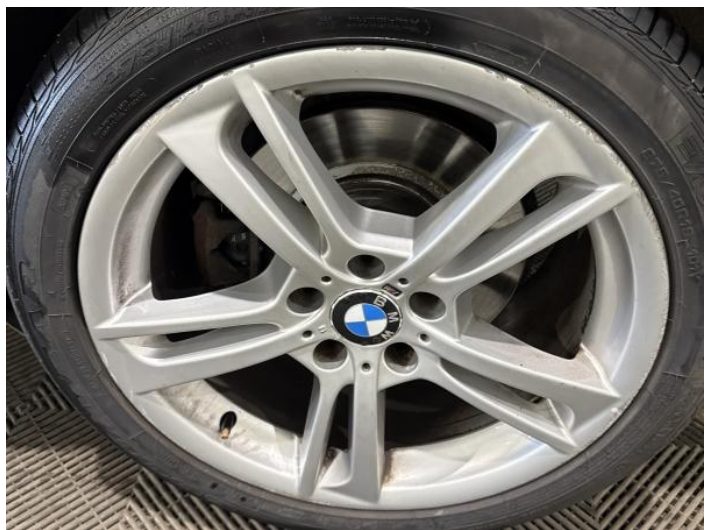
8: Wheel nsr
Scratched
Over 50mm

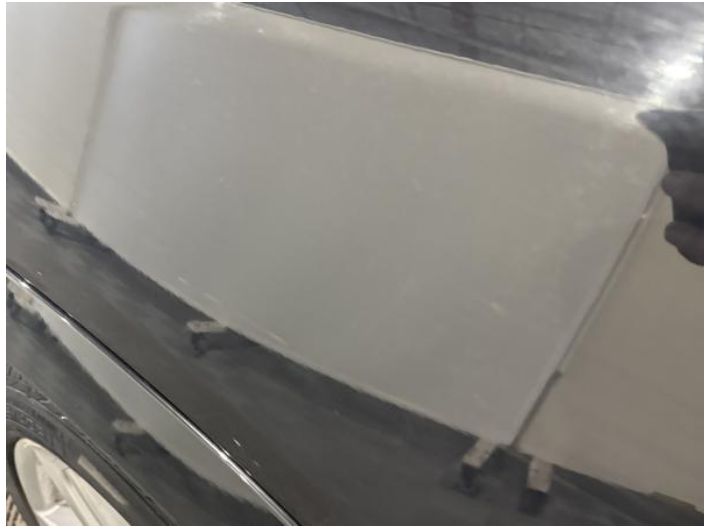
10: Qtr Panel nsr
Scratched
Over 25mm Thru Paint

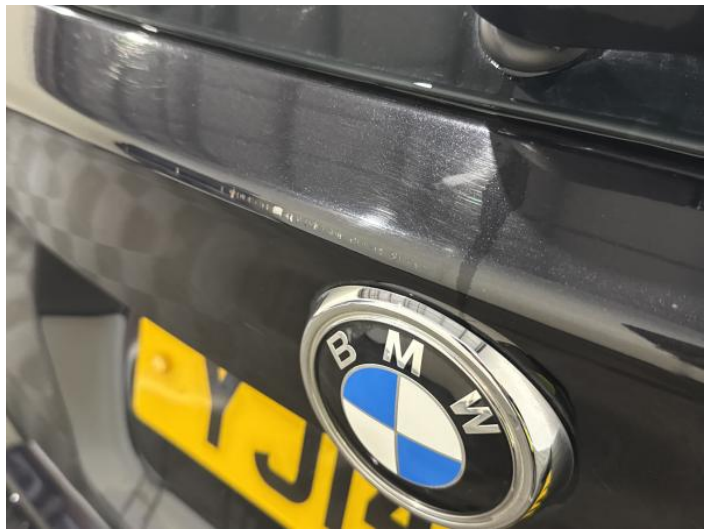
12: Tailgate
Scratched
Over 25mm Thru Paint

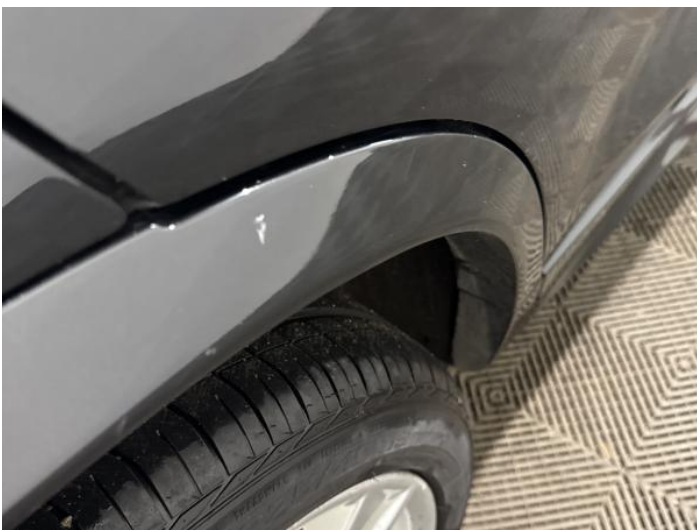
13: Qtr Panel Arch Extension os
Scratched (Painted)
UpTo 25mm Thru Paint

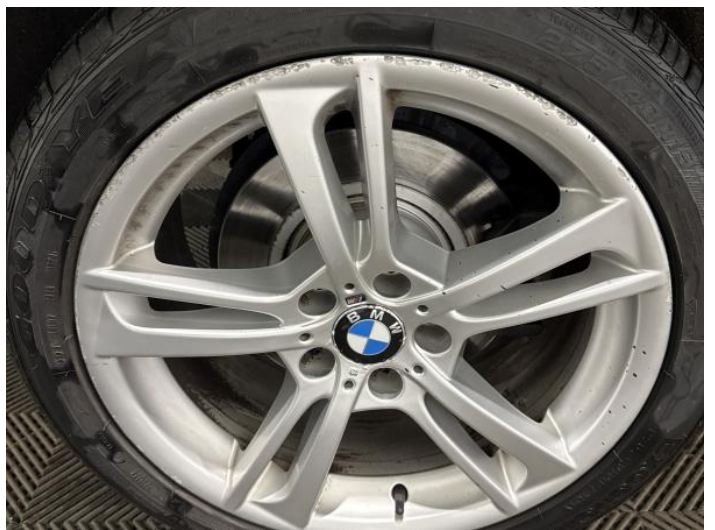
14: Wheel osr
Scratched
Over 50mm

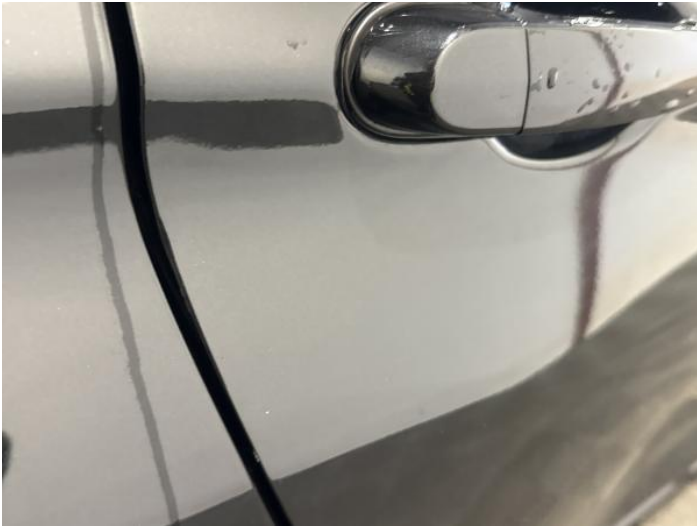
15: Door osr
Chipped
Edge Chip

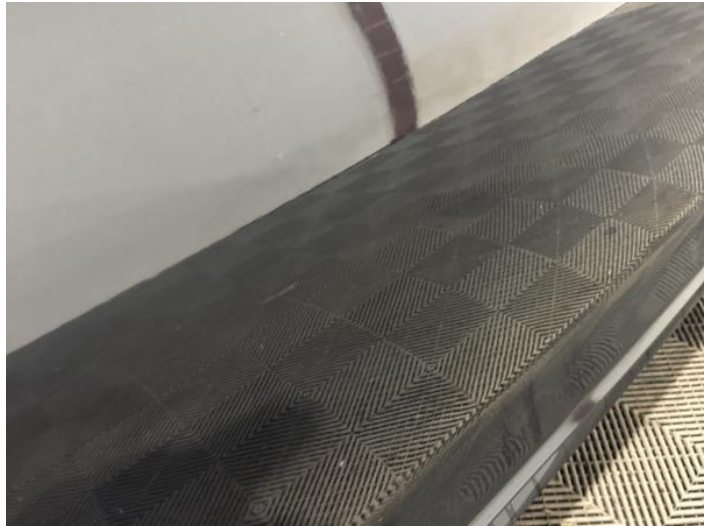
16: Door osf
Scratched
UpTo 25mm Thru Paint

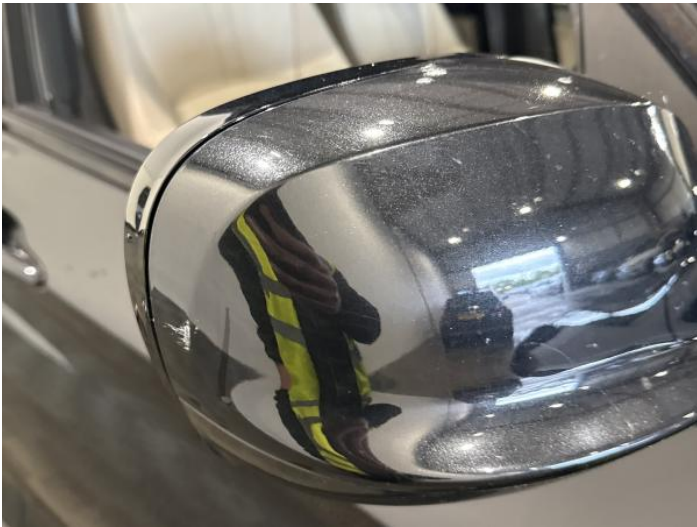
17: Door Mirror Assy osf
Scratched (Painted)
UpTo 25mm Thru Paint

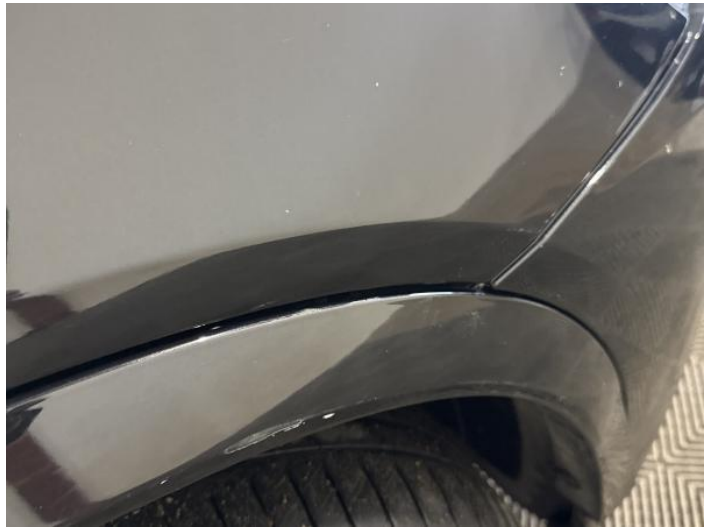
18: Wing osf
Scratched
Over 25mm Thru Paint

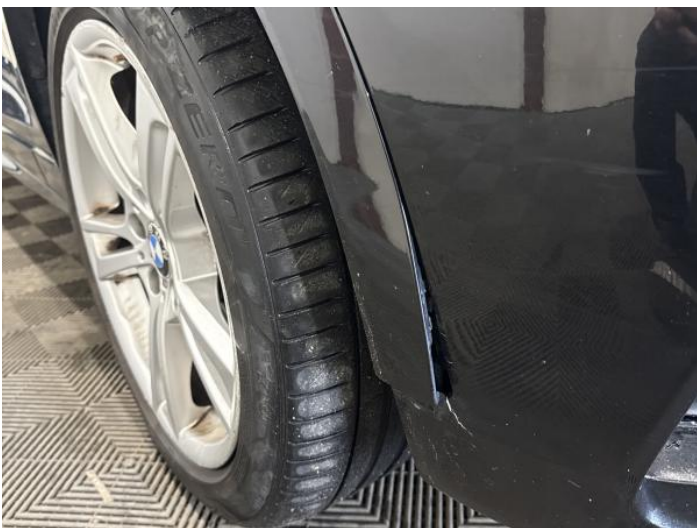
19: Wing Front Arch Extension os
Broken
Replace

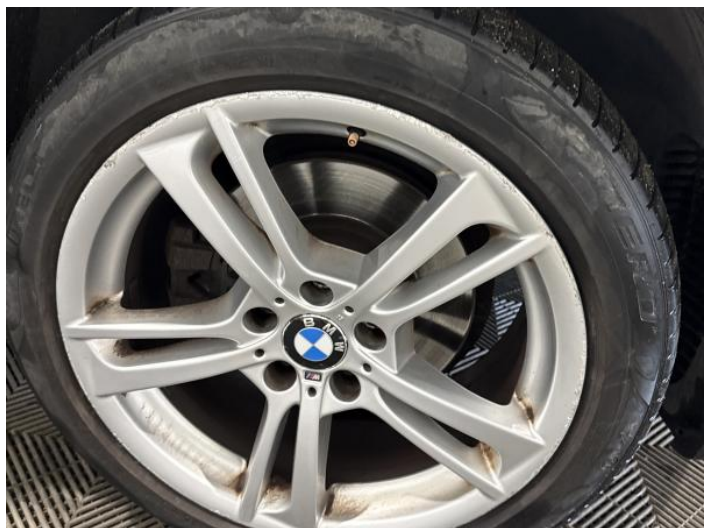
20: Wheel osf
Scratched
Over 50mm

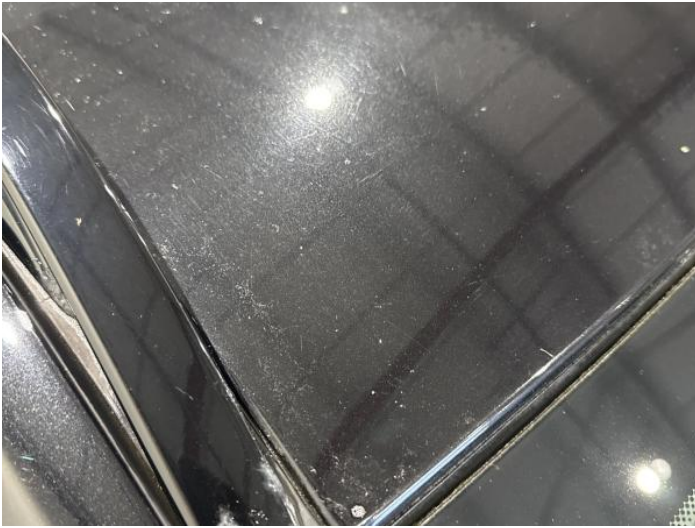
21: Roof
 Scratched
 UpTo 25mm Thru Paint
