VEHICLE INSPECTION REPORT

WK65VFB

Vauxhall Zafira 1.4T SRi 5dr

nama
GRADE
5

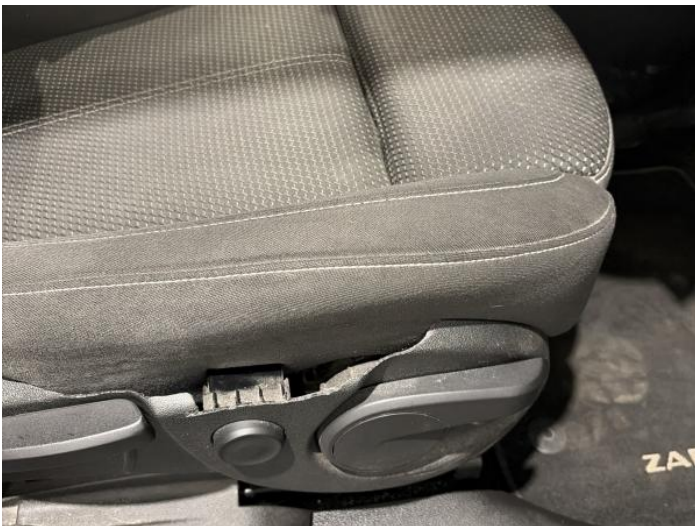
1: Fascia Trim
Damaged
Replace

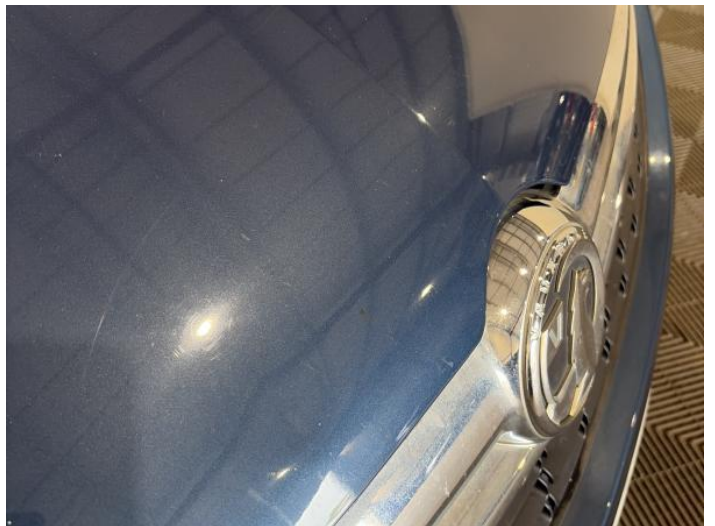
2: Bonnet
Dented
Over 30mm

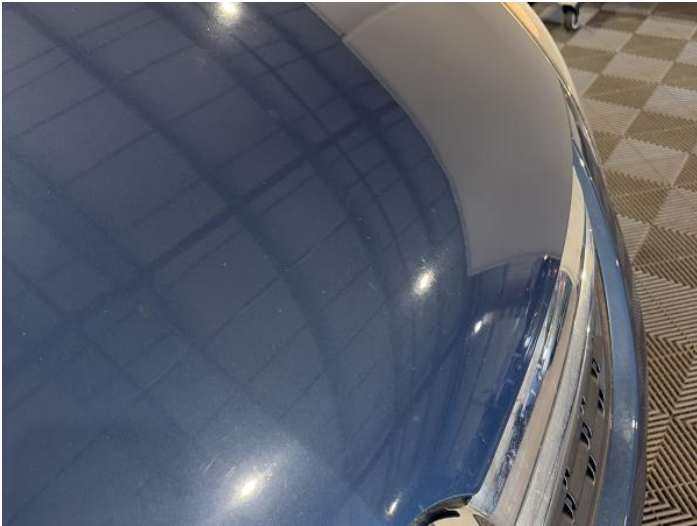
3: Bonnet
Chipped
Multiple Chips

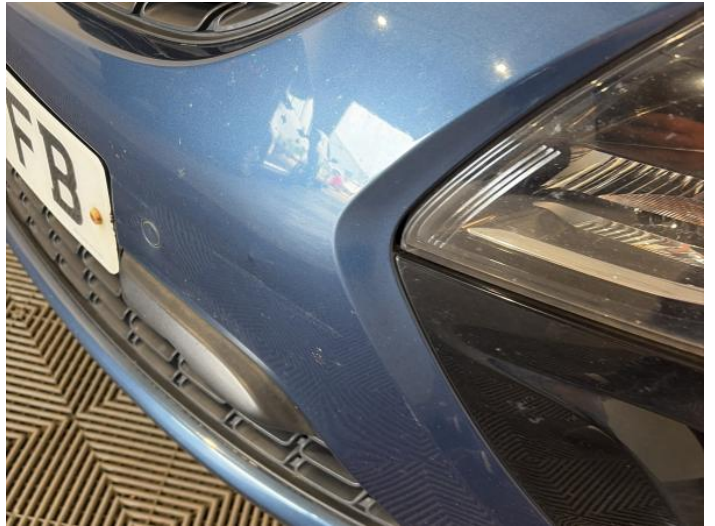
4: Bumper Front
Dented
With Paint Damage

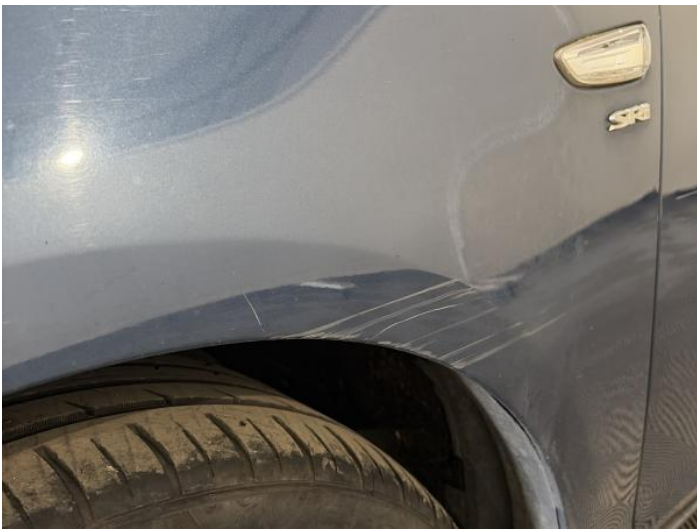
5: Wing nsf
Scratched
Over 25mm Thru Paint

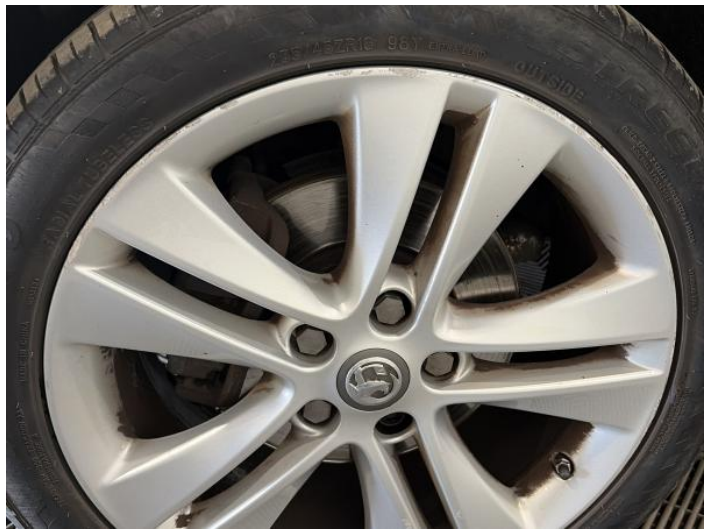
6: Wheel nsf
Scratched
Over 50mm

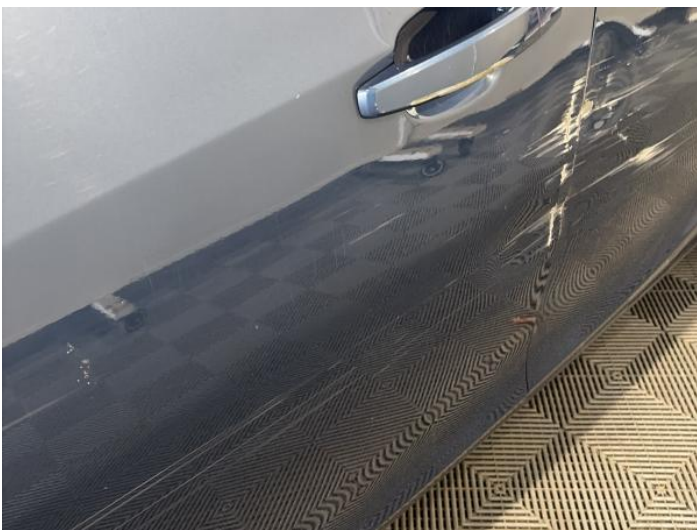
7: Door nsf
Dented
With Paint Damage

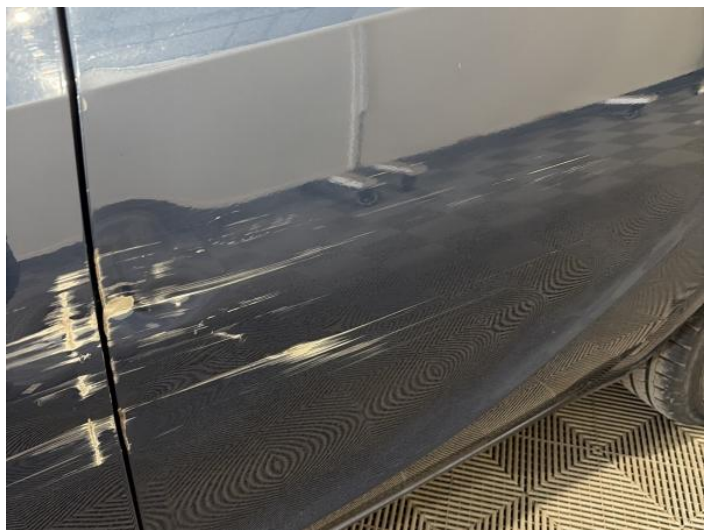
8: Door nsr
Dented
With Paint Damage

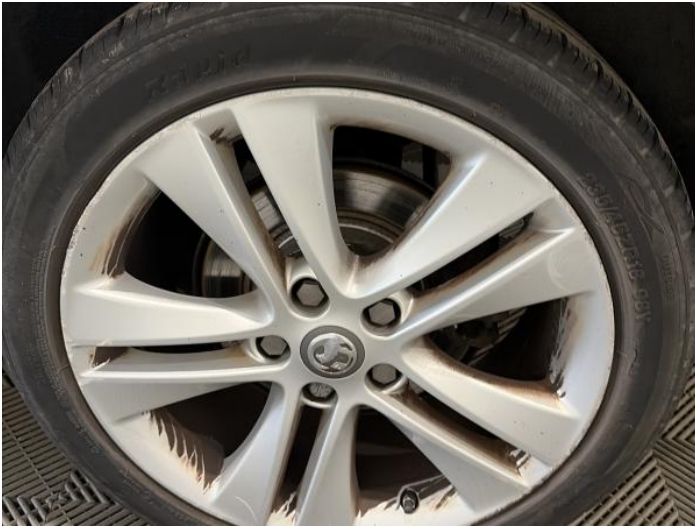
9: Wheel nsr
Scratched
Over 50mm

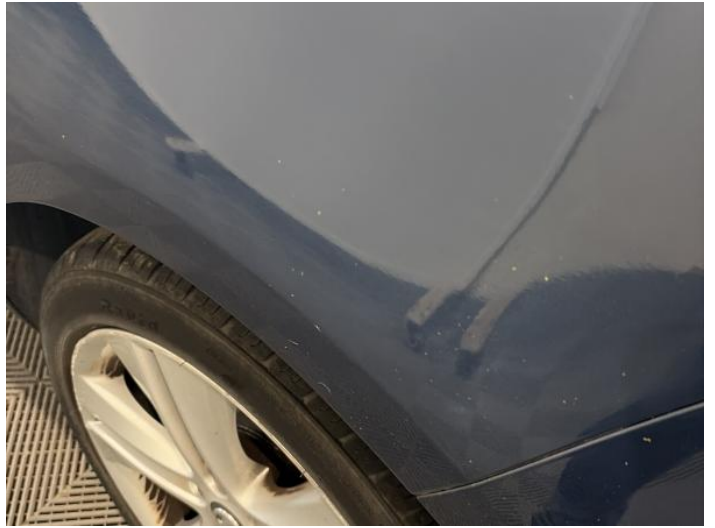
10: Qtr Panel nsr
Scratched
UpTo 25mm Thru Paint

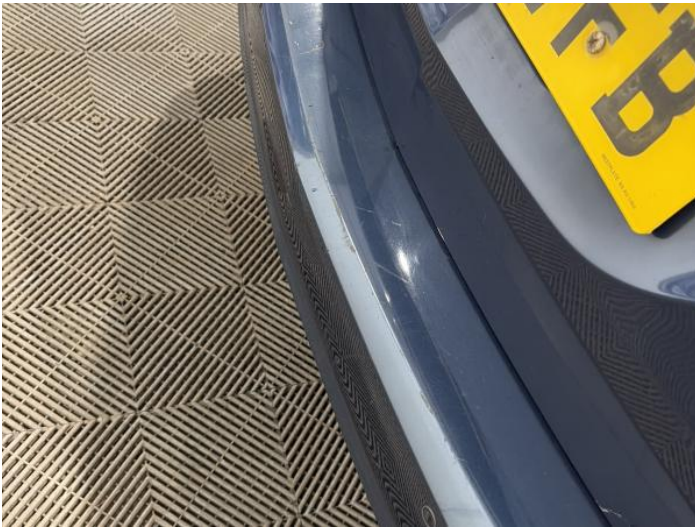
11: Bumper Rear
Scratched
25 to 100mm Thru Paint

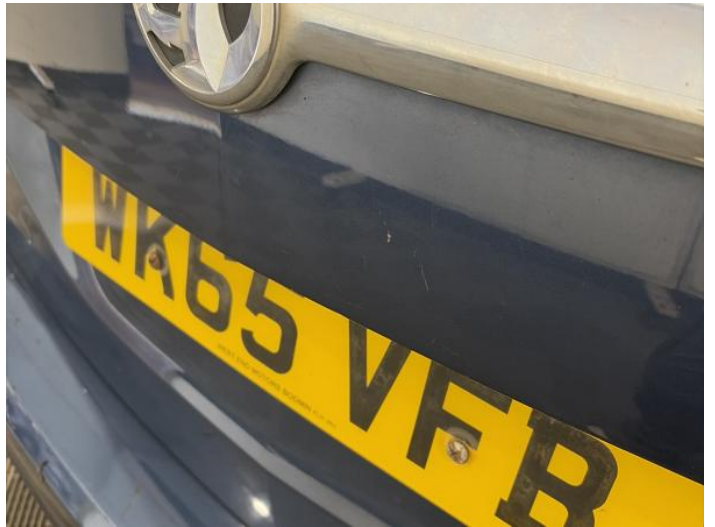
12: Tailgate
Scratched
UpTo 25mm Thru Paint

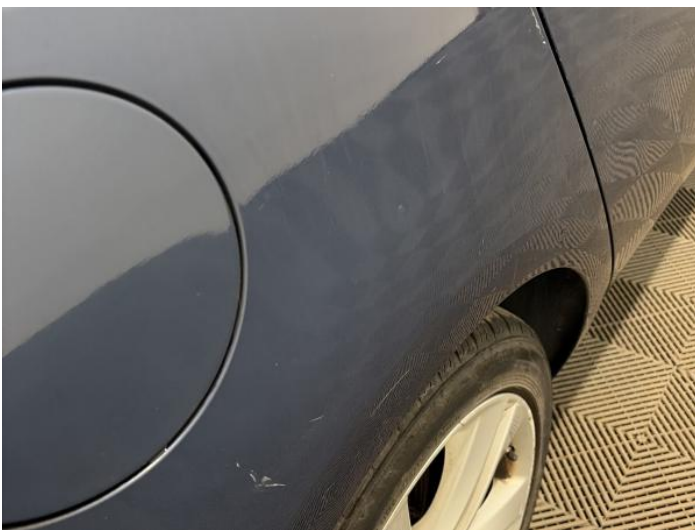
13: Qtr Panel osr
Dented
With Paint Damage

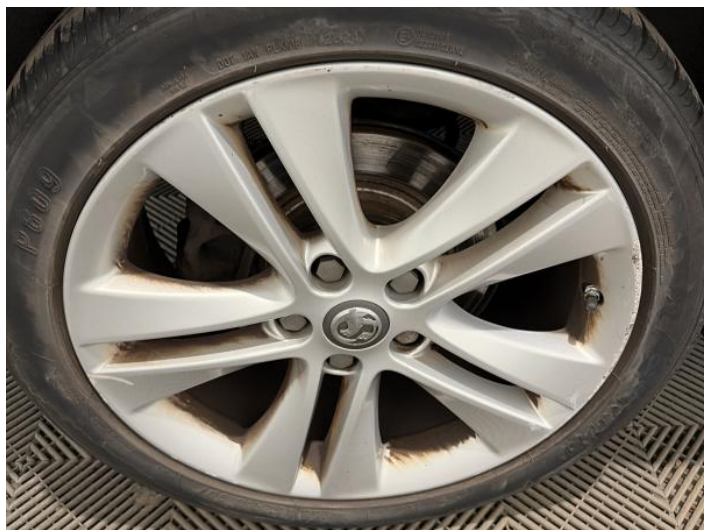
14: Wheel osr
Scratched
Over 50mm

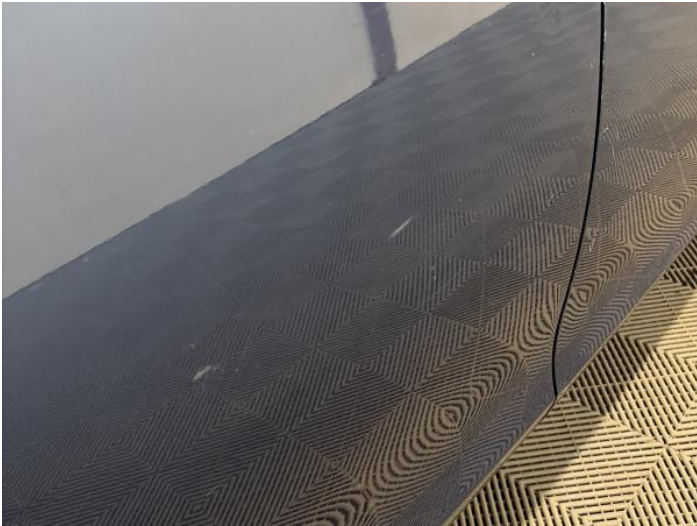
15: Door osr
 Scratched
 Over 25mm Thru Paint

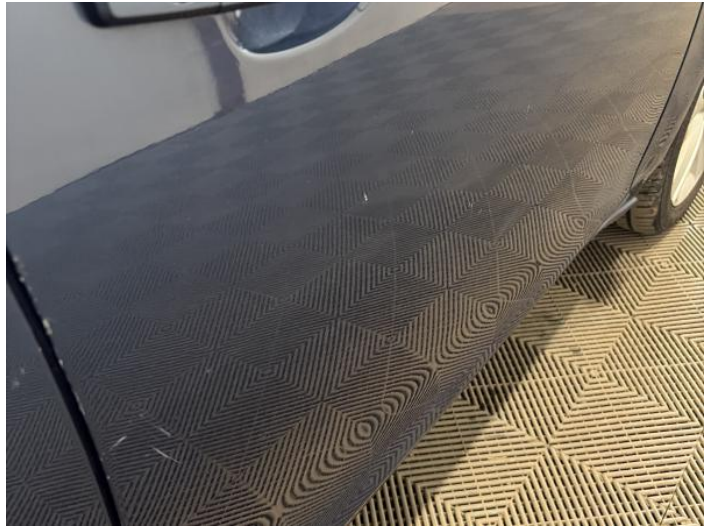
16: Door osf
 Scratched
 Over 25mm Thru Paint

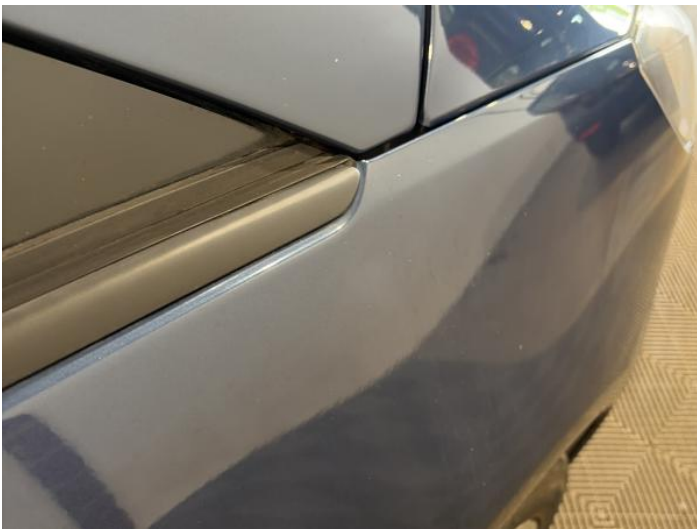
17: Wing osf
 Dented
 Over 30mm
