VEHICLE INSPECTION REPORT

YC14XFL

Volvo V60 D6 AWD Plug-in Hybrid Pure Limited 5dr Auto

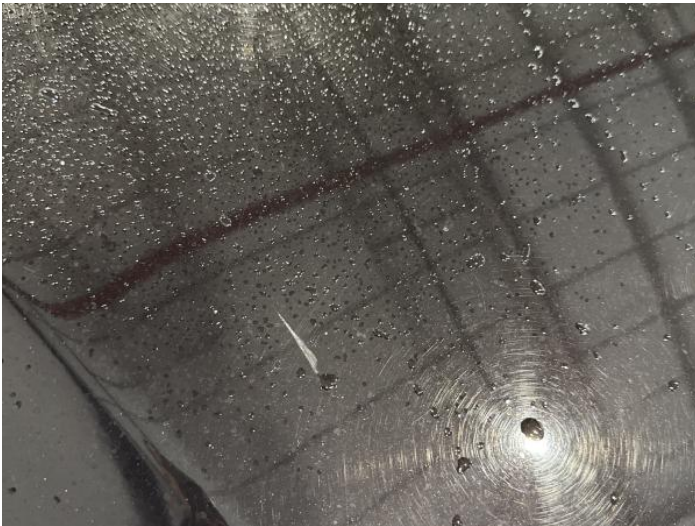
1: Bonnet
Scratched
Over 25mm Thru Paint

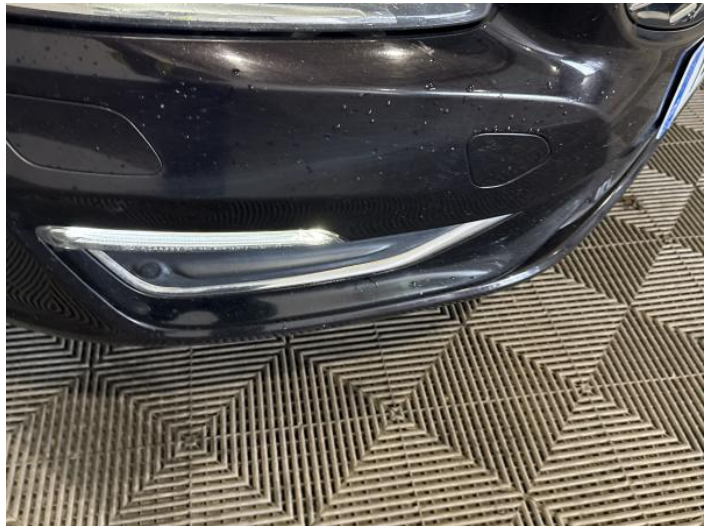
2: Bumper Front
Scratched
Over 100mm Thru Paint

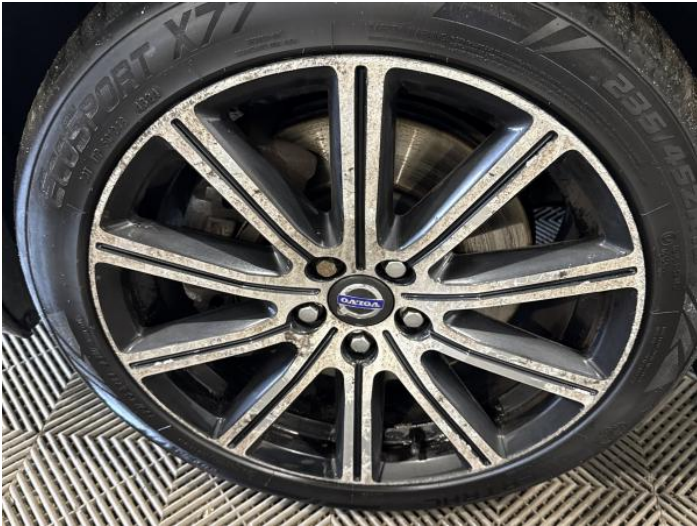
3: Wheel nsf
Scratched
Over 50mm

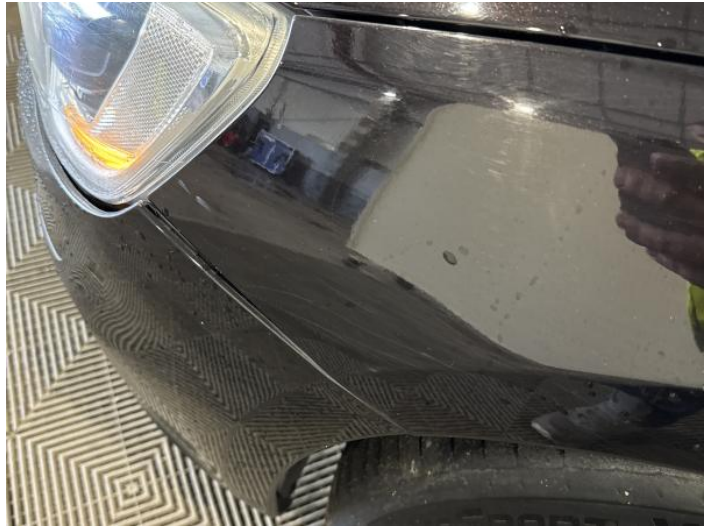
4: Wing nsf
Scratched
Over 25mm Thru Paint

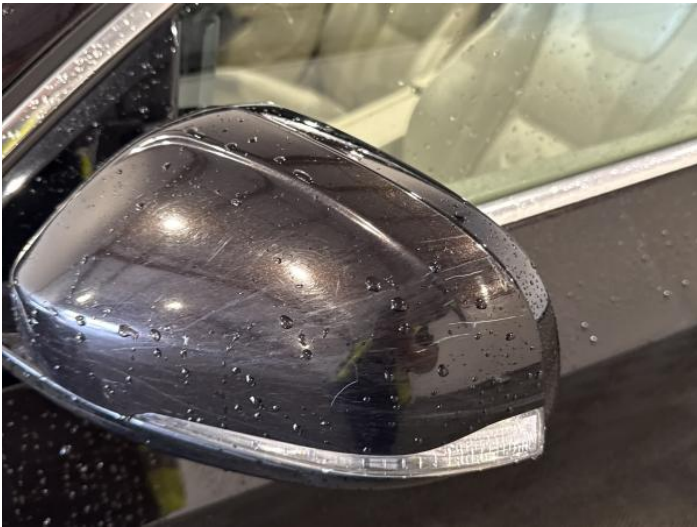
5: Door Mirror Assy nsf
Scratched (Painted)
Over 25mm Thru Paint

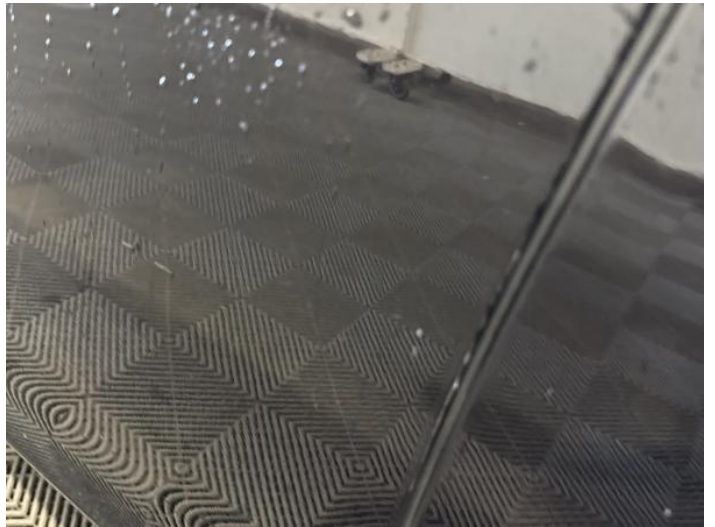
6: Door nsf
Chipped
1 To 5

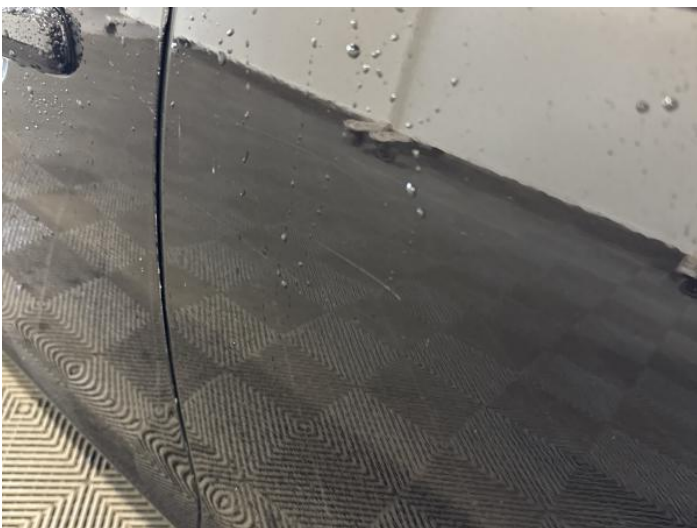
7: Door nsr
Scratched
Over 25mm Thru Paint

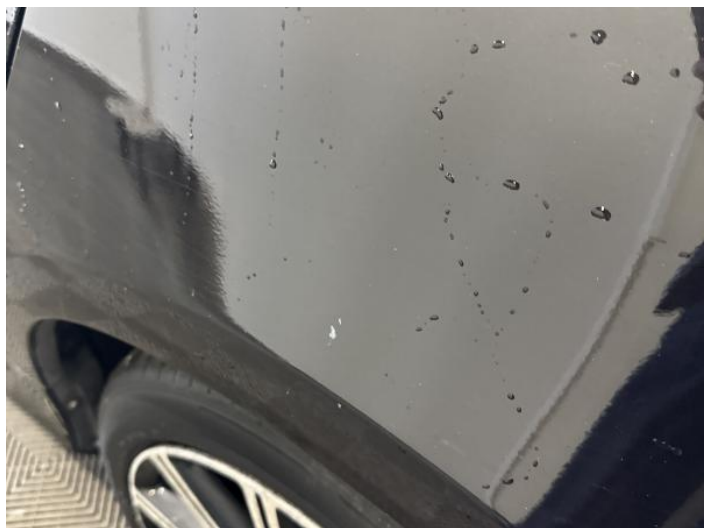
8: Qtr Panel nsr
Chipped
1 To 5

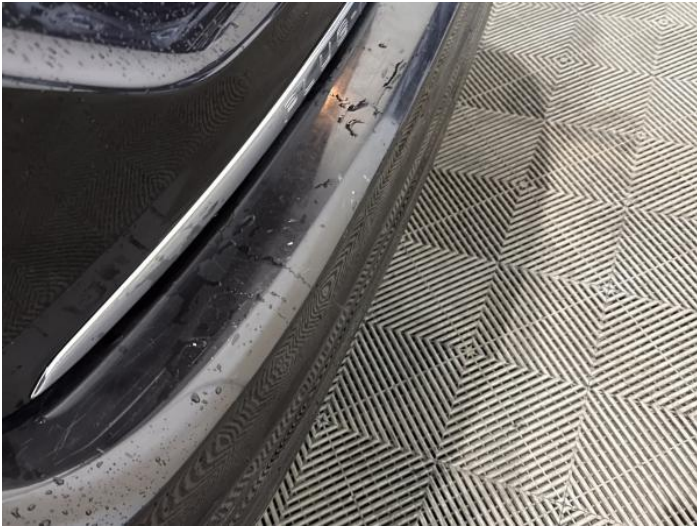
9: Bumper Rear
Scratched
25 to 100mm Thru Paint

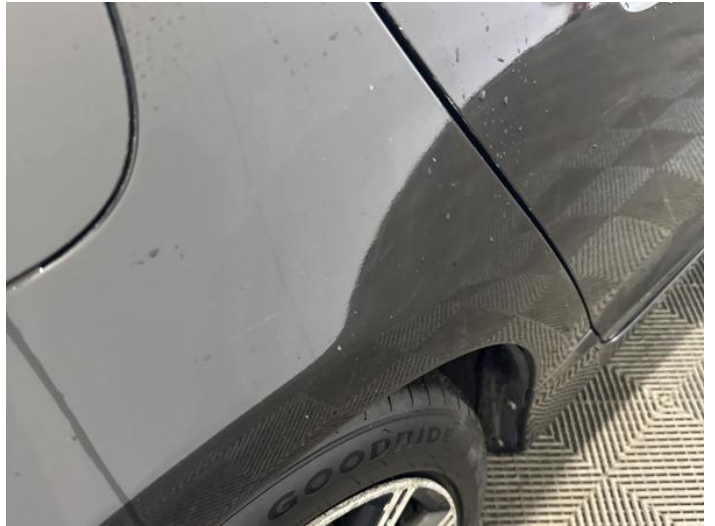
10: Qtr Panel osr
Chipped
1 To 5

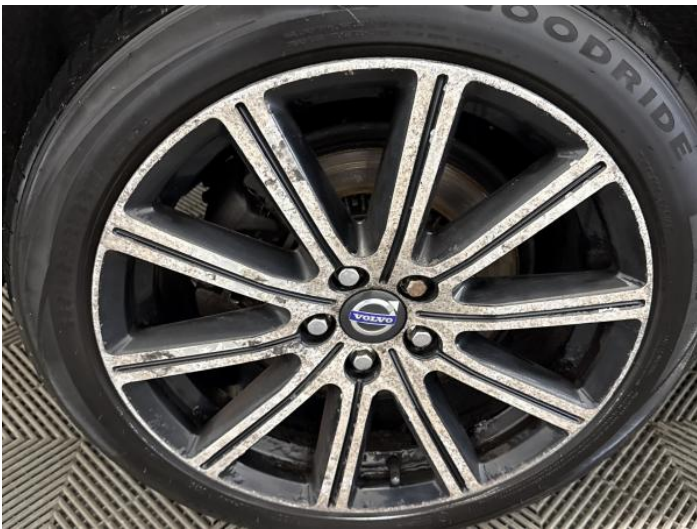
11: Wheel osr
Scratched
Over 50mm

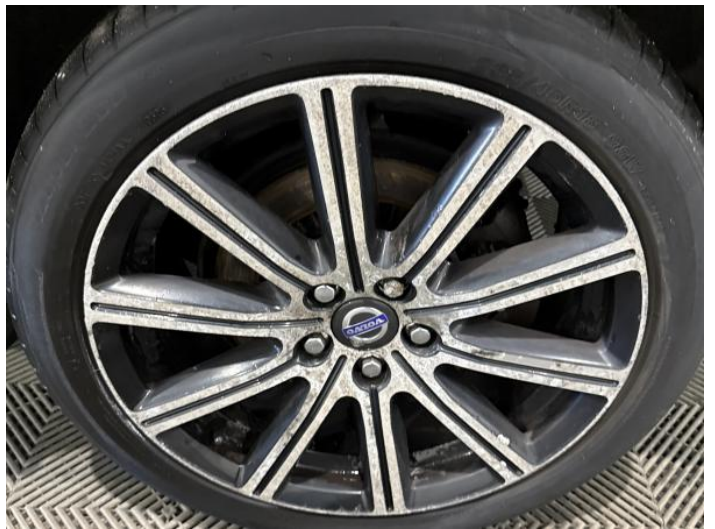
12: Wheel nsr
Scratched
Over 50mm

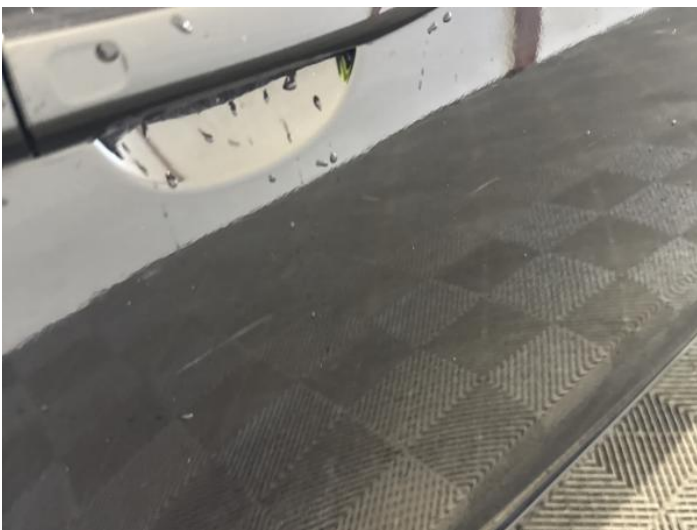
13: Door osr
Scratched
Over 25mm Thru Paint

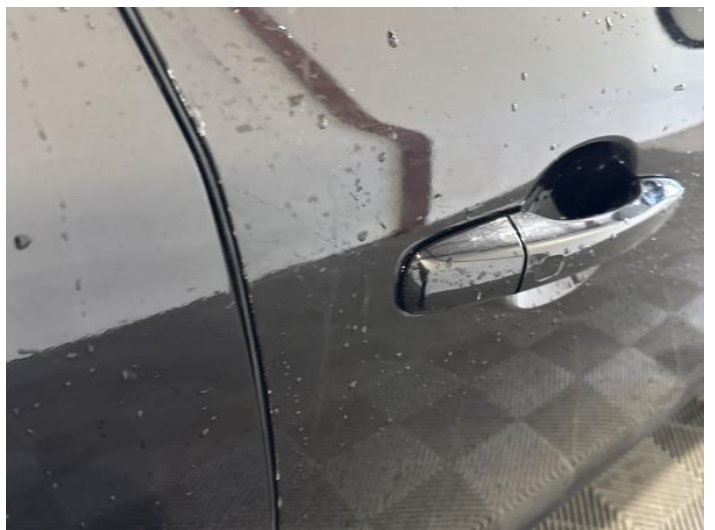
14: Door osf
Chipped
Edge Chip

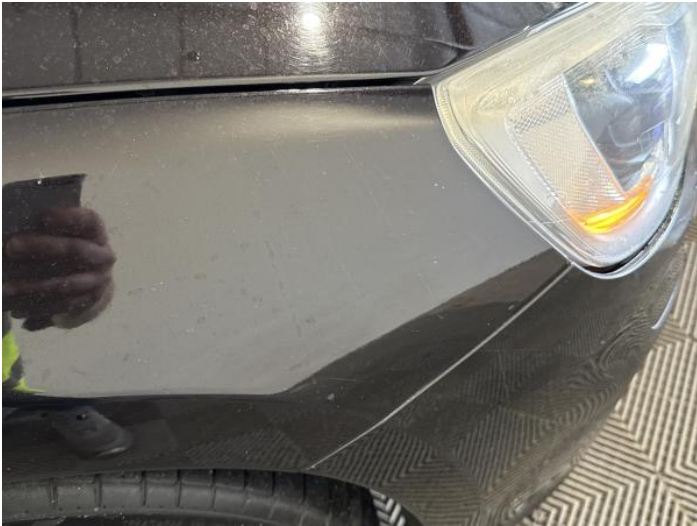
15: Wing of
Chipped
1 To 5

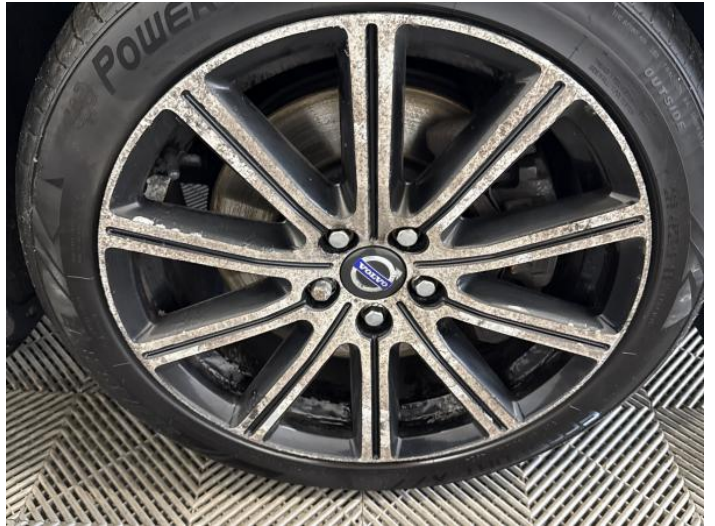
16: Wheel of
Scratched
Over 50mm

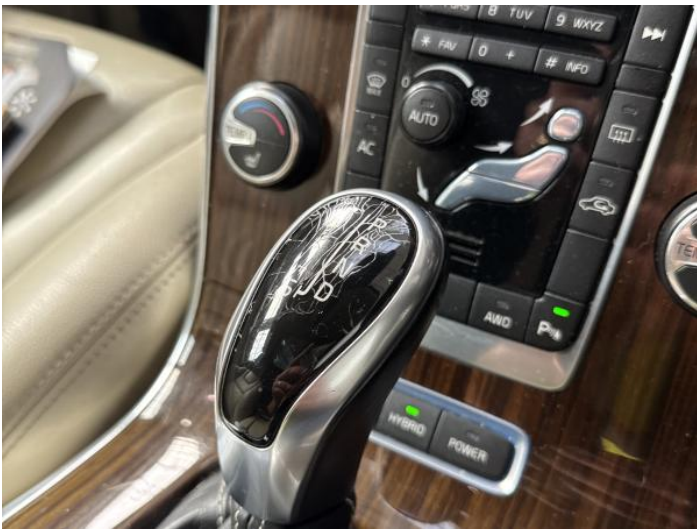
17: Switches And Controls
Broken
Replace
