# VEHICLE INSPECTION REPORT

**DN19EYF**

## Vauxhall Mokka X 1.4T ecoTEC Active 5dr

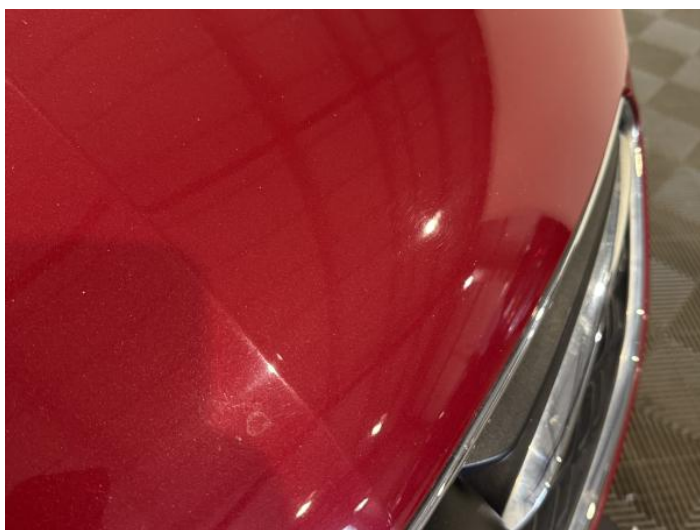
1: Bonnet  
Chipped  
Multiple Chips

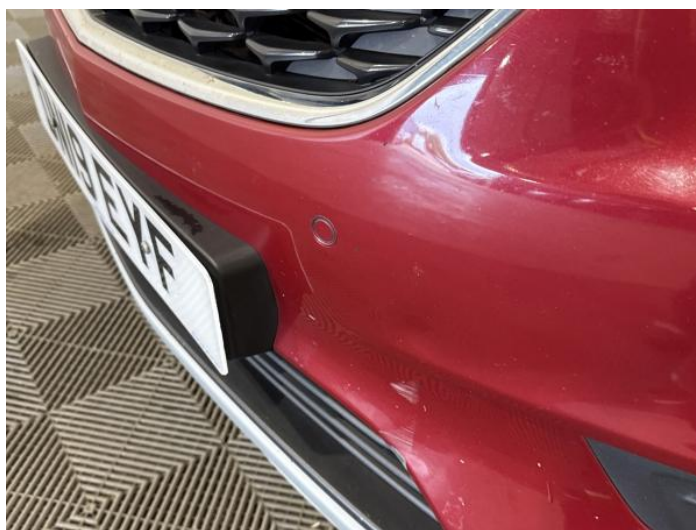
2: Bumper Front  
Poor Previous Repair  
Poor Paint

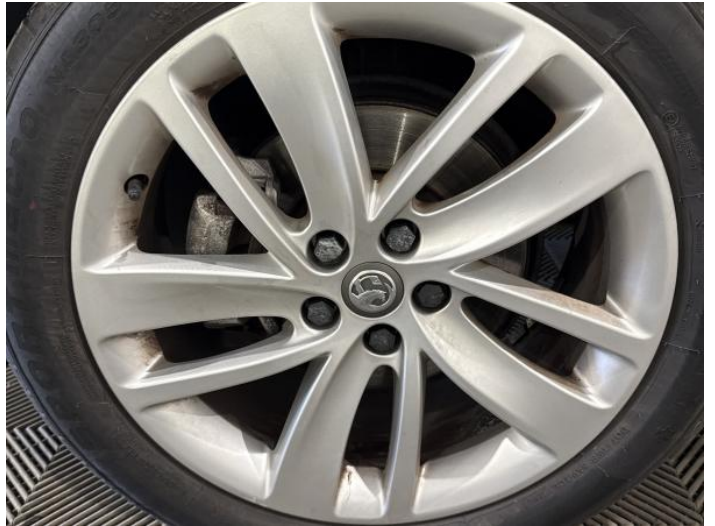
4: Wheel nsf  
Scratched  
Up To 50mm

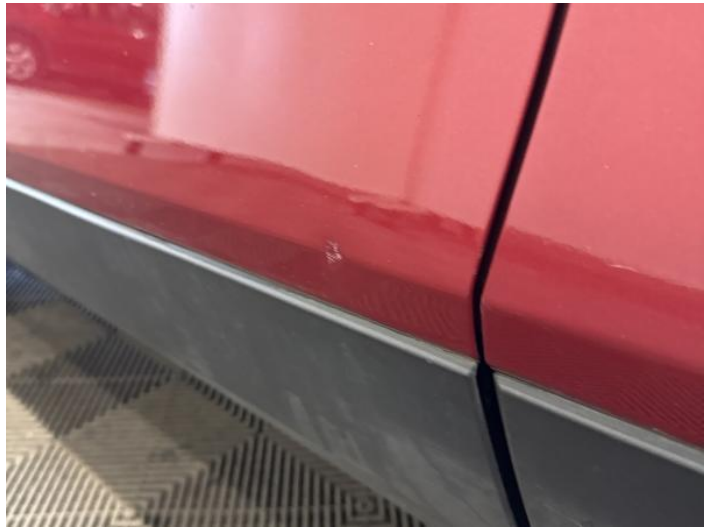
6: Door nsf  
Scratched  
Over 25mm Thru Paint

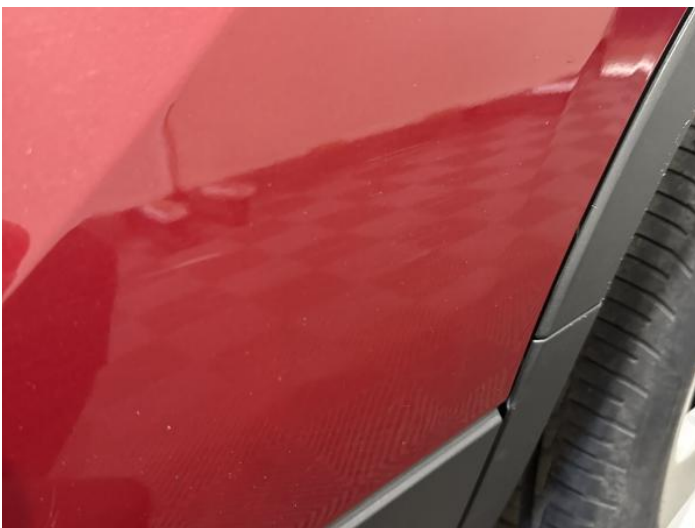
7: Door nsr  
Scratched  
Over 25mm Thru Paint

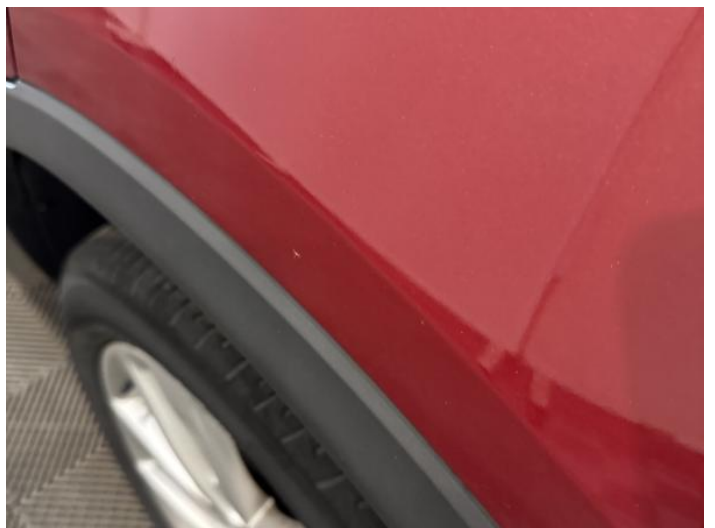
8: Qtr Panel nsr  
Chipped  
1 To 5

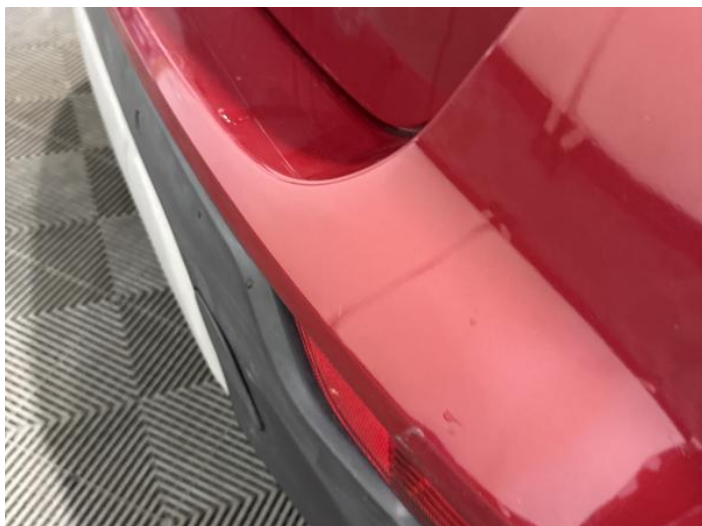
9: Bumper Rear  
Scratched  
25 to 100mm Thru Paint

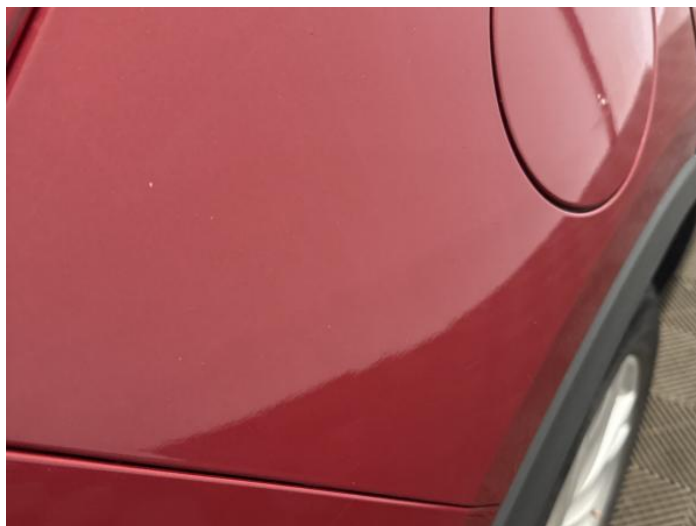
10: Qtr Panel osr  
Dented  
With Paint Damage

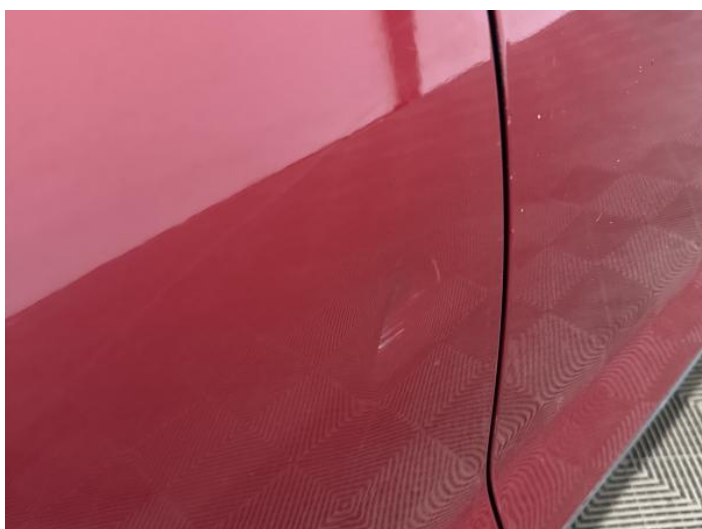
11: Door osr  
Dented  
With Paint Damage

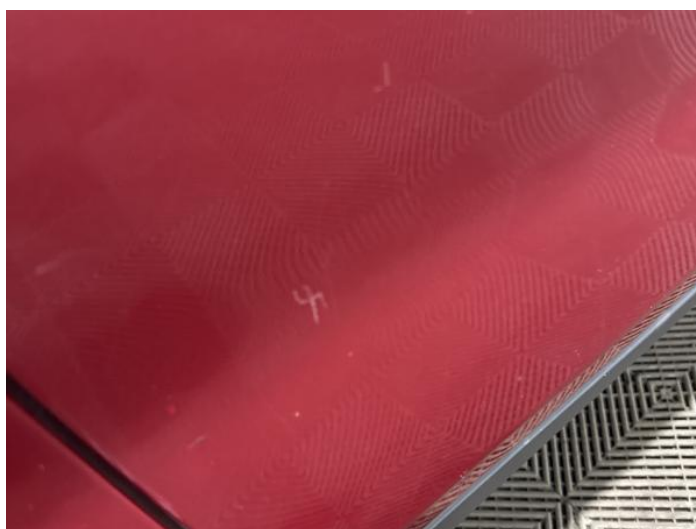
12: Door osf  
Scratched  
UpTo 25mm Thru Paint

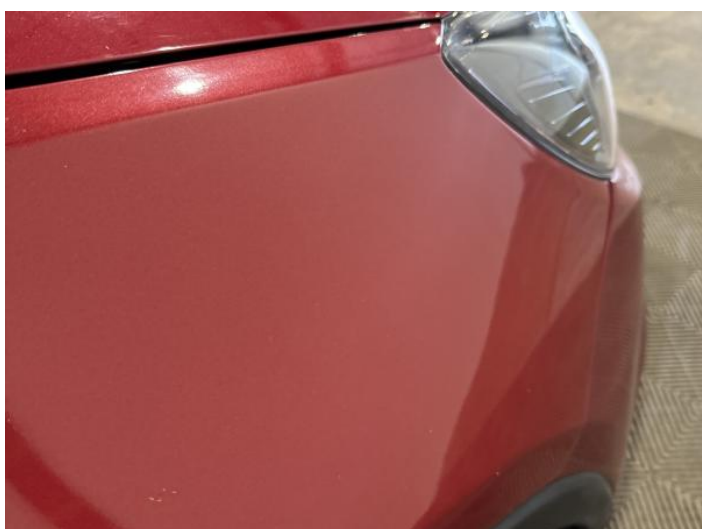
13: Wing osf  
Poor Previous Repair  
Rippled UpTo 30%

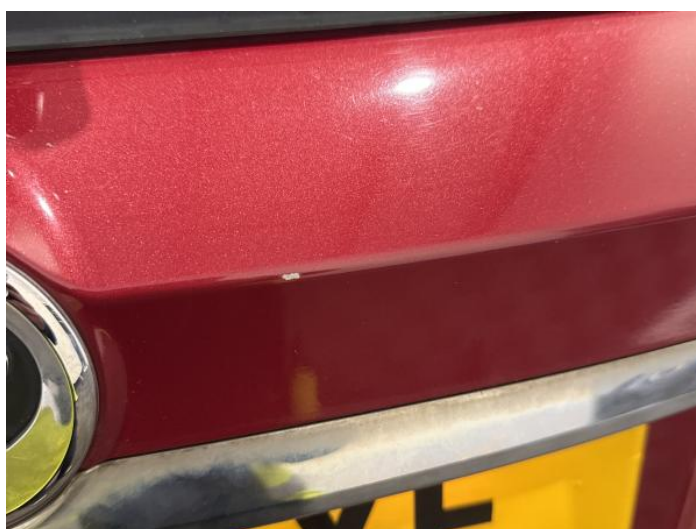
14: Tailgate  
Poor Previous Repair  
Poor Paint

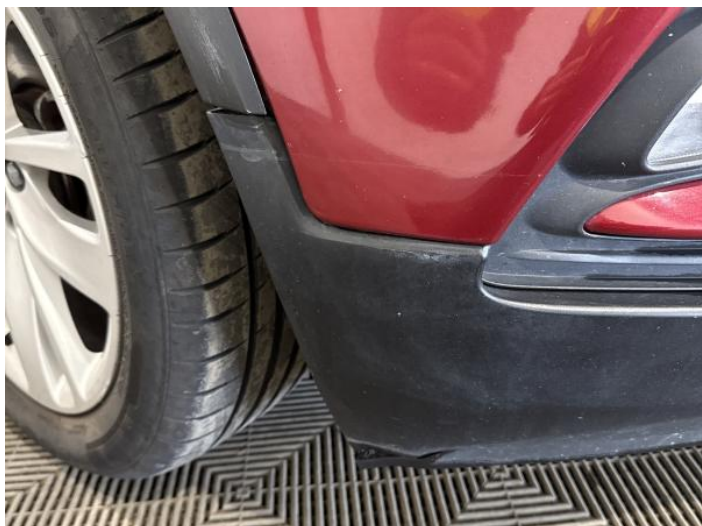
15: Bumper Front Moulding  
Broken  
Replace
