VEHICLE INSPECTION REPORT

HN67KKZ

Kia Stinger GT S

nama
GRADE
4

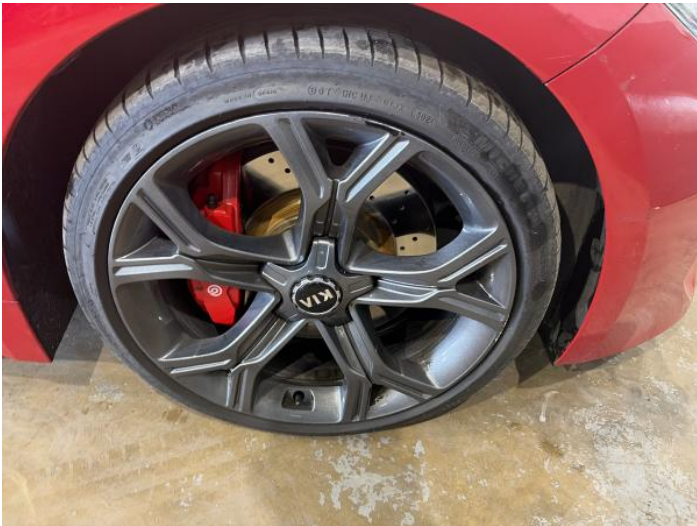
1: Wheel of
Scratched
Over 50mm

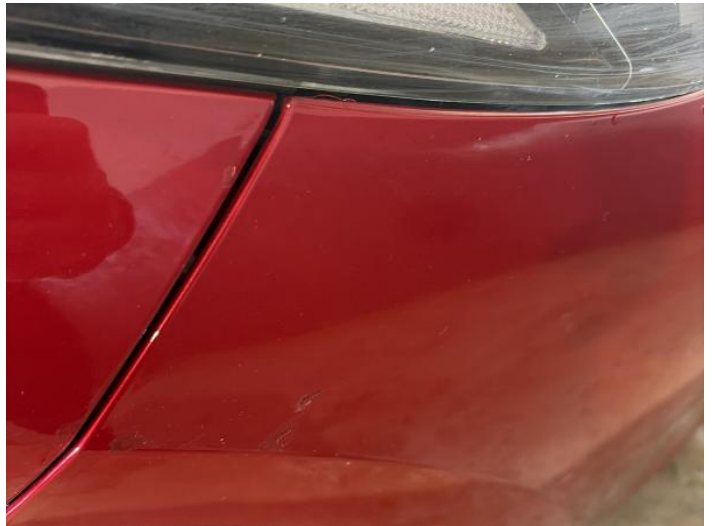
2: Wing of
Chipped
1 To 5

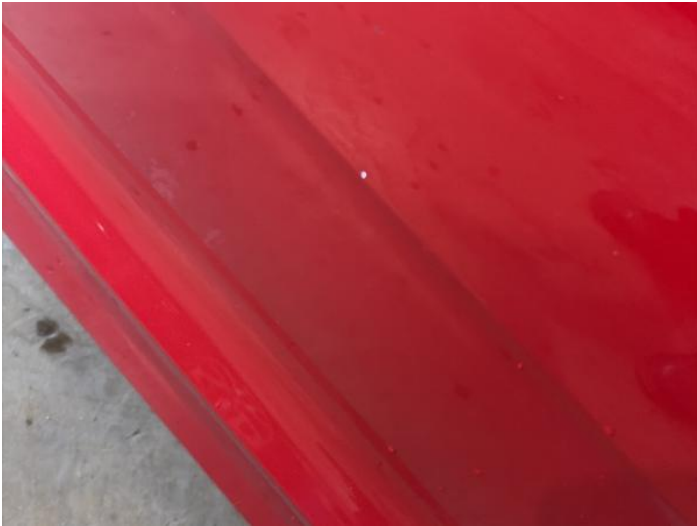
3: Door osf
Chipped
1 To 5

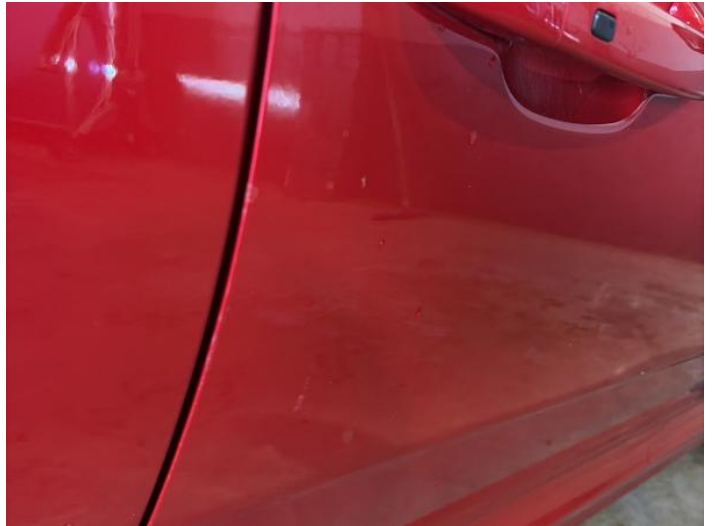
4: Door osf
Chipped
Edge Chip

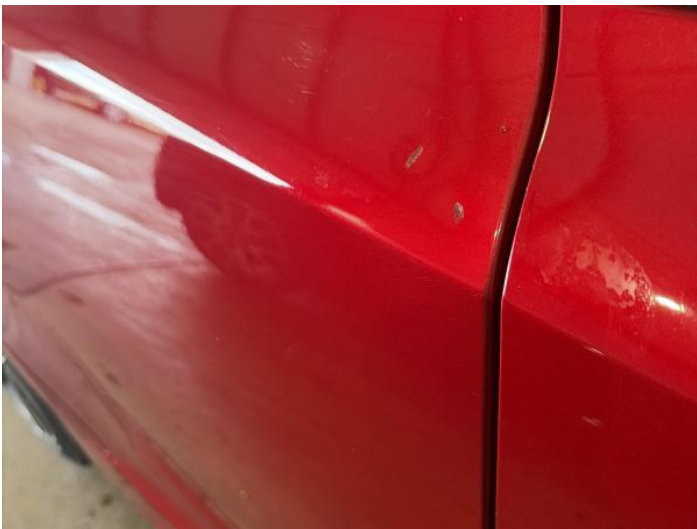
5: Door osr
Dented
With Paint Damage

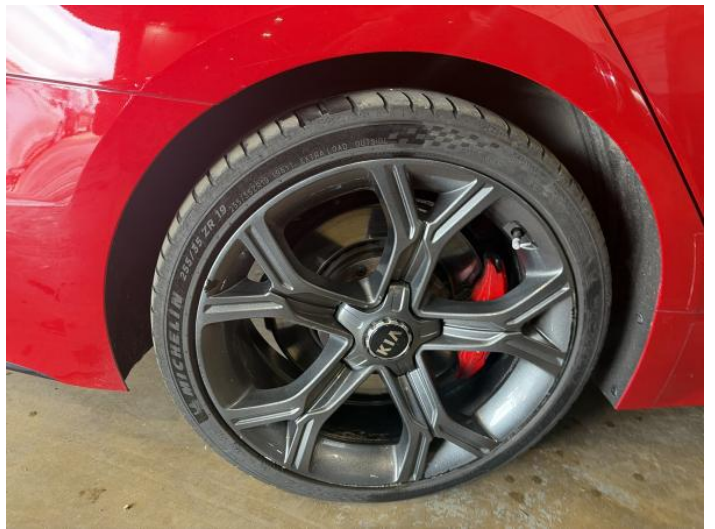
6: Wheel osr
Scratched
Over 50mm

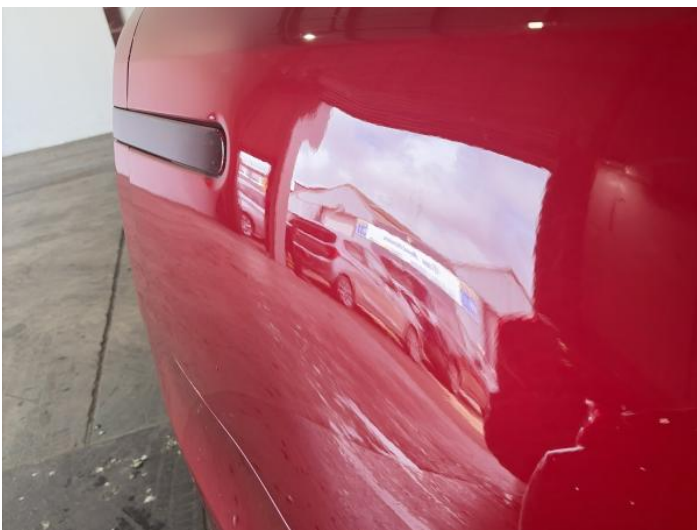
7: Qtr Panel osr
Dented
Over 30mm

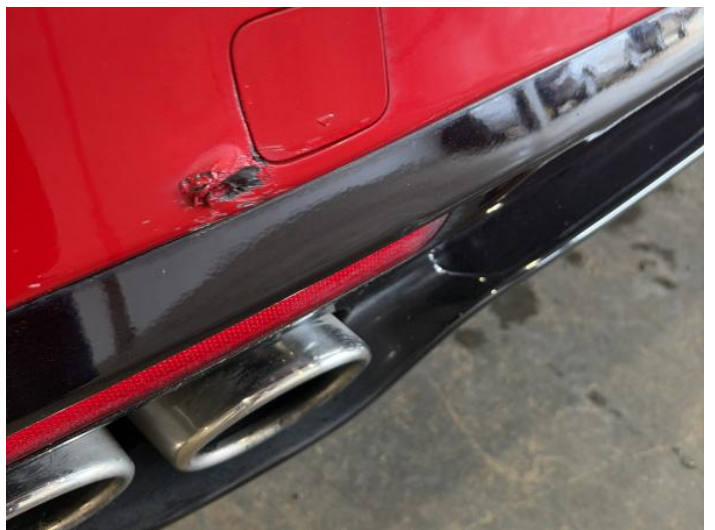
8: Bumper Rear
Dented
With Paint Damage

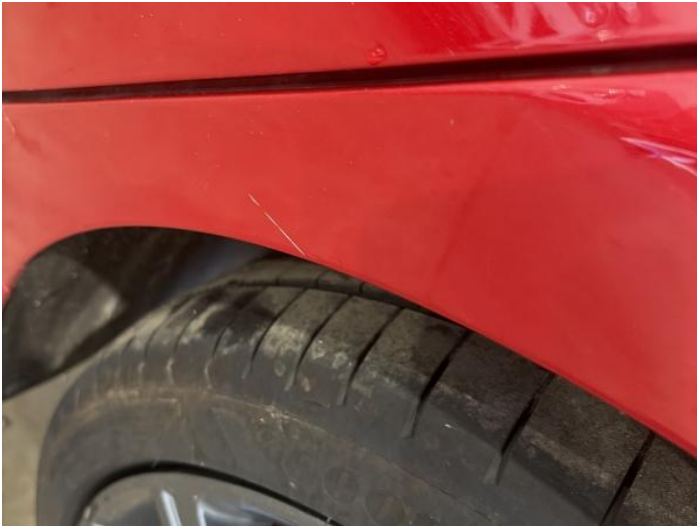
9: Qtr Panel nsr
Scratched
UpTo 25mm Thru Paint

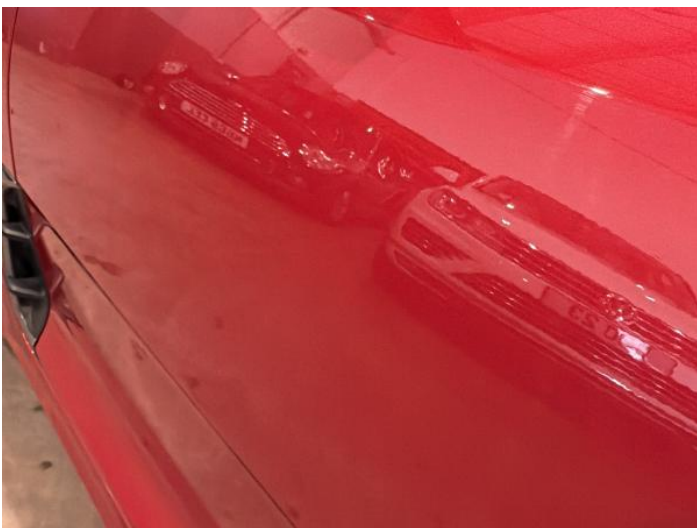
13: Door nsf
Dented
Between 10mm + 30mm

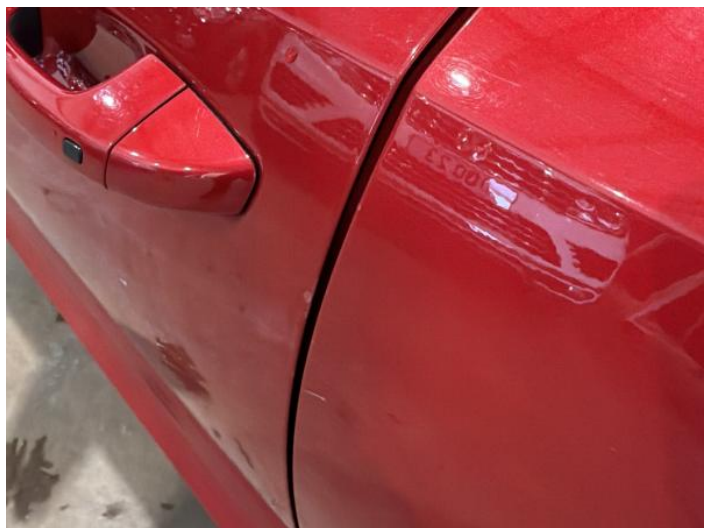
14: Door nsf
Chipped
Edge Chip

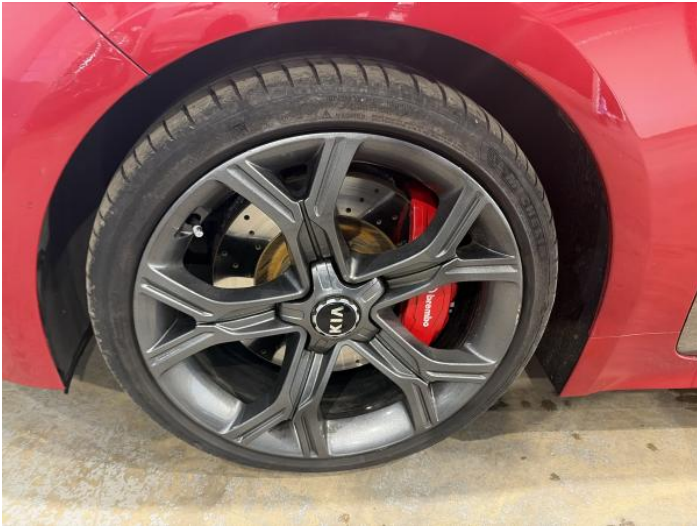
15: Wheel nsf
Scratched
Up To 50mm

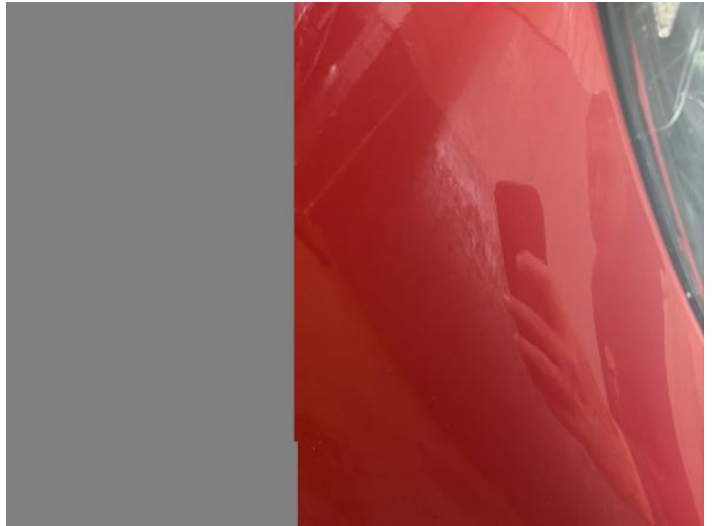
16: Bumper Front
Scratched
25 to 100mm Thru Paint

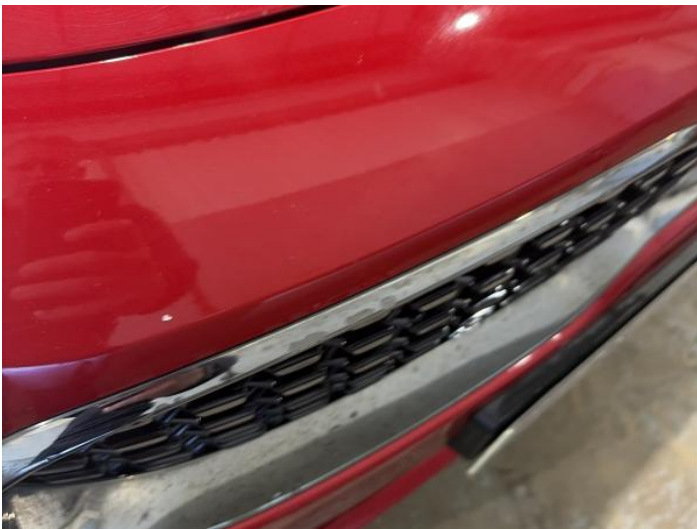
17: Bumper Front
Chipped
Multiple Chips

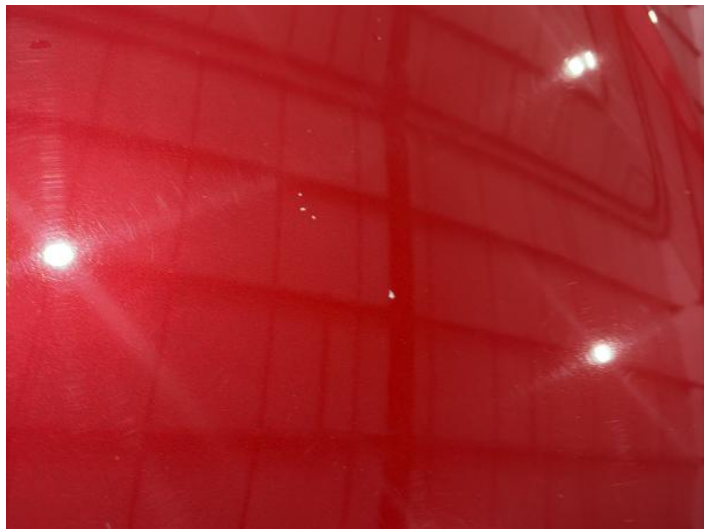
18: Bonnet
Chipped
1 To 5

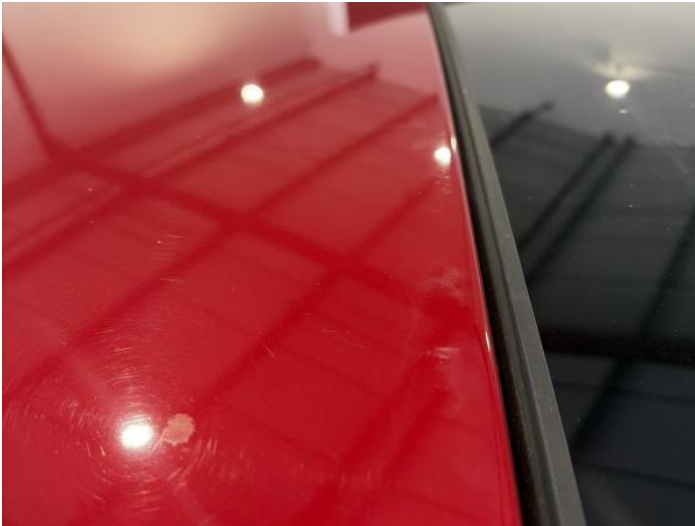
21: Roof
 Dented
 2 Or Less UpTo 10mm
