VEHICLE INSPECTION REPORT

NL60MFE

Honda CR-V 2.2 i-DTEC EX 5dr

nama
GRADE
4

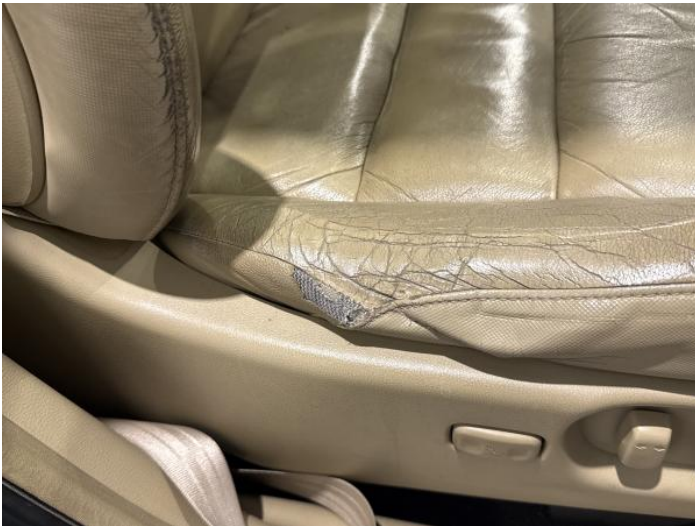
1: Seat Base Cover osf
Scuffed
Over 25mm

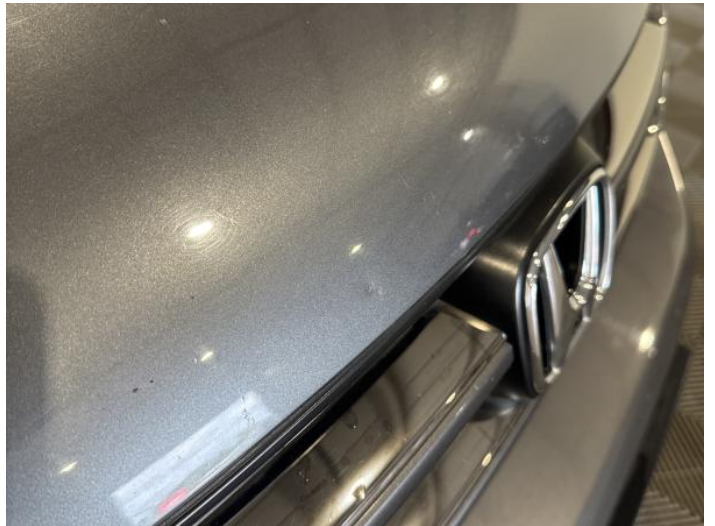
2: Bonnet
Dented
Between 10mm + 30mm

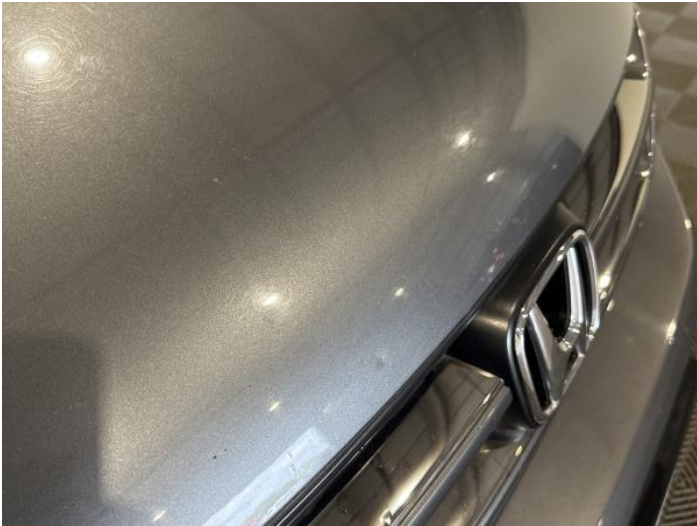
3: Bonnet
Chipped
1 To 5

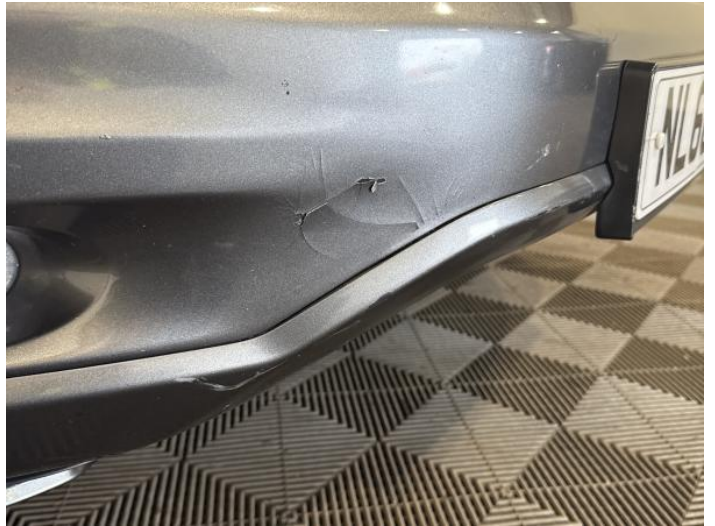
4: Bumper Front
Dented
With Paint Damage

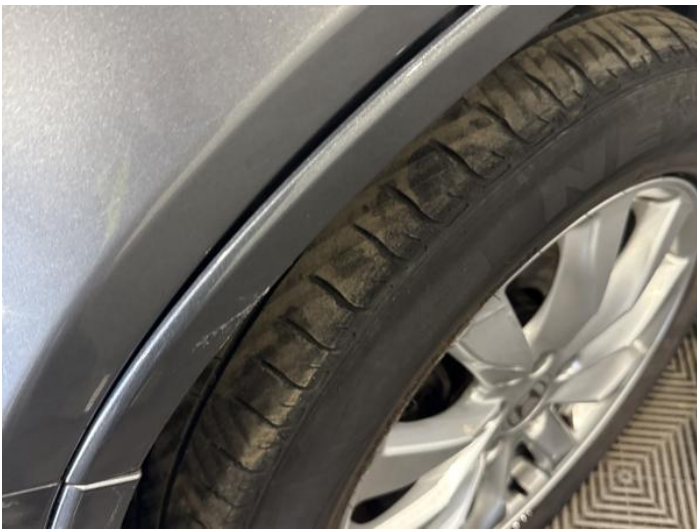
5: Wing Front Arch Extension ns
Scratched (Painted)
Over 25mm Thru Paint

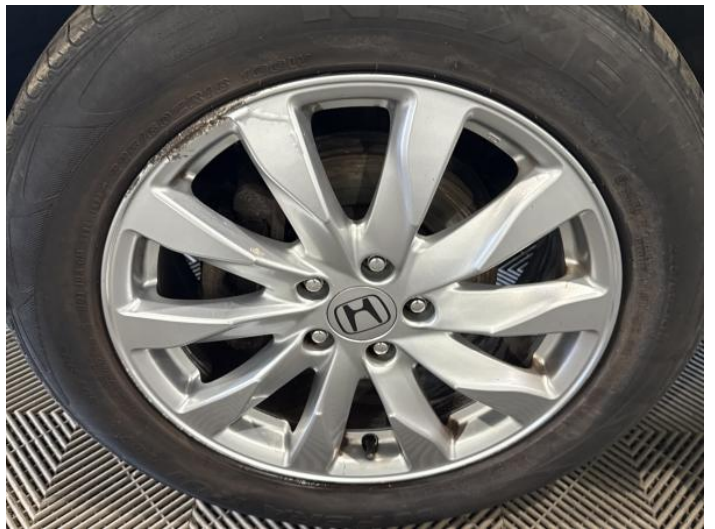
6: Wheel nsf
Scratched
Over 50mm

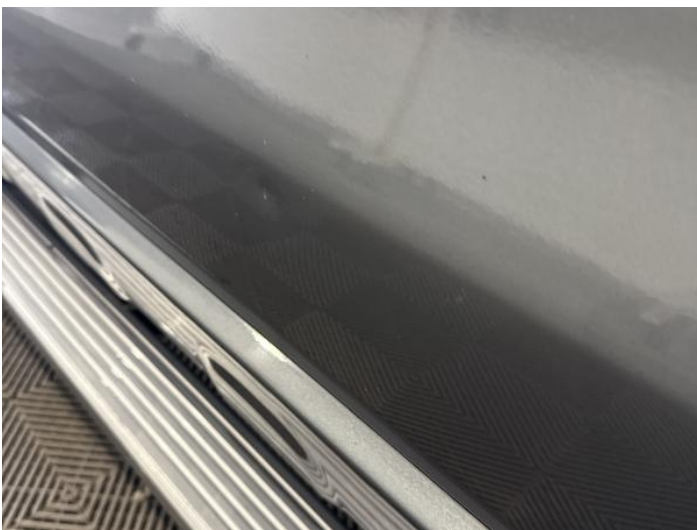
7: Door nsf
Dented
Between 10mm + 30mm

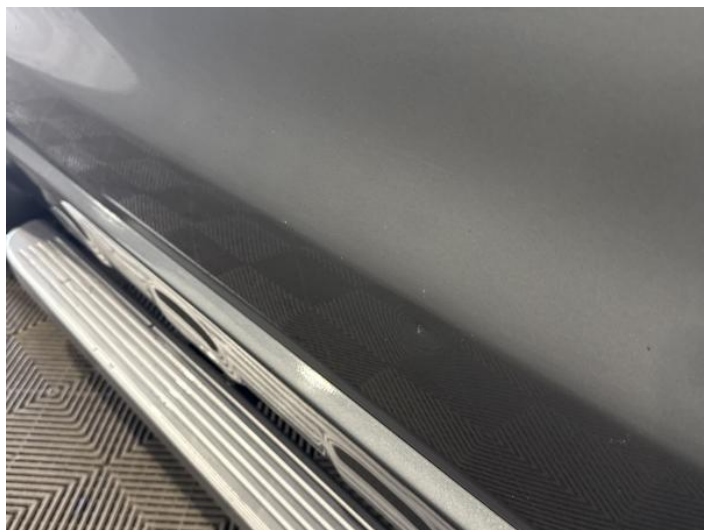
8: Door nsr
Chipped
1 To 5

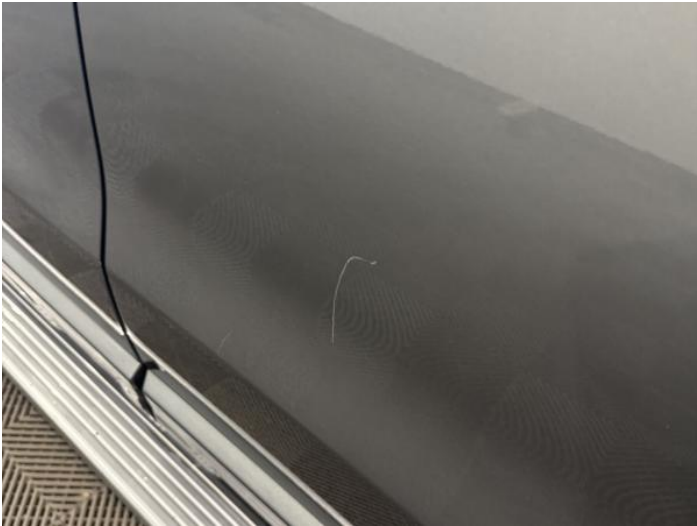
9: Door nsr
Scratched
Over 25mm Thru Paint

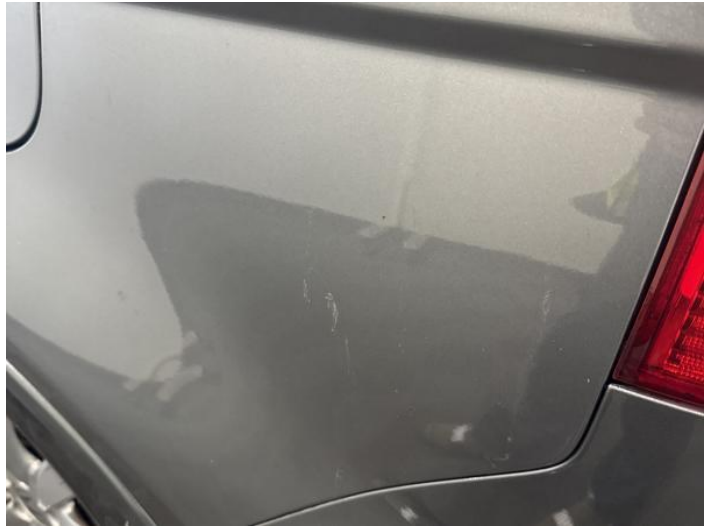
10: Qtr Panel nsr
Scratched
Over 25mm Thru Paint

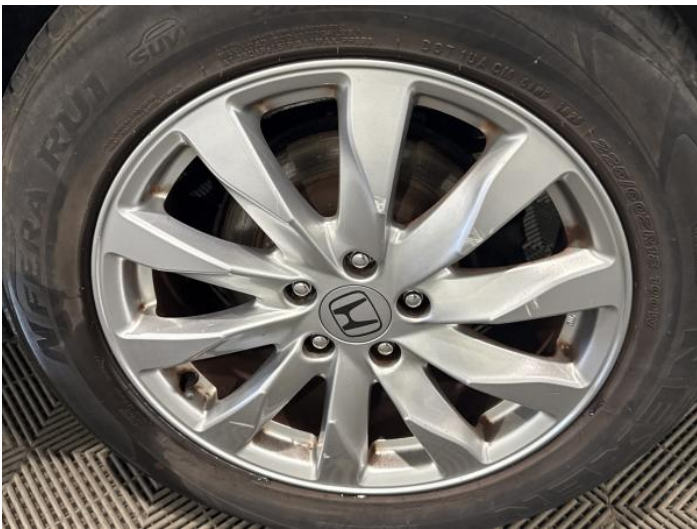
11: Wheel nsr
Scratched
Over 50mm

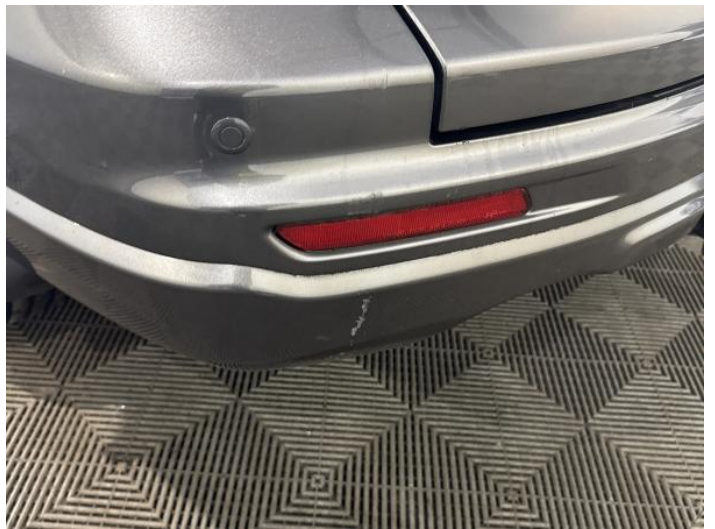
12: Bumper Rear
Scratched
25 to 100mm Thru Paint

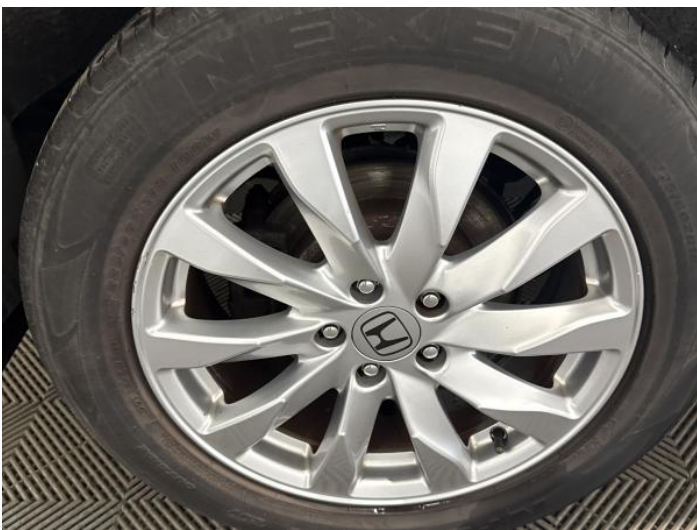
13: Wheel osr
Scratched
Over 50mm

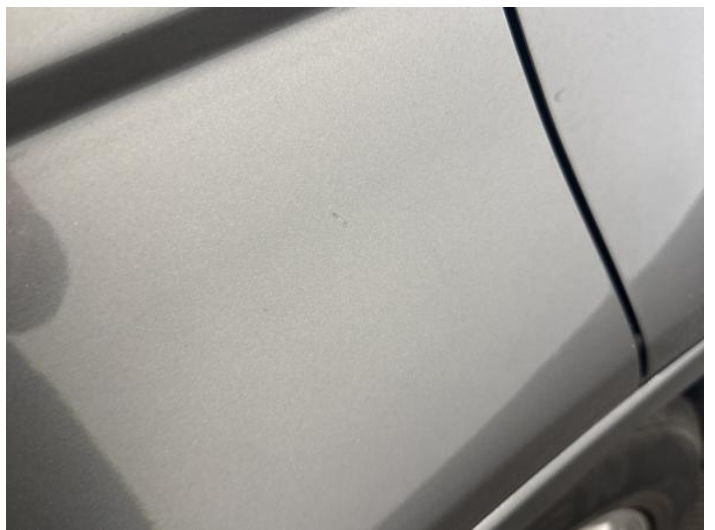
14: Qtr Panel osr
Scratched
UpTo 25mm Thru Paint

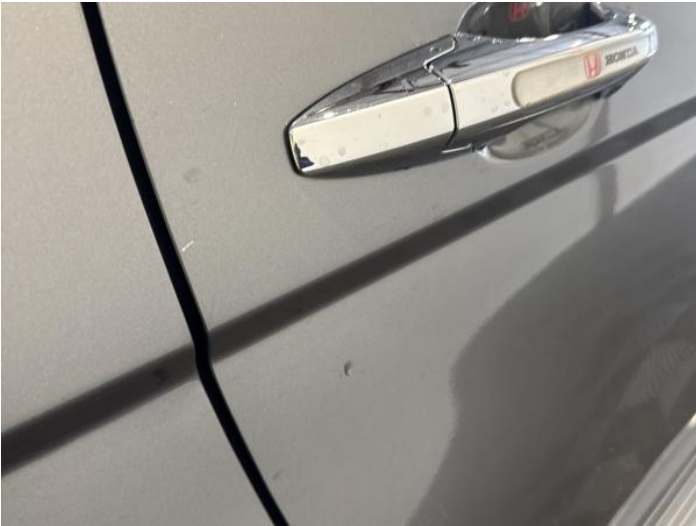
15: Door osr
Scratched
UpTo 25mm Thru Paint

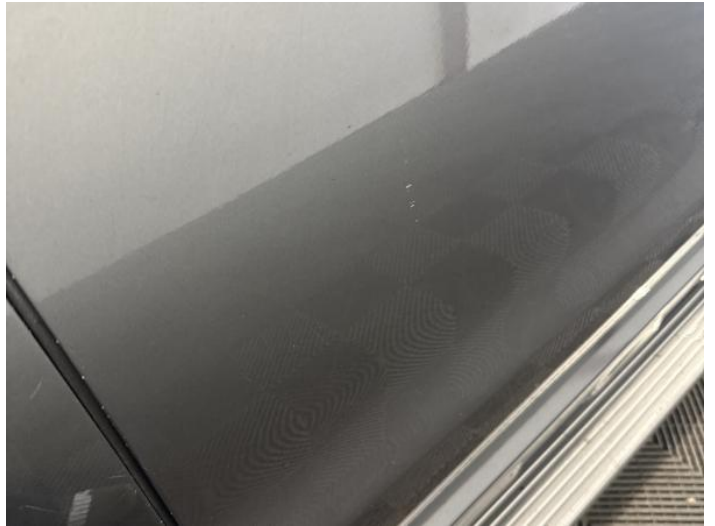
16: Door osf
Chipped
1 To 5

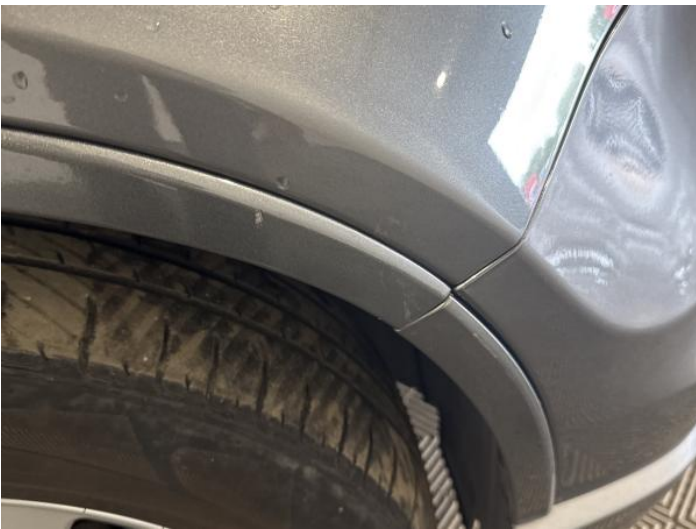
17: Wing osf
Scratched
UpTo 25mm Thru Paint

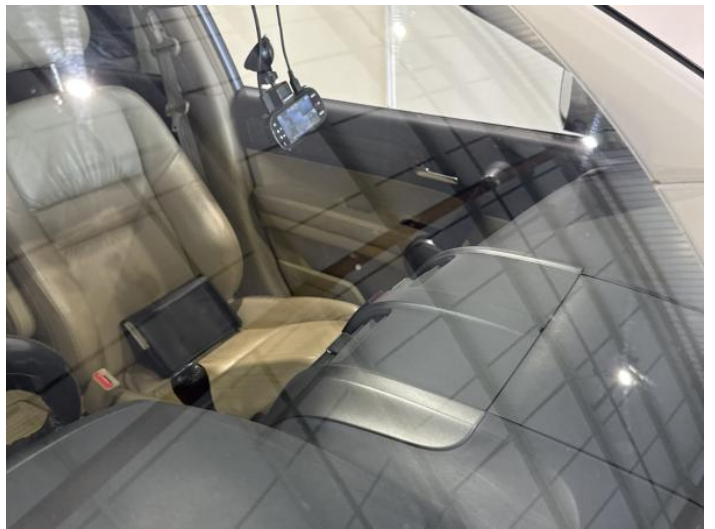
18: Screen Front
Chipped
UpTo 10mm

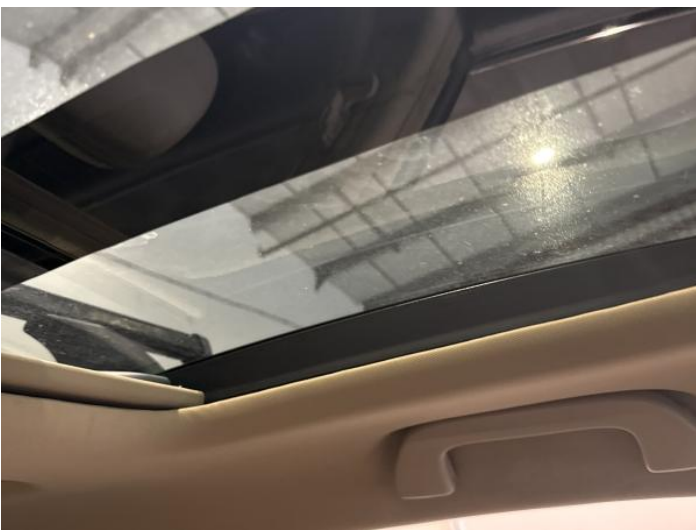
19: Glass Roof
Cracked
Replace

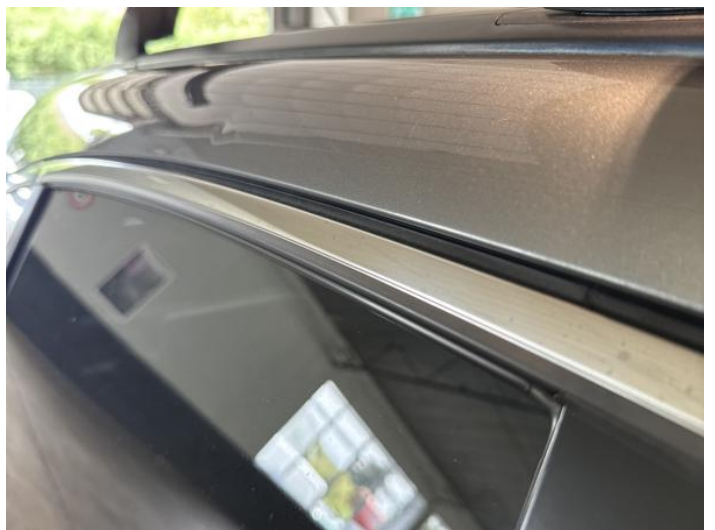
20: B Post os
Dented
Between 10mm + 30mm
