# VEHICLE INSPECTION REPORT

**LV62XPU**

## Mercedes-Benz C Class C180 BlueEFFICIENCY Executive SE 4dr Auto

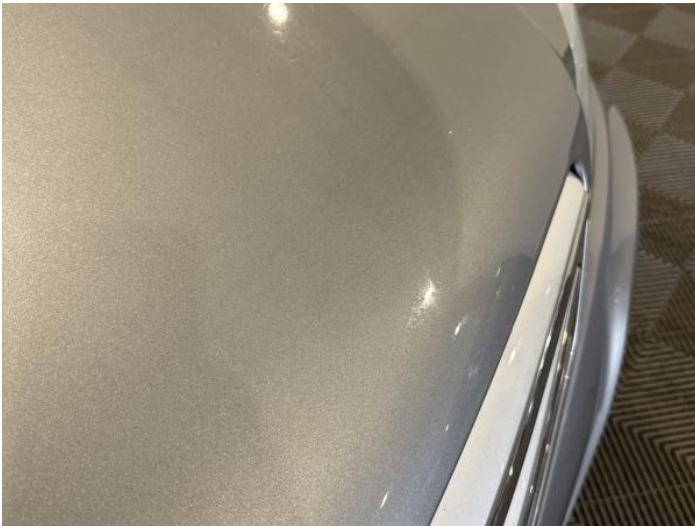
1: Bonnet  
Chipped  
1 To 5

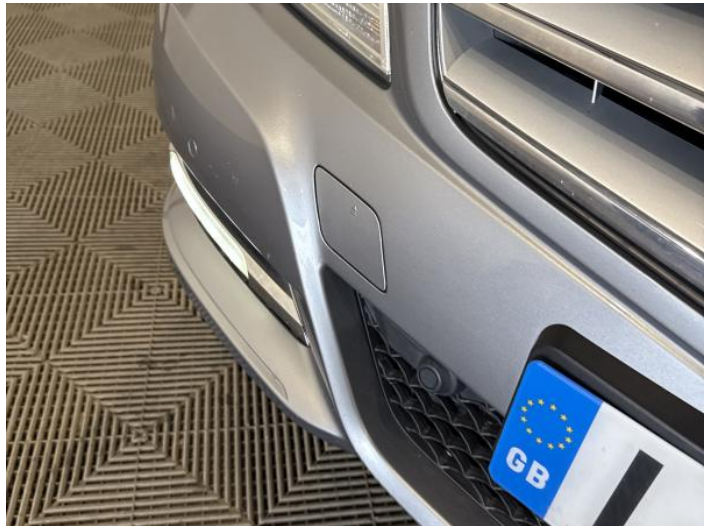
2: Bumper Front  
Scratched  
25 to 100mm Thru Paint

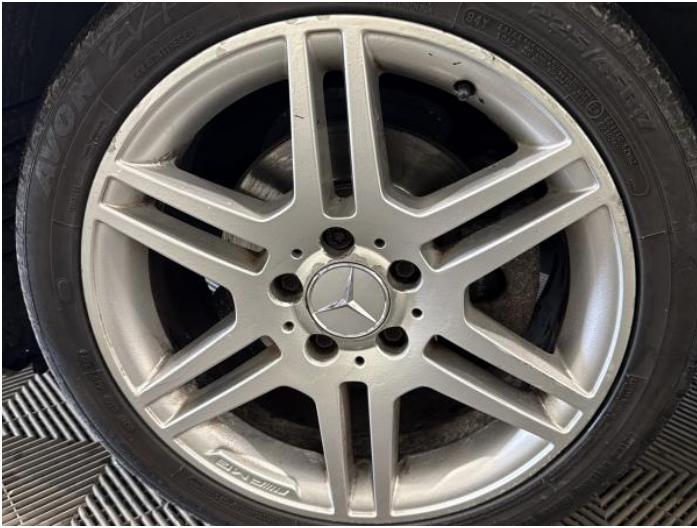
3: Wheel nsf  
Scratched  
Over 50mm

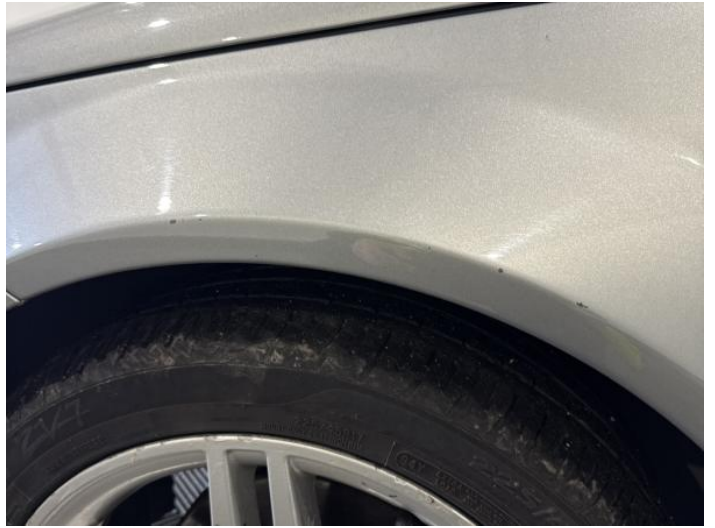
4: Wing nsf  
Chipped  
Multiple Chips

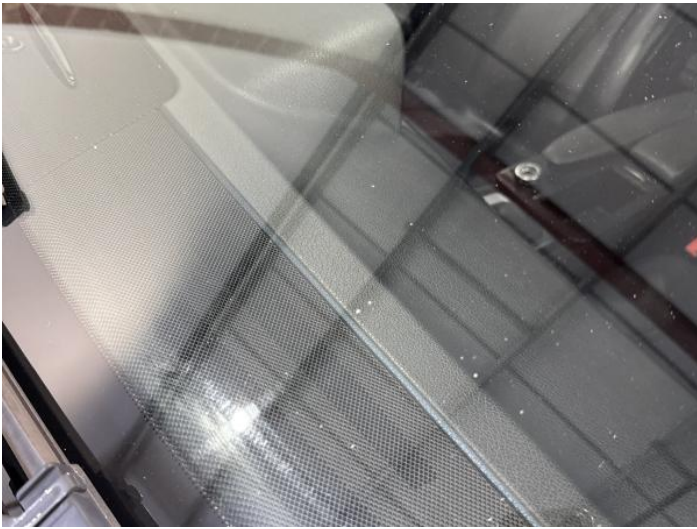
5: Screen Front  
Chipped  
UpTo 10mm

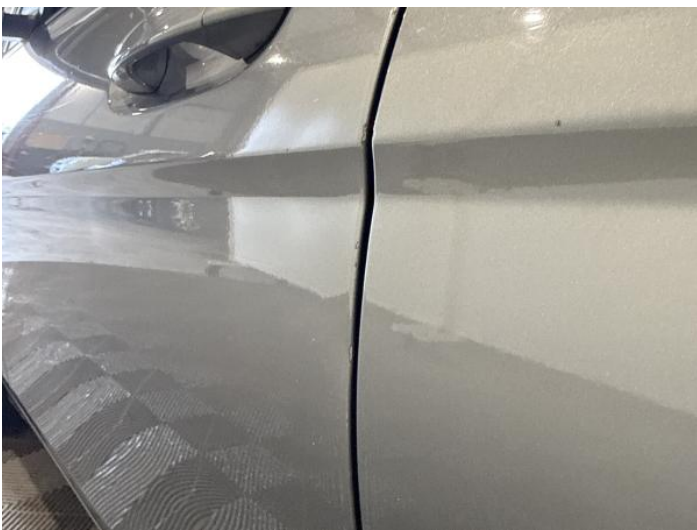
7: Door nsf  
Chipped  
Edge Chip

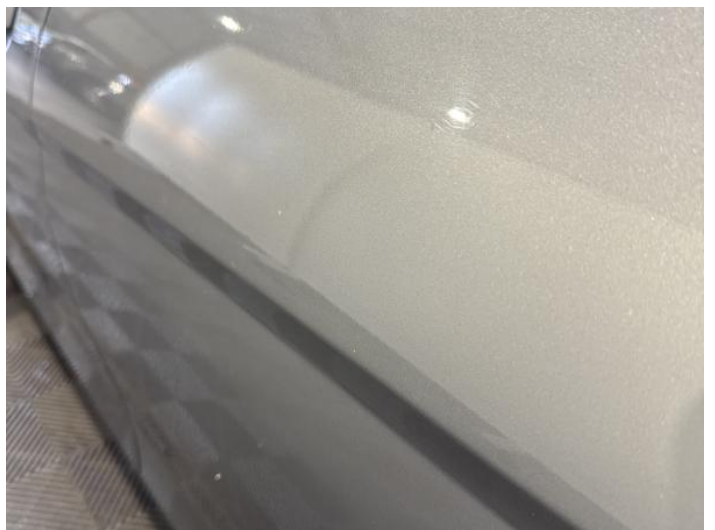
8: Door nsr  
Dented  
Between 10mm + 30mm

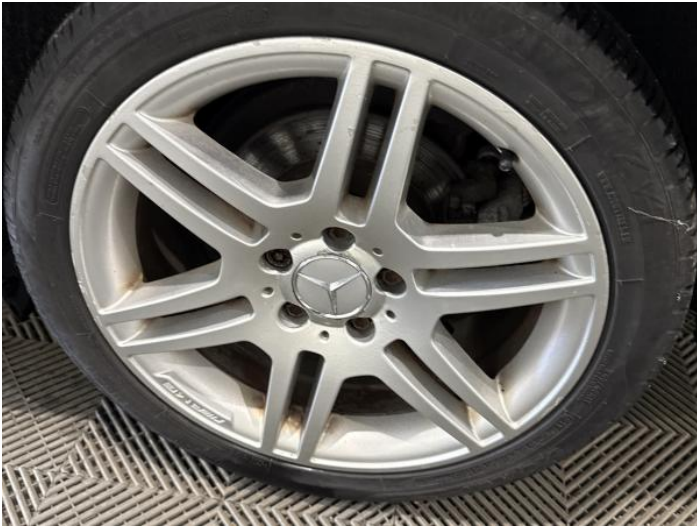
9: Wheel nsr  
Scratched  
Over 50mm

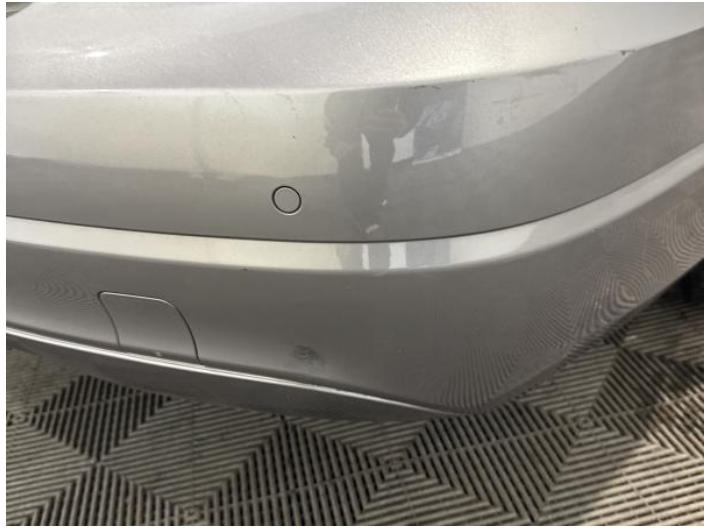
10: Bumper Rear  
Dented  
With Paint Damage

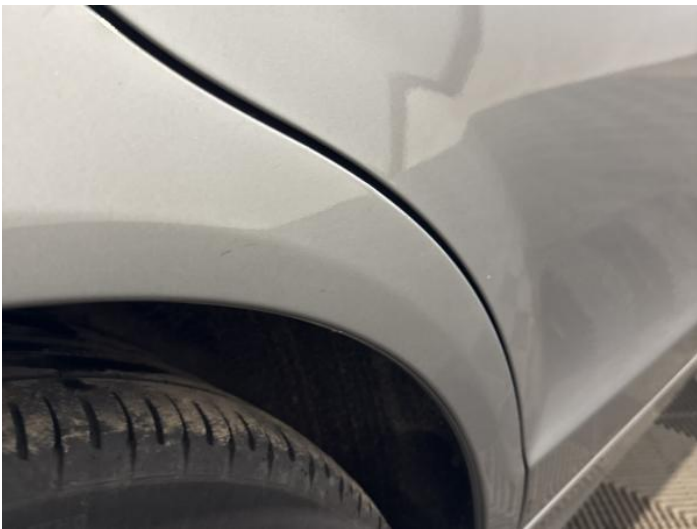
11: Qtr Panel osr  
Scratched  
UpTo 25mm Thru Paint

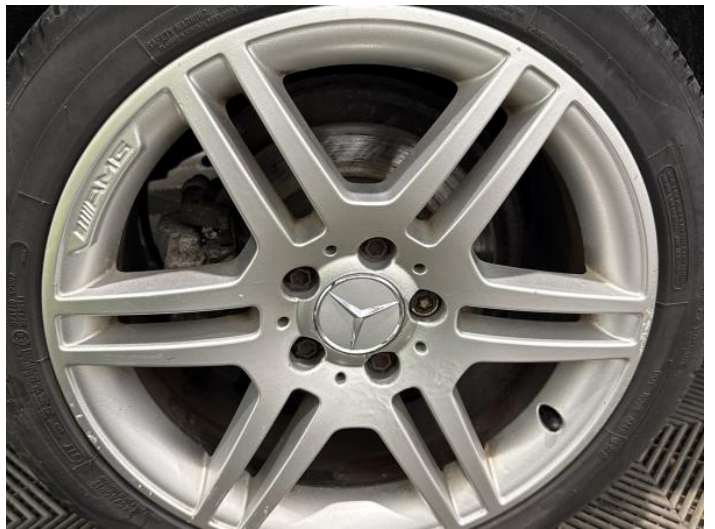
12: Wheel osr  
Scratched  
Up To 50mm

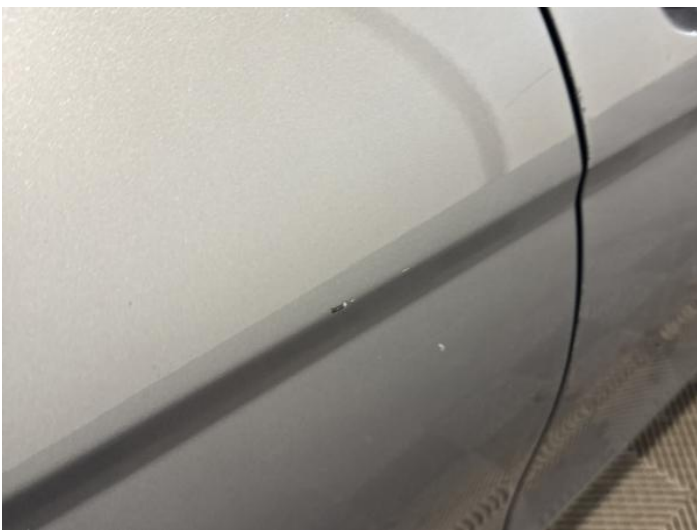
13: Door osr  
Scratched  
UpTo 25mm Thru Paint

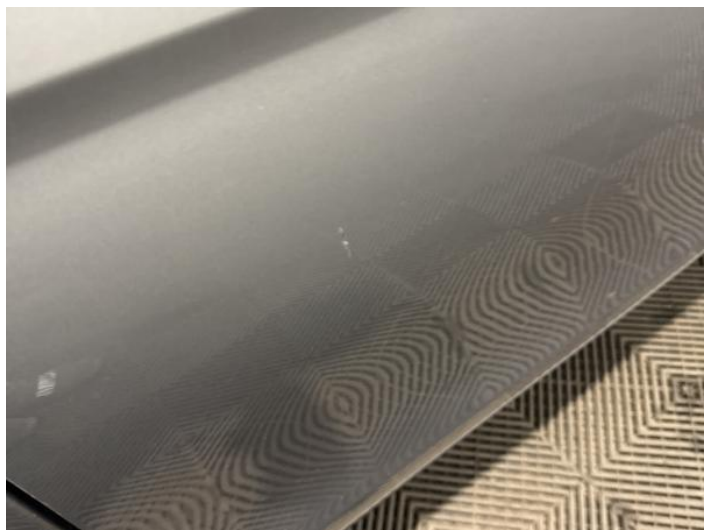
14: Door osf  
Scratched  
UpTo 25mm Thru Paint

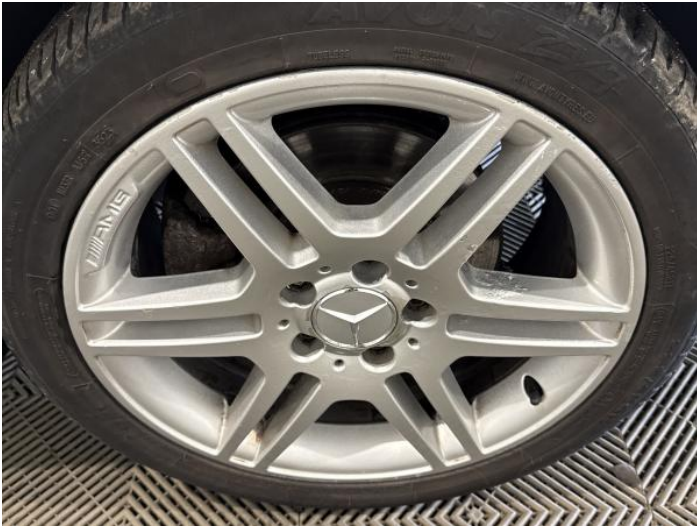
15: Wheel osf  
 Scratched  
 Over 50mm

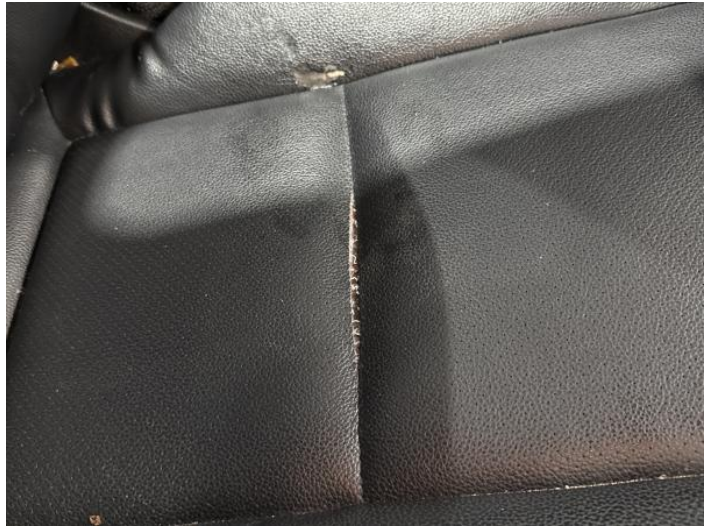
16: Seat Base Cover nsf  
 Torn  
 Over 3mm

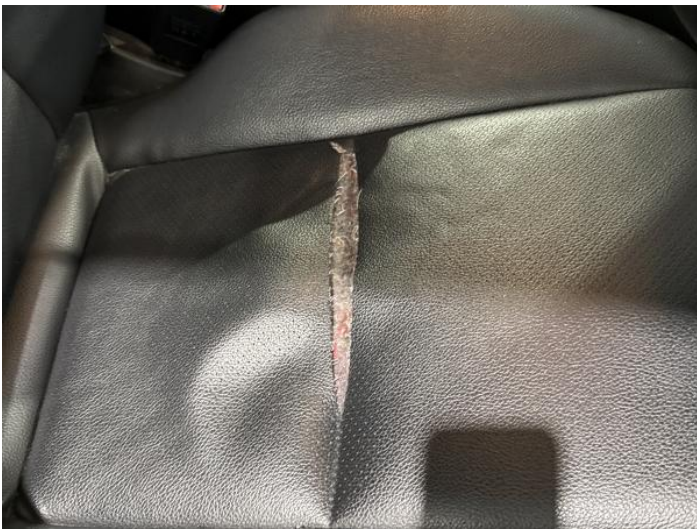
17: Seat Base Cover osf  
 Torn  
 Over 3mm
