VEHICLE INSPECTION REPORT

GK66SVY

MG Mg 3 3 STYLE LUX VTI-TECH

nama
GRADE
4

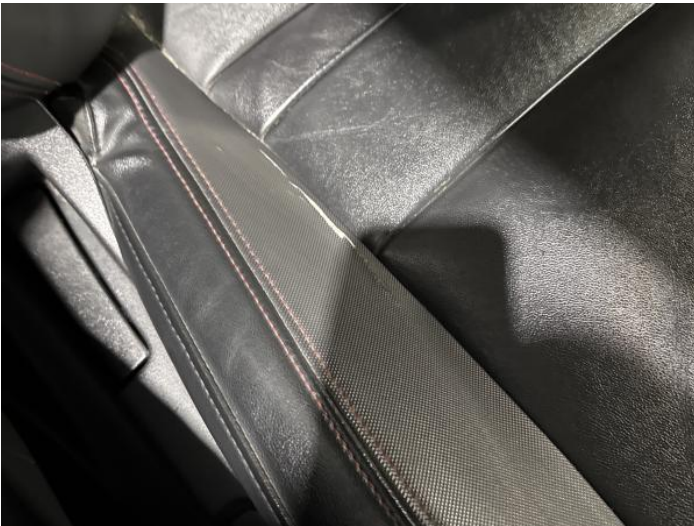
1: Seat Base Cover osf
Torn
Over 3mm

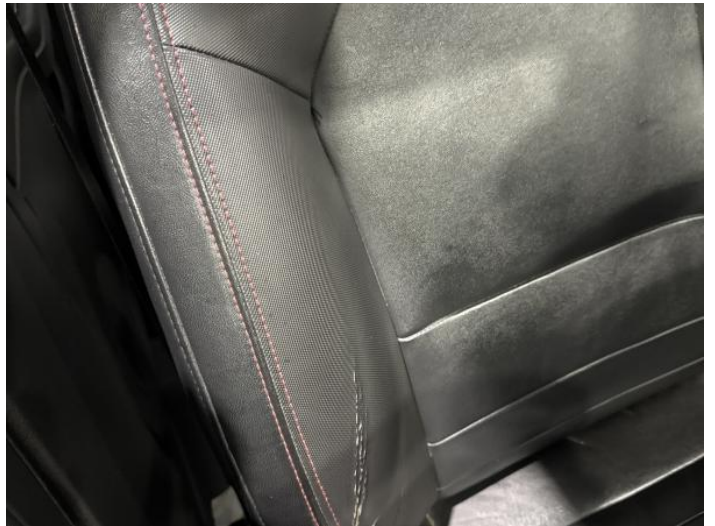
2: Seat Back Cover osf
Scuffed
Over 25mm

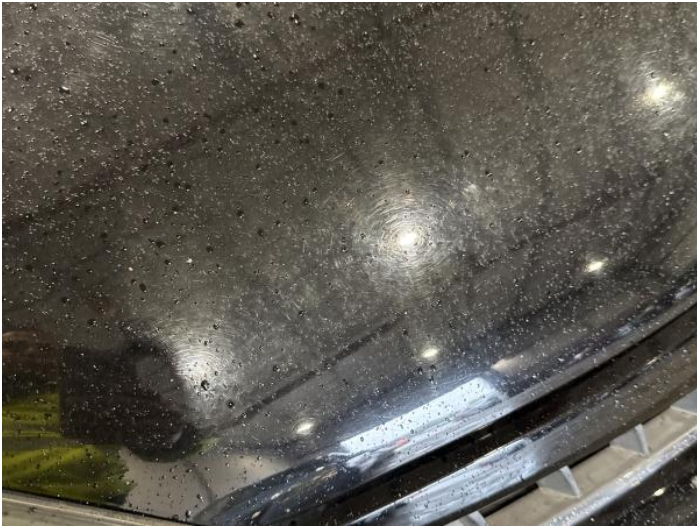
3: Bonnet
Chipped
1 To 5

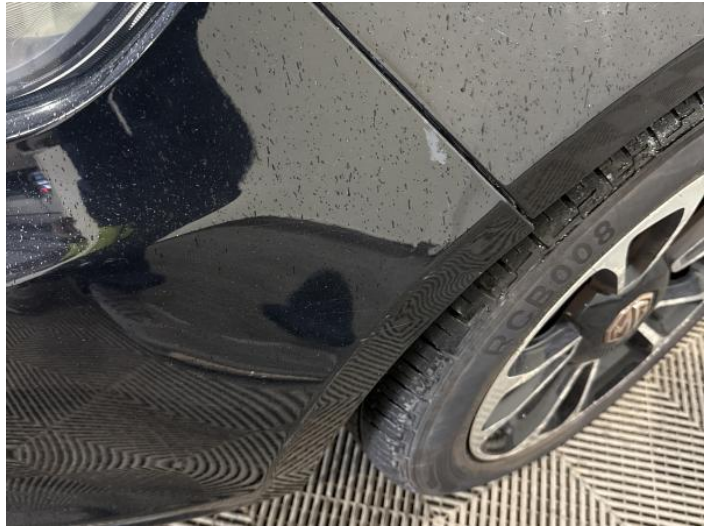
4: Bumper Front
Poor Previous Repair
Paint Flake

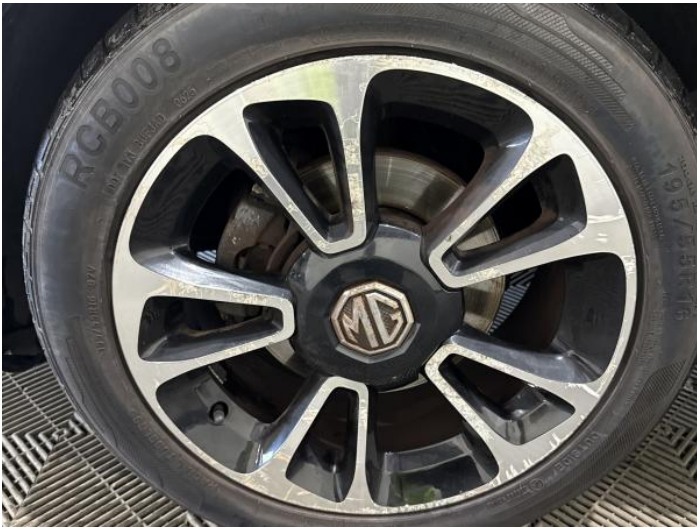
5: Wheel nsf
Scratched
Over 50mm

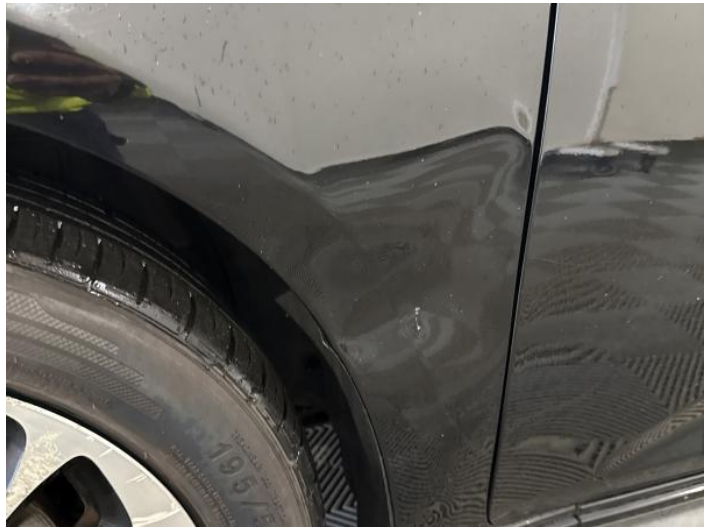
6: Wing nsf
Dented
With Paint Damage

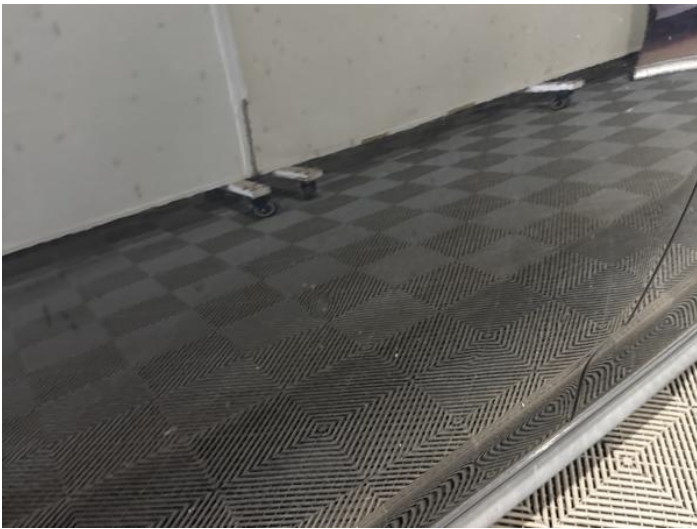
7: Door nsf
Dented
Between 10mm + 30mm

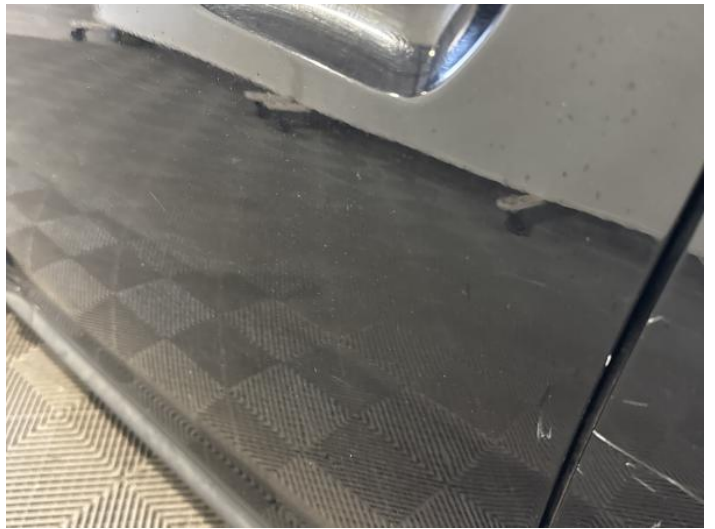
8: Door nsf
Scratched
UpTo 25mm Thru Paint

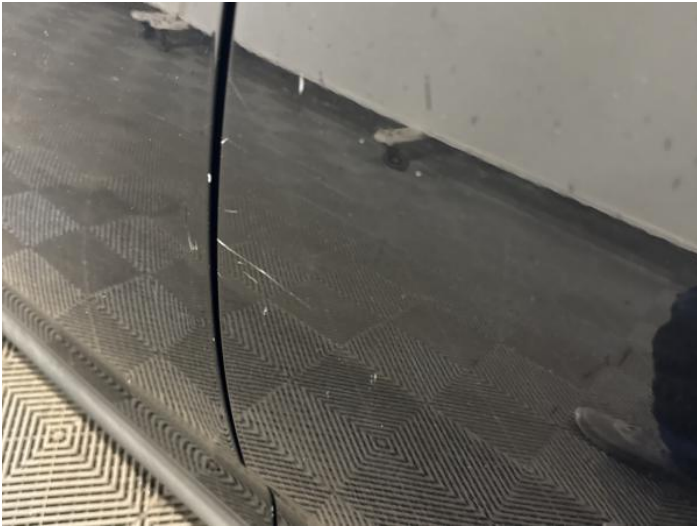
9: Door nsr
Scratched
Over 25mm Thru Paint

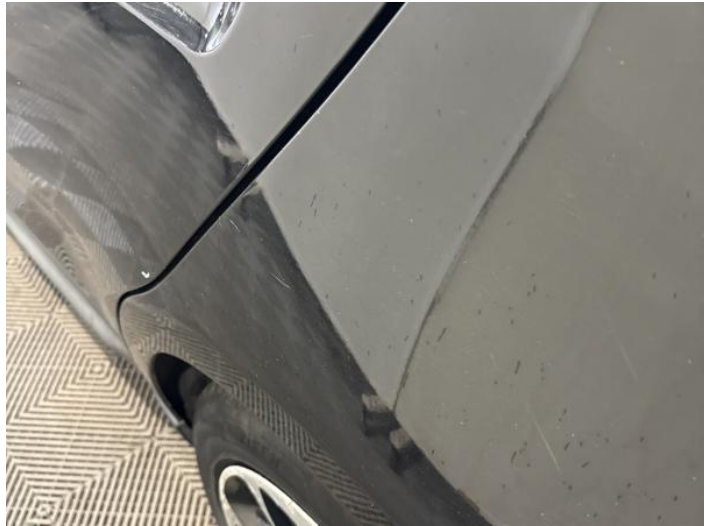
10: Qtr Panel nsr
Scratched
Over 25mm Thru Paint

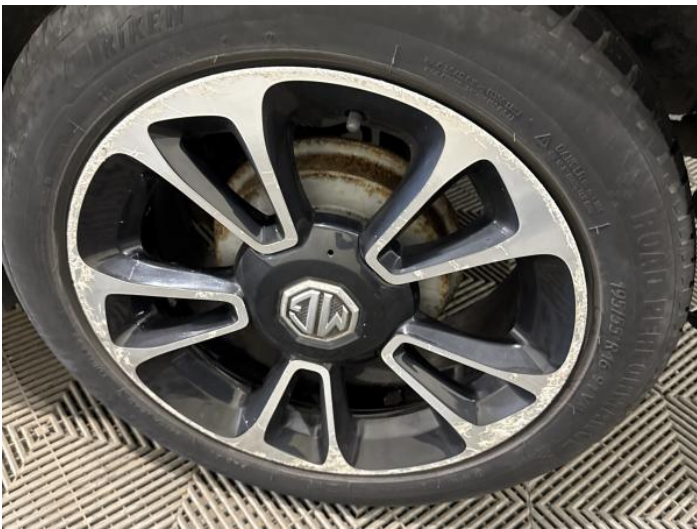
11: Wheel nsr
Scratched
Over 50mm

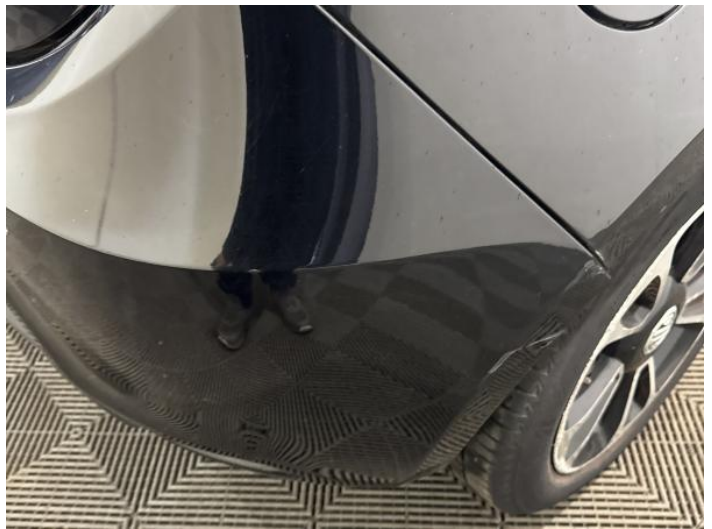
12: Bumper Rear
Scratched
25 to 100mm Thru Paint

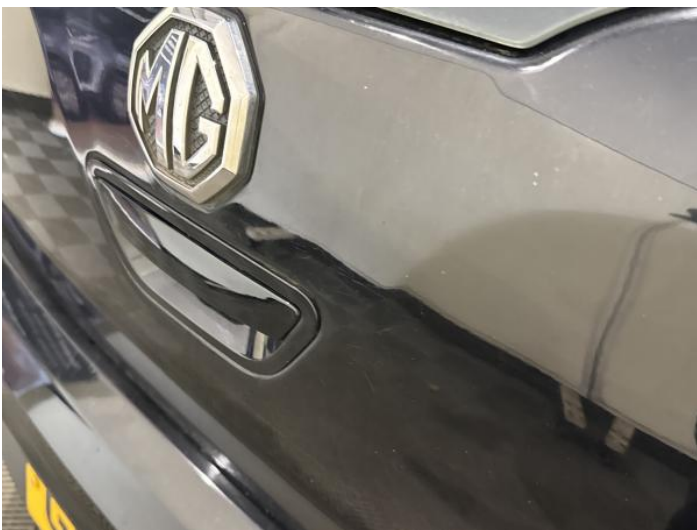
13: Tailgate
Scratched
Over 25mm Thru Paint

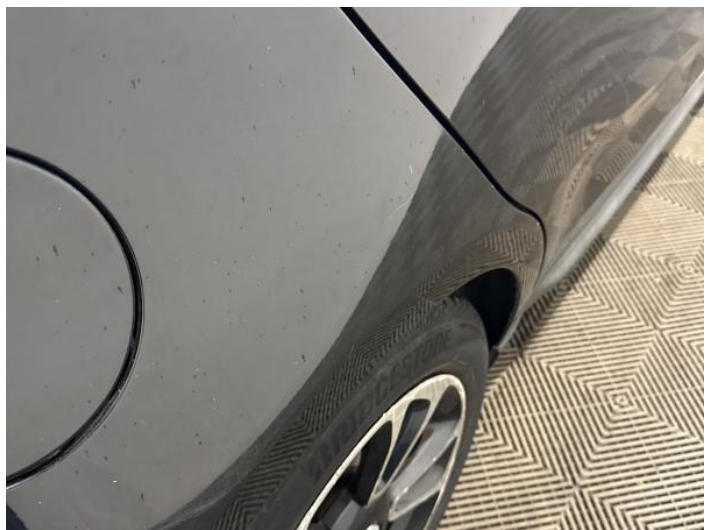
14: Qtr Panel osr
Scratched
Over 25mm Thru Paint

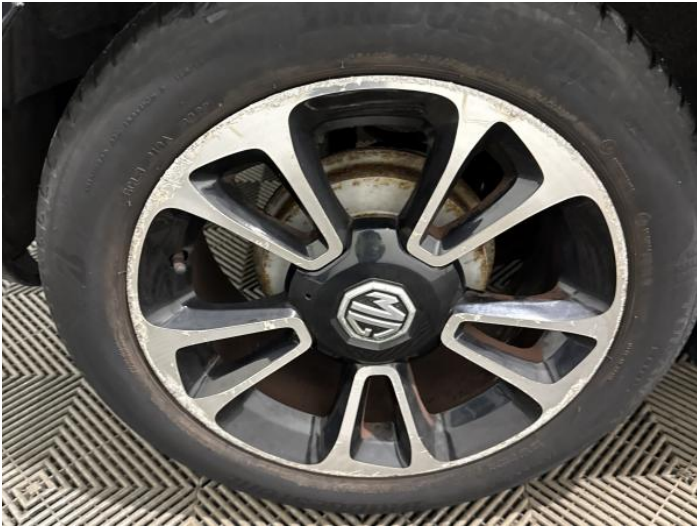
15: Wheel osr
Scratched
Over 50mm

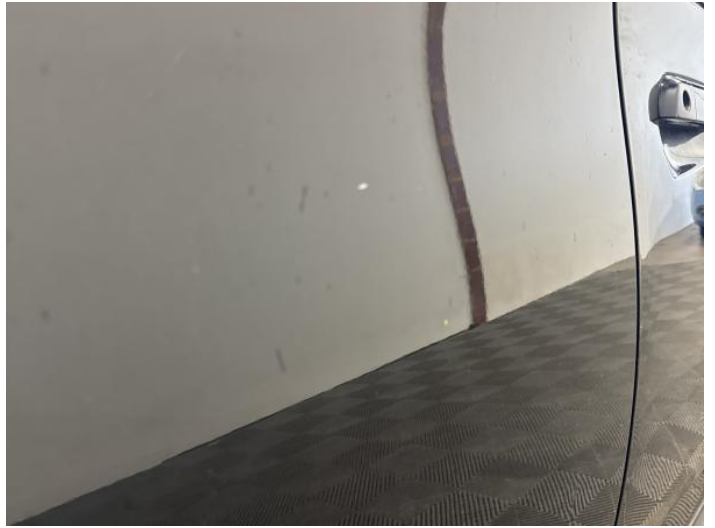
16: Door osr
Dented
2 Or Less UpTo 10mm

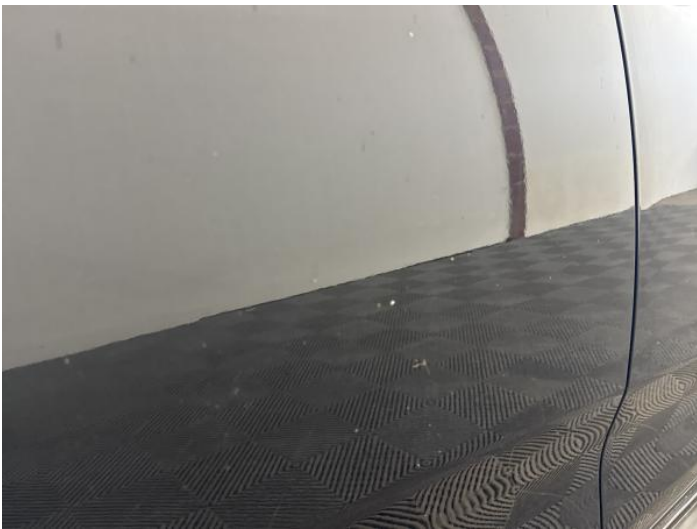
17: Door osr
Chipped
1 To 5

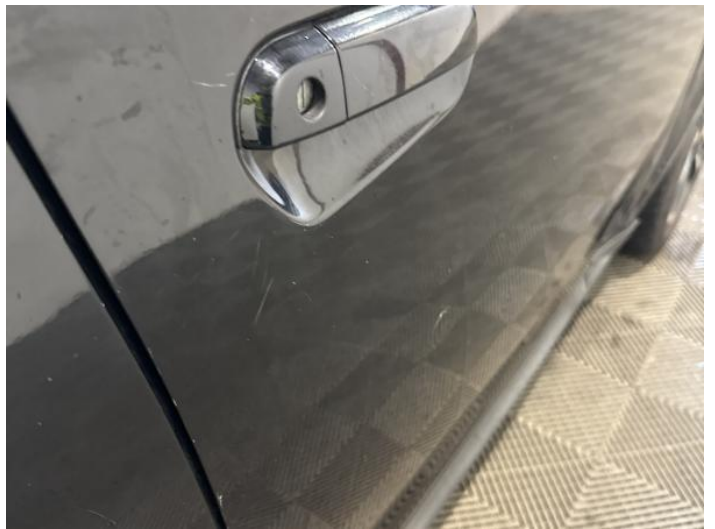
18: Door osf
Scratched
Over 25mm Thru Paint

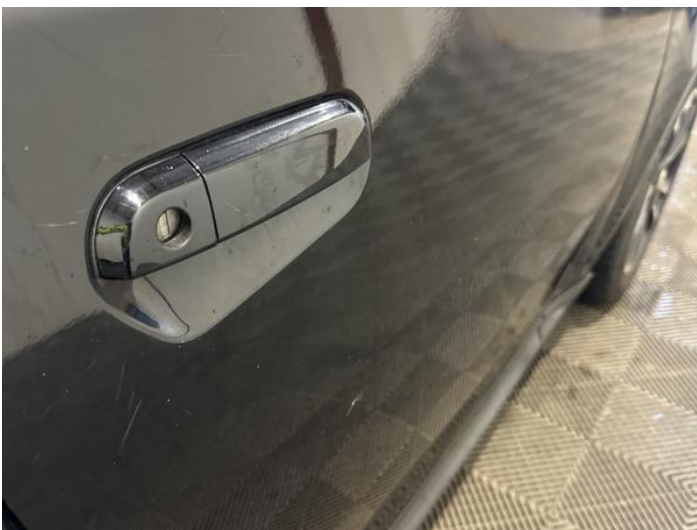
19: Door osf
Dented
2 Or Less UpTo 10mm

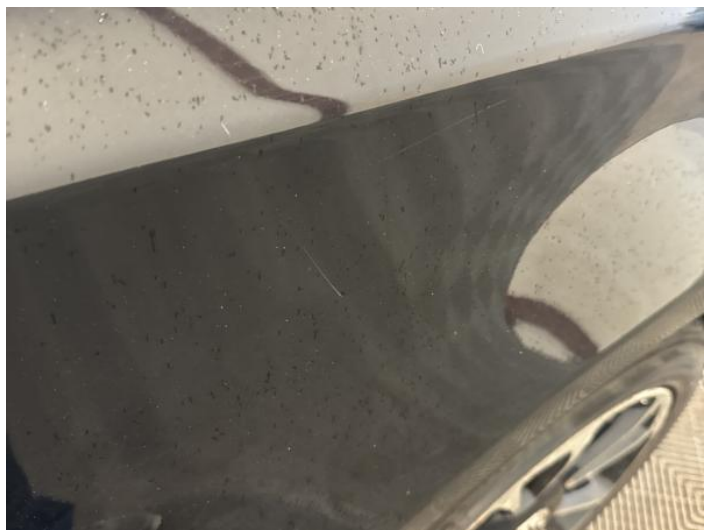
20: Wing osf
Scratched
Over 25mm Thru Paint

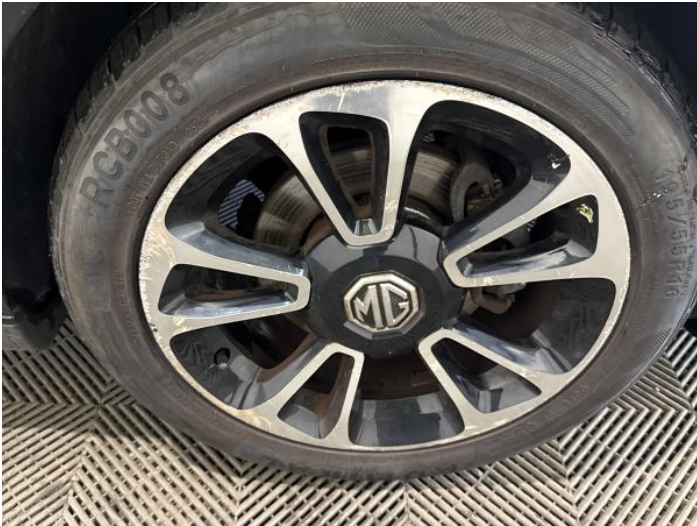
21: Wheel of
Scratched
Over 50mm

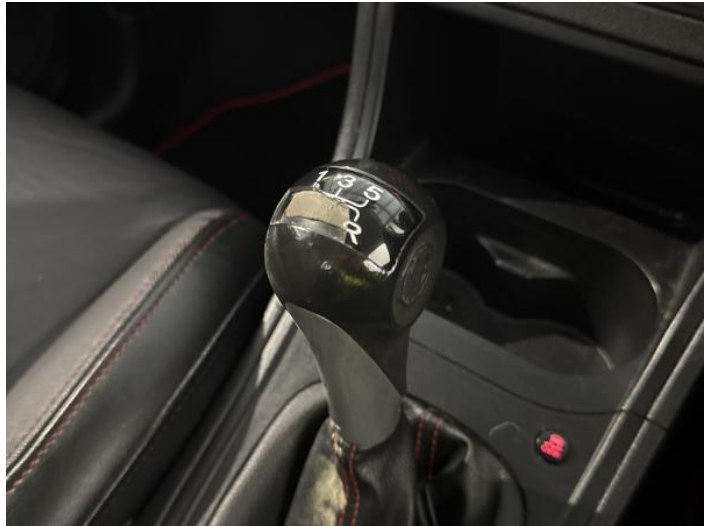
22: Switches And Controls
Broken
Replace

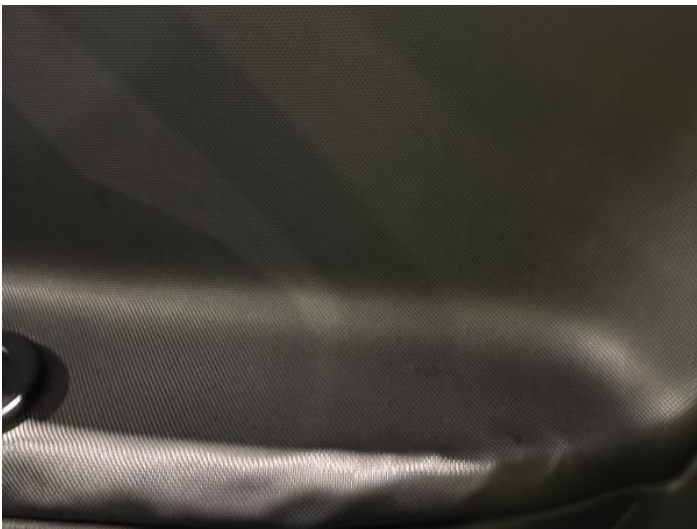
23: Door Pad of
Scuffed
Over 25mm
