VEHICLE INSPECTION REPORT

LP15LWC

Jaguar XE 2.0d SE 4dr Auto

nama
GRADE
4

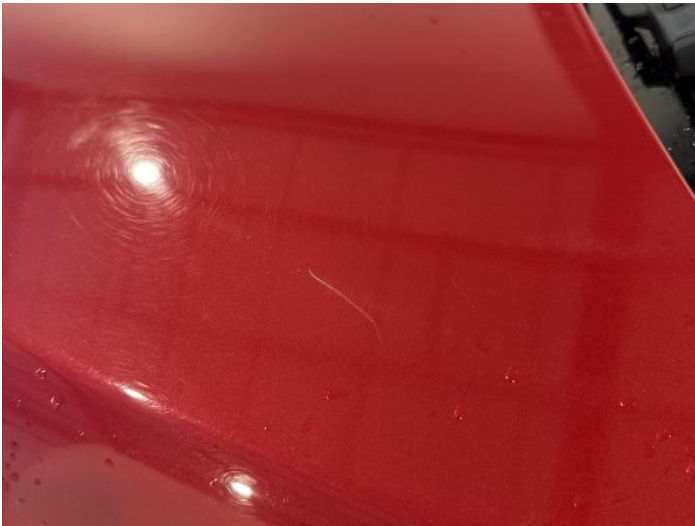
1: Bonnet
Scratched
Over 25mm Thru Paint

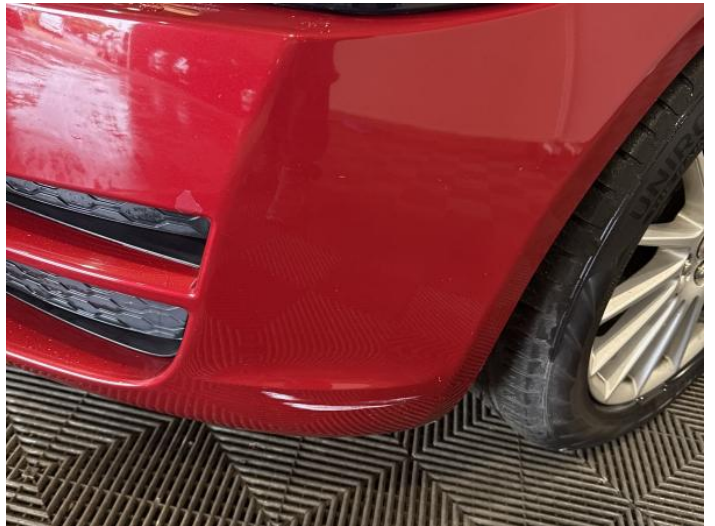
2: Bumper Front
Poor Previous Repair
Paint Flake

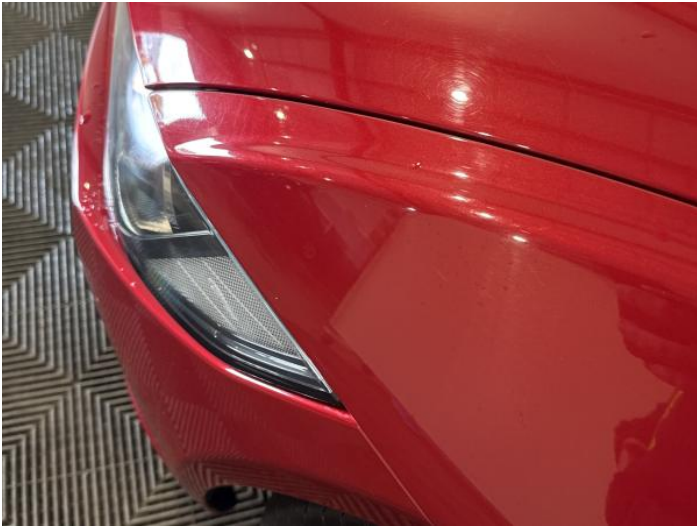
3: Wing nsf
Chipped
1 To 5

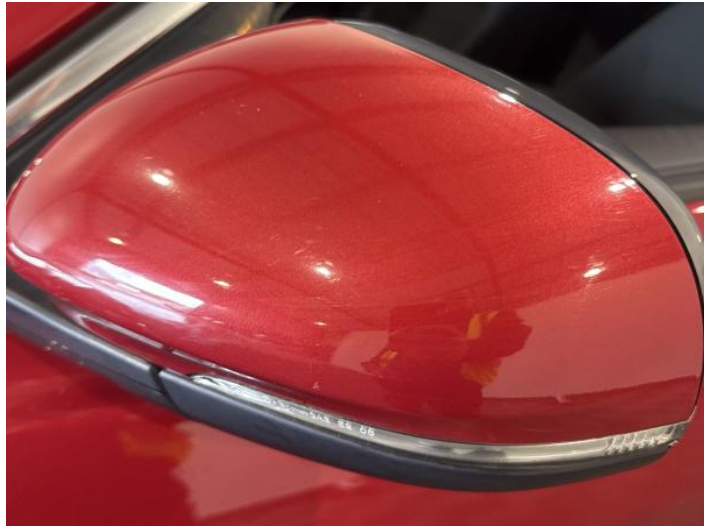
4: Door Mirror Assy nsf
Scratched (Painted)
UpTo 25mm Thru Paint

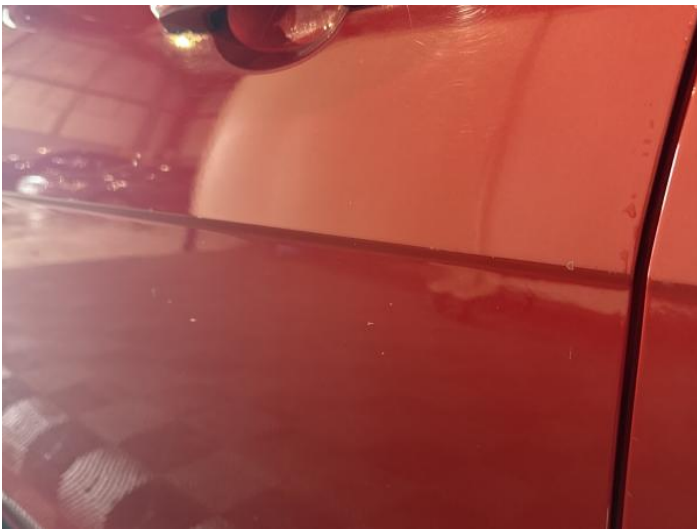
5: Door nsf
Dented
With Paint Damage

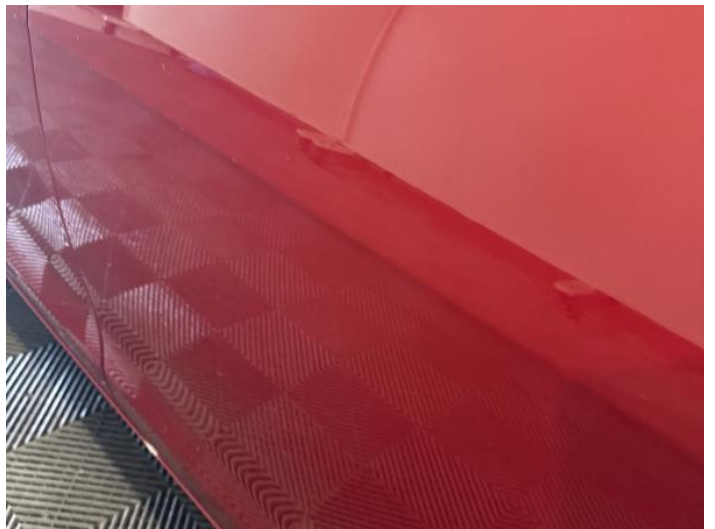
6: Door nsr
Dented
With Paint Damage

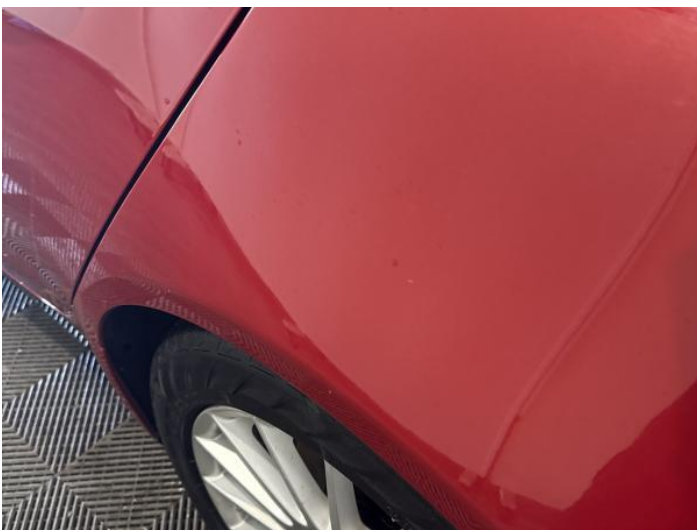
7: Qtr Panel nsr
Chipped
1 To 5

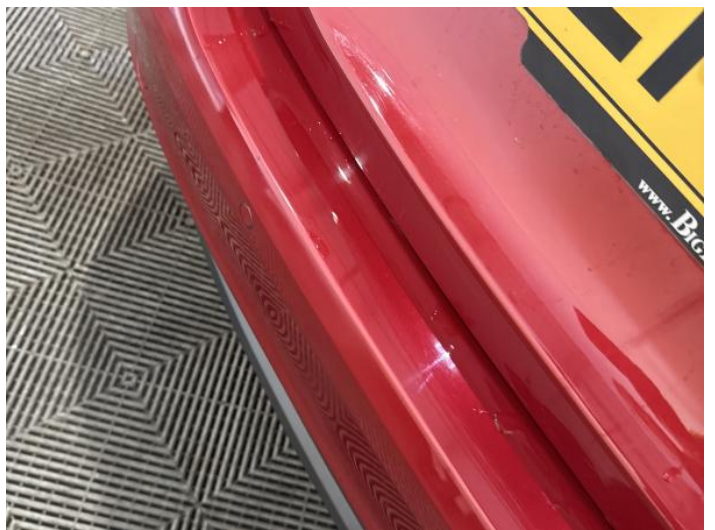
8: Bumper Rear
Chipped
1 To 5

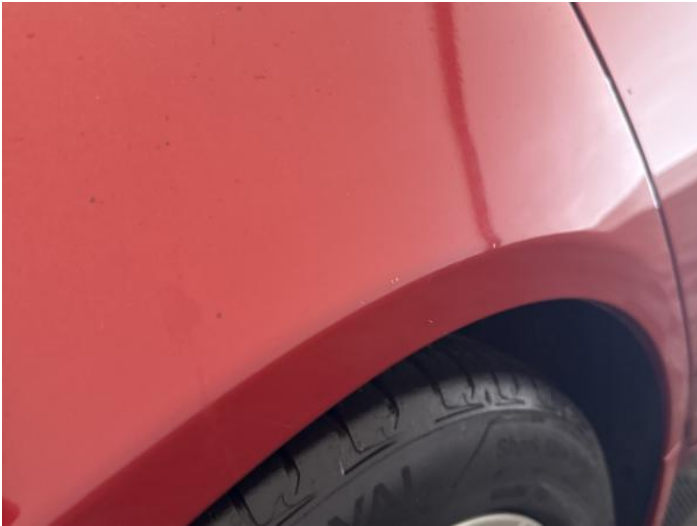
9: Qtr Panel osr
Chipped
1 To 5

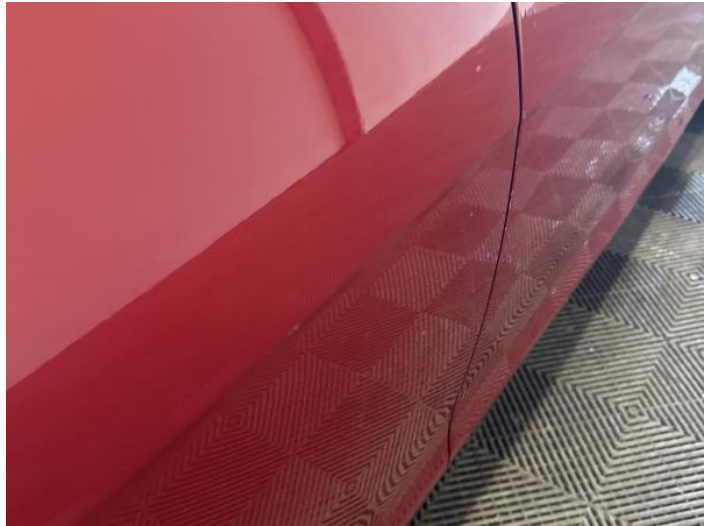
10: Door osr
Dented
Between 10mm + 30mm

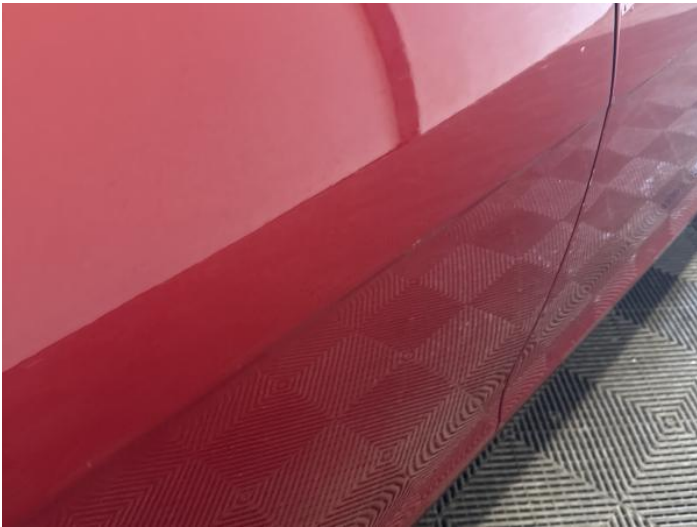
11: Door osr
Chipped
1 To 5

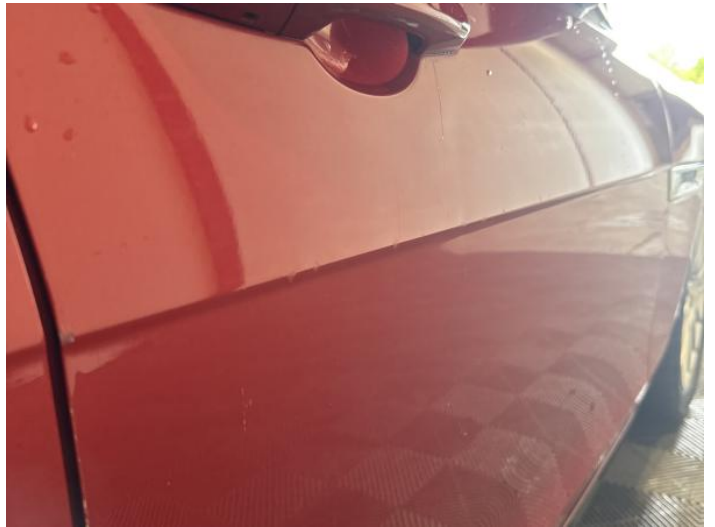
12: Door osf
Dented
With Paint Damage

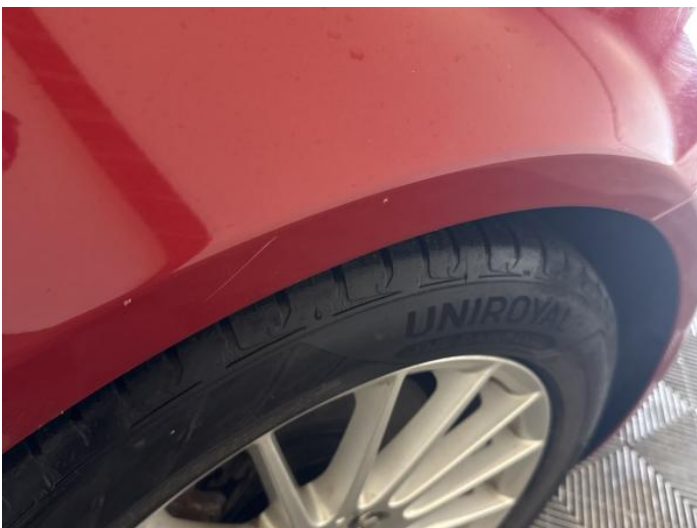
13: Wing osf
Scratched
Up To 25mm Thru Paint

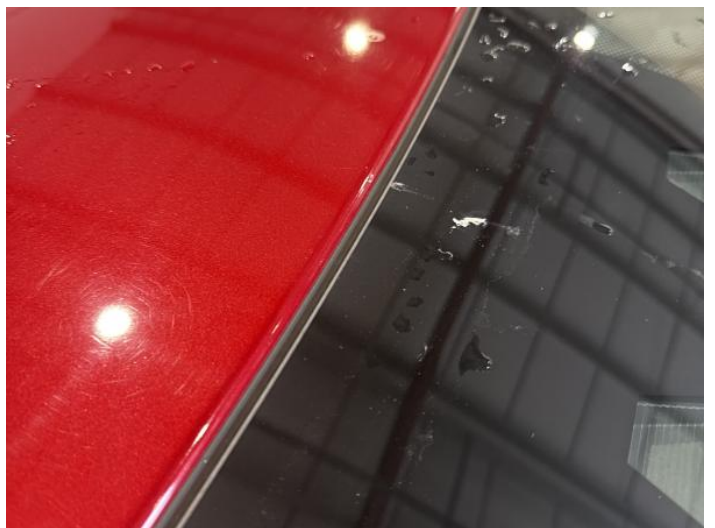
14: Roof
Chipped
Edge Chip
