### VEHICLE INSPECTION REPORT

LN170WR

## Lexus RX 450h 3.5 Premier 5dr CVT [Sunroof]

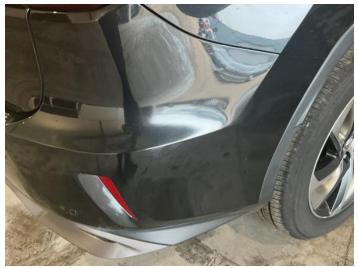
1: Bumper Rear Scratched 25 to 100mm Thru Paint No Image

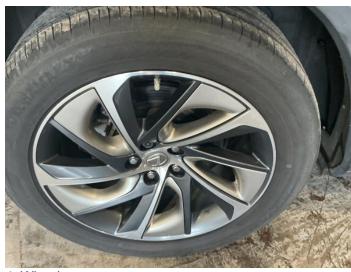
4: Wheel osr Scratched Up To 50mm

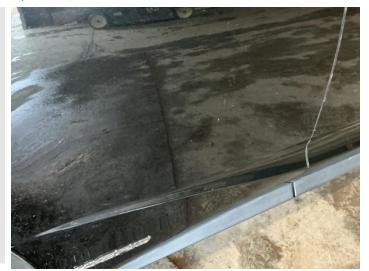
6: Door osr Chipped Multiple Chips

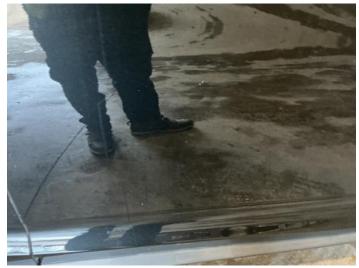
7: Door osf Chipped Multiple Chips

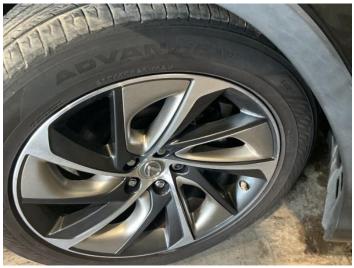
8: Wheel osf Scratched Up To 50mm

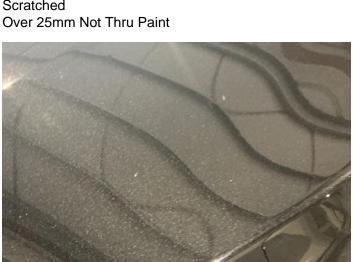
11: Bonnet Chipped 1 To 5

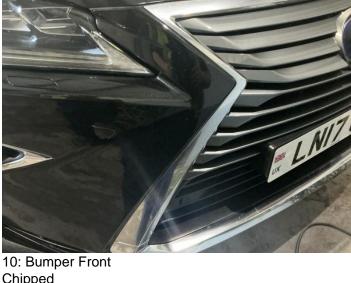
Chipped Multiple Chips

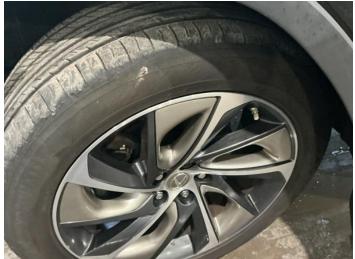
12: Wheel nsf Scratched Up To 50mm

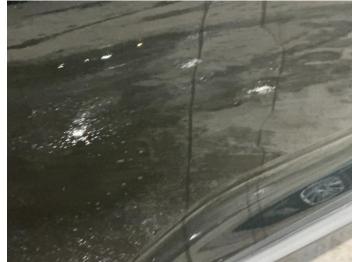
13: Door nsf Chipped 1 To 5

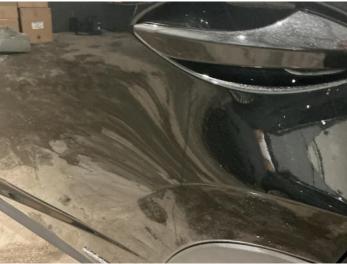
14: Door nsr Chipped 1 To 5
