VEHICLE INSPECTION REPORT

NJ68FUB

BMW X2 sDrive 20i Sport 5dr Step Auto

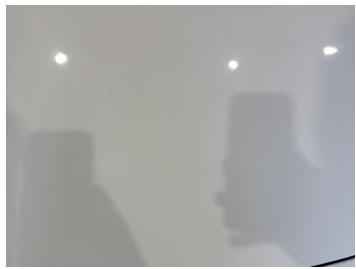
1: Bonnet Chipped 1 To 5

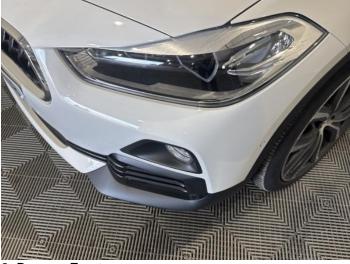
2: Bumper Front Chipped Multiple Chips

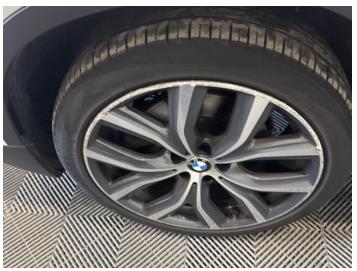
3: Wheel nsf Scratched Over 50mm

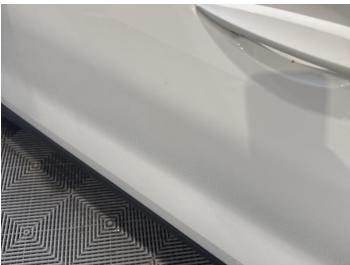
4: Door nsf Chipped 1 To 5

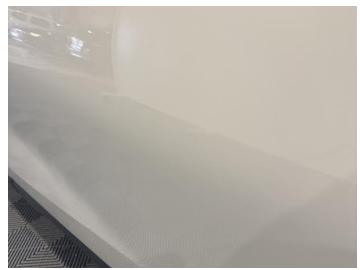
5: Door nsr Dented 2 Or Less UpTo 10mm

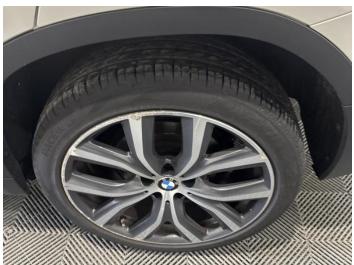
6: Wheel nsr Scratched Over 50mm

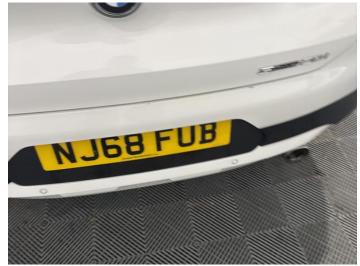
7: Bumper Rear Scratched 25 to 100mm Thru Paint

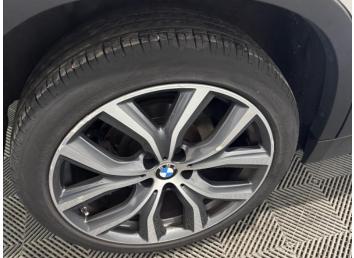
8: Wheel osr Scratched Over 50mm

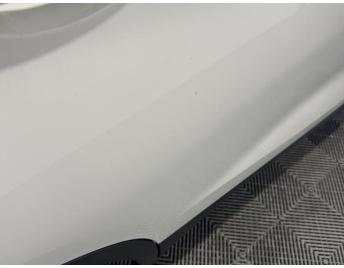
10: Door osr Chipped 1 To 5

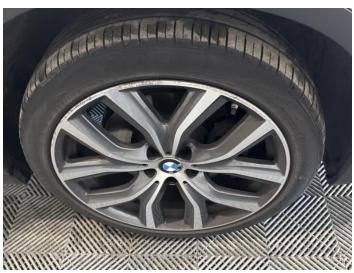
12: Wheel osf Scratched Over 50mm
