VEHICLE INSPECTION REPORT

WU63YPV

Ford Focus 1.0 125 EcoBoost Zetec 5dr

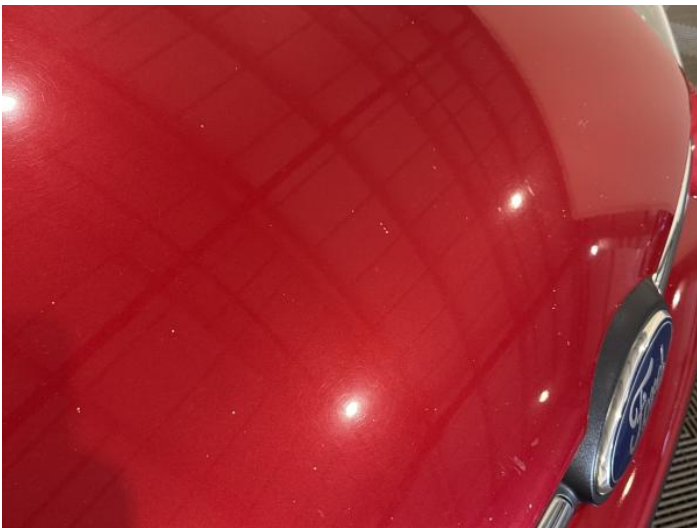
1: Bonnet
Chipped
Multiple Chips

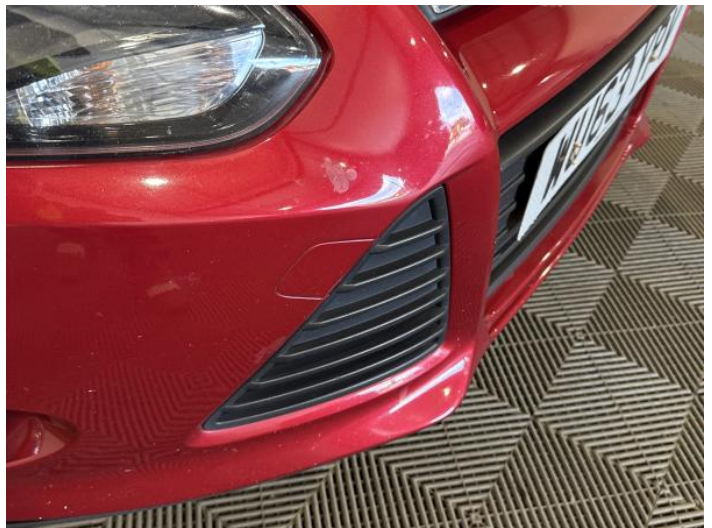
2: Bumper Front
Poor Previous Repair
Poor Paint

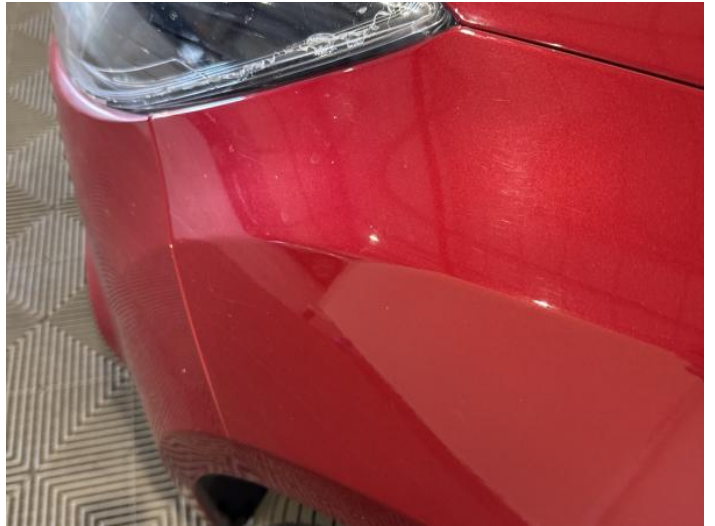
4: Wing nsf
Chipped
1 To 5

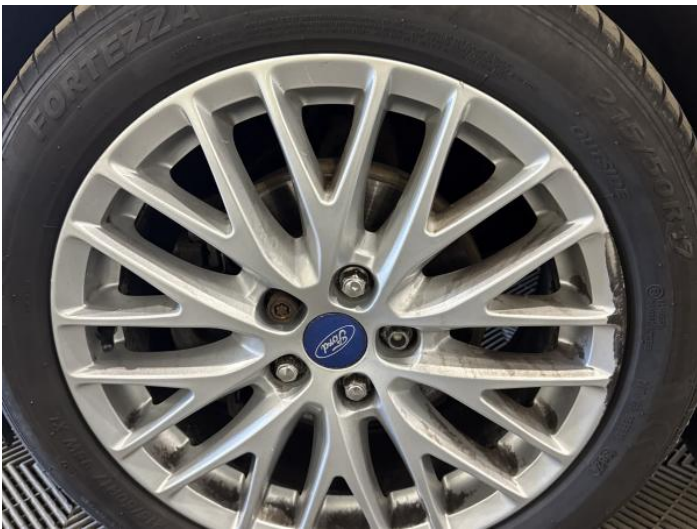
5: Wheel nsf
Scratched
Up To 50mm

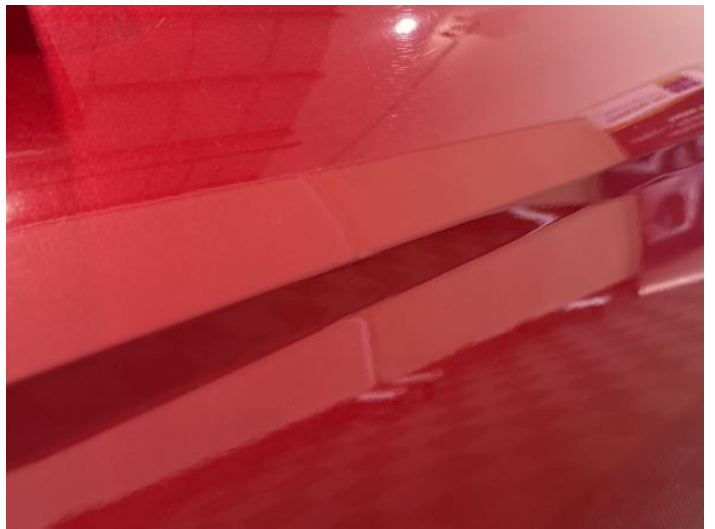
6: Door nsf
Chipped
1 To 5

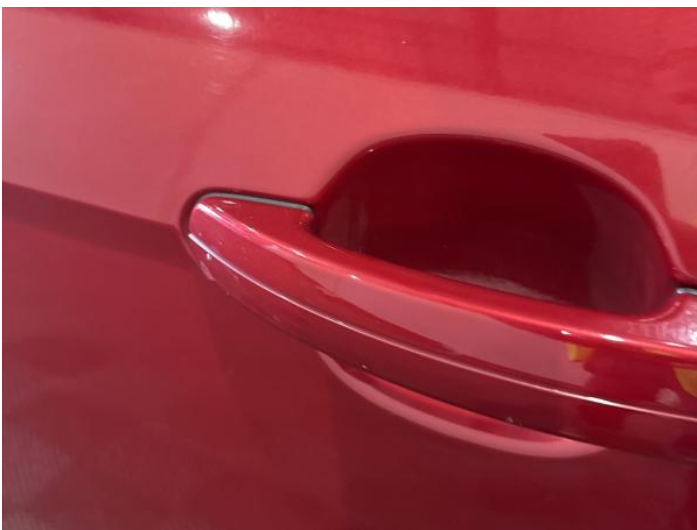
7: Handle Outer nsf
Scratched (Painted)
Up To 25mm Thru Paint

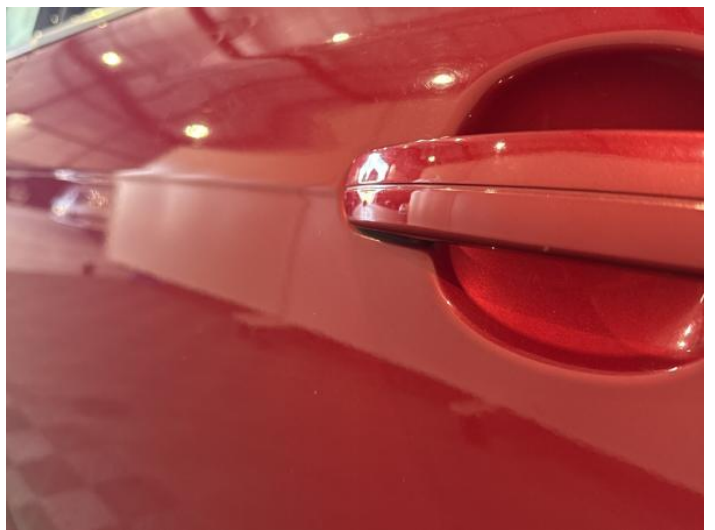
8: Door nsr
Chipped
1 To 5

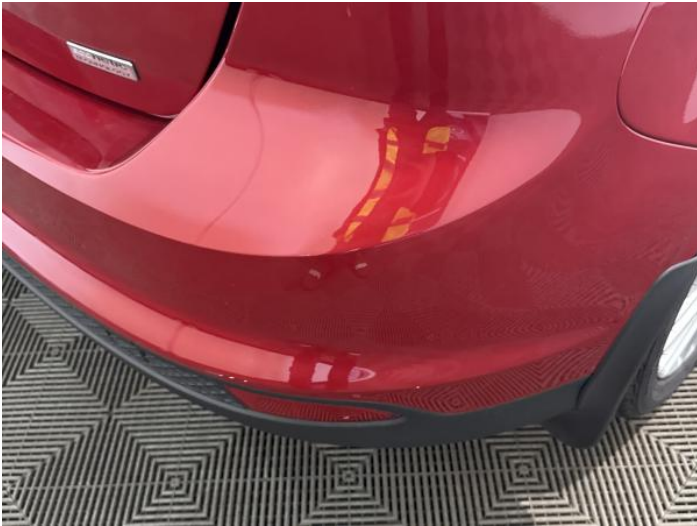
9: Bumper Rear
Scratched
25 to 100mm Thru Paint

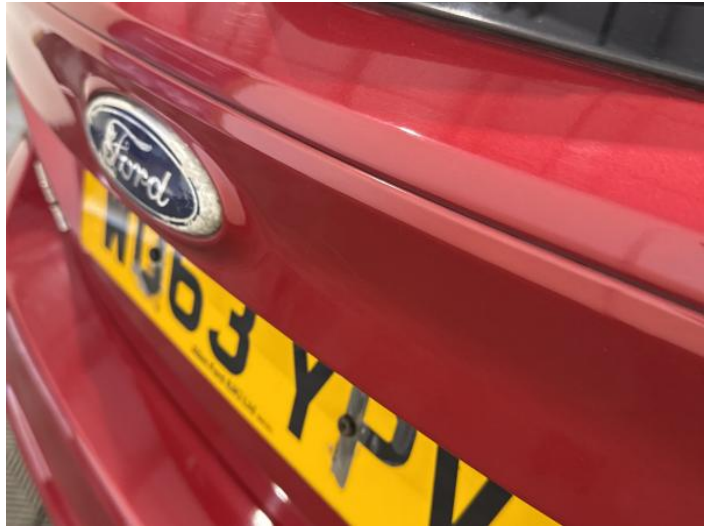
10: Tailgate Trim Panel
Scratched (Painted)
Over 25mm Thru Paint

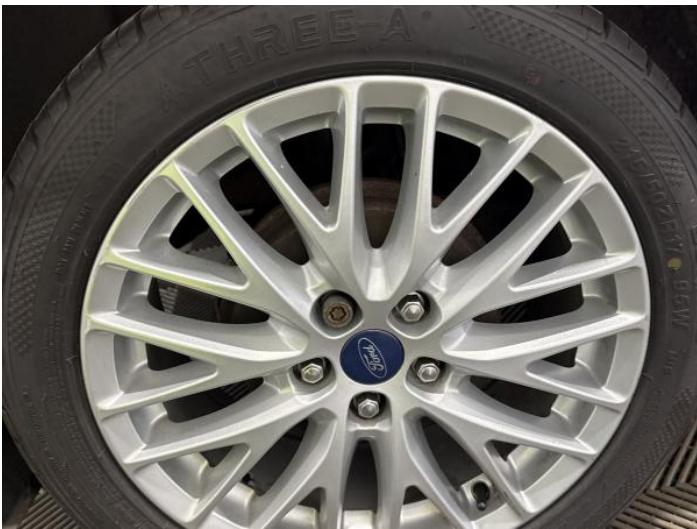
11: Wheel osf
Scratched
Over 50mm

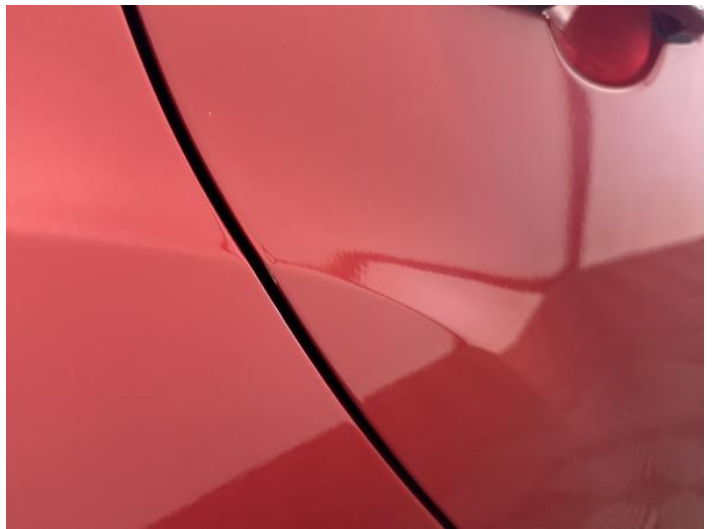
12: Door osf
Chipped
Edge Chip

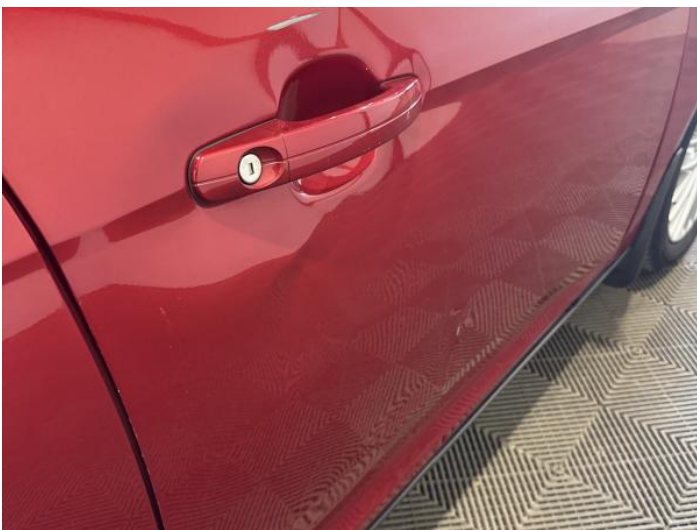
13: Door osf
Dented
With Paint Damage

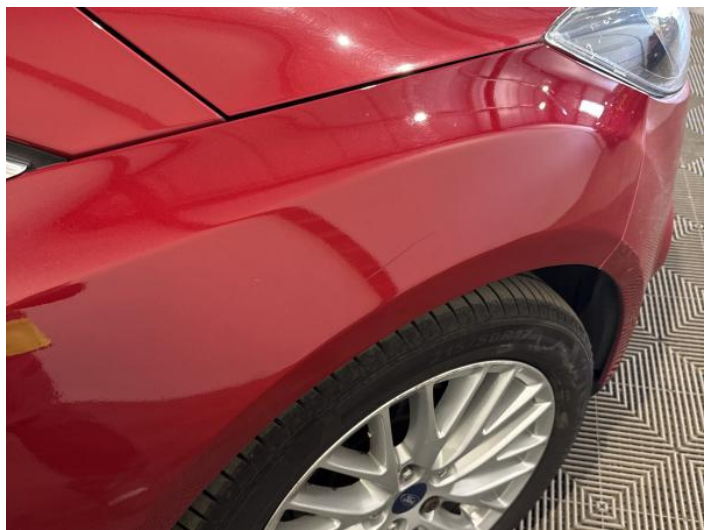
14: Wing osf
Poor Previous Repair
Poor Paint

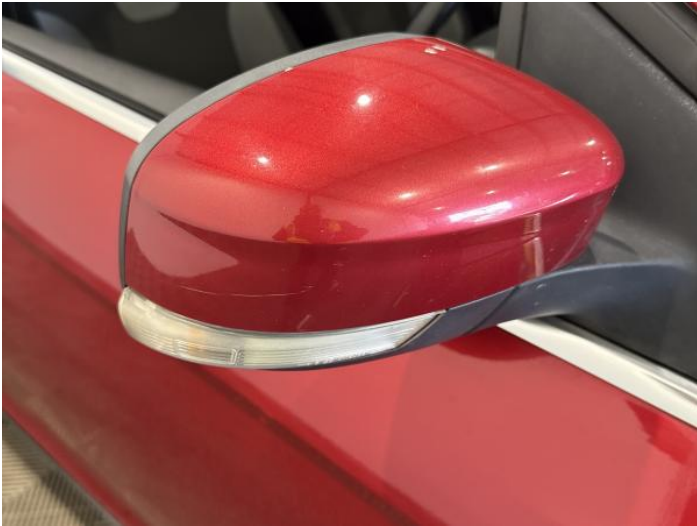
15: Door Mirror Assy osf
Scratched (Painted)
Over 25mm Thru Paint

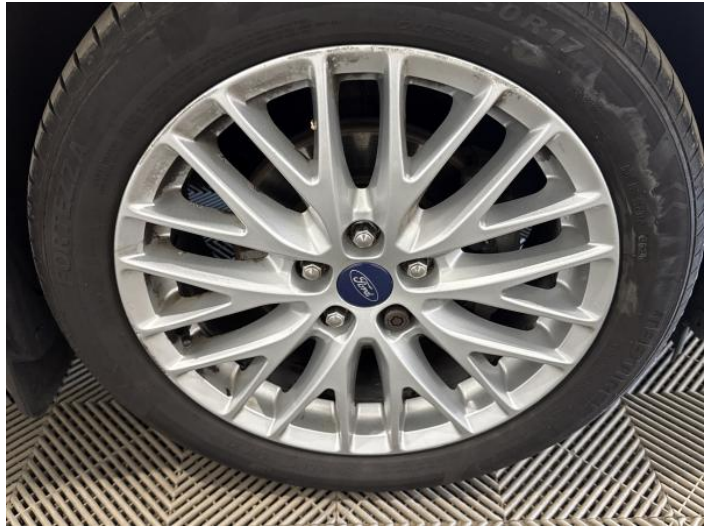
16: Wheel osf
Scratched
Over 50mm

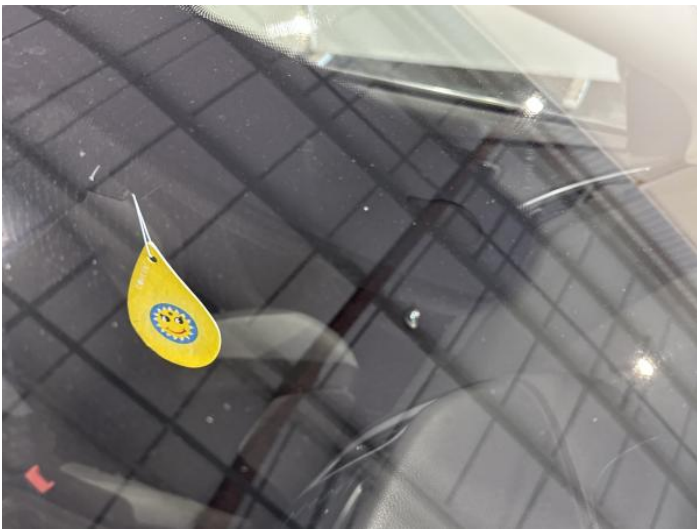
17: Screen Front
Chipped
Over 10mm

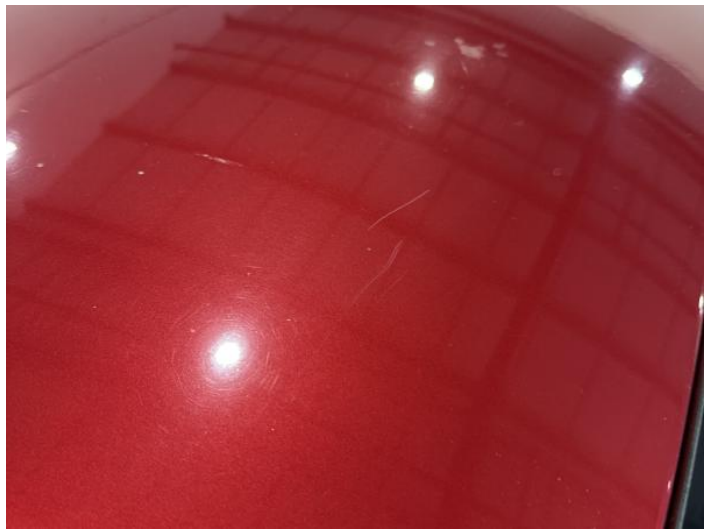
18: Roof
Scratched
Over 25mm Thru Paint
