# VEHICLE INSPECTION REPORT

**GU64UMF**

## Volkswagen UP 1.0 Move Up 5dr

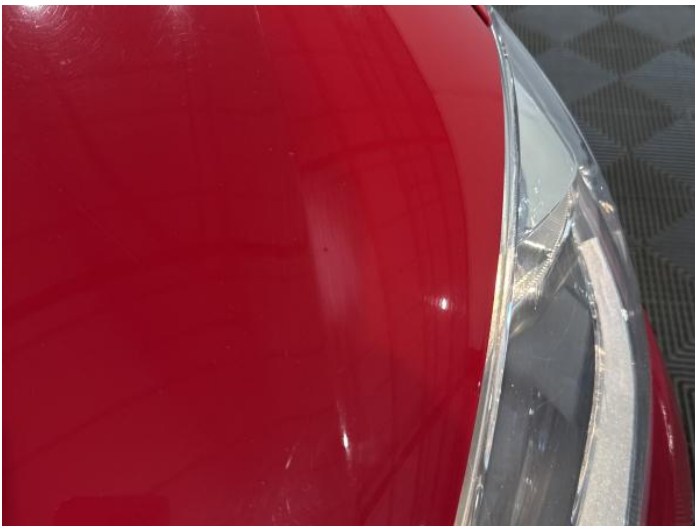
1: Bonnet  
Scratched  
Over 25mm Thru Paint

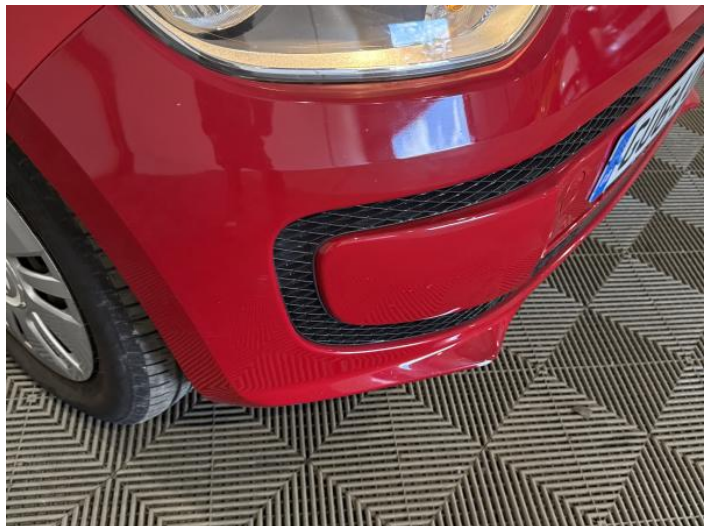
2: Bumper Front  
Poor Previous Repair  
Poor Paint

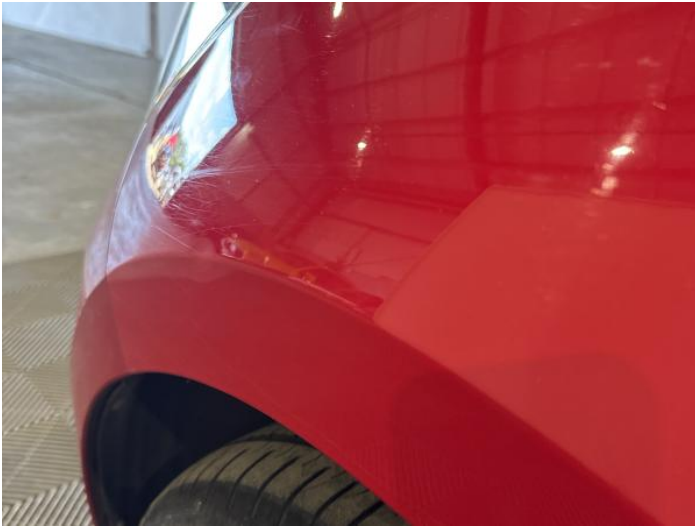
3: Wing nsf  
Dented  
Between 10mm + 30mm

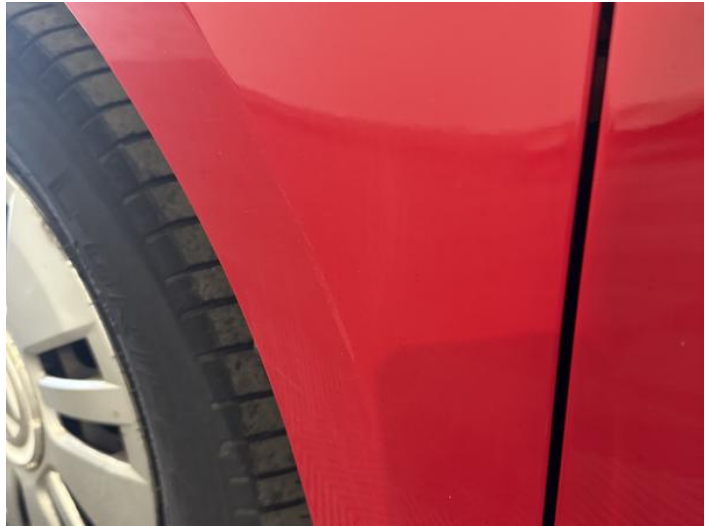
4: Wing nsf  
Scratched  
Over 25mm Thru Paint

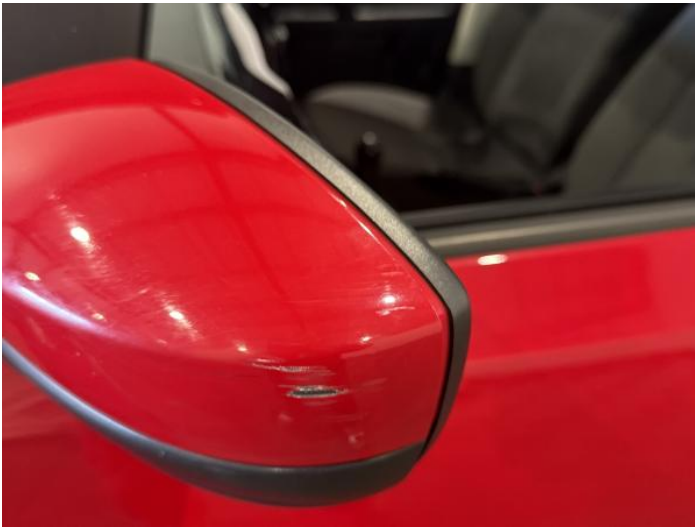
5: Door Mirror Assy nsf  
Scratched (Painted)  
Over 25mm Thru Paint

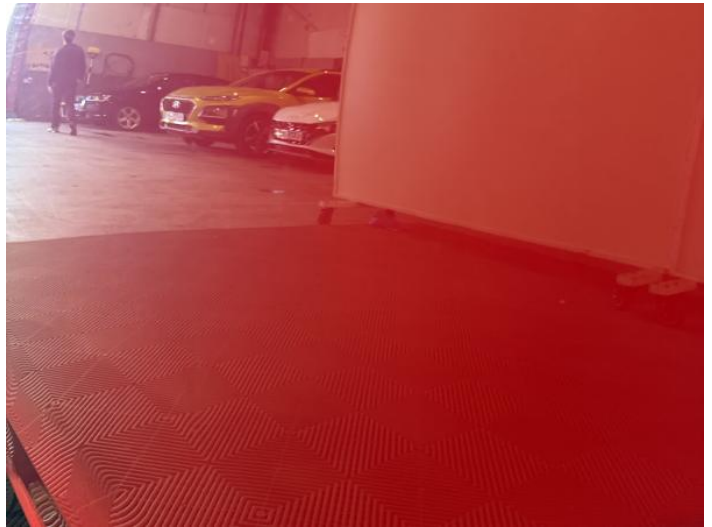
6: Door nsf  
Dented  
Between 10mm + 30mm

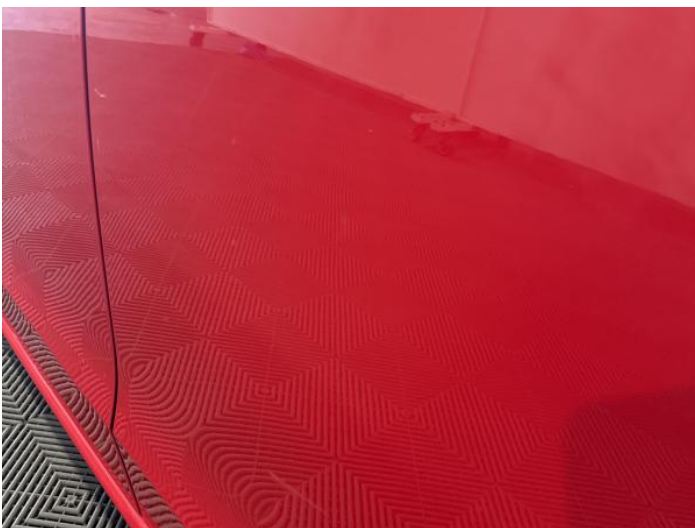
7: Door nsr  
Scratched  
Over 25mm Thru Paint

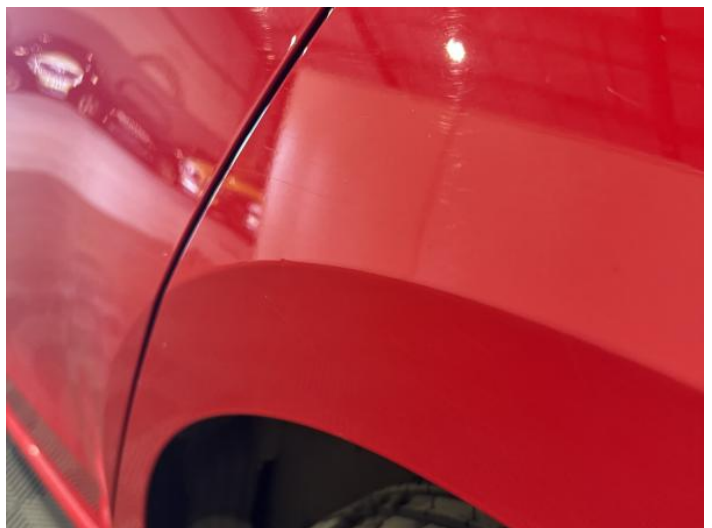
8: Qtr Panel nsr  
Dented  
Between 10mm + 30mm

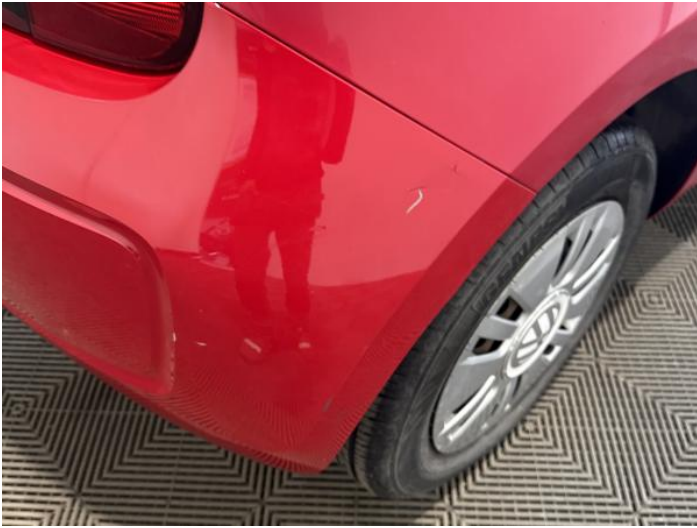
9: Bumper Rear  
Dented  
With Paint Damage

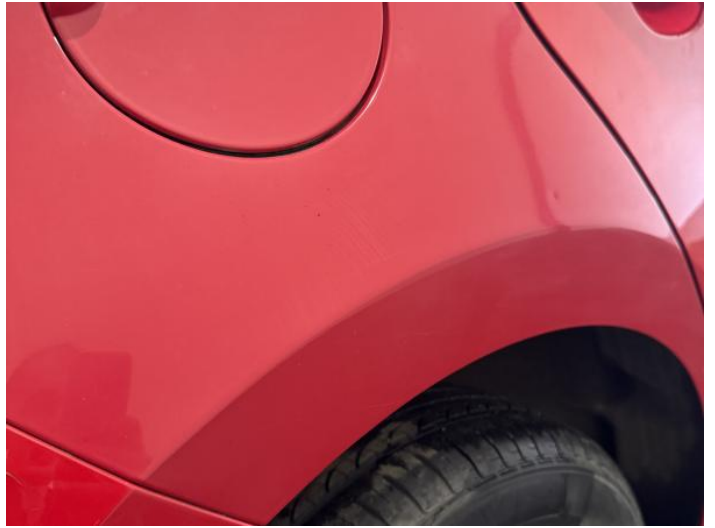
10: Qtr Panel osr  
Poor Previous Repair  
Poor Paint

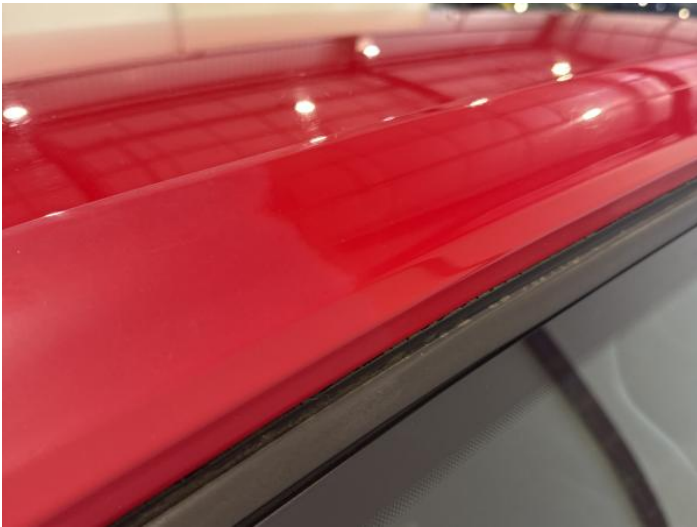
11: B Post os  
Scratched  
Over 25mm Thru Paint

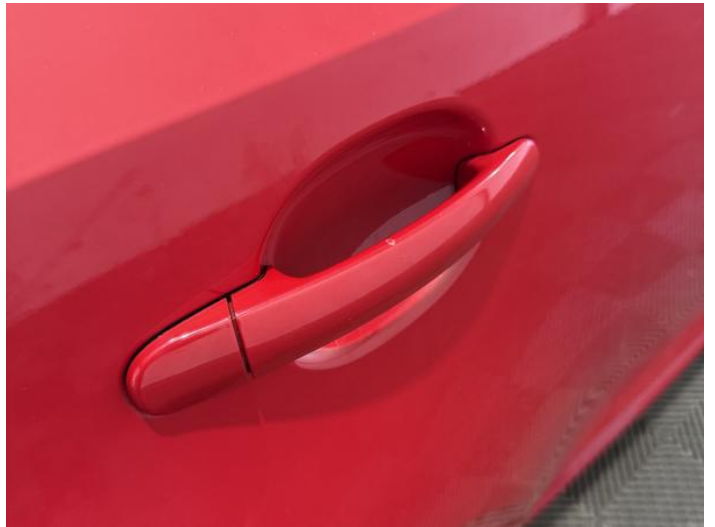
12: Handle Outer osr  
Scratched (Painted)  
UpTo 25mm Thru Paint

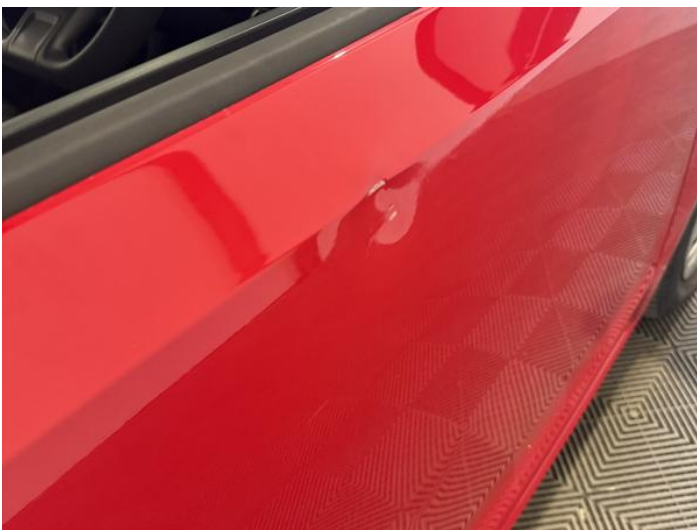
13: Door osf  
Dented  
With Paint Damage

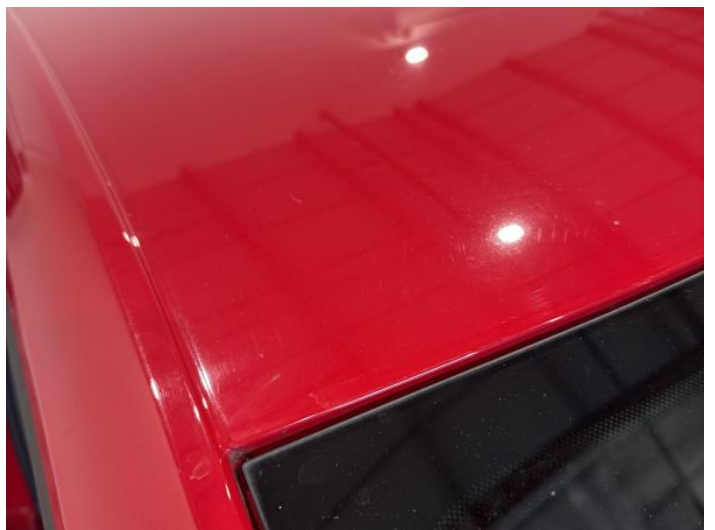
14: Roof  
Chipped  
1 To 5

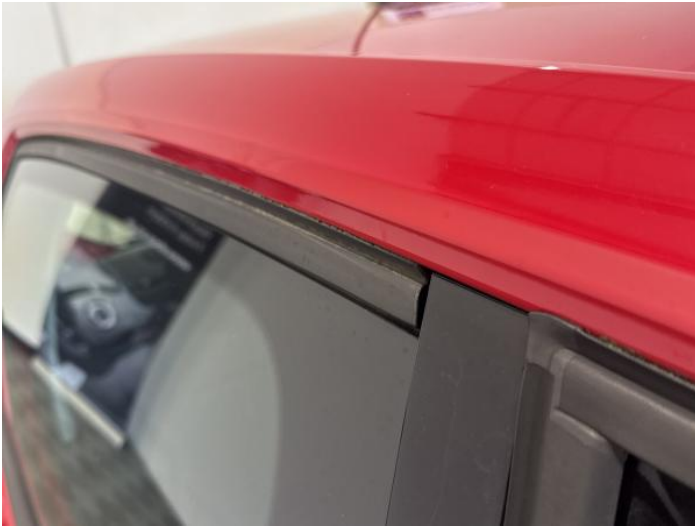
15: B Post os  
Dented  
Between 10mm + 30mm

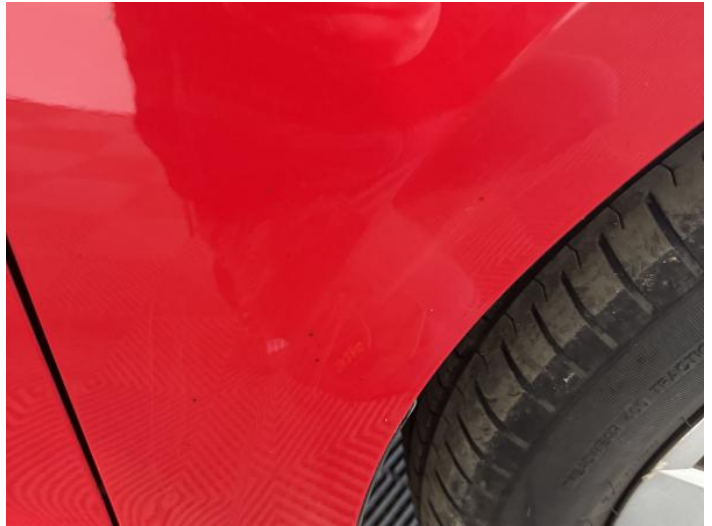
16: Wing osf  
Scratched  
Over 25mm Thru Paint
