VEHICLE INSPECTION REPORT

HY69RUH

Volkswagen Golf 1.5 TSI EVO 150 R-Line 5dr DSG

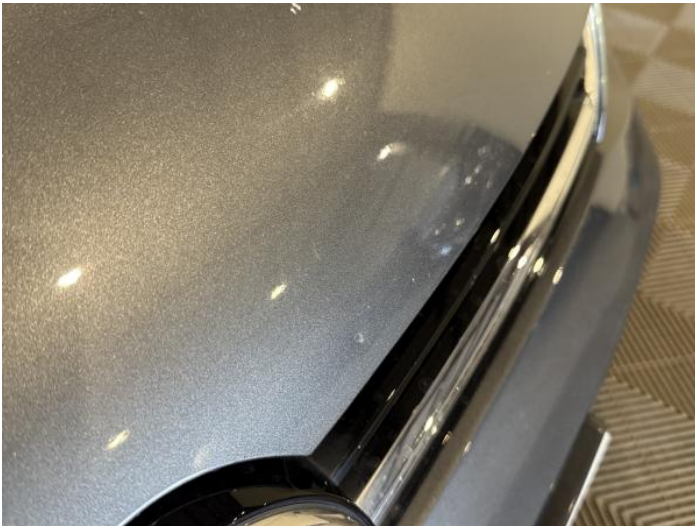
1: Bonnet
Dented
Between 10mm + 30mm

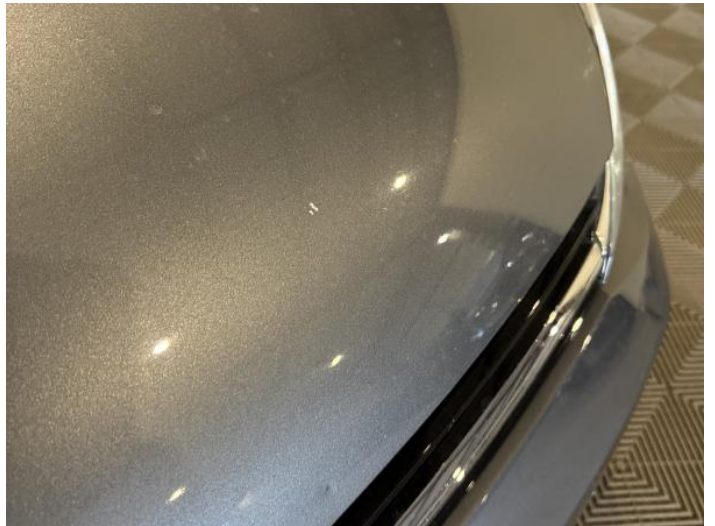
2: Bonnet
Chipped
Multiple Chips

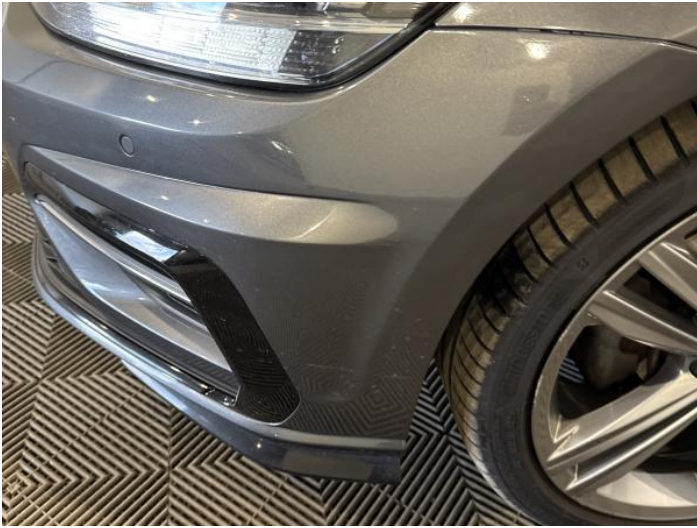
3: Bumper Front
Scratched
25 to 100mm Thru Paint

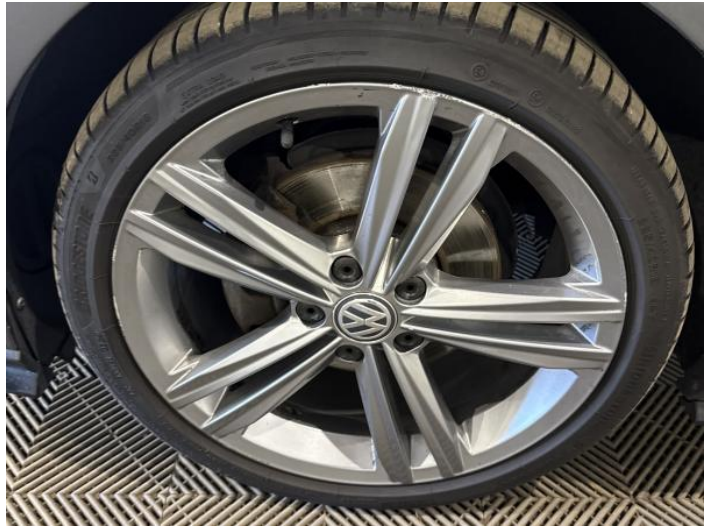
4: Wheel nsf
Scratched
Over 50mm

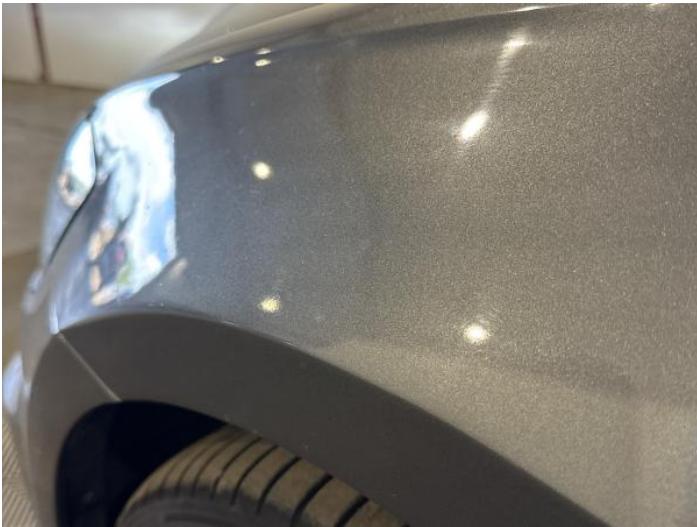
5: Wing nsf
Poor Previous Repair
Poor Paint

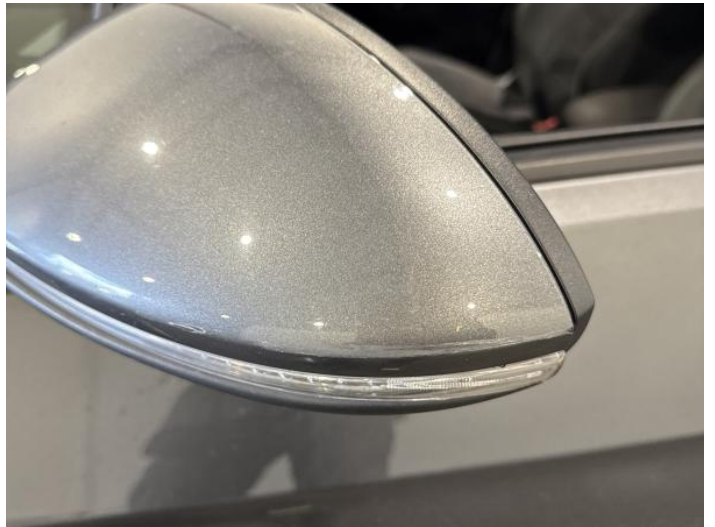
6: Door Mirror Assy nsf
Scratched (Painted)
Over 25mm Thru Paint

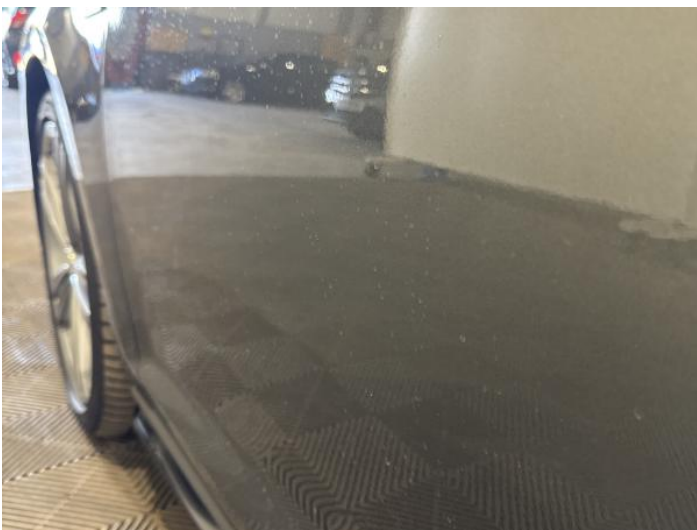
7: Door nsf
Dented
Between 10mm + 30mm

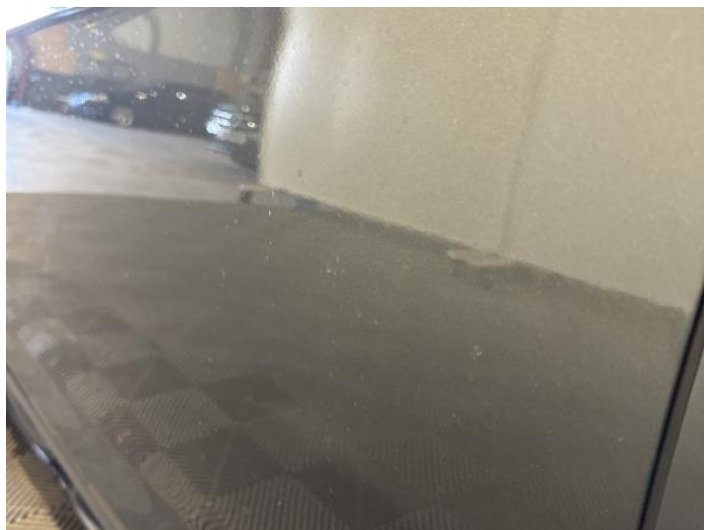
8: Door nsf
Chipped
1 To 5

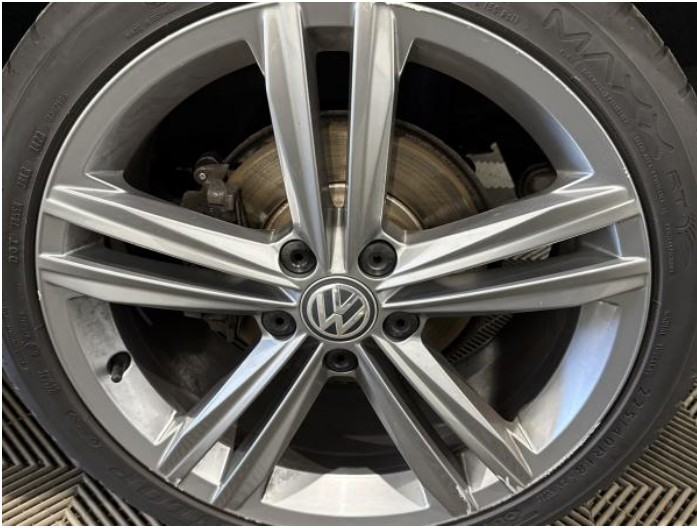
9: Wheel nsr
Scratched
Over 50mm

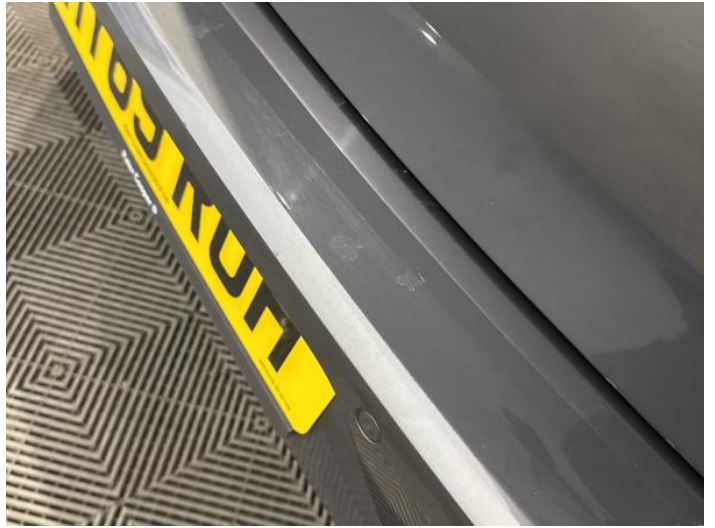
10: Bumper Rear
Chipped
1 To 5

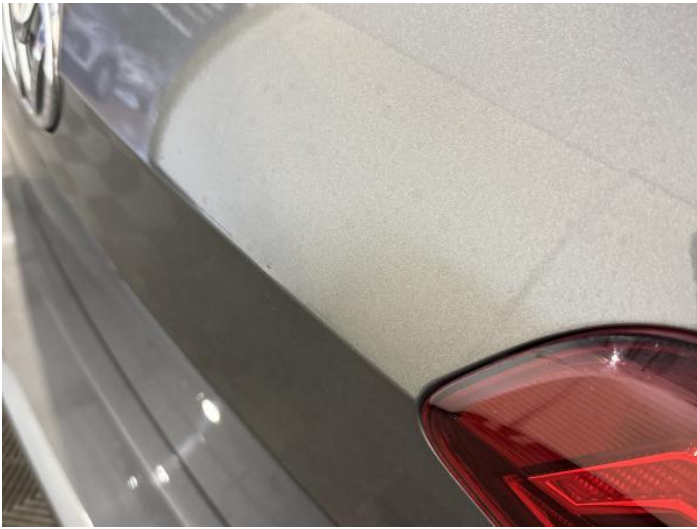
11: Tailgate
Dented
Between 10mm + 30mm

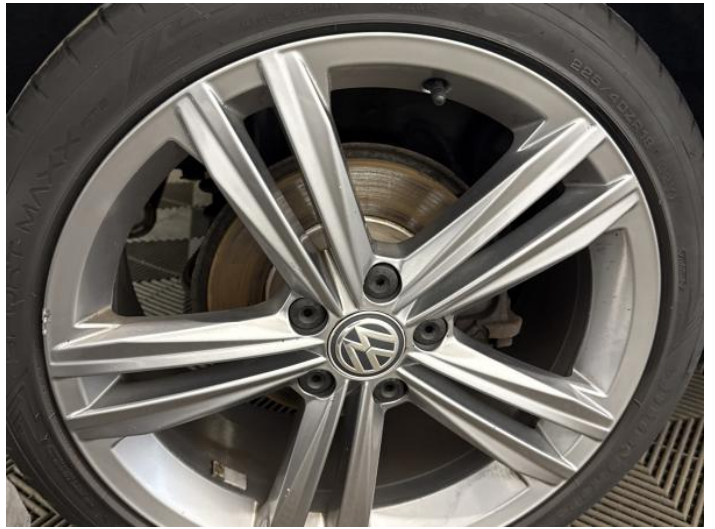
12: Wheel osr
Scratched
Up To 50mm

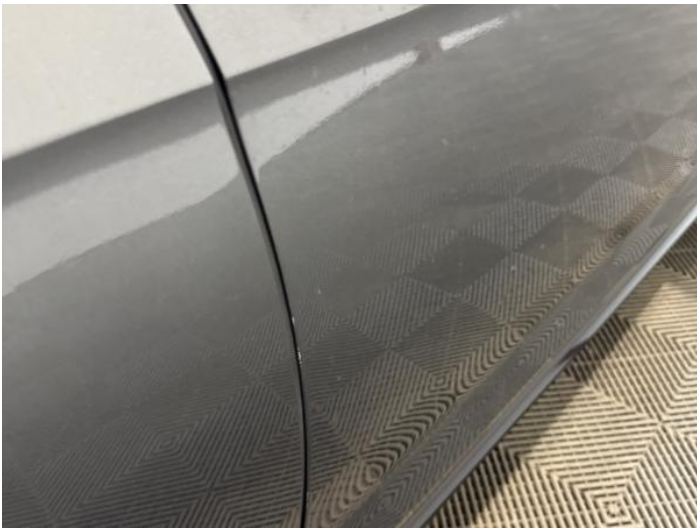
13: Door osf
Chipped
Edge Chip

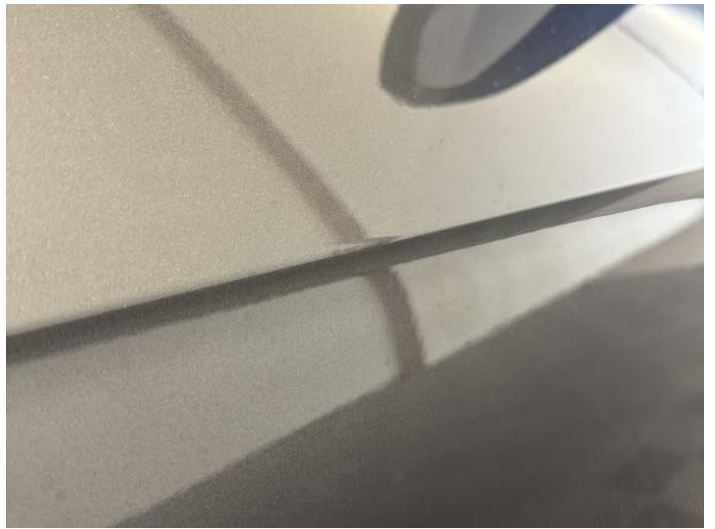
14: Door osf
Scratched
Up To 25mm Thru Paint

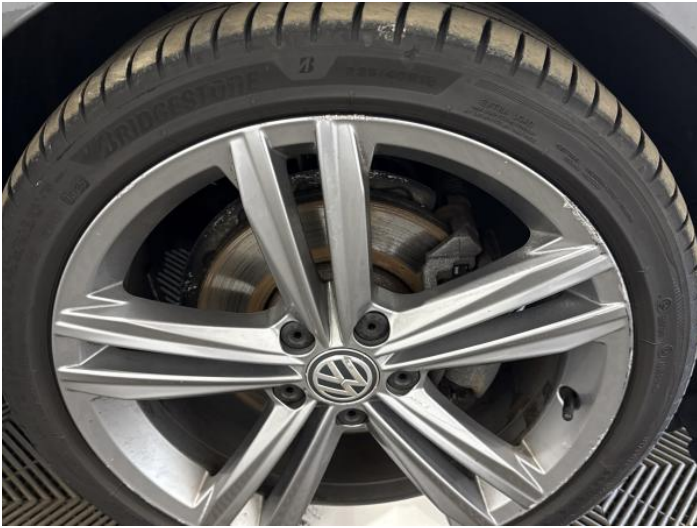
15: Wheel osf
Scratched
Over 50mm

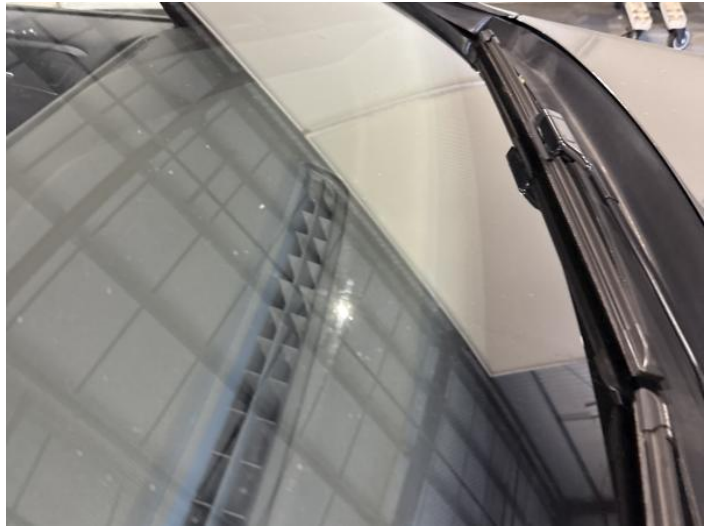
16: Screen Front
Chipped
UpTo 10mm

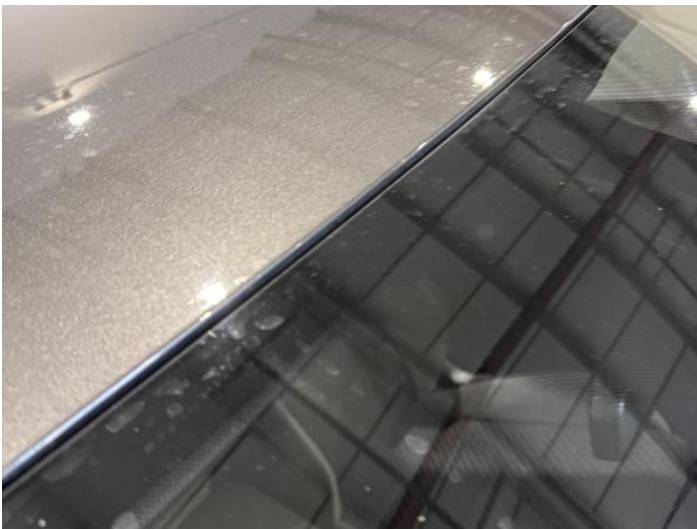
17: Roof
Chipped
Edge Chip
