VEHICLE INSPECTION REPORT

LL18HSD

Audi A5 2.0 TFSI S Line 2dr

nama
GRADE
4

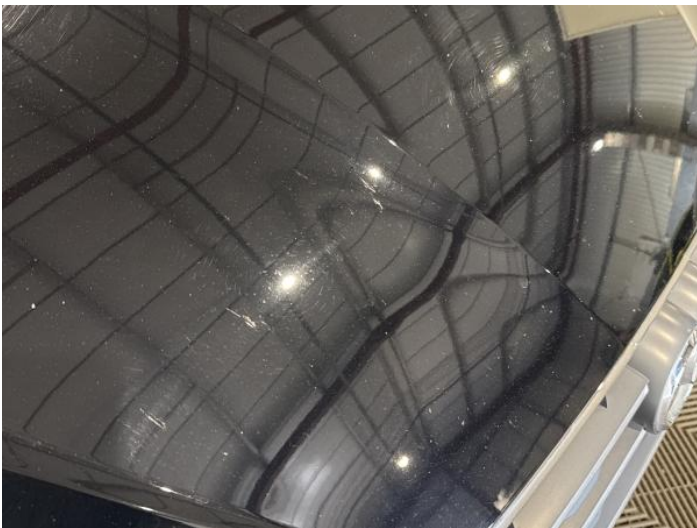
1: Bonnet
Chipped
Multiple Chips

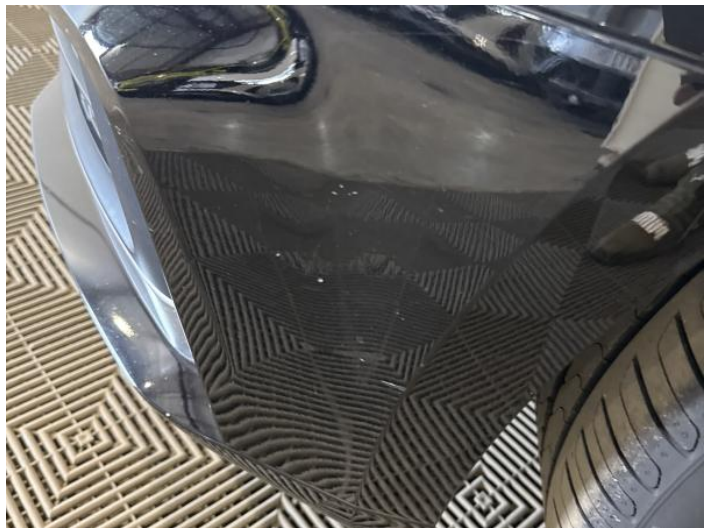
2: Bumper Front
Scratched
UpTo 25mm Thru Paint

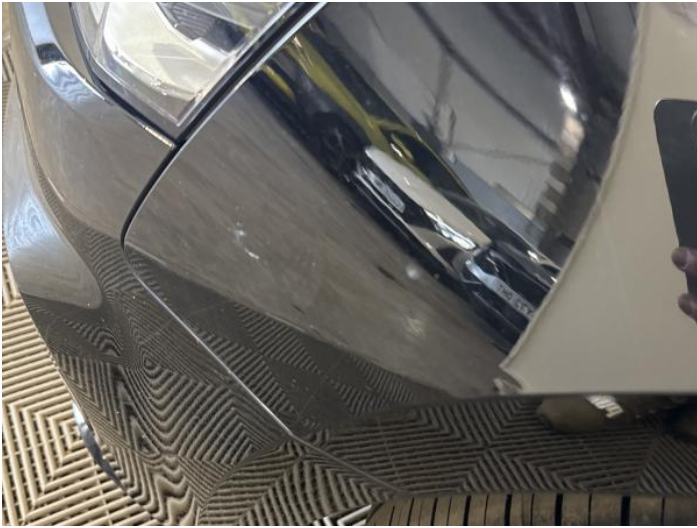
3: Wing nsf
Scratched
Up To 25mm Thru Paint

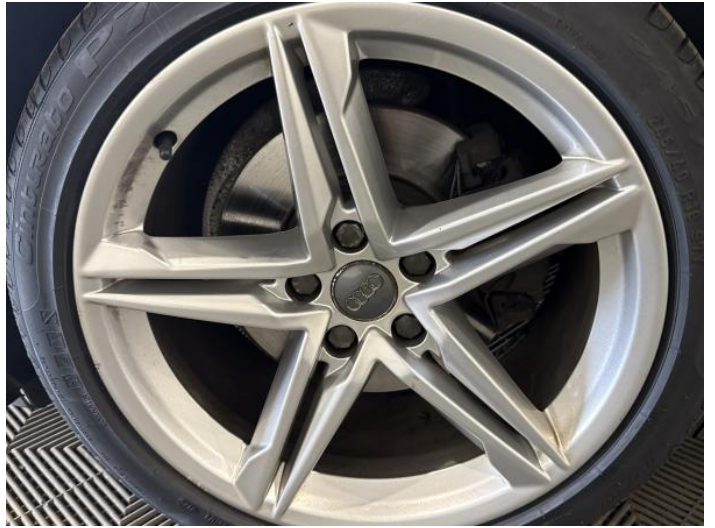
4: Wheel nsf
Scratched
Up To 50mm

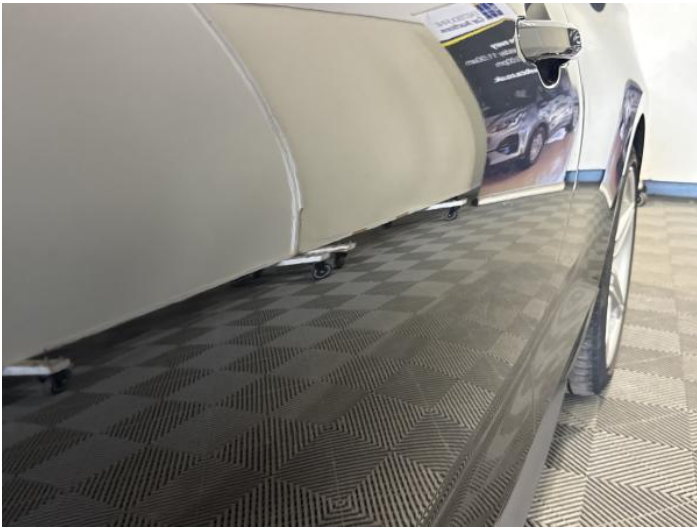
5: Door nsf
Dented
Over 30mm

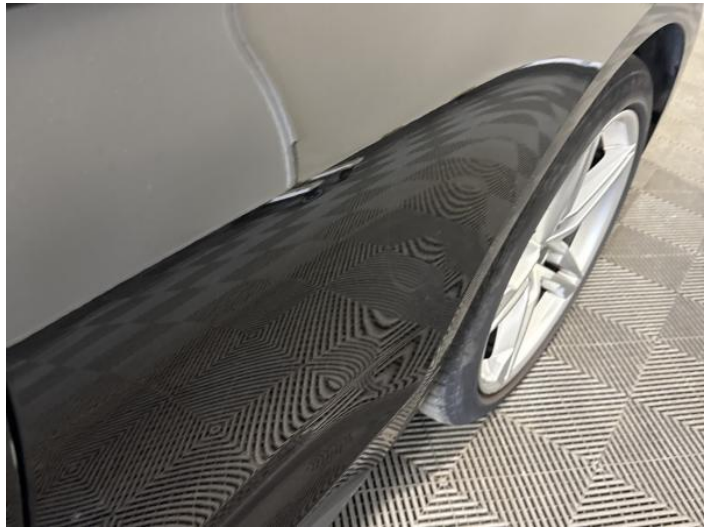
6: Qtr Panel nsr
Dented
Over 30mm

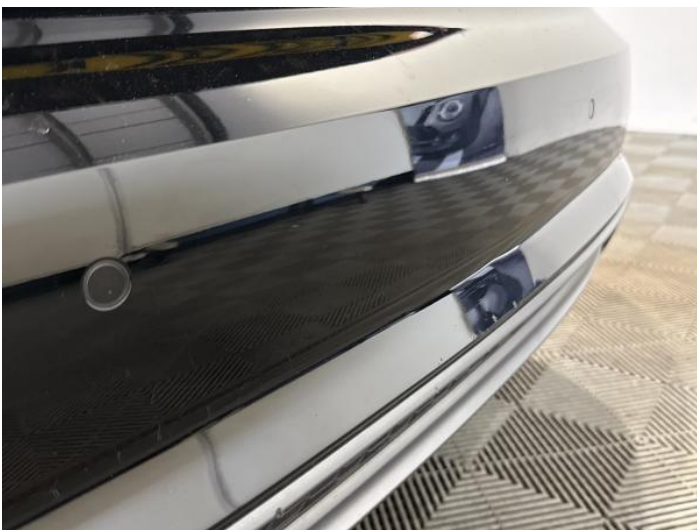
7: Bumper Rear
Scratched
25 to 100mm Thru Paint

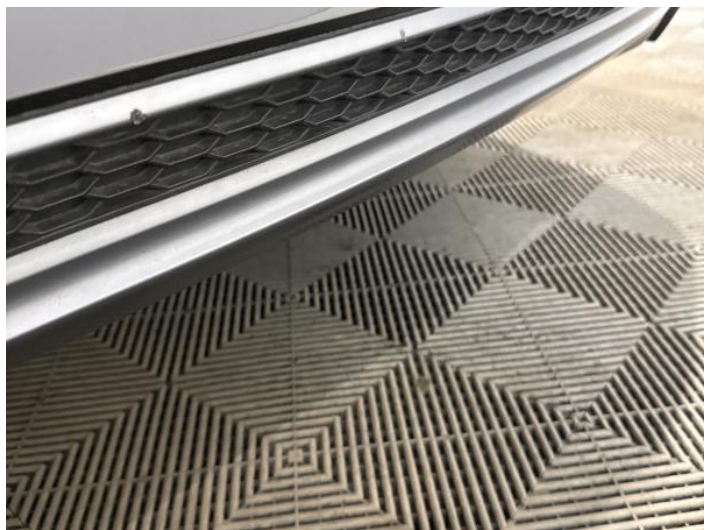
8: Bumper Rear Moulding
Scratched (Painted)
Over 25mm Thru Paint

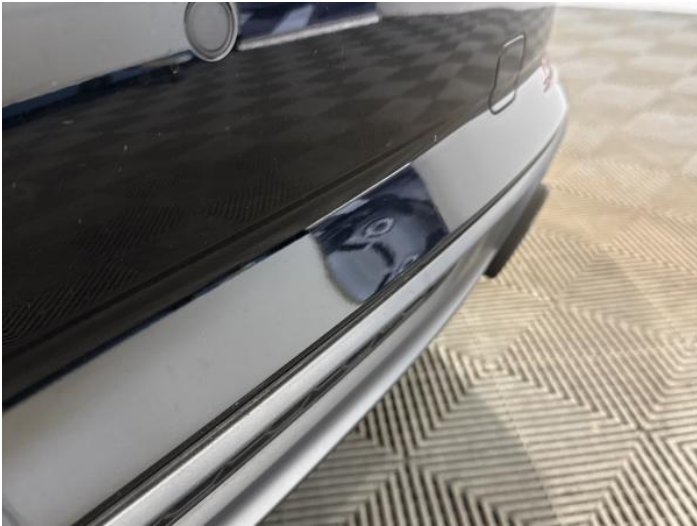
9: Bumper Rear
Dented
Between 10mm + 30mm

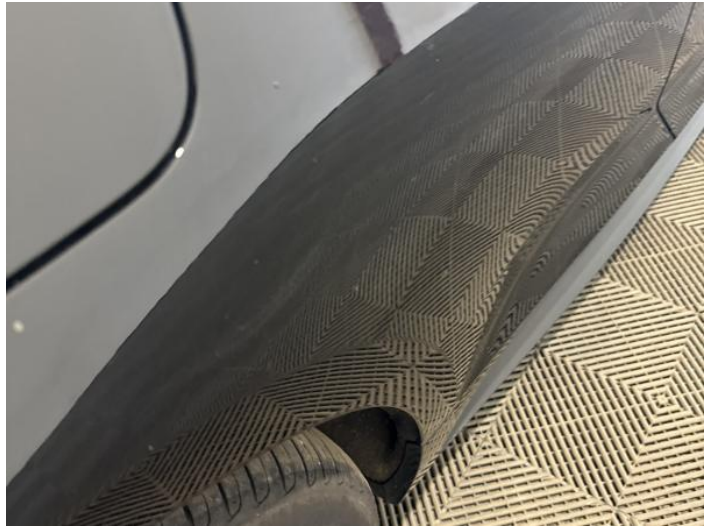
10: Qtr Panel osr
Scratched
Over 25mm Thru Paint

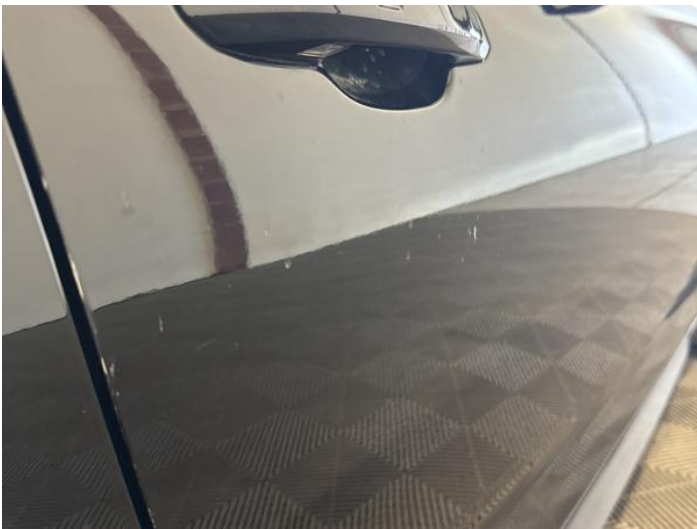
11: Door osf
Scratched
Over 25mm Thru Paint

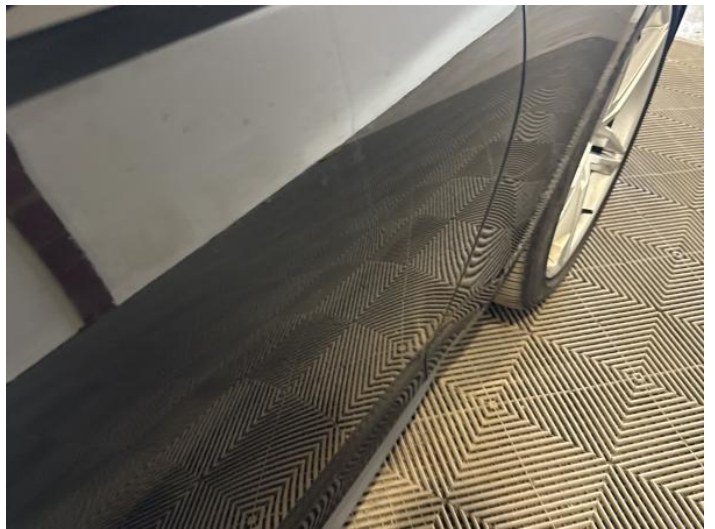
12: Door osf
Dented
Over 30mm

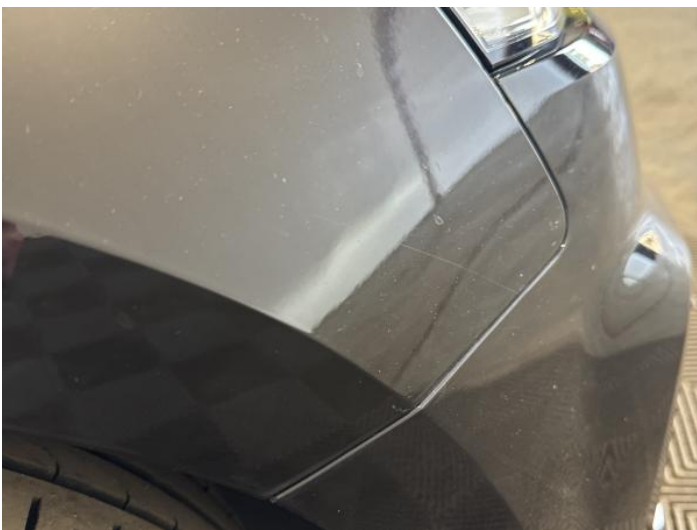
13: Wing osf
Chipped
1 To 5

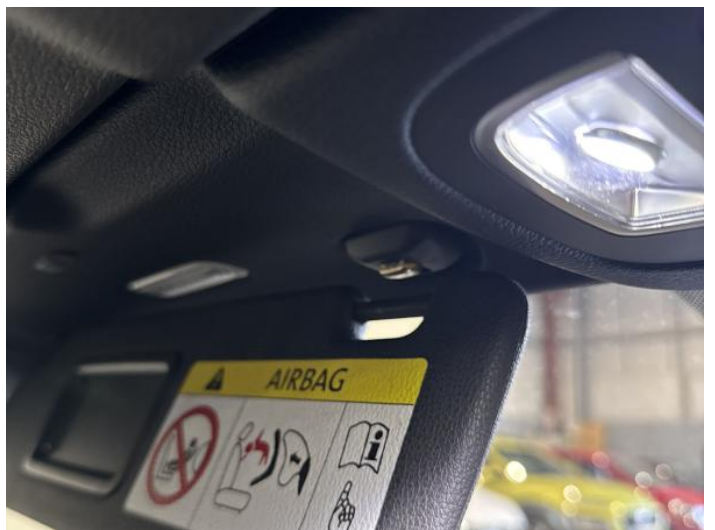
14: Sunvisor ns
Broken
Replace
